**SHAMS POWER COMPANY**  
**ENGINEERING DIVISION**  
**INSPECTION & CORROSION SECTION**  
**SHAMS 1**

**CERTIFICATE OF INSPECTION**

**ITEM : Pre- heater (SGG-2)**

## **REMOTE FIELD EDDY CURENT INSPECTION REPORT (RFET) OF PREHEATER 2 R1HAC12- BC010**

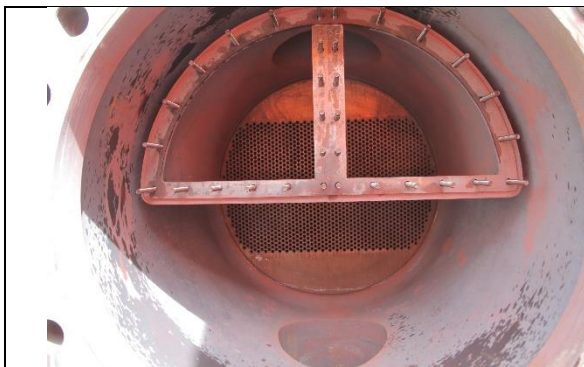
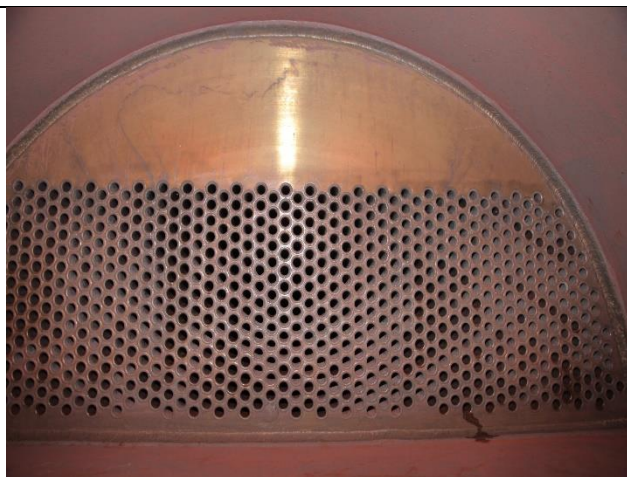
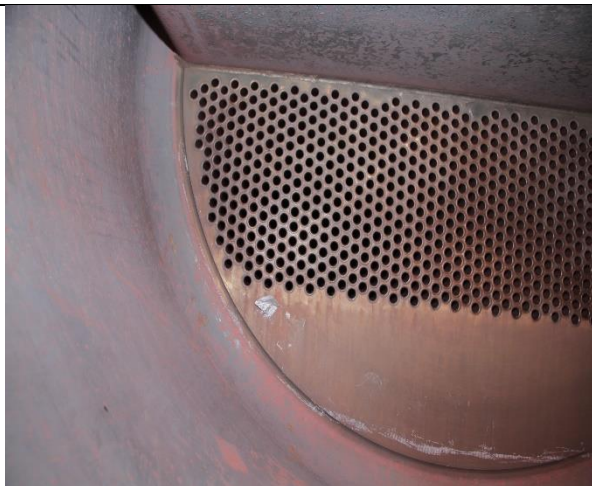
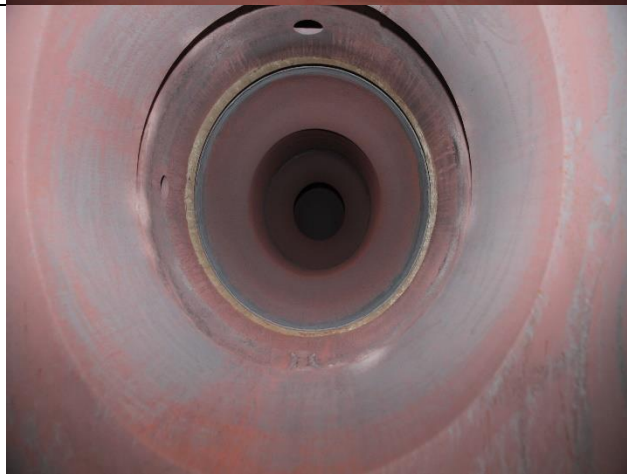
- 5.2.1 All tubes as could see internal surfaces found satisfactory condition without evidence of corrosion, apart from a considerable amounts of deposits which have cleaned by high pressure hydro jetting.
- 5.2.2 All tube to tube sheet welds found in satisfactory condition.
- 5.2.3 Diaphragm was cut out for tube inspection access and welded back successfully.

Tubes (3 plugged) , welds and internal surfaces of ( channel & pass partition)

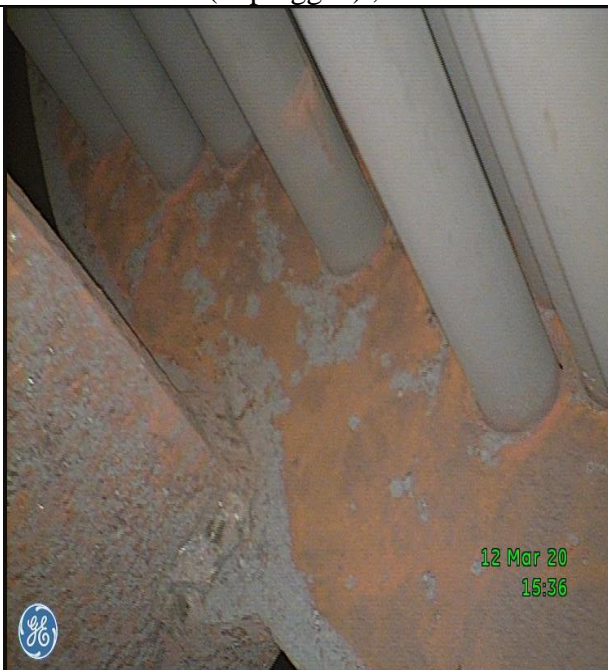
Tubes outside surfaces and baffles condition inside shell

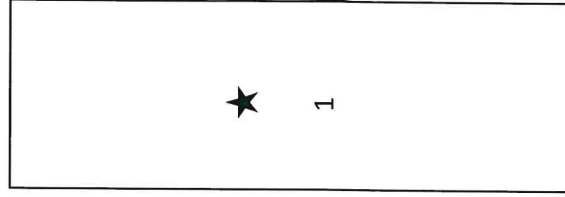
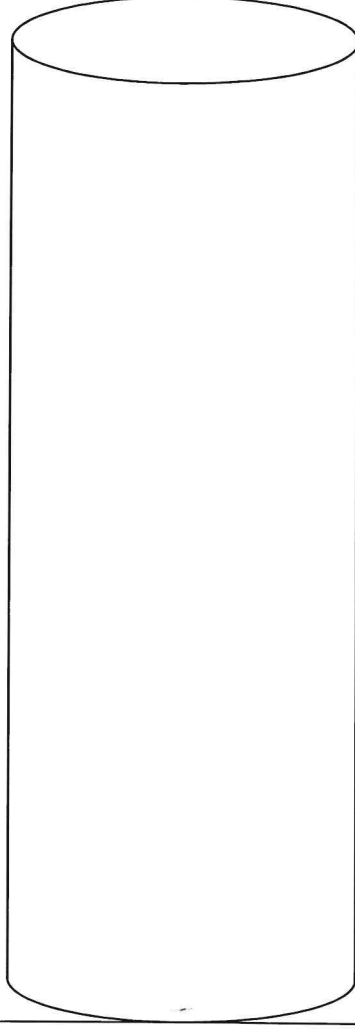
**ULTRASONIC THICKNESS SCANNING DRAWING SHEET**

LOCATION	ORIENTATION	MEASURED THICKNESS (mm)
1	12 O'CLOCK	100.01
1	3 O'CLOCK	99.99
1	6 O'CLOCK	100.20
1	9 O'CLOCK	100.10

★ **UTG LOCATION**

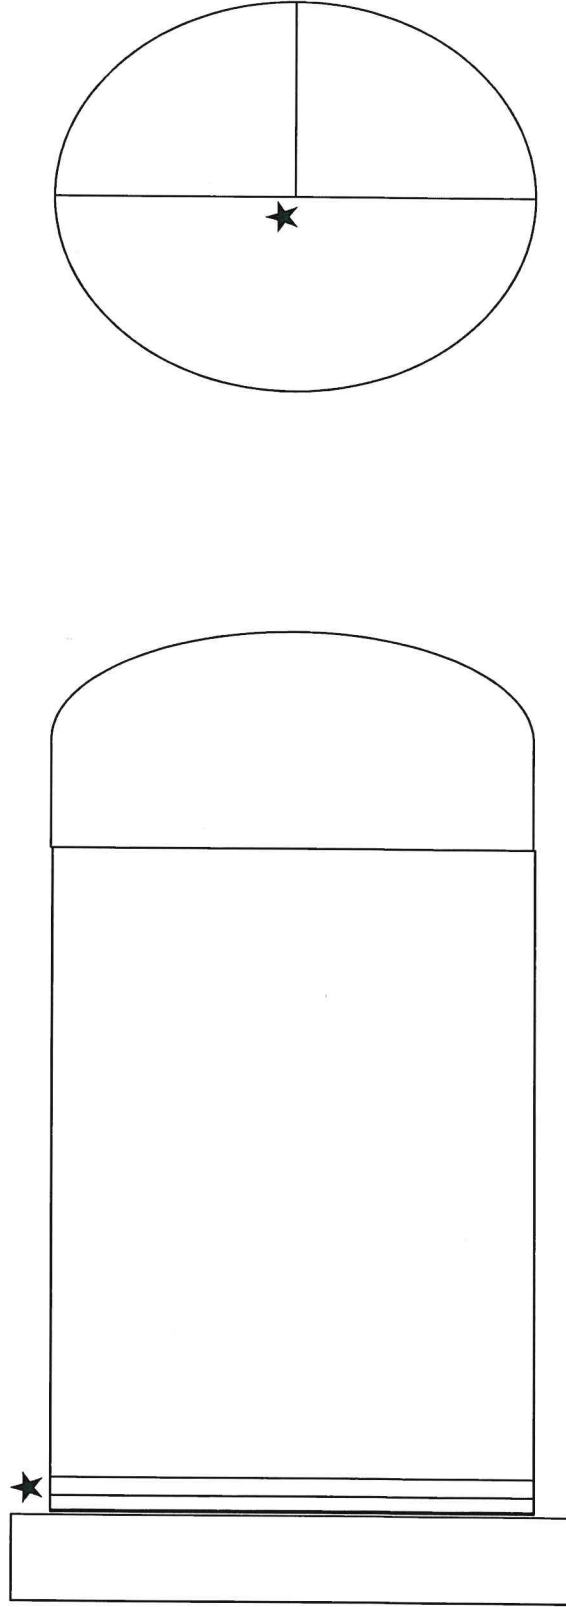
**LIQUID PENETRANT EXAMINATION - DRAWING SHEET**

# PT WAS DONE ON TUBE END WELD JOINT (PARTIALY COMPLETED)

# NO RELEVANT INDICATION WAS OBSERVED DURING THE TIME OF INSPECTION.

★ PT DONE LOCATION
