Index	FileName	Orientation	Width	Instance	Image
0	0	diagonal2.png	Diagonal	4.46	1

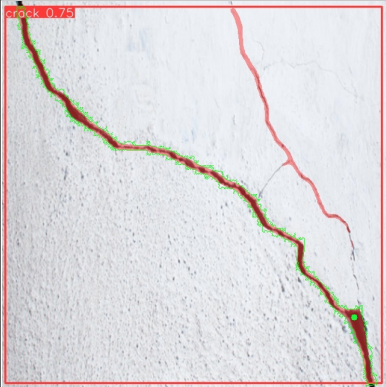
A photograph of a light-colored, textured surface with a prominent diagonal crack running from the top-left towards the bottom-right. The crack is highlighted with a green outline, and a red rectangular bounding box is drawn around it. A small red label in the top-left corner of the bounding box reads "crack 0.75".
1	1	vertical.jpg	Vertical	2.42	1
