## 1. Summary

This report provides results from testing conducted by the Bioengineering Department on the Anschutz Medical Campus in Aurora Colorado. Test procedures were adapted from the American National Standards Institute (ANSI) standard Z87.1-2003 [1] and guidelines compiled for the Journal of Occupational and Environmental Hygiene [2]. This test does not assess mechanical impacts.

Test articles reported on are described in Table 1.

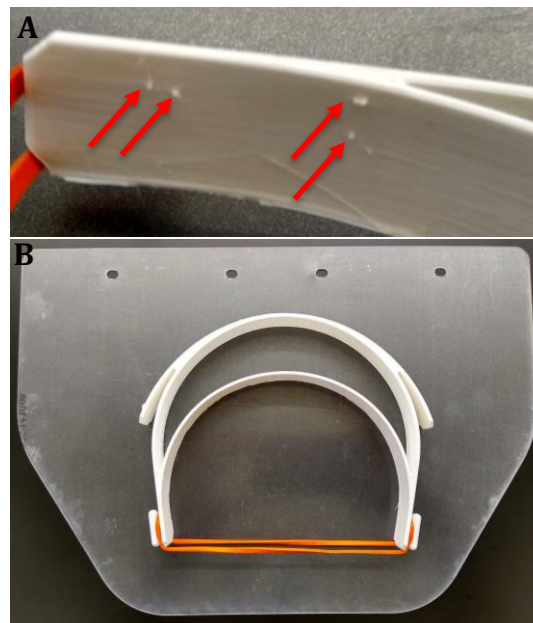
Results are summarized in Table 2. Specifications were derived from the ANSI standards and the clinical guidelines [1,2]. When the test articles arrived, there appeared to be manufacturing defects on the skin-contacting part of the halo (Figure 1a); they otherwise appeared as pictured on the submission form (Figure 1b). The shields studied were partially functional, demonstrating no flammability and no vision impairment or degradation after cleaning, but liquid penetration was observed during spraying. The shields tested demonstrated no shifting during use, but the rubber band made shield removal difficult due to catching of the tester's hair. The shields studied were not biocompatible, demonstrating skin irritation after a short period of use.

*Figure 1: Test article upon arrival.*

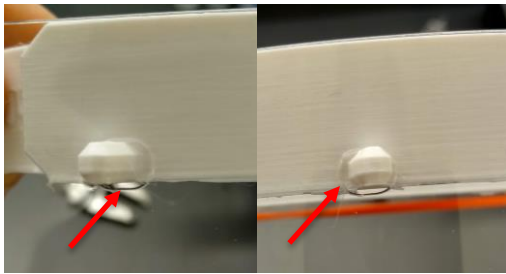
*Figure 3: Openings at shield attachment points.*

After spraying the shield three times at eye-level from three sides, liquid penetration was observed on the forehead area of the test mannequin (Figure 6). It appeared that droplets made it over the gap between the forehead and halo (Figure 3).

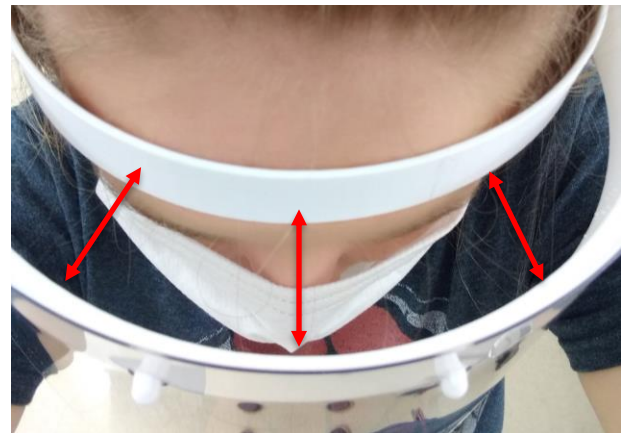
*Figure 2: Opening between forehead and outer halo.*

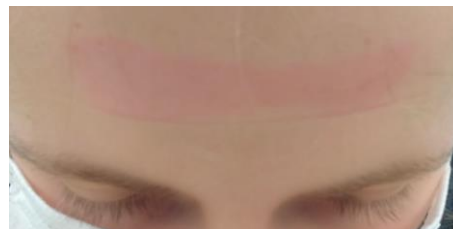
Irritability	Irritation of skin?	Tester feedback	Skin irritation and contact redness at forehead after 30 minutes, side head pain	Fail

When moving the head side-to-side and up-and-down repeatedly, the shield did not shift. In the initial wear test up to 30 minutes, there was skin irritation and noticeable contact points from the shield (Figure 4). The tester experienced difficulties with donning and doffing with long hair catching on the rubber band and experienced pain at the halo end points (Figure 5).

*Figure 4: Tester's forehead after 30 minutes of wear.*

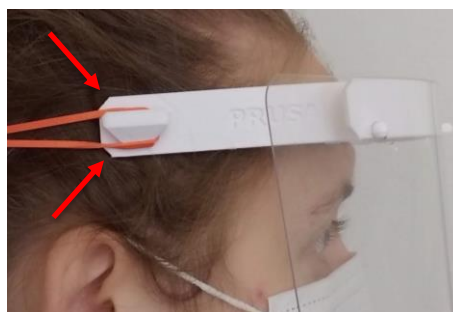
*Figure 5: Location of head pain relative to halo.*

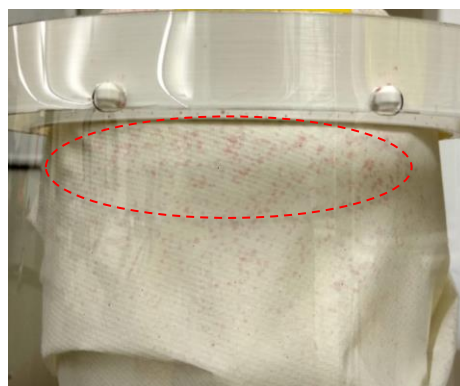
*Figure 6: Location of spray test liquid penetration.*
