Project Phase 13

Abstract:

The goal of our research is to employ the statistics of the earthquake to figure out which areas were hit the hardest and to connect that with foundation types and building age. The factors of consideration include but are not limited to foundation type, building age, geographic region and used materials. We use 2015 Nepal Gorkha earthquake data to help determine which factors are important to withstand any future earthquakes. We build a model from using Classification Analysis to figure out the connection between the variables, and their importance.

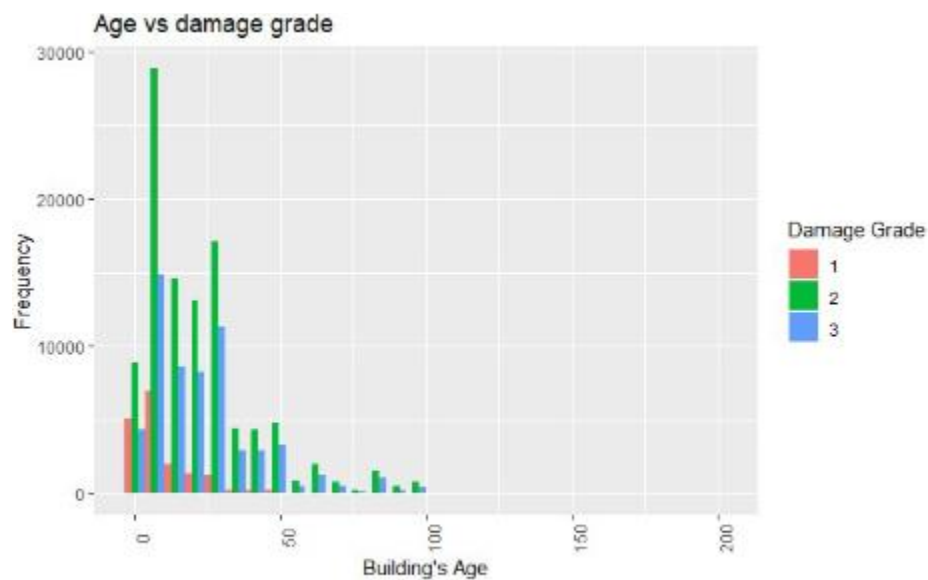
Building age association with the damage that was dealt to it.

- 1) The more floors, the more damage is done to a building.
- 2) The youngest buildings had the most devastating damages.

To reduce damage from future earthquakes, we can look at the plots and determine that the number of floors and the building age directly affected the amount of damage a building endured. We would recommend that buildings are more frequent but have a reduced number of floors. Another is that they would need to be sure they kept buildings well equipped with modern technology and keep with new structural integrity strategies.

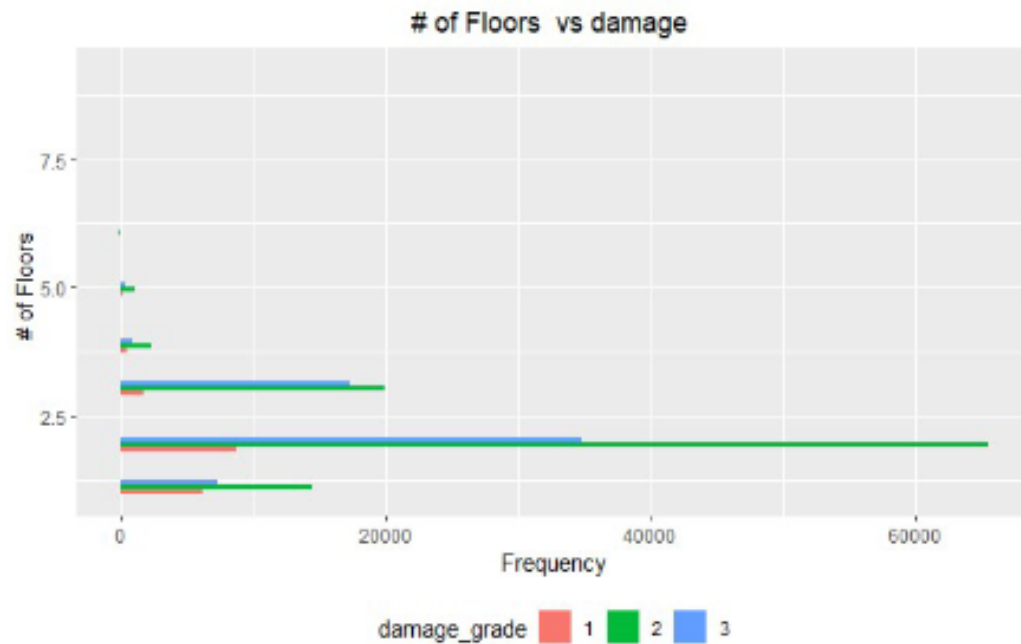
Building floors association with the damage that was dealt to it.

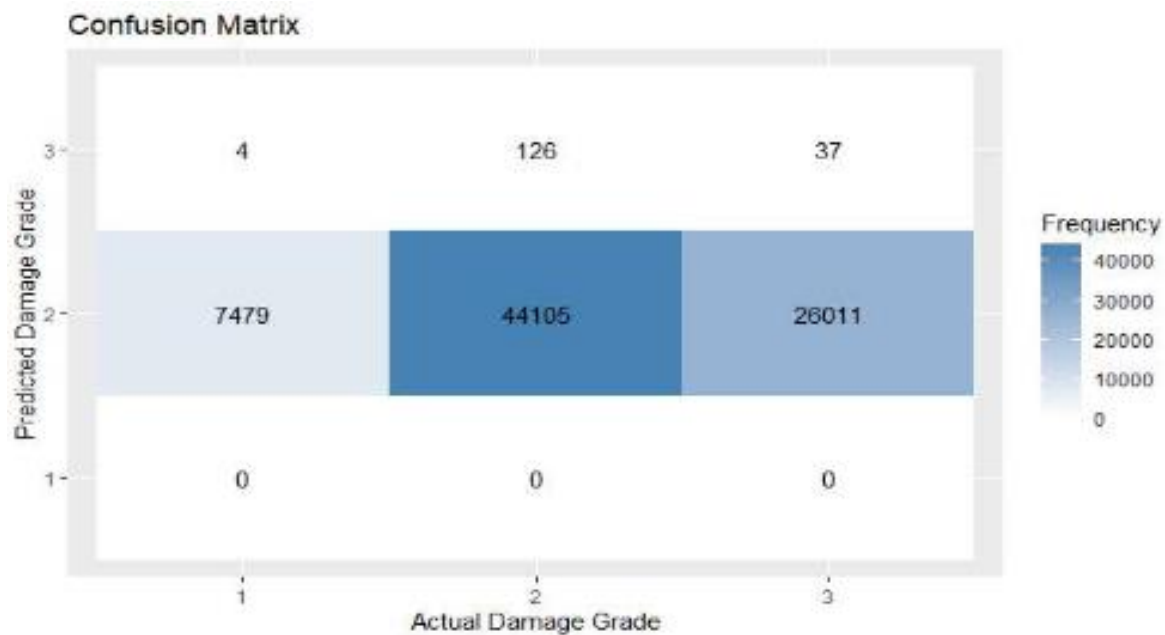
Finished Confusion Matrix Table showing predicted and actual values.

After looking at the dataset and determining which variables we would indicate as our “key variables,” we came to a conclusion that we would be using a decision tree or logistic regression. The decision tree path came to a hard close as it just was not working out for us and we had produced a satisfying result with our logistic regression. Following the Logistic Regression, it was then decided to fit it into a confusion matrix to see the predicted and actual values of the damages.
