Uniform Mitigation Verification Inspection Form

Inspection Date: October 9, 2015		
Owner Information		
Owner Name: Gail Loretta Kossie		Contact Person:
Address: 2905 Farragut Lane		Home Phone:
City: West Palm Beach	Zip: 33409	Work Phone:
County: Palm Beach		Cell Phone:
Insurance Company:		Policy #:
Year of Home : 1985	# of Stories: 1	Email:

Photographs: 2905 Farragut Lane, West Palm Beach, FL 33409

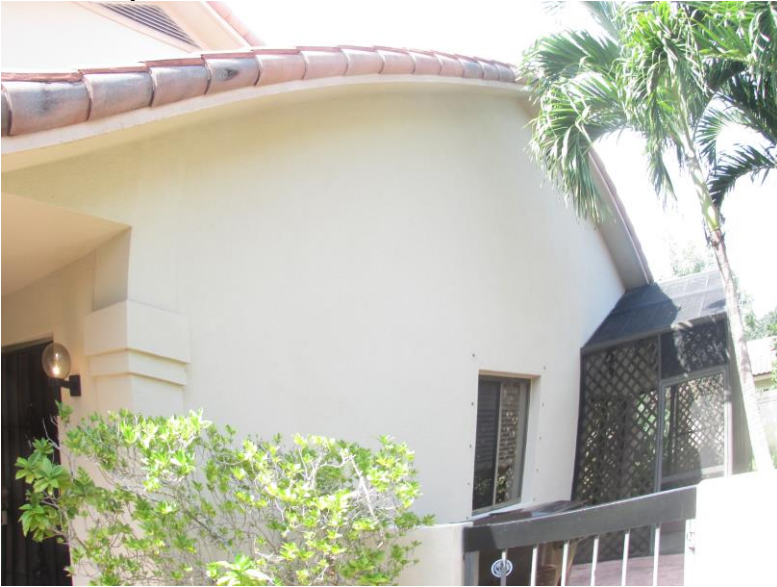
Roof Geometry

- ☐ A. Hip Roof Hip roof with no other roof shapes greater than 10% of the total roof system perimeter.
Total length of non-hip features: _____ feet; Total roof system perimeter: _____ feet
- ☐ B. Flat Roof Roof on a building with 5 or more units where at least 90% of the main roof area has a roof slope of less than 2:12. Roof area with slope less than 2:12 _____ sq ft; Total roof area _____ sq ft
- ☒ C. Other Roof Any roof that does not qualify as either (A) or (B) above.

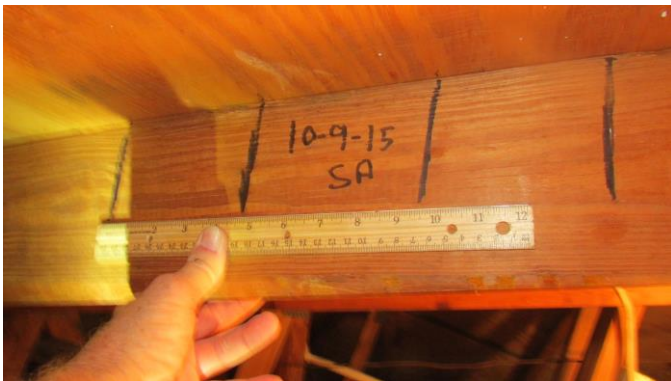
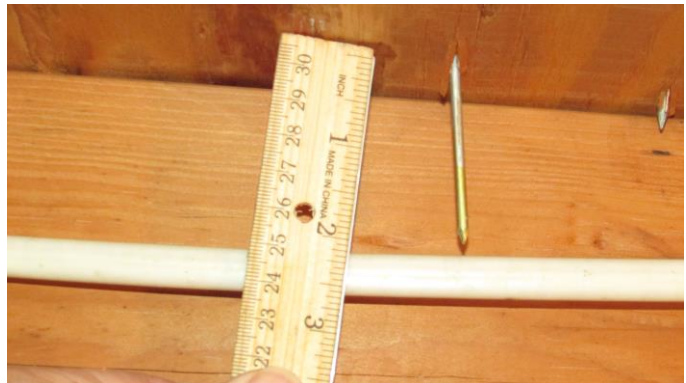
Roof to Deck Attachment

- ☒ C. Plywood/OSB roof sheathing with a minimum thickness of 7/16" inch attached to the roof truss/rafter (spaced a maximum of 24" inches o.c.) by 8d common nails spaced a maximum of 6" inches in the field. -OR- Dimensional lumber/Tongue & Groove decking with a minimum of 2 nails per board (or 1 nail per board if each board is equal to or less than 6 inches in width). -OR- Any system of screws, nails, adhesives, other deck fastening system or truss/rafter spacing that is shown to have an equivalent

or greater resistance than 8d common nails spaced a maximum of 6 inches in the field or has a mean uplift resistance of at least 182 psf.

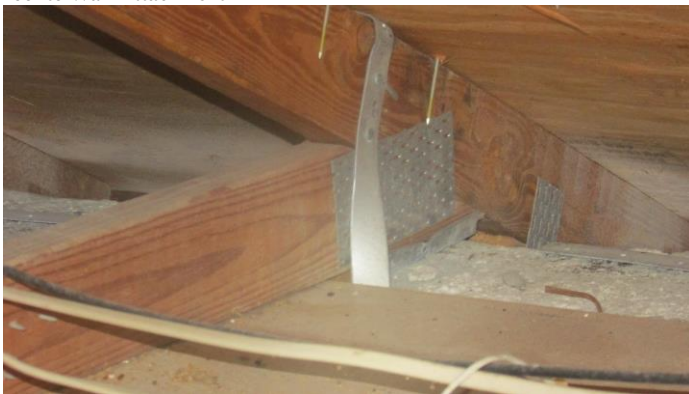
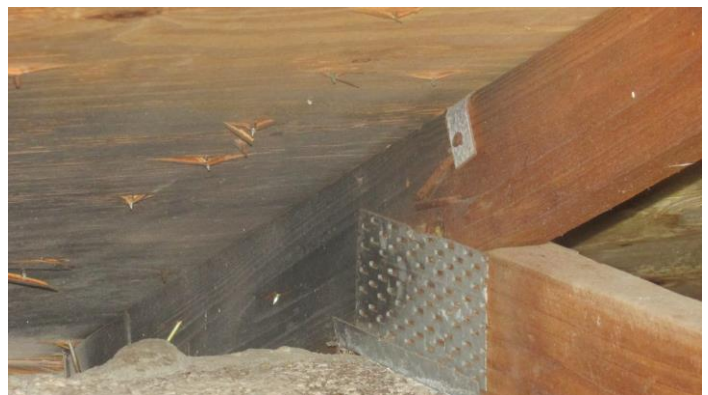
Roof to Wall Attachment

- ☒ Secured to truss/rafter with a minimum of three (3) nails, **and**
- ☒ Attached to the wall top plate of the wall framing, or embedded in the bond beam, with less than a 1/2" gap from the blocking or truss/rafter **and** blocked no more than 1.5" of the truss/rafter, **and** free of visible severe corrosion.

- ☒ C. Single Wraps
 - Metal connectors consisting of a single strap that wraps over the top of the truss/rafter and is secured with a minimum of 2 nails on the front side and a minimum of 1 nail on the opposing side.

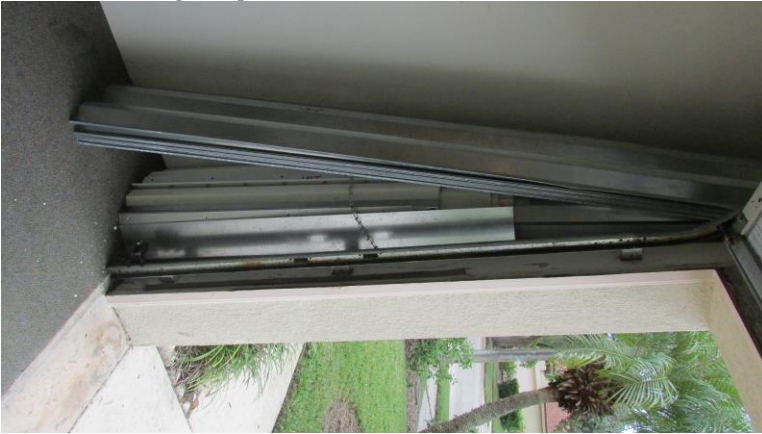
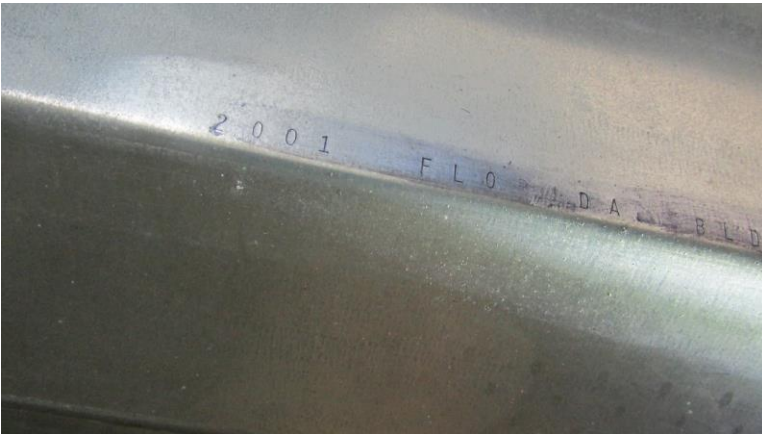
Shutters and Rating Stamp

- ☒ **A. Exterior Openings Cyclic Pressure and 9-lb Large Missile (4.5 lb for skylights only)** All Glazed openings are protected at a minimum, with impact resistant coverings or products listed as wind borne debris protection devices in the product approval system of the State of Florida or Miami-Dade County and meet the requirements of one of the following for "Cyclic Pressure and Large Missile Impact" (Level A in the table above).

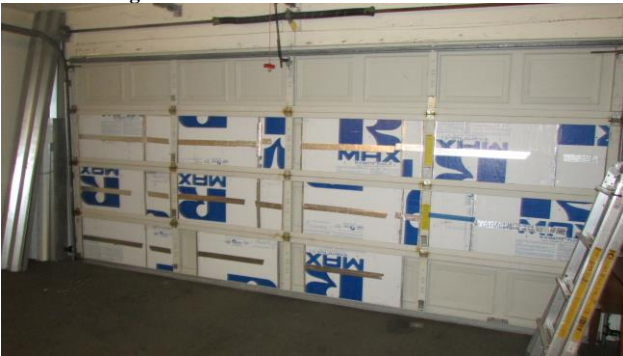
- ☒ A.3 One or More Non-Glazed Openings is classified as Level B, C, N, or X in the table above
- ☐ **B. Exterior Opening Protection- Cyclic Pressure and 4 to 8-lb Large Missile (2-4.5 lb for skylights only)** All Glazed openings are protected, at a minimum, with impact resistant coverings or products listed as windborne debris protection devices in the product approval system of the State of Florida or Miami-Dade County and meet the requirements of one of the following for "Cyclic Pressure and Large Missile Impact" (Level B in the table above):

Unrated Garage Door

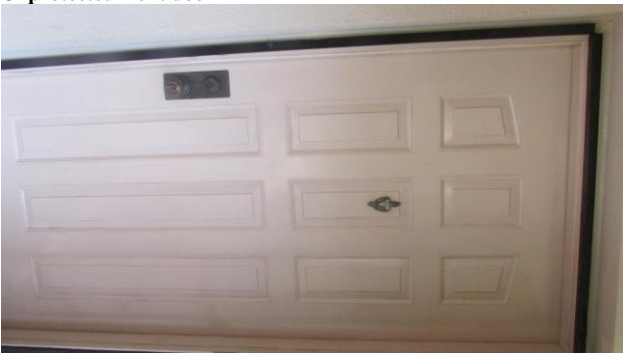
Unprotected front door
