# HARMONICS AUDIT REPORT BY DELTA CLEAN-TECH

**SAMPLE REPORT**

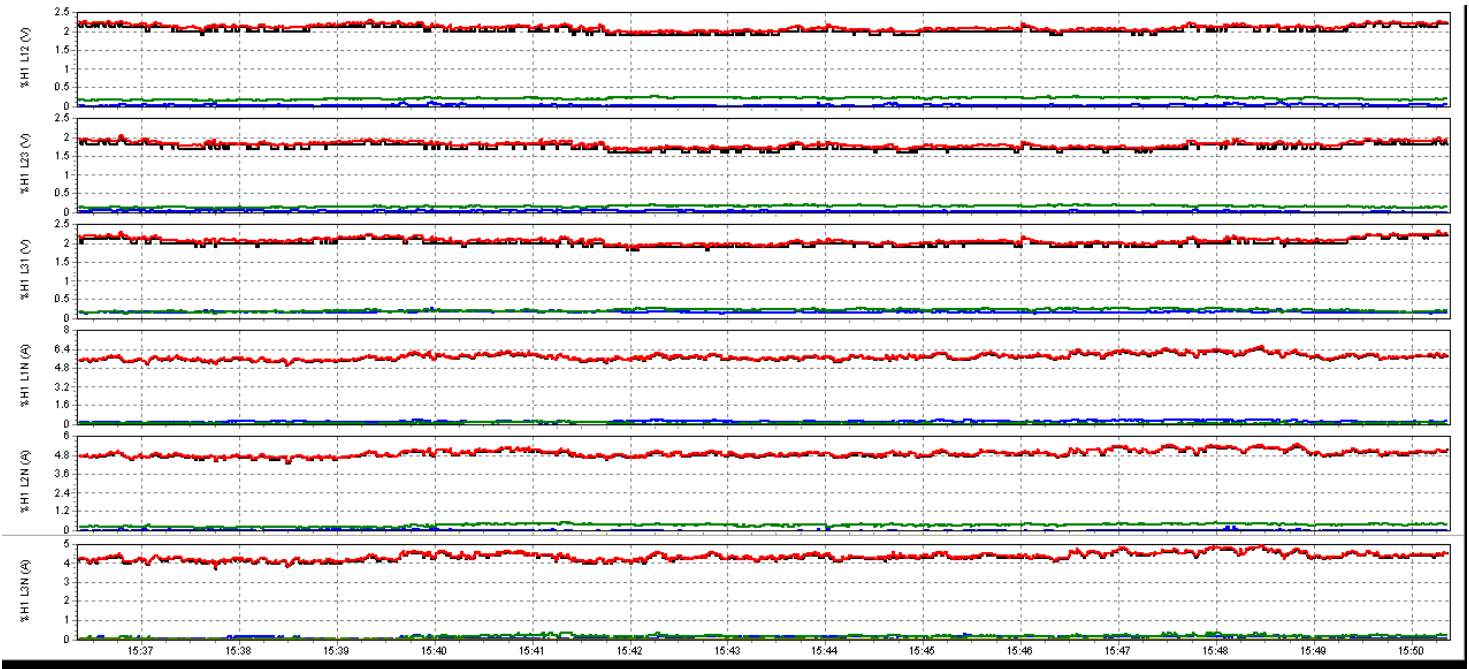
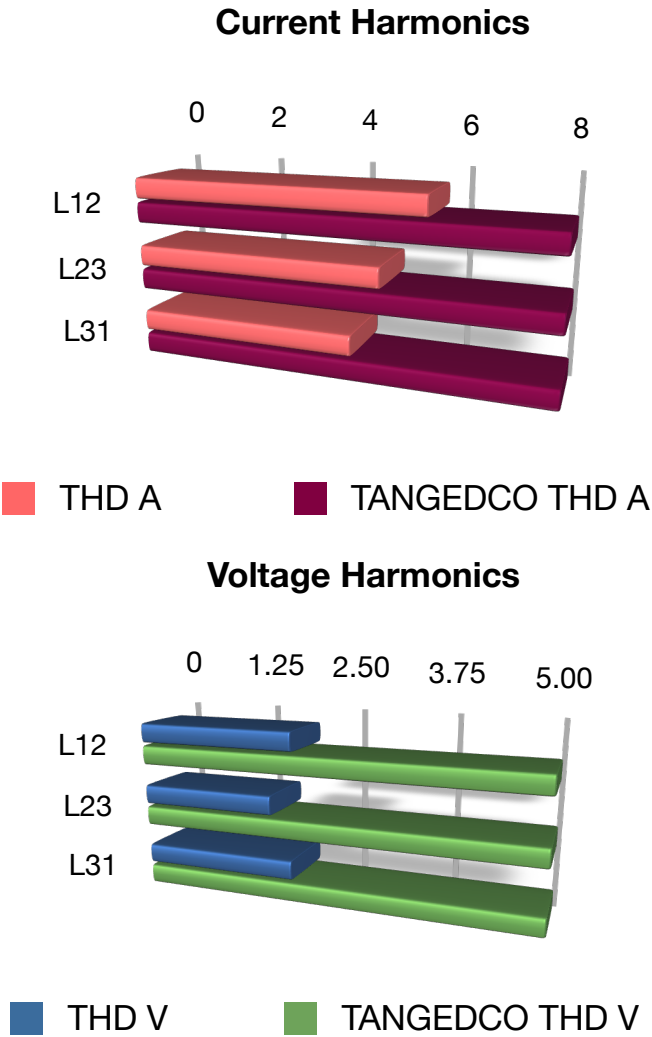
DATA POINT 1 : 11KV INCOMER

Chart below shows readings taken at 11KV incomer and presence of 5th harmonics. As per CEA regulations THD V, V ind and THD A are within limits.

THD V L12 Avg	THD V L23 Avg	THD V L31 Avg
2.034244946	1.743043995	2.007372176
Volts H5 L12 Avg	Volts H5 L23 Avg	Volts H5 L31 Avg
2.099926278	1.808850178	2.06412604
THD A L12 Avg	THD A L23 Avg	THD A L31 Avg
5.713793103	4.86313912	4.317241379
