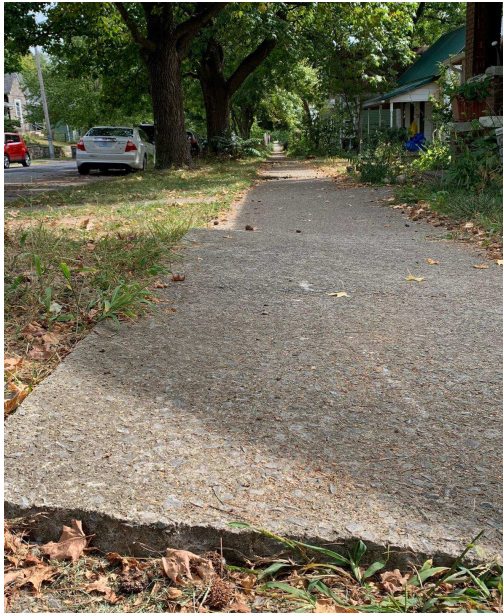
1.

The photos below illustrate the degradation of the primary project area on West 6th Street between N. Fairview Street and N. Elm Street. The first four pictures are of trip hazards that exceed 2" in elevation. In the area chosen, Public Works staff has identified more than 60 of these trip hazards, which create safety hazards for all that utilize this area as a means of mobility. .

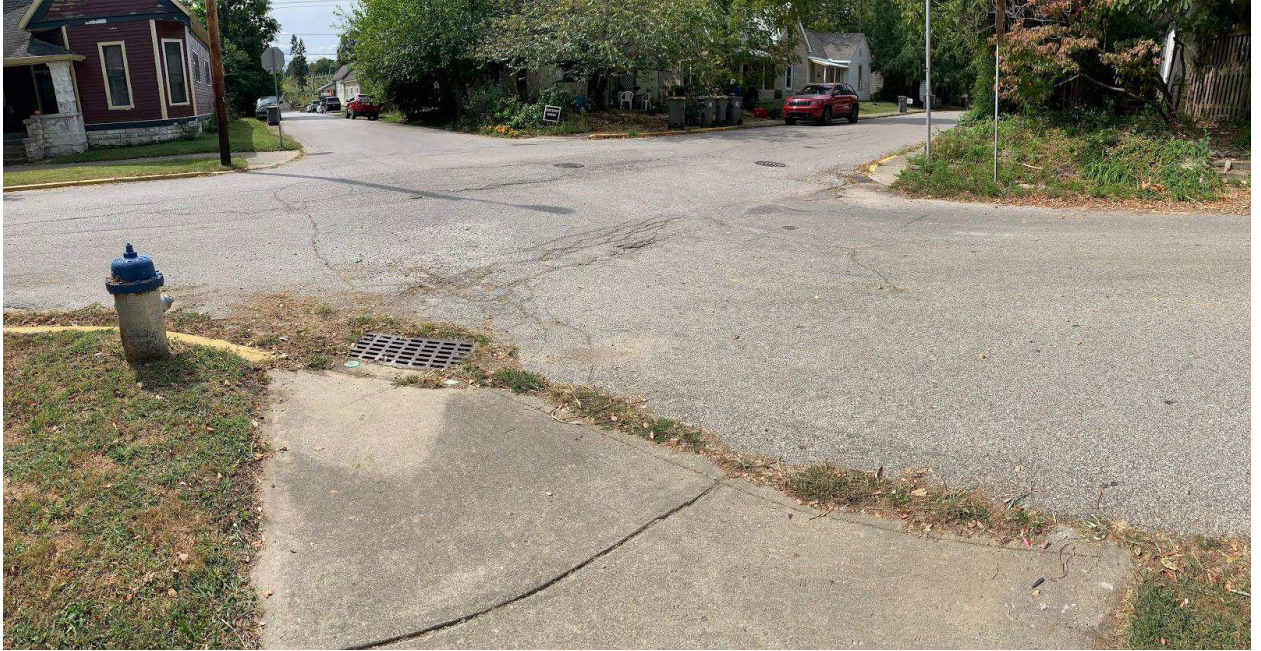
5.

The fifth and sixth picture are of non-compliant ADA ramps and street cuts. The seventh photo is of the sidewalk on the eastside of South Elm Street that is in disrepair. Per the photos of the damage, non-compliant driveway and street cuts, and level of disrepair, this area was selected to address and correct a multitude of issues that are currently existing. Repairs will resolve all of these issues allowing for a more pedestrian friendly infrastructure.
