OD-box RR4 potential internal interference between valves and housing

1. Background

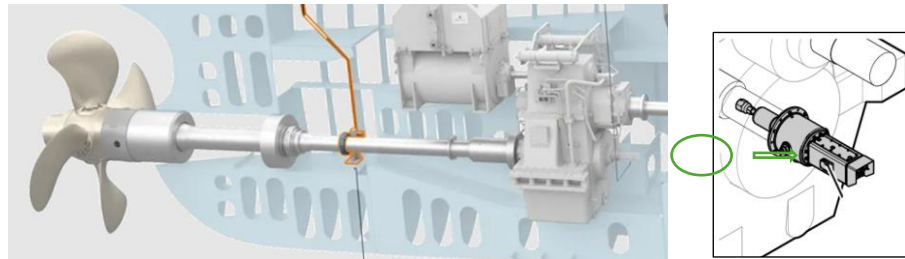
Fig.1 OD-Box type RR4, it's located in front of the reduction gearbox, at free end of output shaft.

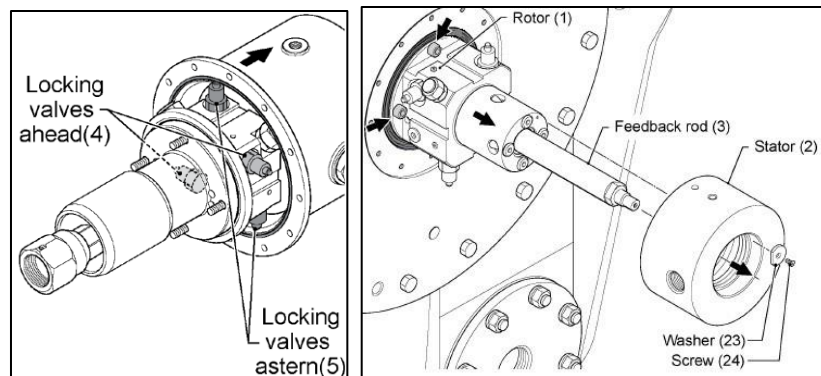
Every guiding bush (rotor) has installed 4 locking valves, 2 in each direction (see fig.2) the purpose is to keep/ hold the pitch in position. The existing locking valves are two types: 4-port (long type) and 3-port (short type). The short valves (3 port) are standard type, long valves (4 port) are normally used in installation with a high ice-class.

Fig.2 Pitch locking valves installed in the guiding bush (rotor)

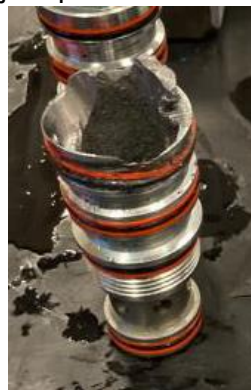
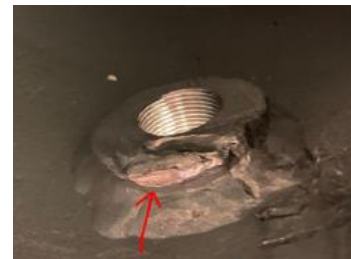
The locking valves are heavily colliding the welding inserts inside of the housing. If this occurs, in the worst-case scenario this might cause:

- The propeller pitch goes uncontrolled to full astern after valves are broken off.
- System is severely contaminated and therefore, expensive flushing and cleaning of the whole hydraulic circuit is required.
- Major operational disturbance for the customer.

Fig.4 Locking valve severely destroyed and welding insert with heavy contact marks

Due to the possibility of the worst-case scenario special attention is recommended for how to handle the locking valves in stock on board.
