Network Installation at

Sean P. Stretch

Western Governors University

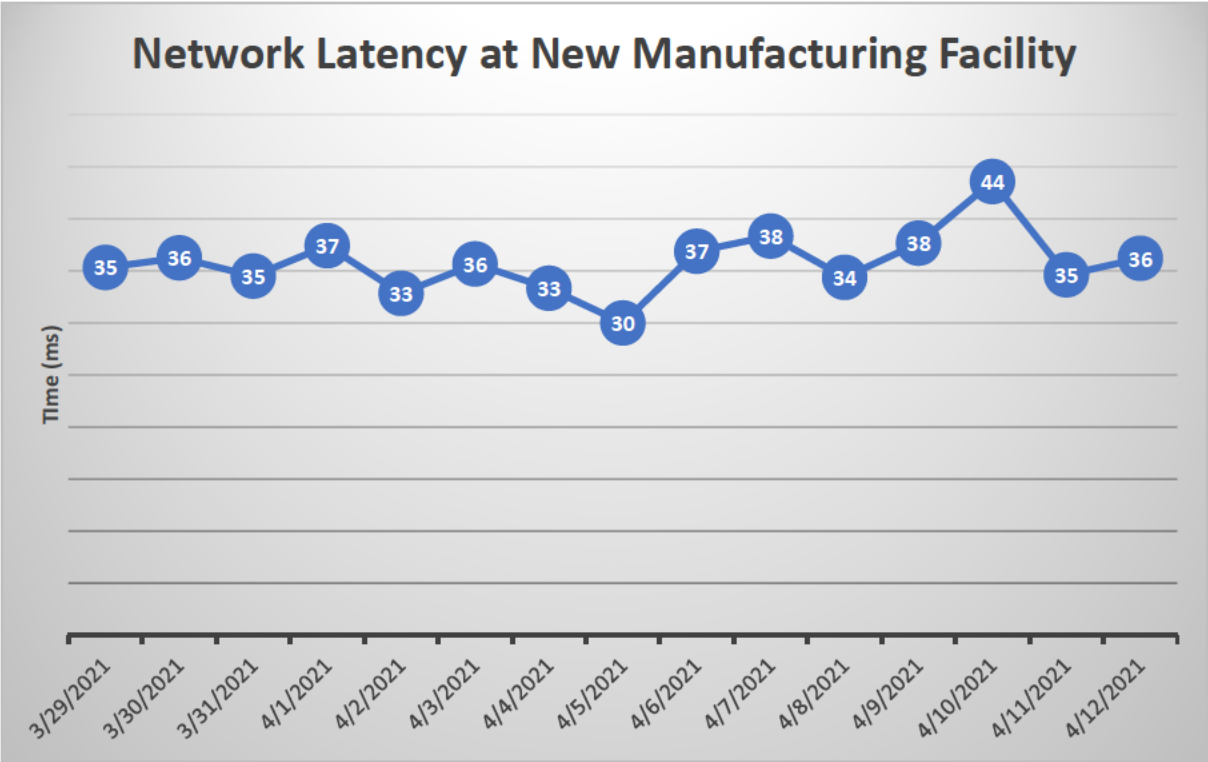
MPLS Latency Chart

reduce production costs, and reduce shipping times to customers. One of the measurable outcomes was to ensure a low WAN latency to the corporate office. This can be measured over the two-week established monitoring period, where the goal of the latency is to be averaging under 50 milliseconds. This goal was accomplished after conducting a WAN latency test, which showed that the network averaged 35 seconds of latency for the two-week monitoring period.

With the network installation project completed at the new manufacturing facility, [REDACTED] observed an immediate change in the speed and reliability of the new network. The installation of the new Cisco router, along with the new MPLS circuit, enabled fast connectivity to all [REDACTED] locations. Appendix A provides an overview of the AT&T MPLS network map before and after the installation at the new facility was completed. This enabled the product design engineers at the remote facilities to send large files involving product changes to the manufacturing facility more efficiently. Appendix B shows the MPLS

Latency chart, which reached an average of 35 milliseconds during the two-week monitoring period.

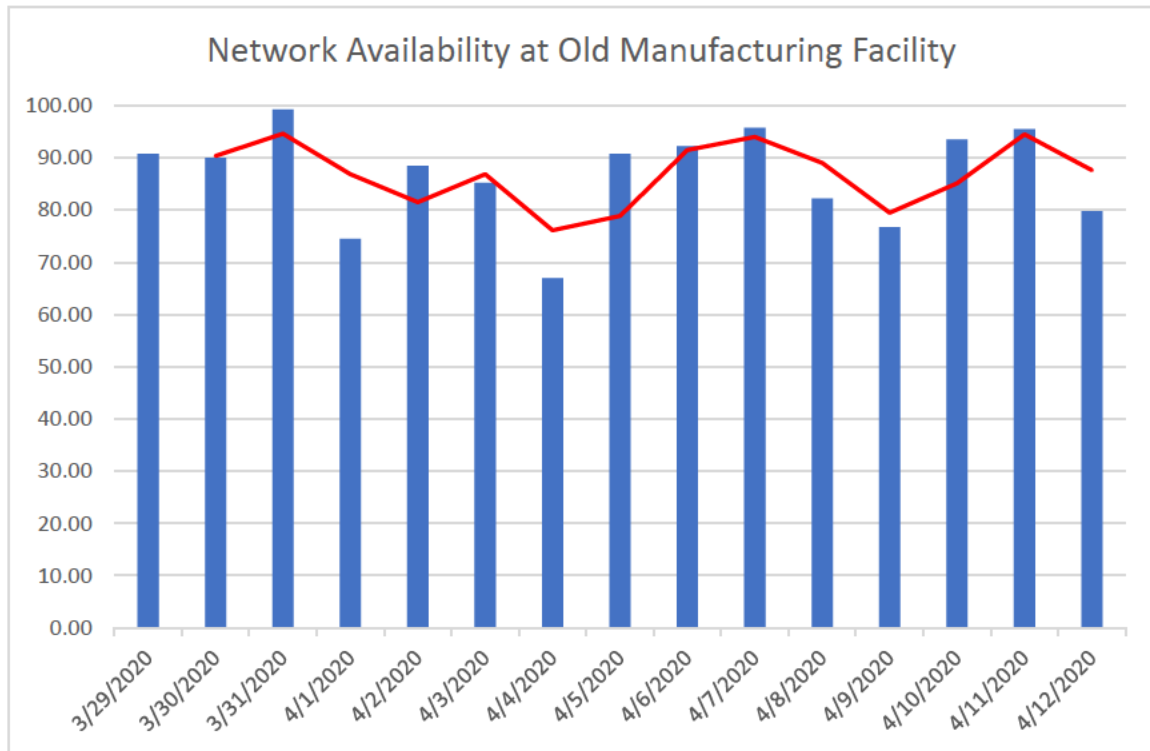
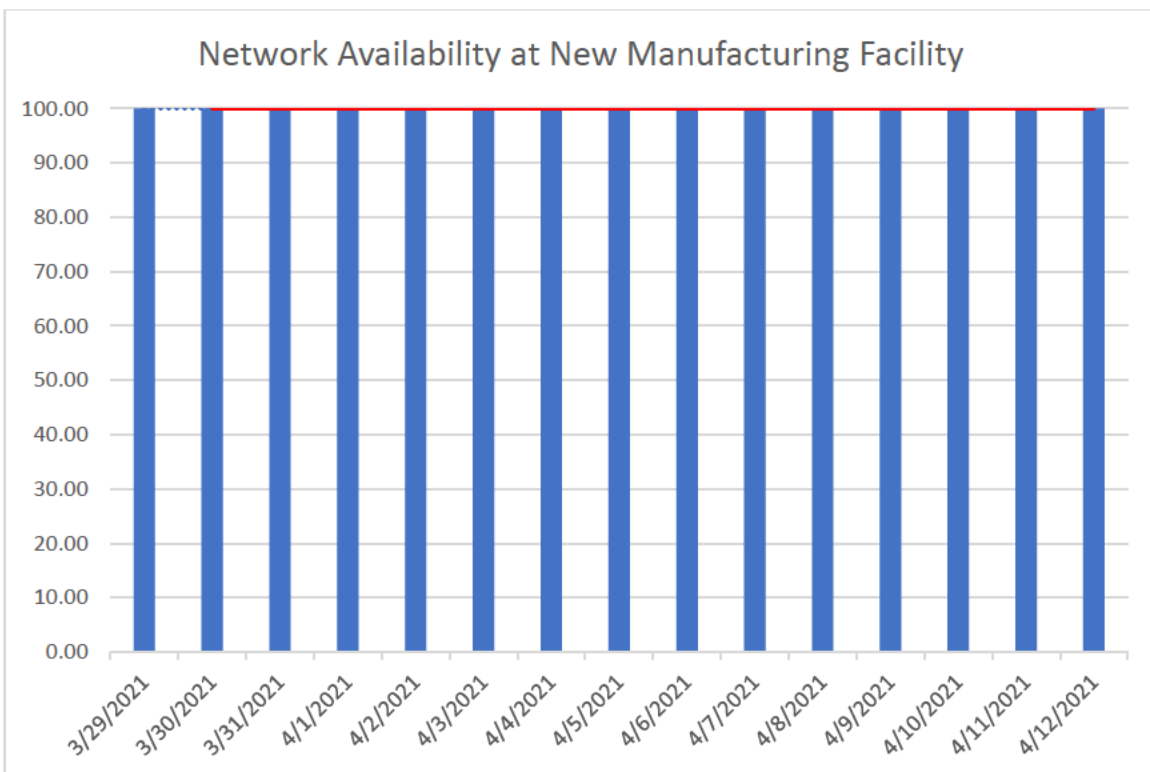
Appendix D

Network Availability Chart

The network in the old manufacturing facility was unreliable and disconnected frequently, which caused production to slow to a crawl and introduced a large backlog of work which cost the company lost revenue. The network installation project was crucial to prevent unreliable connectivity from occurring throughout the new manufacturing facility. The network switches and wireless access points were monitored for a two-week timeframe and resulted in 100% availability, exceeding the 99.99% availability rate target. With both the WAN connection latency measuring under 50 milliseconds and the switches and wireless access points availability above the 99.99% targeted availability rate, this project has been accepted as successful and completed.
