## MECHANICAL SEAL INSPECTION

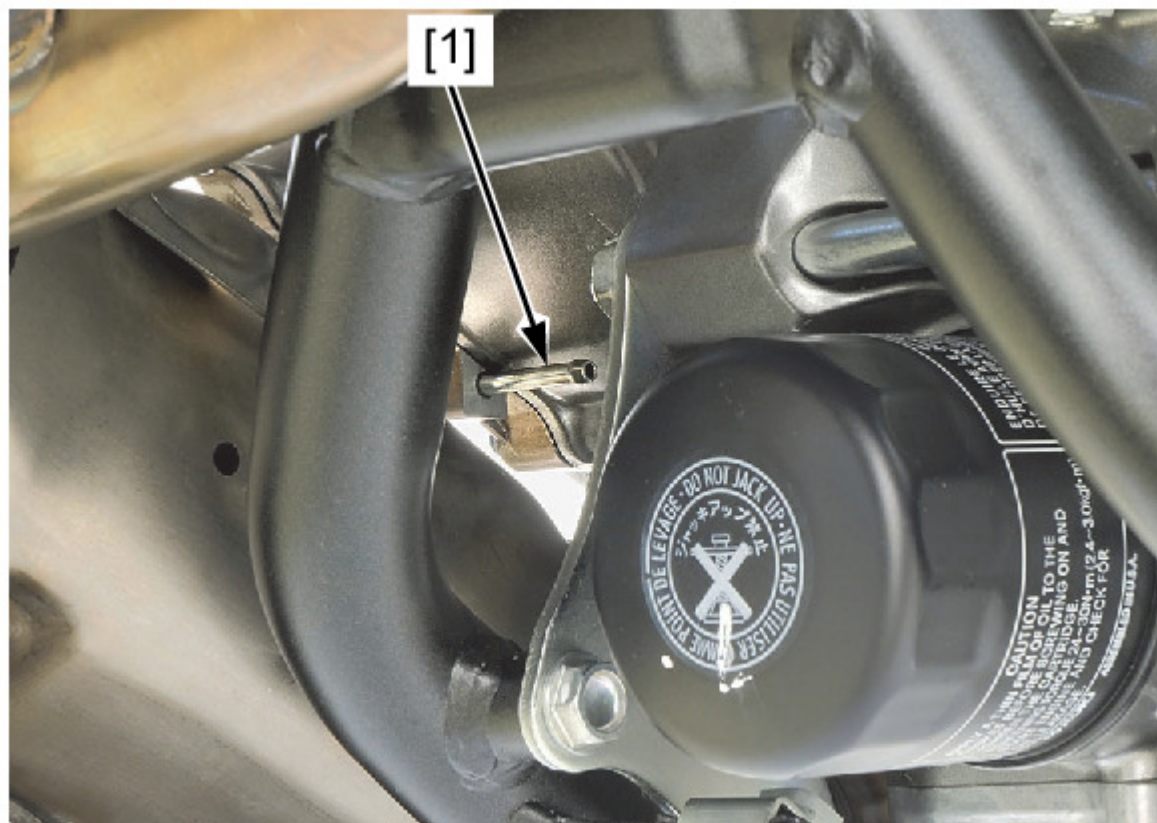
Check the water pump bleed pipe [1] for signs of coolant leakage.

- A small amount of coolant weeping from the bleed pipe is normal.
- Make sure that there is no continuous coolant leakage from the bleed pipe while operating the engine.

Replace the water pump as an assembly if necessary.
