Design case studies A: Electric vans and Docklands Light Railway

Engr 514:2014 Design of safety-critical systems
Roger Kemp, January 2014

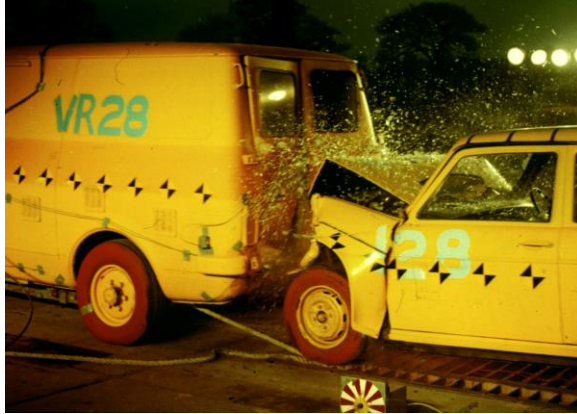
Crash testing

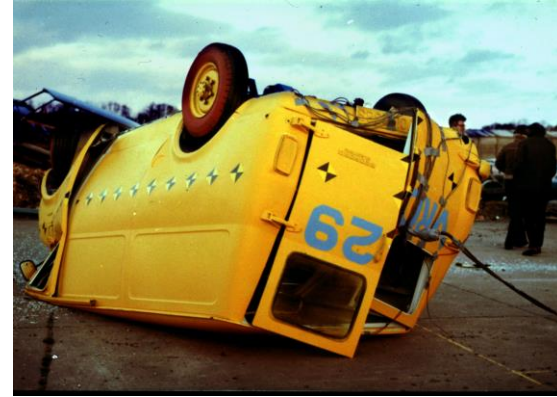
Overturning test

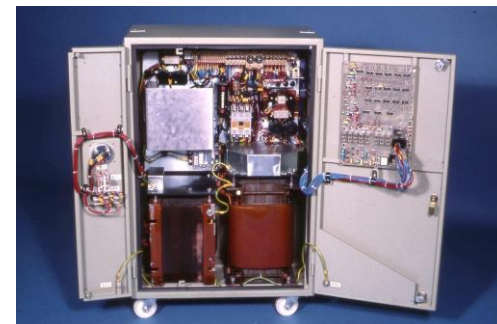
Battery charger (10 kW)

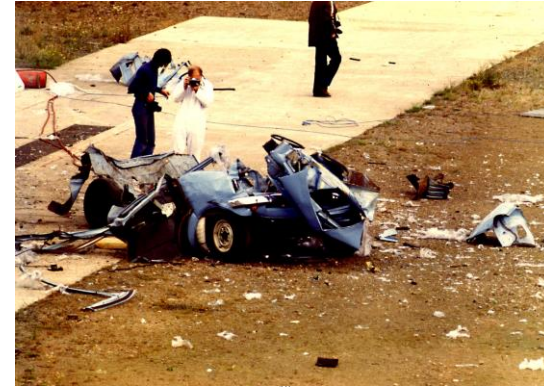
Explosion test

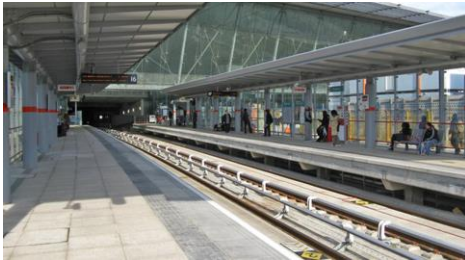
Stratford station

- No earthed metalwork (including vending machines) within reach of platform edge
- Insulating layer below paved surface

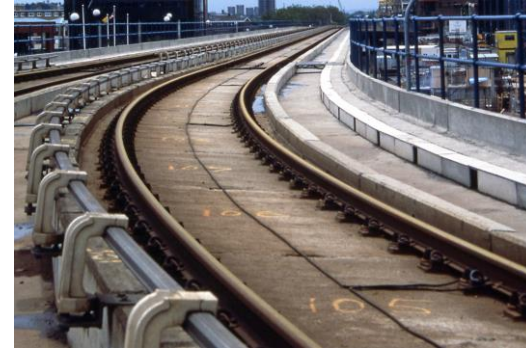
DLR conductor rail

Note also ATP track loops

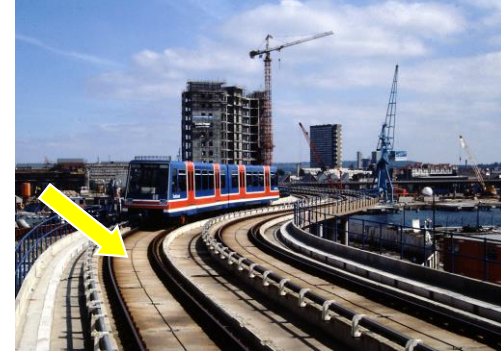
ATP transposed conductors

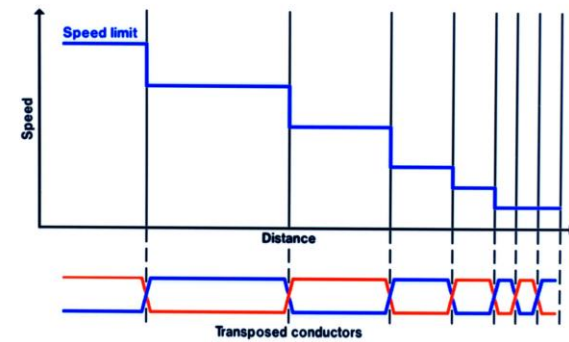
Speed limit into station

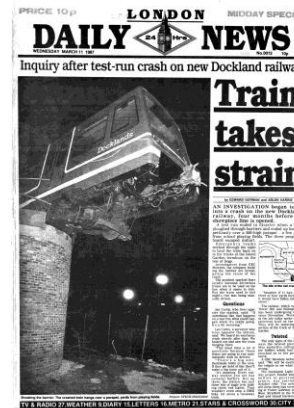
Testing the ATP

- Test not adequately planned
- Inadequate risk assessment
- Phase of adjacent loops not synchronised
- Train driven manually by graduate trainee

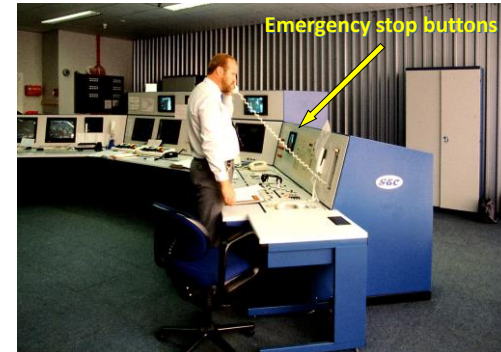
Redesigned interface
