Design case studies B: Eurostar and Class 91 retrofit

Engr 514:2014 Design of safety-critical systems

Roger Kemp, January 2014

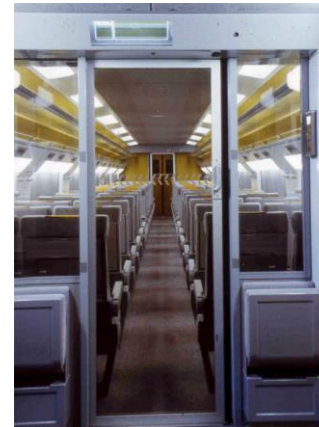
Saloon doors

Toughened glass, designed to resist fire. Power-operated controlled by handle to prevent inadvertent opening

Additional fire doors near gangway connection close in tunnel (visible at far end of car)

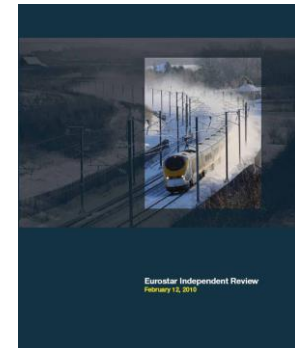
- Quadruplicated data links only gave increase in reliability of part of the system
- The control and signalling equipment cubicle did not have adequate snow-proofing, resulting in a common-mode failure
- Several trains became stuck in Tunnel when electrical systems short-circuited due to melted snow

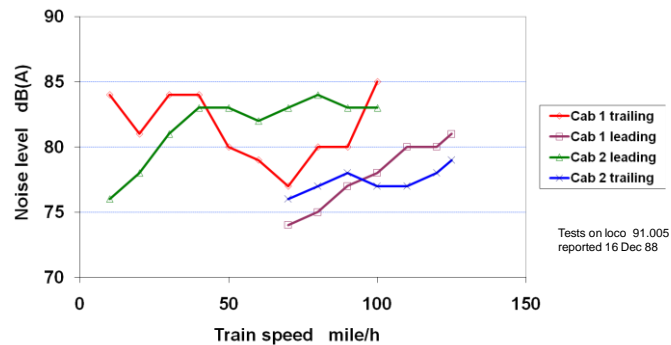
Step 1 – make some measurements

- Noise level between 74 and 85 dB(A)
- Strong 100Hz component
- No obvious correlation with speed
- No obvious correlation with loco direction

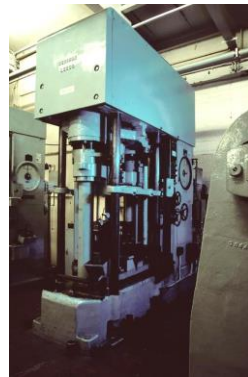
Stage 5 – intensive tests: static performance

Check design can withstand proof stresses anticipated in crash situations

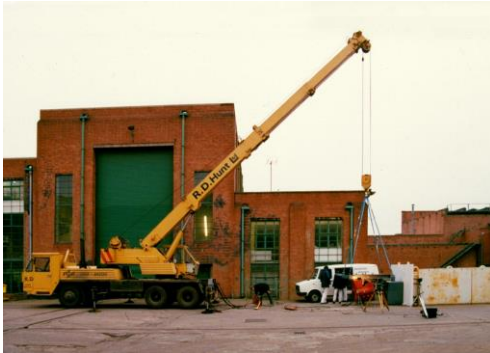
Stage 6 – safety validation: simulation of 3g Suspend motor and swing against 200t mass

- 100 Hz noise level reduced by 20dB.
 - *BR management and unions satisfied*
- Retrofit could be done in depot - no need to return locos to build works
- Safety tests demonstrated that new design could withstand crash forces
- Work completed in 3 months
 - *Did not delay entry into service*
