# Comprehensive Case Mrs S

Severe tooth wear and  
loss of posterior  
support treated by  
composite build ups  
and upper denture  
with precision  
attachments while  
increasing the OVD

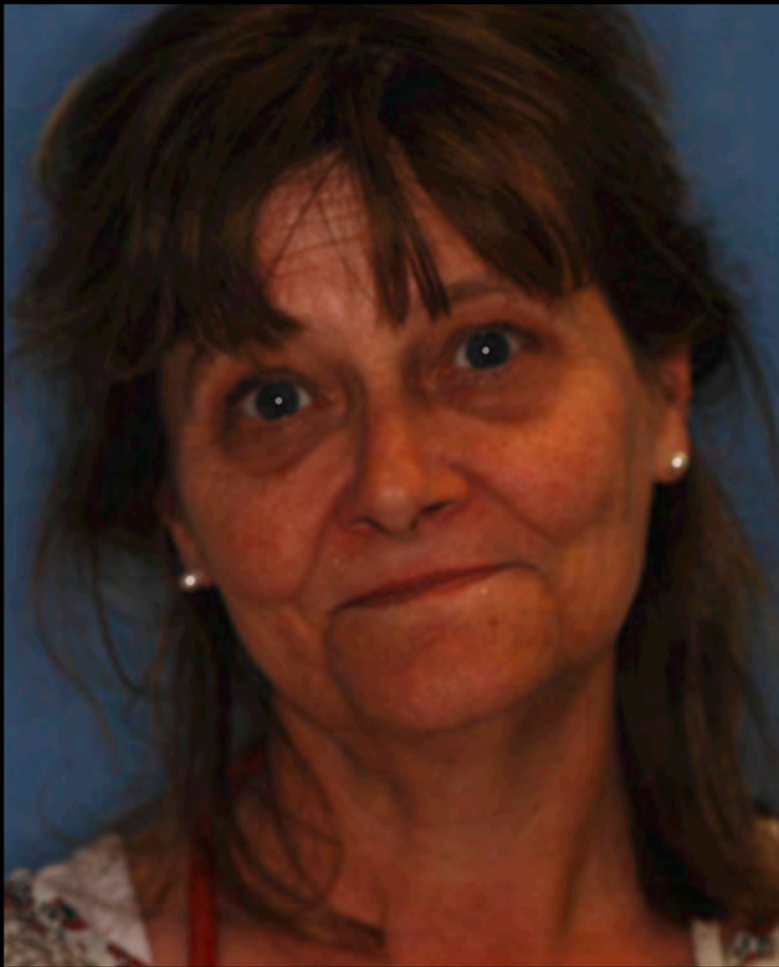
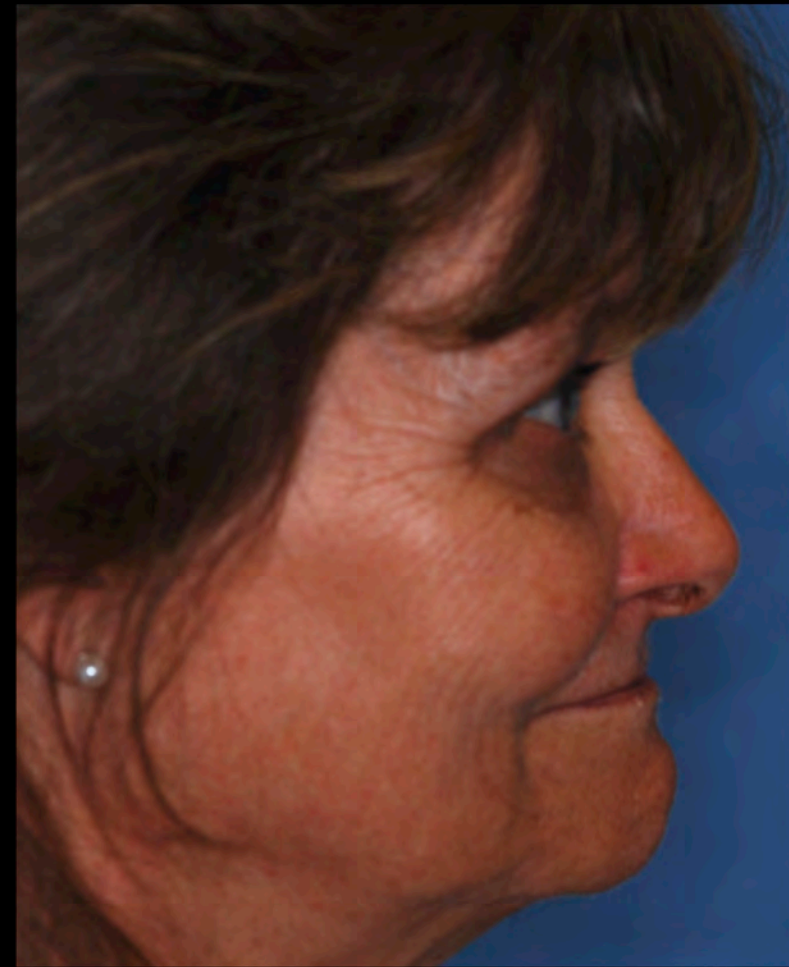
Extra Oral Photos 4/5/11

I was not able to determine the first contact in RCP at the first visit, I attempted to record RCP using a lucia jig and mounted study casts, the resulting mounted models were however also incorrect as wear facets on the 26 and 35 would indicate that a much more retruded position is possible. Indeed the side profile shot would indicate that this lady is grossly overclosed.

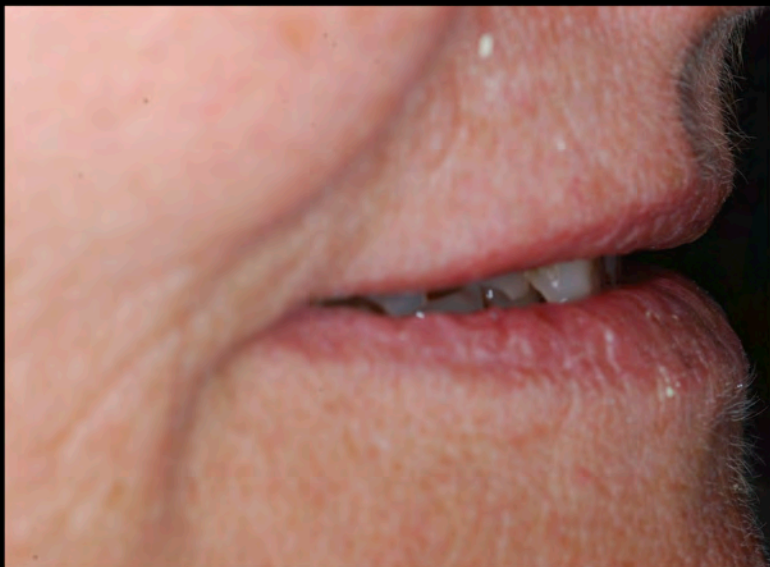
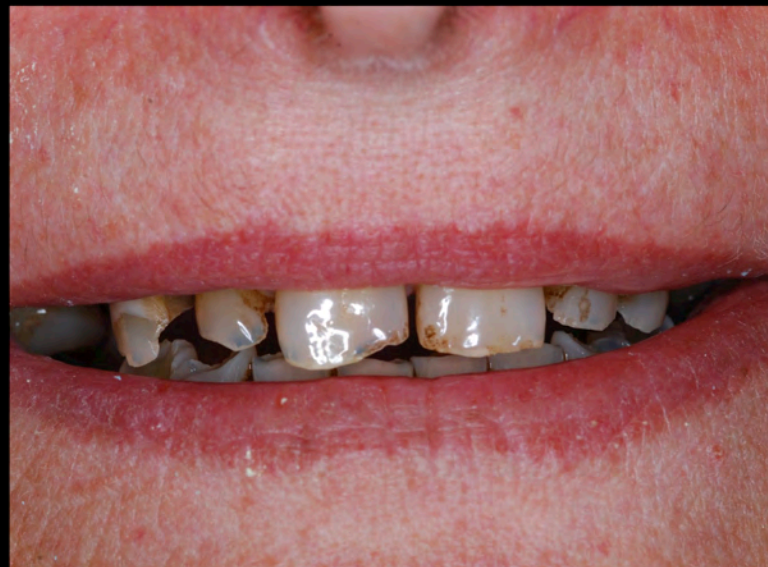
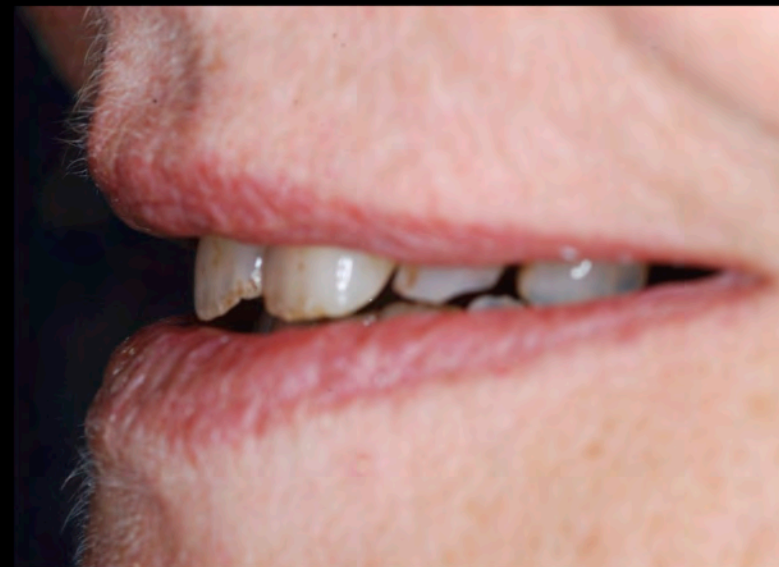
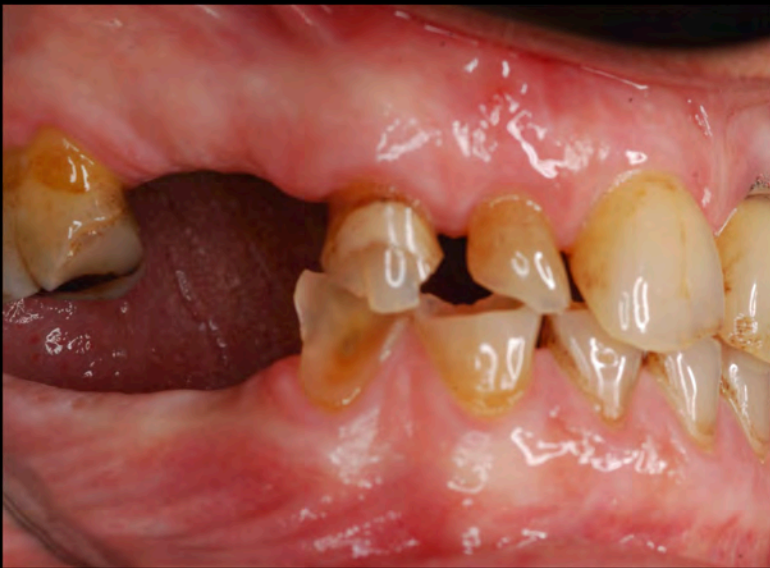
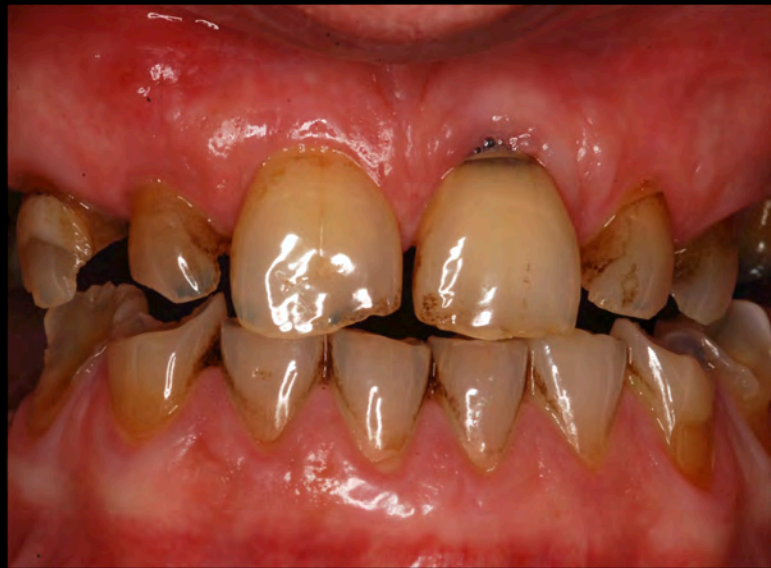
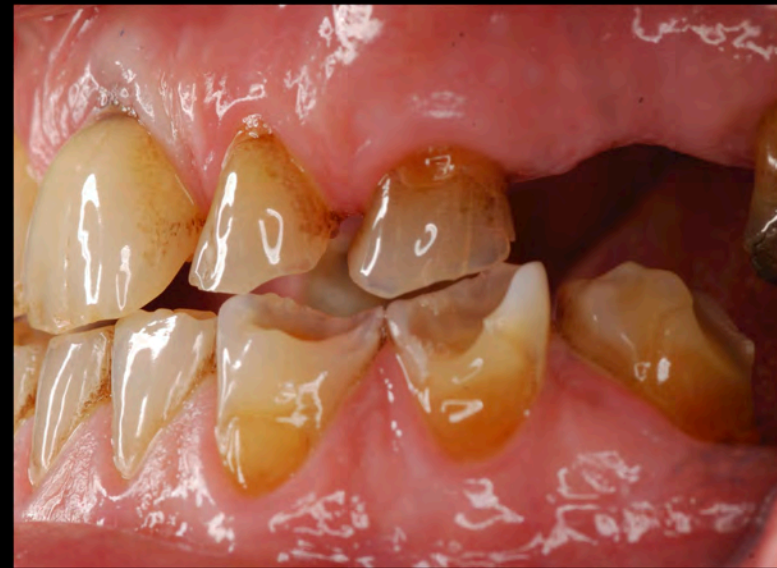
Intra Oral Photos 4/5/11

- Keratosis of the edentulous ridges evident, otherwise the soft tissues are healthy
- Advanced toothwear of both upper and lower teeth evident, due to both erosion and attrition. Toothwear extends into the pulp of several teeth

Group function is seen on both right and left lateral excursions with a NWSI seen on right lateral excursions on 26 & 37.

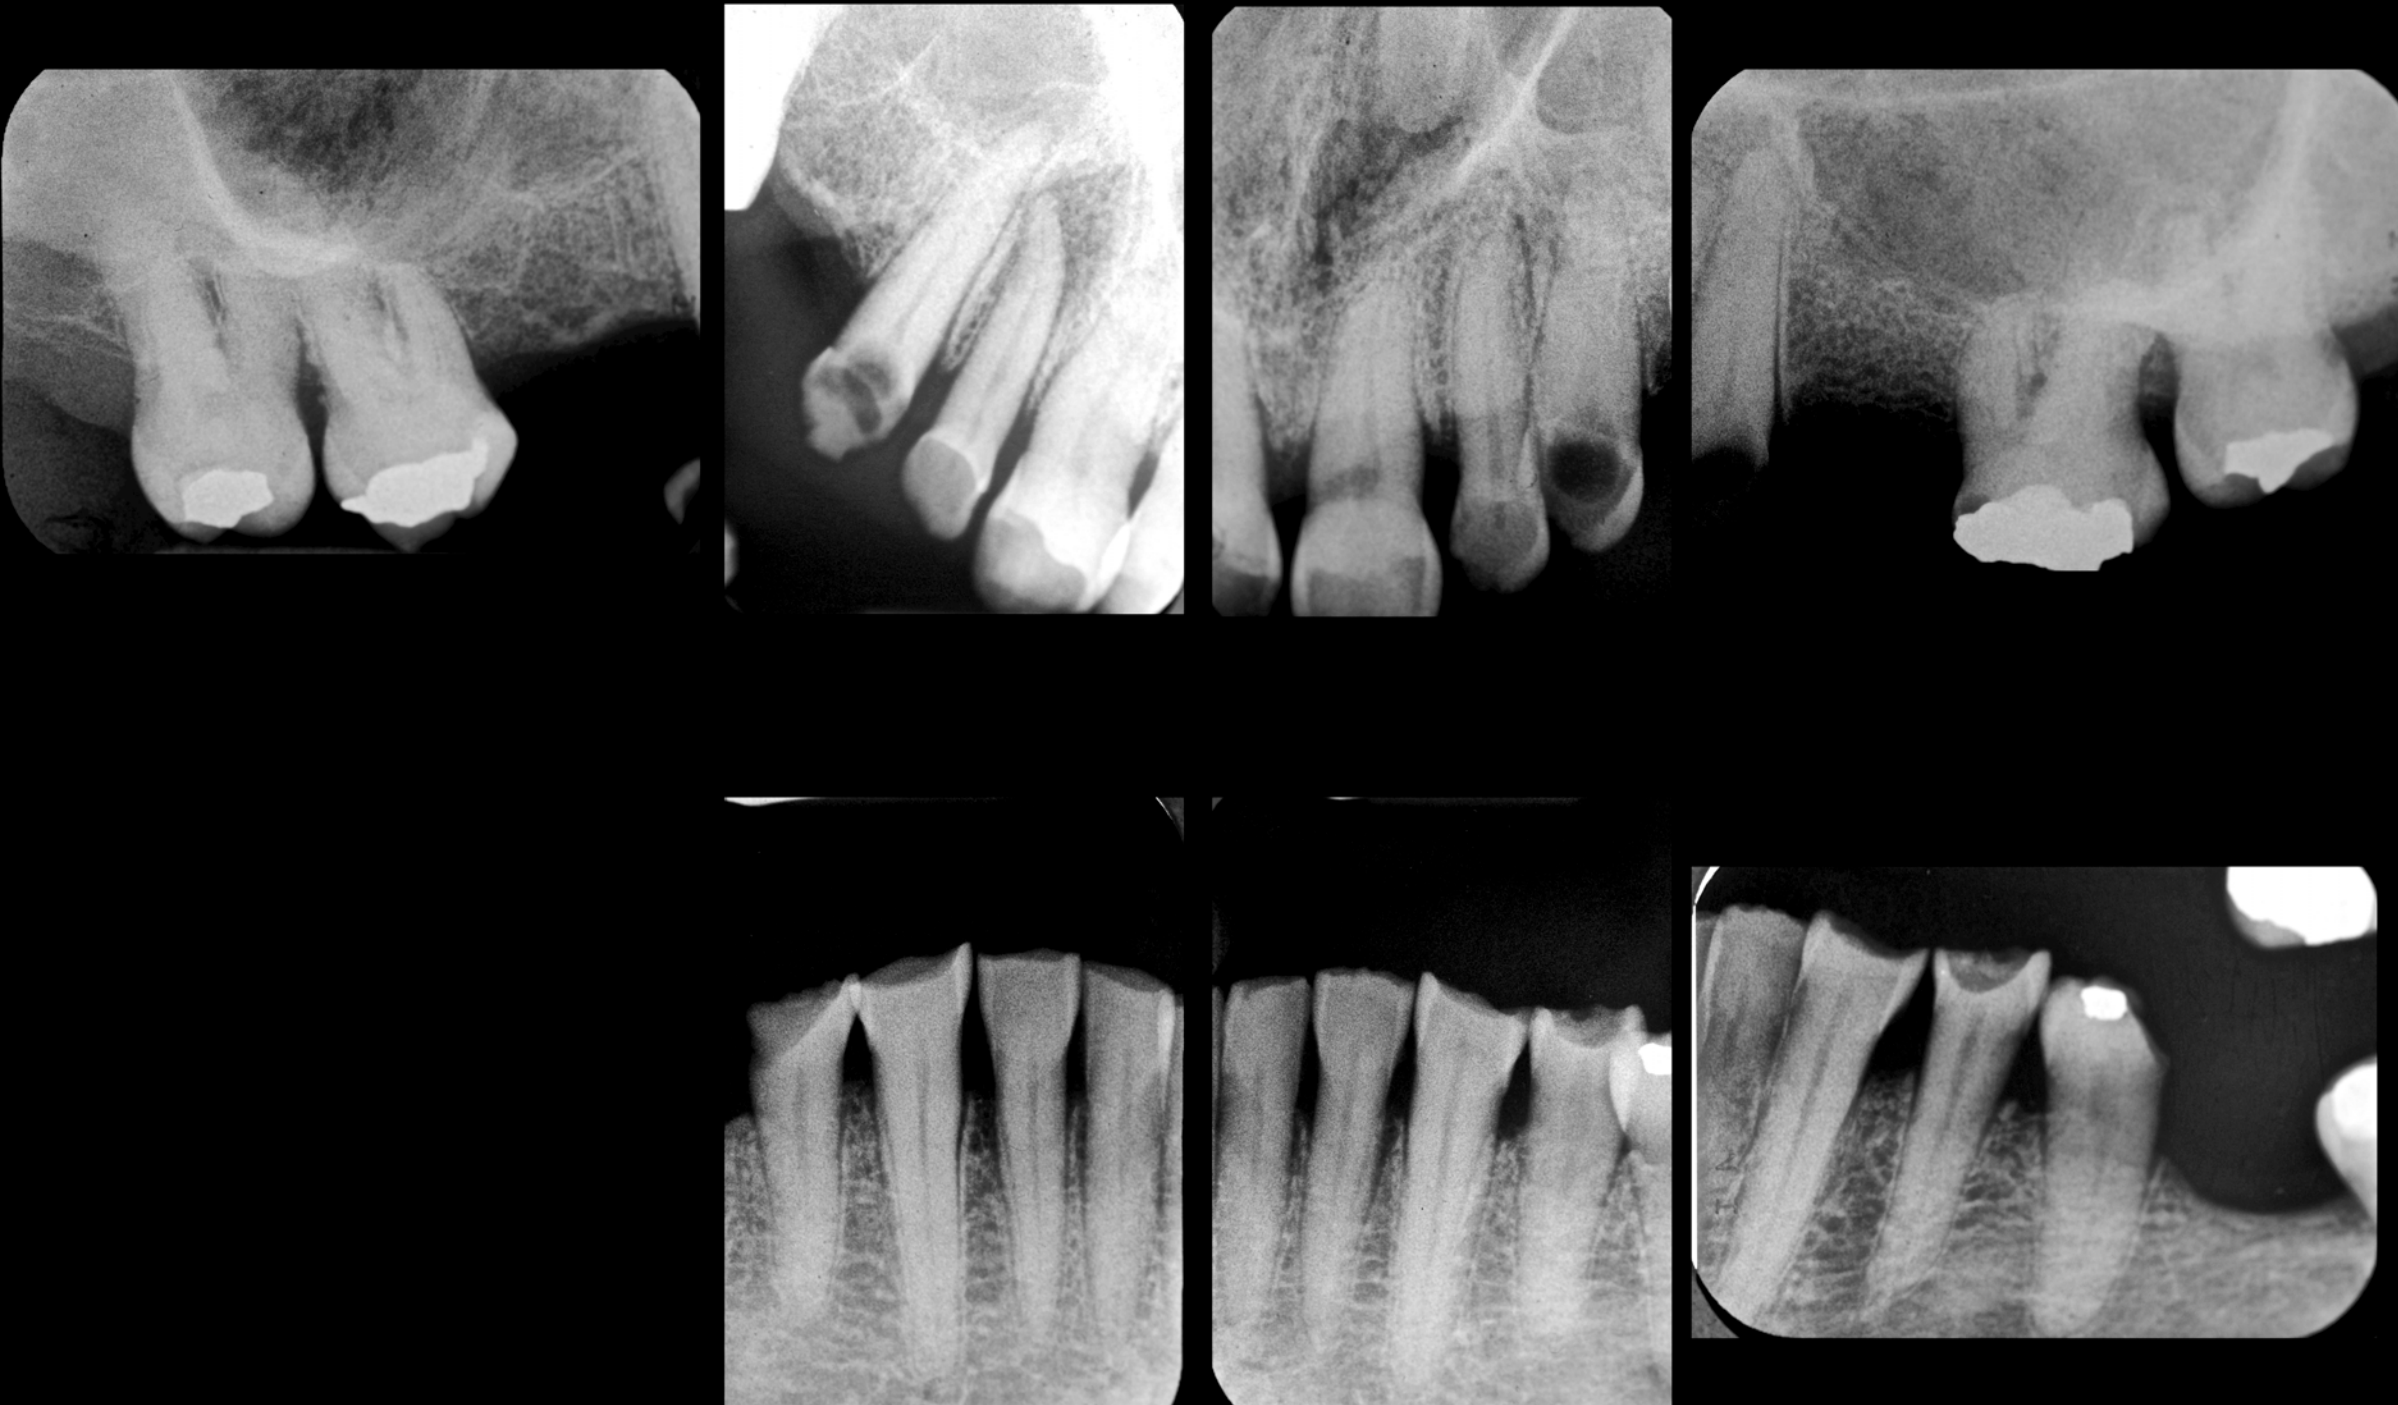
# Radiographs 12/4/11

- 13,12,13 appear to have peri-apical pathology
- approximately 2mm generalised bone loss with the exception of 17,16 where a vertical defect is present associated with ++ subgingival calculus

Endofrost confirms that 13,12,23 are non vital  
27 is grade 2 mobile - most likely due to occlusal trauma.

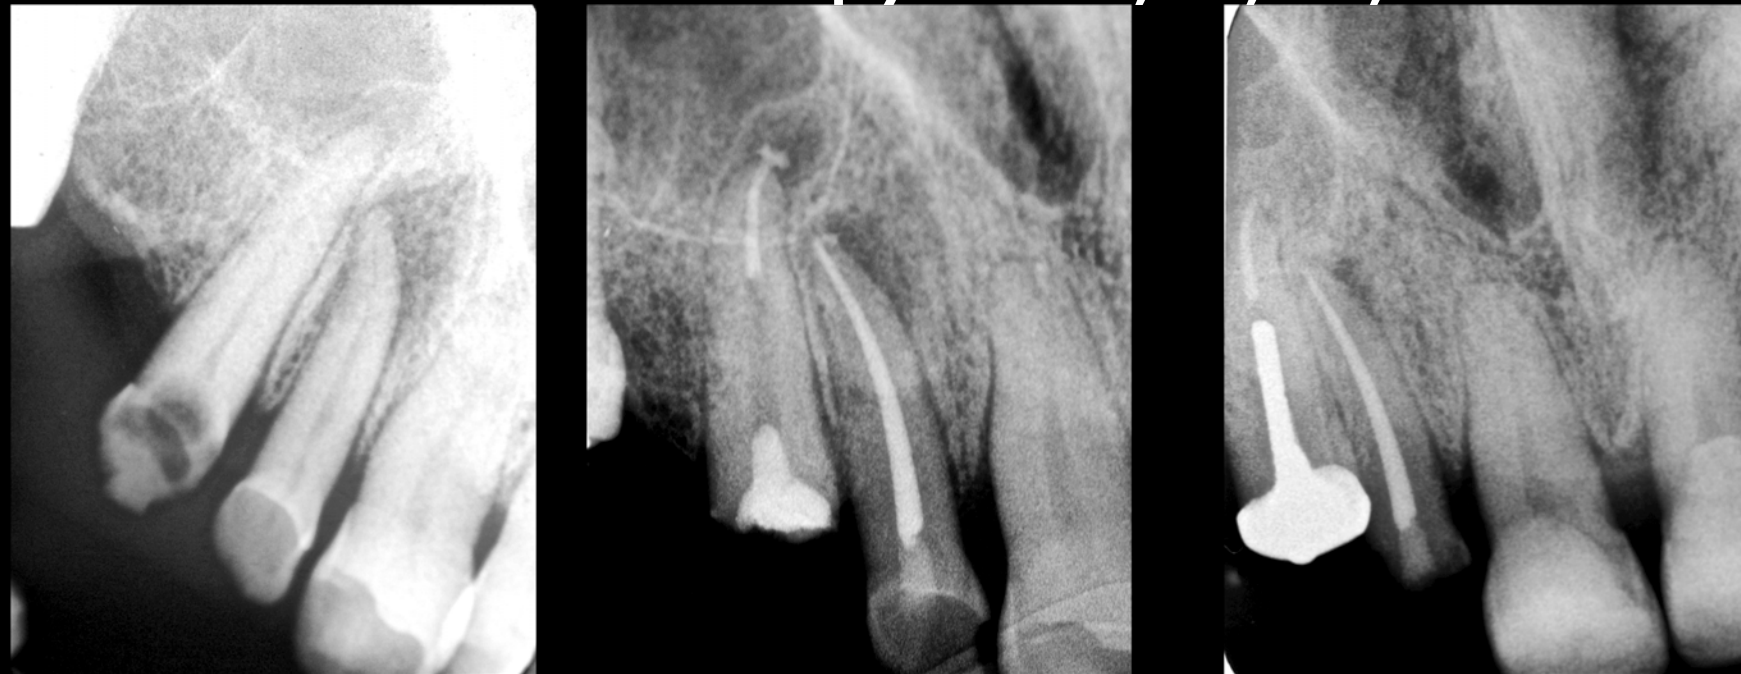
# Root canal therapy of 13,12,22,23

13,12, and 22 were root treated in one visit, anesthesia was administered and rubber dam was applied. Canals were negotiated to near the WL as estimated from the radiographs and S1 protaper used to flare the canal. Working lengths were determined with an apex locator and visually compared to the radiographs. Canals were worked to size 20 flexofile 0.5 mm short of the apex locator reading.

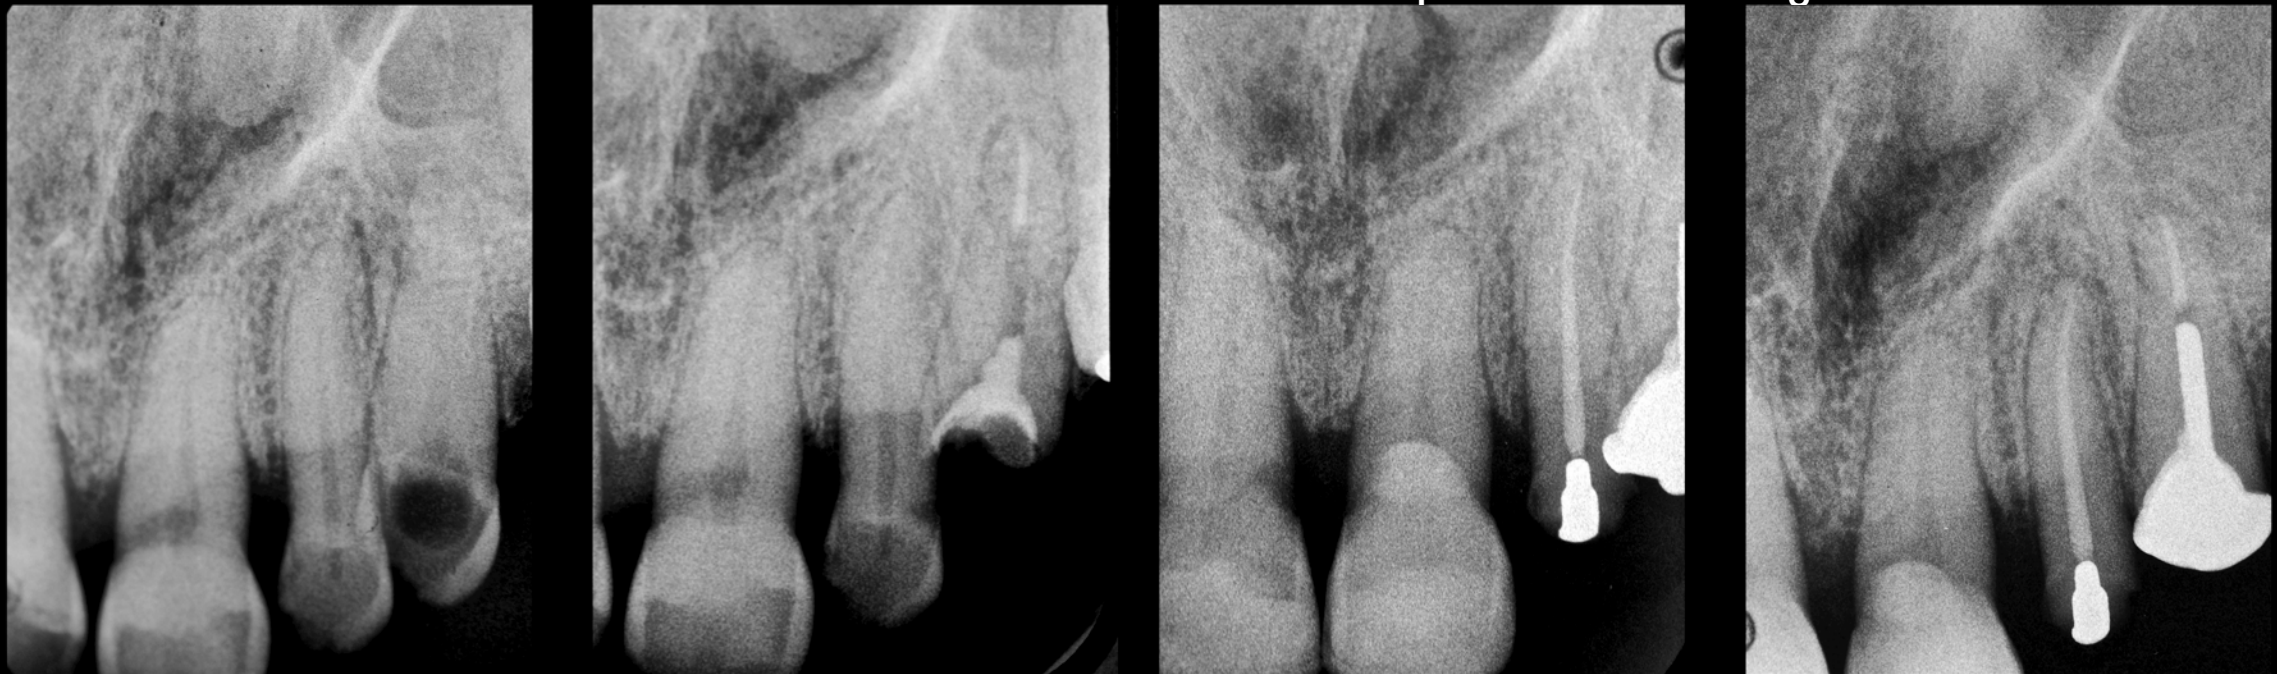
Canals were then worked through F1, F2, and F3 maintaining patency with a size 15 flexofile and rechecking the WL with the apex locator after F2. Canals were irrigated with 5% hypochlorite followed by a 17% EDTA solution. Obturation was carried out with F3 GP points. 13 and 23 were prepared for posts to (red) leaving 4 mm of GP apically. 22 was root treated at a later date in a similar manner.

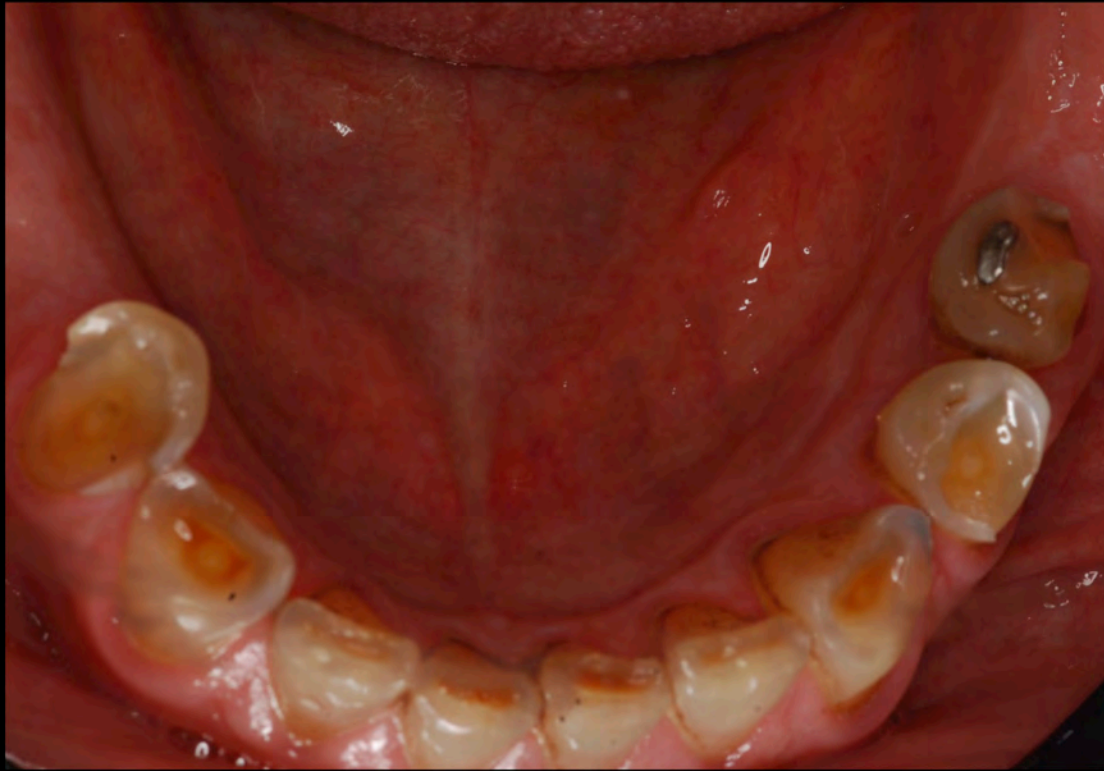
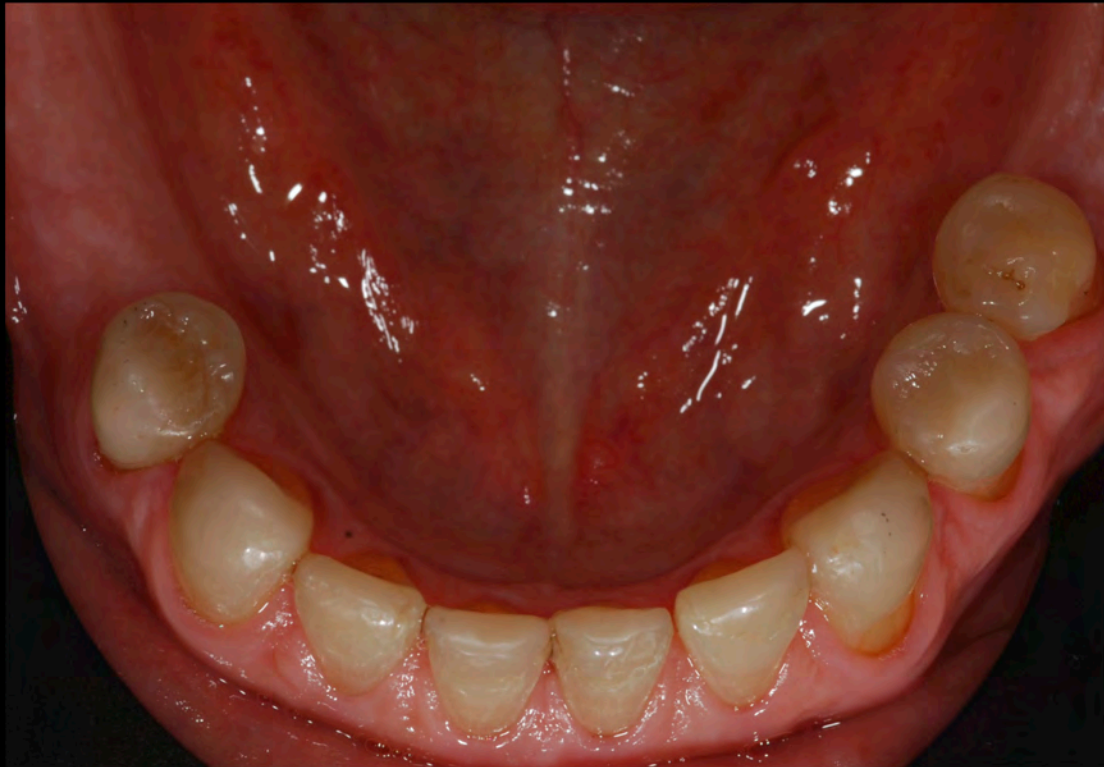
# Build up of lower teeth

The intention of the build ups was to return these teeth to their original form. While these teeth would open the OVD final refinement of the OVD was to be done with the maxillary teeth as were refinements in lateral excursions.

Anesthesia was administered and rubber dam placed, a coarse diamond bur was used to roughen the tooth surface (especially the sclerotic dentine) to encourage bonding and the teeth were sandblasted with 50 micron alumina particles to encourage bonding. A 3 step bonding agent (optibond FL) was used and the teeth were built up incrementally using a nanofilled composite (filtek supreme) in dentine and enamel shades. Final curing was carried out with the teeth covered by glycerine jelly. Polishing was carried out using soft flex discs. Patient was warned that the bite was going to be "high".

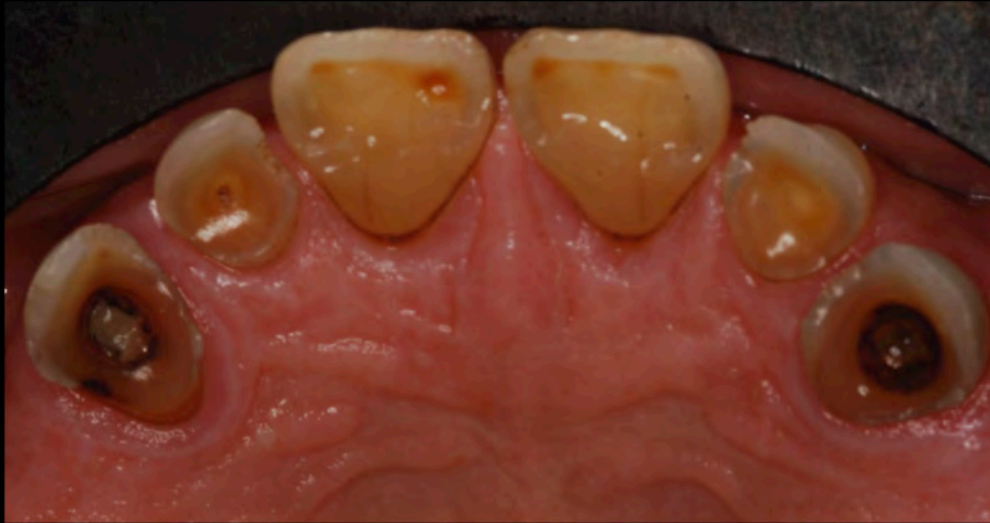
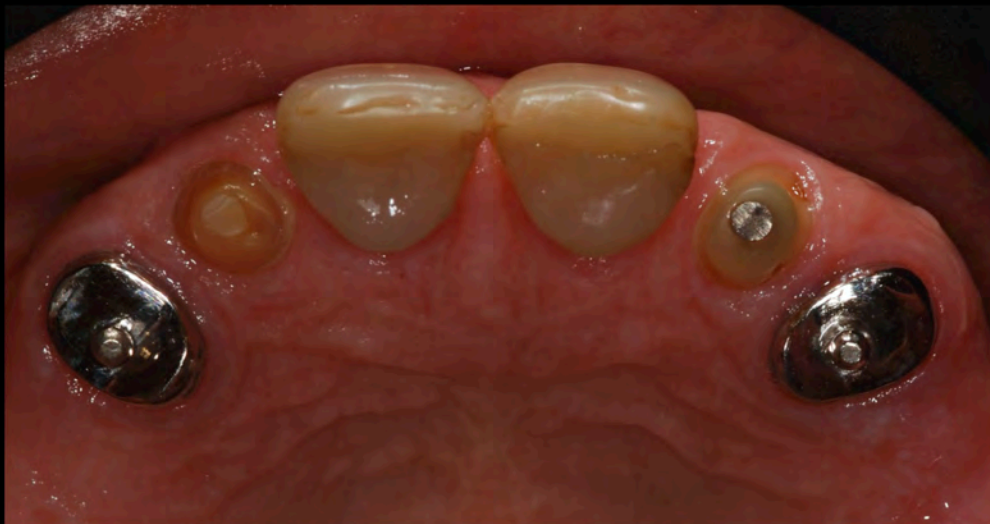
# Restoration of anterior 6 teeth

13 and 23 were prepared for cast post cores (non precious) and these were constructed with bredent ball end attachments, these were cemented with zinc phosphate. 12 and 22 were prepared for overdenture abutments. Finally 11 and 21 were built up in composite. A nanofilled composite with enamel and dentine shades was used along with a 3 stage bonding agent

Firstly the facial aspect was built up to return the tooth to its original shape. Next the OVD was increased until the facial profile did not appear overclosed. Then the occlusal platform was extended palatally such that when Mrs SC1057 retruded her mandible her lower teeth were still loading 11,21 axially.

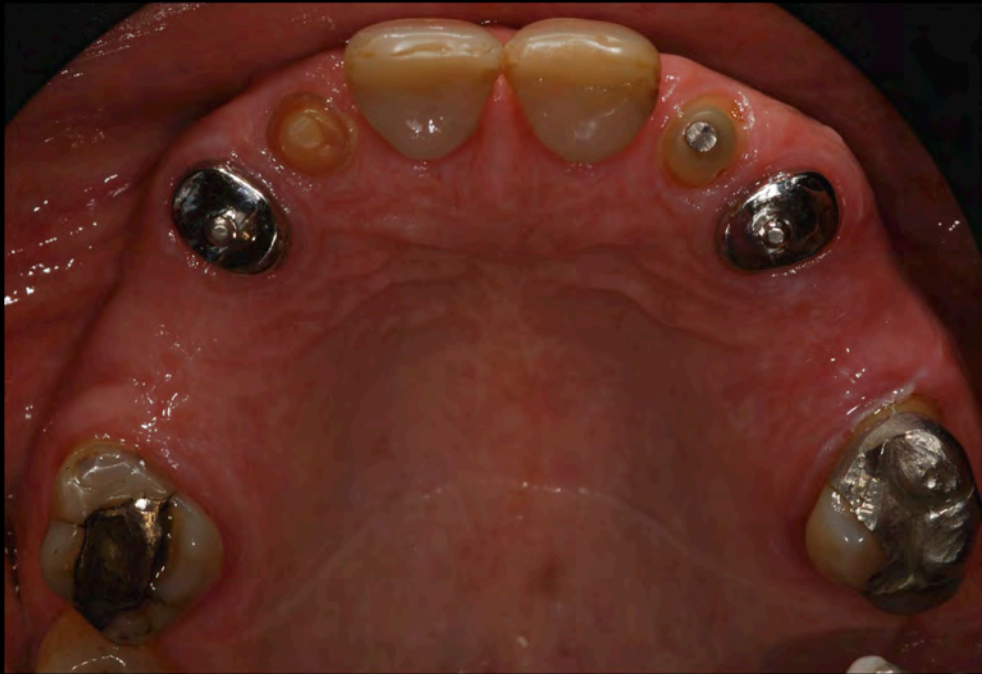
# Denture Construction

While the special tray was being constructed 26 had an extensive amalgam restoration placed and 27 had to be extracted as there was not enough access to carry out the root treatment. Guide planes were prepared in the mesial surfaces of 16,26 and a mesial rest seat in 26. The master impression was taken in a medium body addition cured silicone.

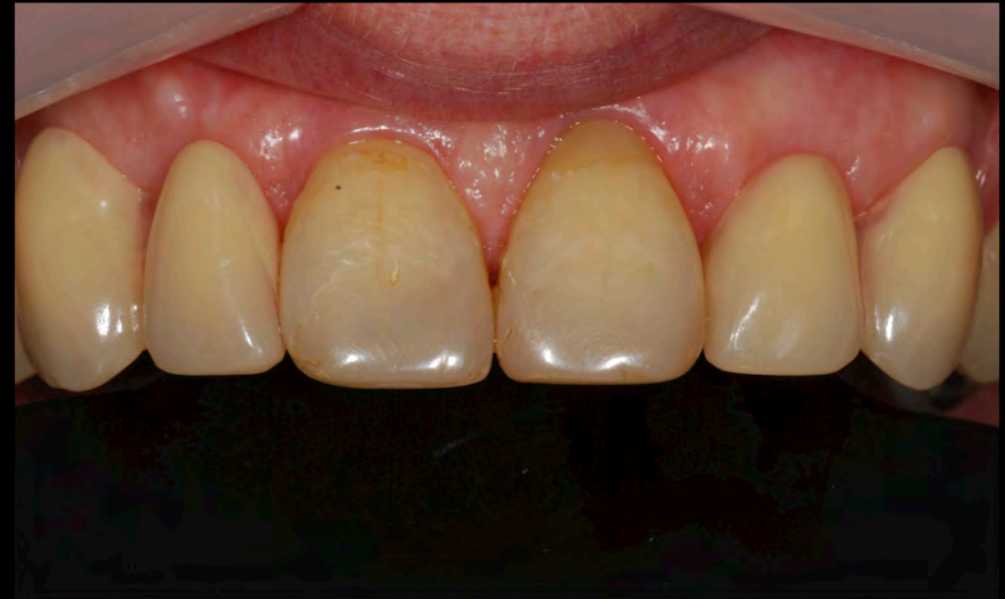
A facebow registration was taken and a blue mouse bite was taken in RCP. It was decided to go straight to finish as 11 21 were the sole teeth in occlusion. The decision was also made to have the denture teeth 13,12,22,and 23 fitted gum as there had been no soft tissue loss in these areas and retention was not an issue

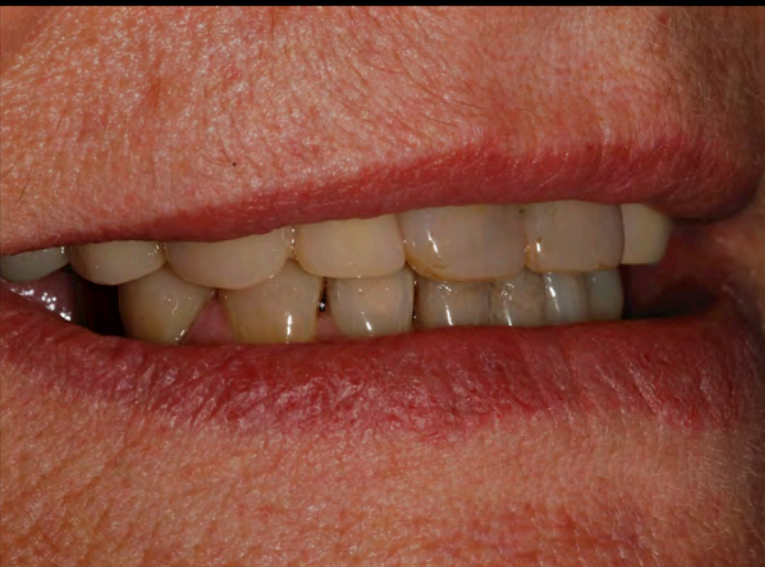
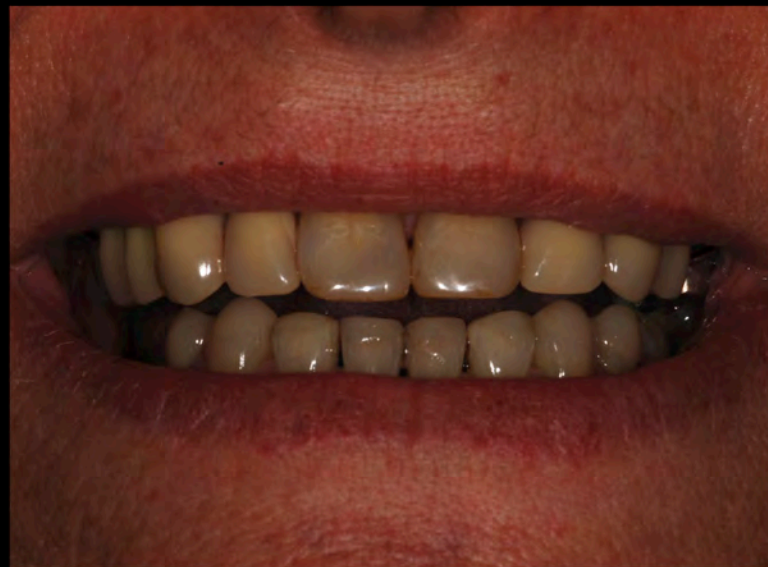
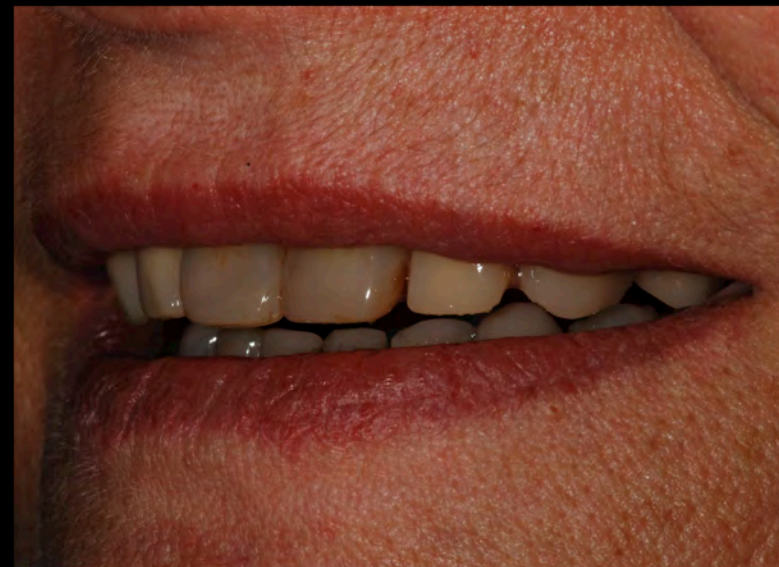
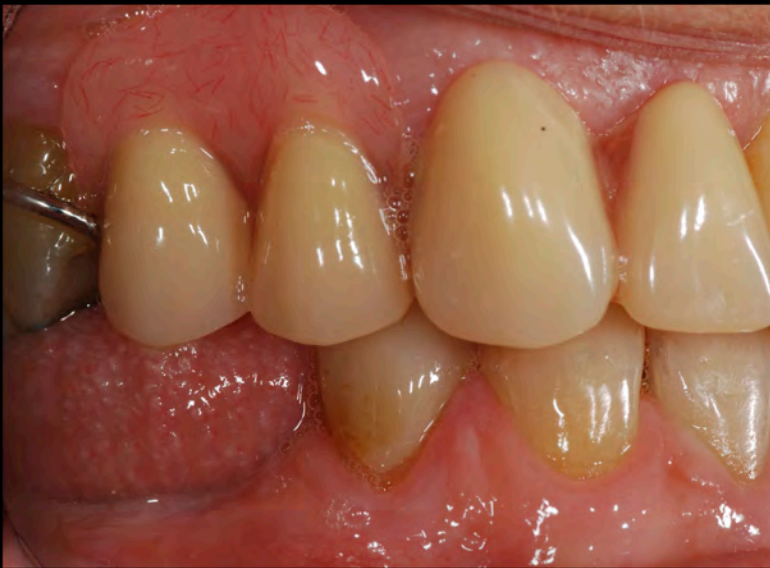
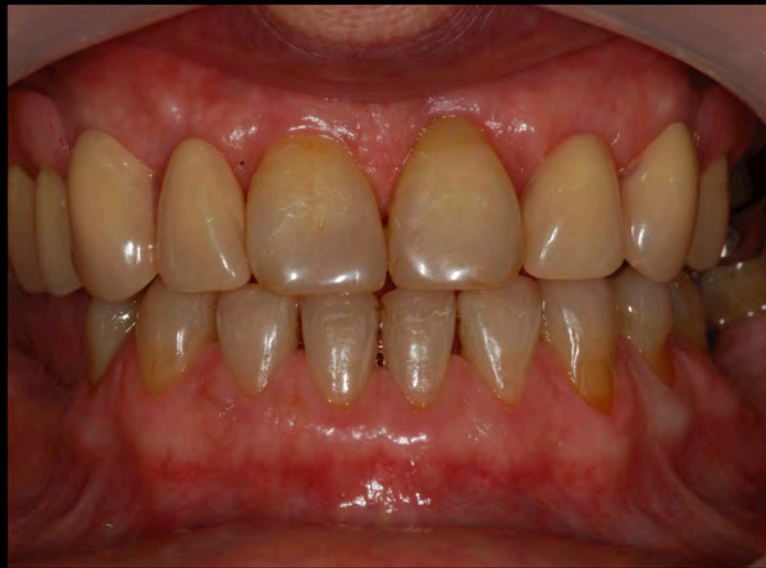
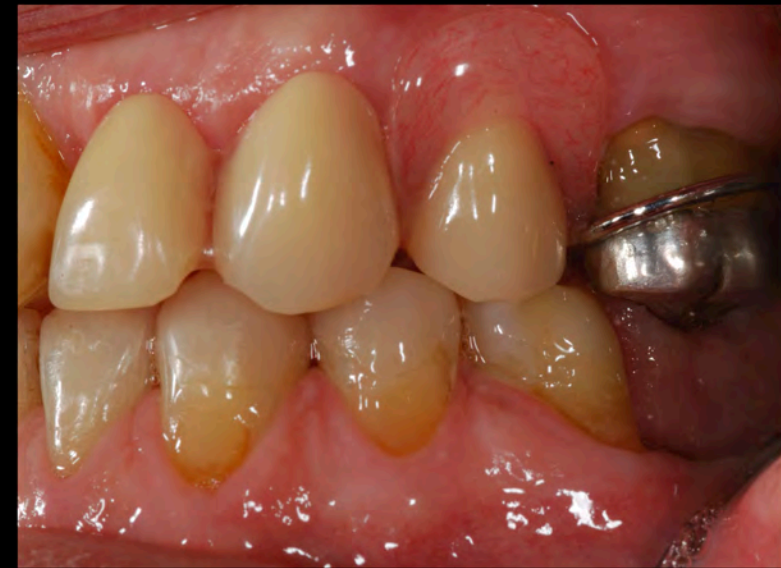
Intra Oral Photos 29/5/12

Cemented precision attachments 13,23  
All lower teeth except 37 restored with composite  
to replace lost tooth structure

Mrs S is to be seen on a 3 monthly recall initially to reinforce oral hygiene procedures and the need to stay away from carbonated drinks. We will monitor the restorations and should any # of the composite occur we will repair them. The composite build ups will need to be polished approximately every 6 months to maintain their appearance
