Comprehensive case Mr S

Failing bridge removed, 3
crowns placed, metal
denture, and multiple root
canal treatments

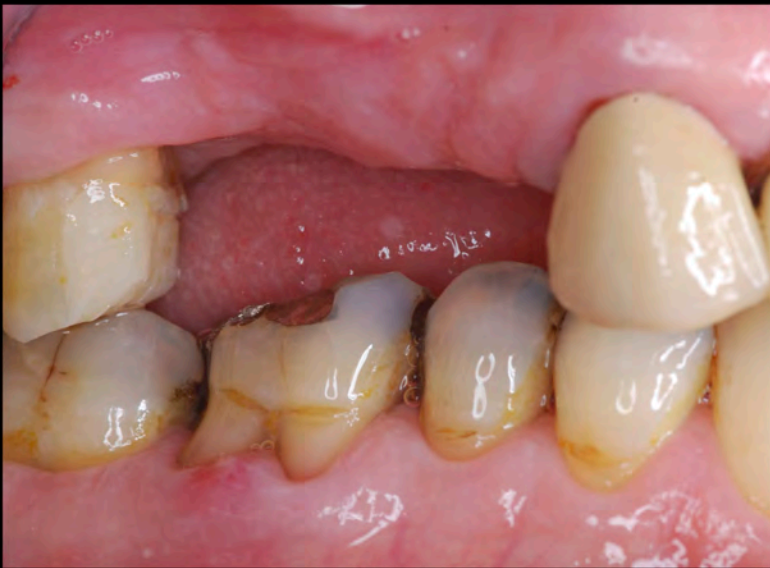
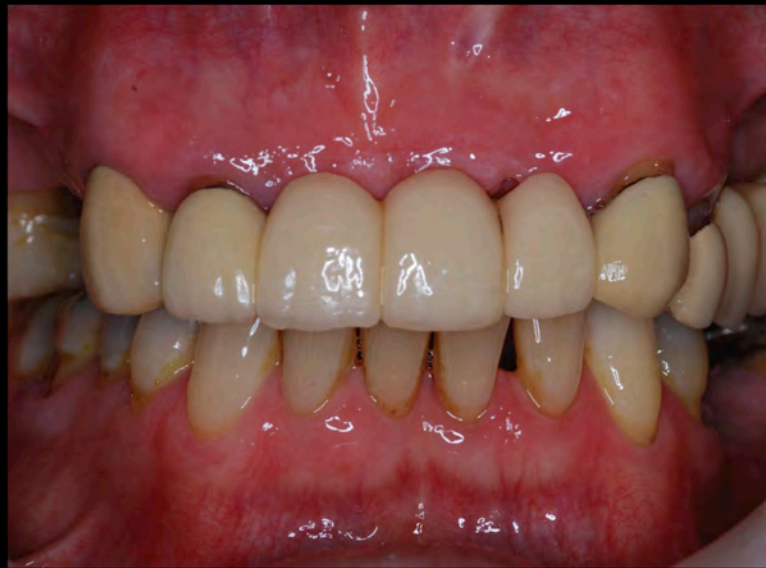
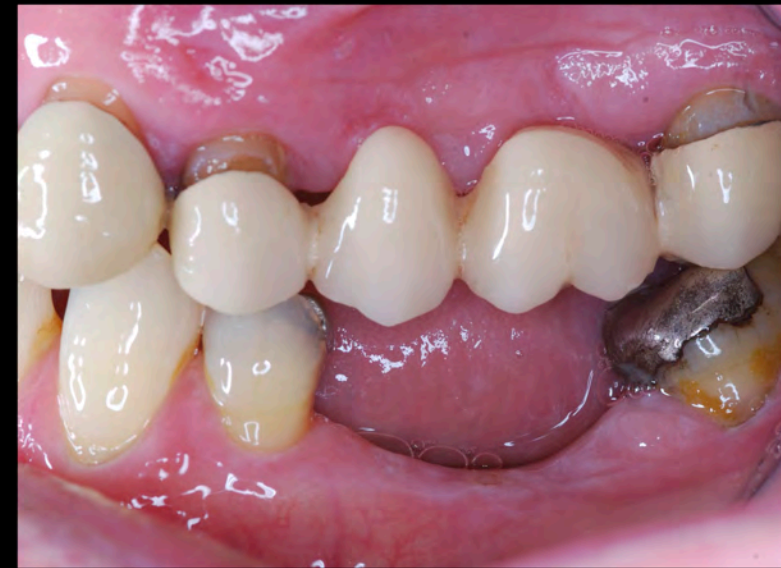
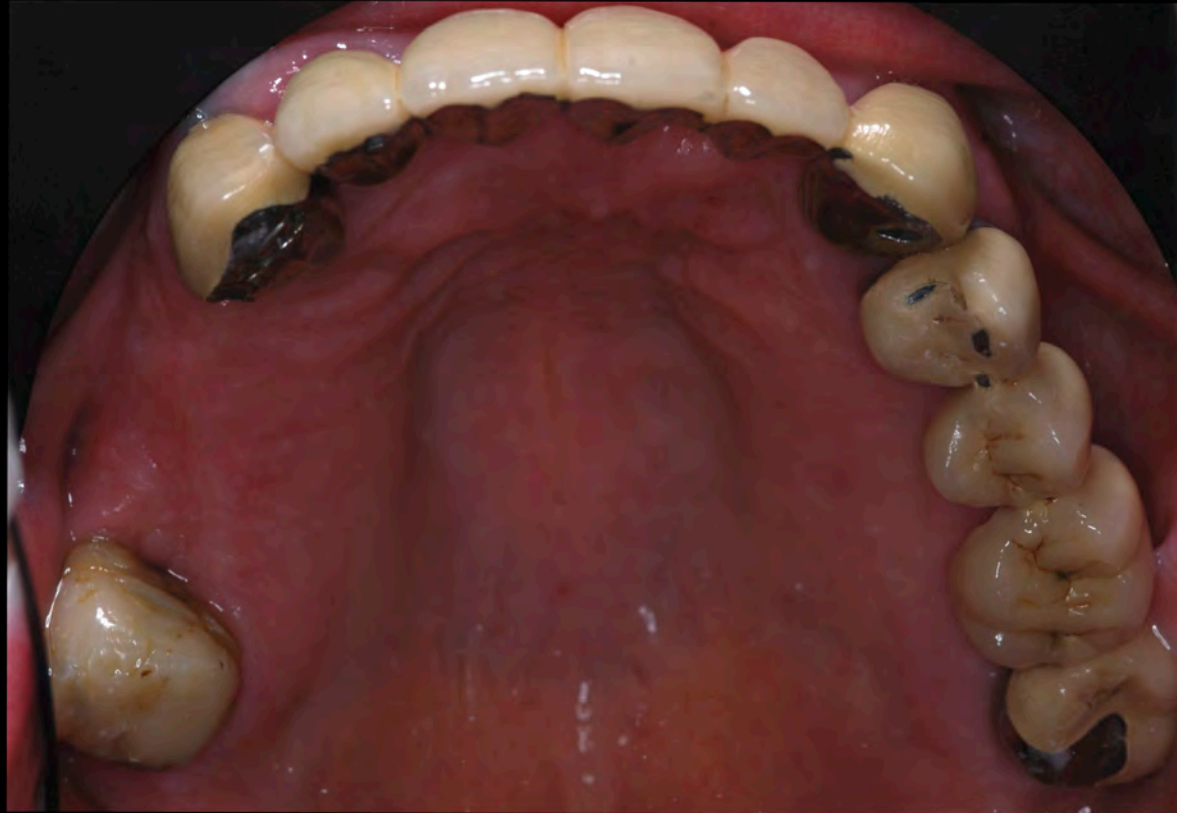
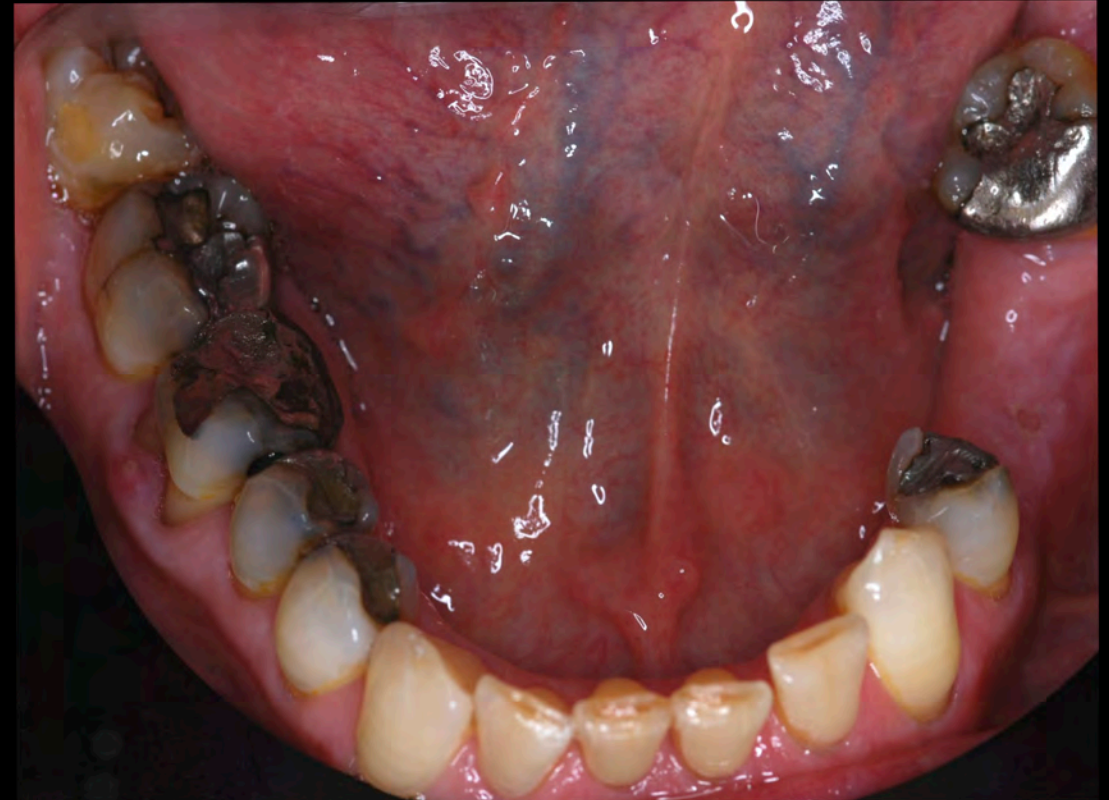
Intra Oral Photos 18/8/10

- sinus buccal to 46
- otherwise soft tissues healthy
- Bridge spanning from 24 - 27 has decemented from the 24 and is being retained by only the 27
- generally a very heavily restored dentition

RCP not equal to ICP
 First contact in RCP - DL cusp of 27
 Slide is mainly vertical
 Wear facets seen on 34 33 43
 Porcelain # seen on 24
 NWSI seen on 27
 Mild evidence of grinding however likely to be attributed to previous palatal porcelain on opposing restorations
 No tongue/cheek faceting
 Class 1
 Skeletal Base 1

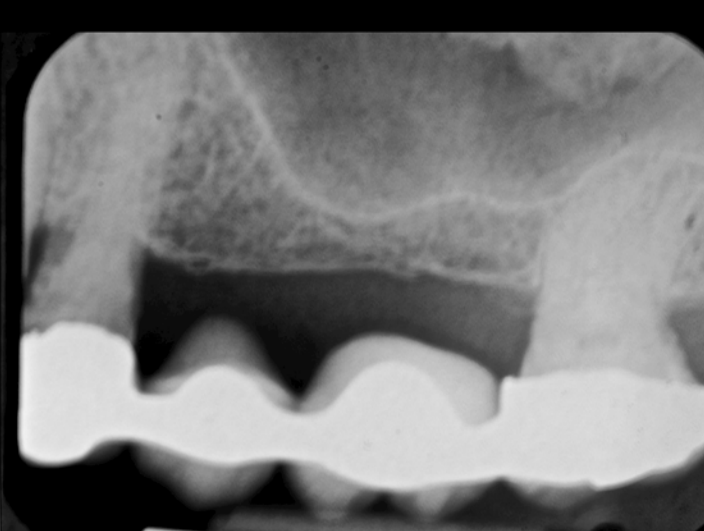
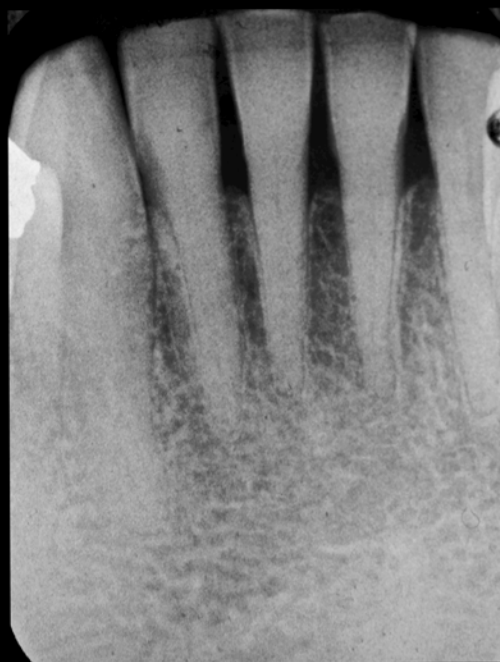
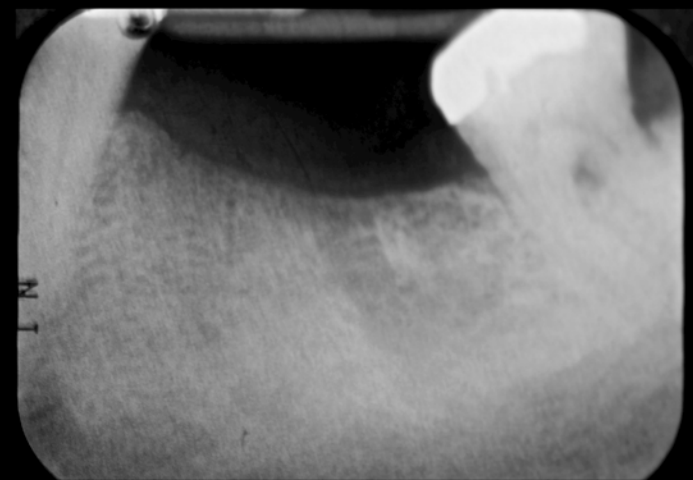
Radiographs - taken 15/7/10

- In the upper arch there has been approximately 4 mm of generalised bone loss
- The lower arch has 2 mm of generalised bone loss with localised vertical defects related to the 47

- The upper left maxilla has very little bone - potentially complicating future implant placement
- 17 appears to have peri-apical pathology and is heavily filled, however has long roots and good bony support

- 13 is root filled and has peri-apical pathology, the root treatment is 3-4 mm short and poorly condensed
- 12 appears sclerosed coronally, though the canal is evident apically with no pathology

- 24 appears totally sclerosed with no evidence of any peri-apical pathology
- 37 appears to have periodontal furcation involvement
- 45 has a 5 mm diameter peri - apical lesion

- 46 has peri-apical lesions related to both mesial and distal canals, is heavily restored and has a large overhang contributing to a vertical distal bony defect

- 47 is heavily filled with sub-gingival calculus and vertical bony defects

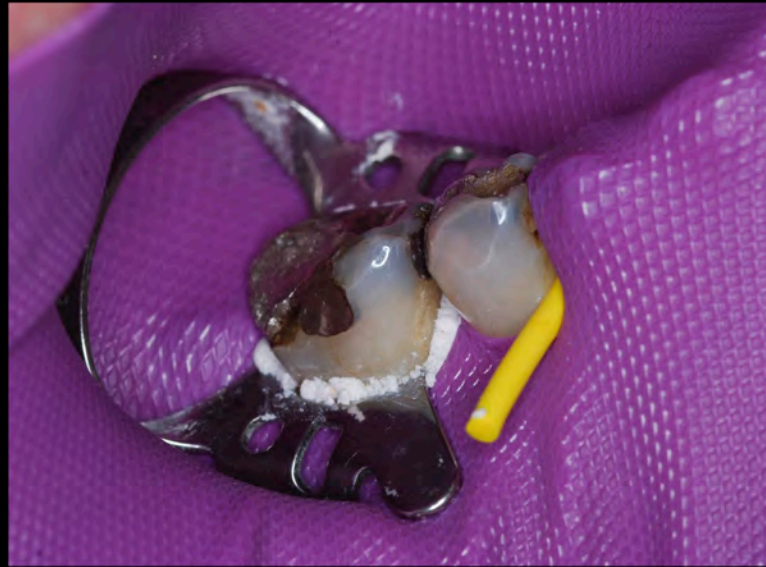
Root treatments 45,46

At the first visit 2/9/10 teeth 45,46 were isolated and the existing restorations and caries was removed, 4 canals were identified in 46 with a size 10 flexofile, the access was flared coronally with S1 Protaper and the tooth was continuously irrigated with sodium hypochlorite. The canals were dressed with non setting calcium hydroxide.

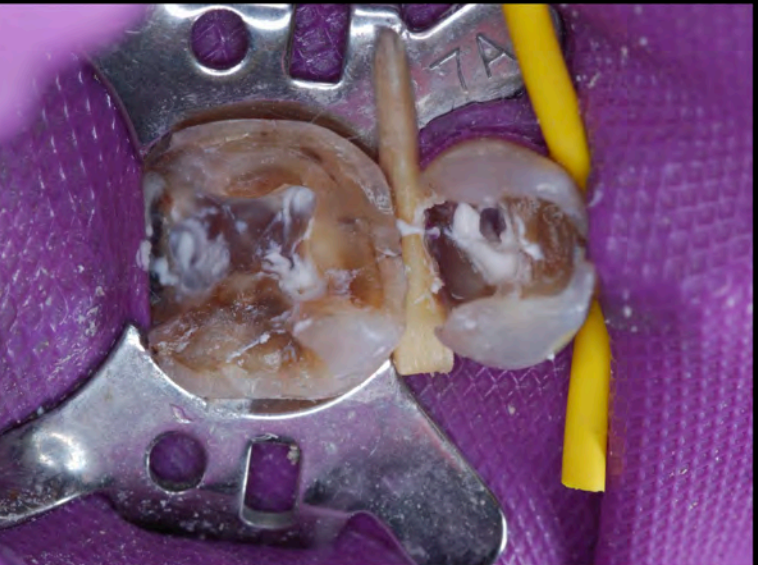
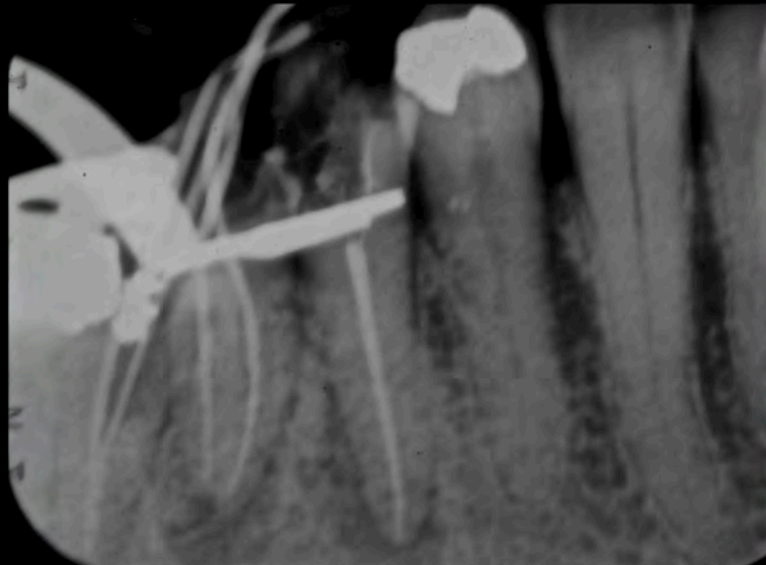
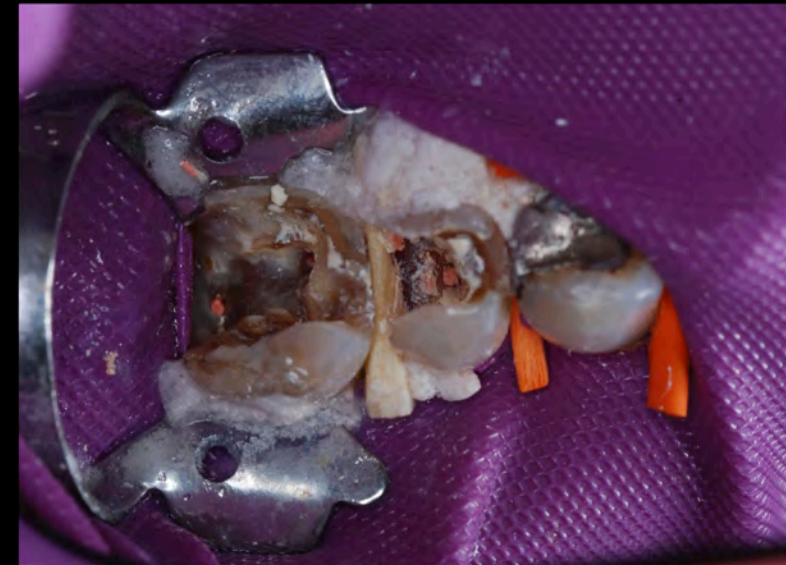
Unusually 2nd stage RCT was carried out the next day, using an apex locator to determine the working length. Canals were worked up to size 20 flexofile .5 mm short of the working length and then the 46 canals were worked to F3 protaper while maintaining patency. 45 was worked to MAF 40 flexofile with step back while maintaining patency. Sodium hypochlorite was used throughout with a 17 % EDTA solution and then finally 2% chlorhexadine (this would now only be used in retreatment cases). A check radiograph was taken to verify lengths and the canals were obturated. 45 obturated using cold lateral condensation and 46 using protaper GP points only.

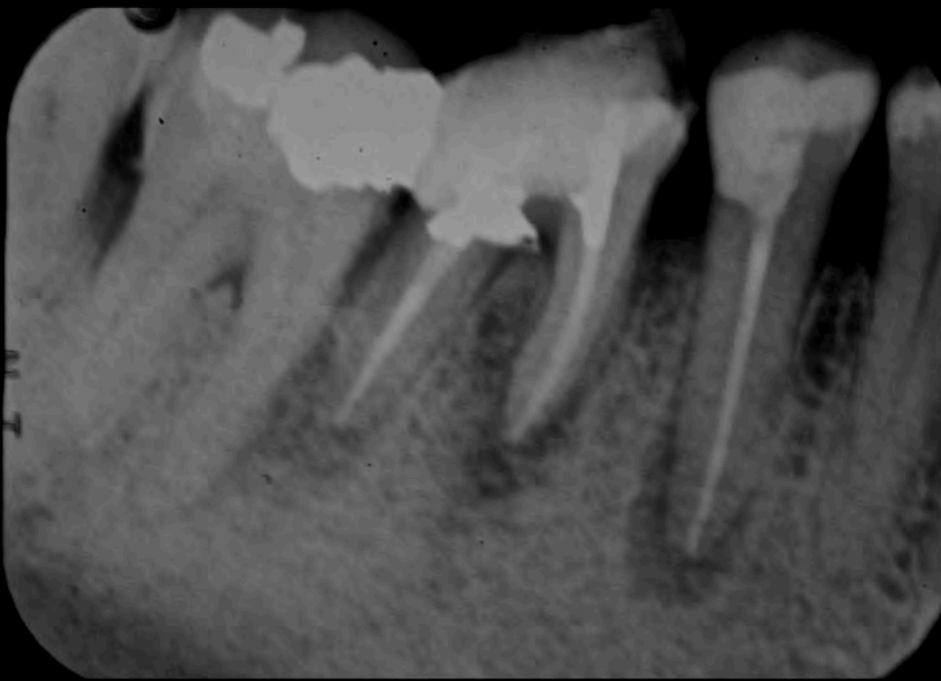
Following obturation 45 was restored using a hybrid composite, while time did not permit restoration of 46 a small amalgam was condensed into the canals to provide a seal. Radiograph taken on 3/9/10 show adequate RCT's. On 6/9/10 amalgam build up was completed

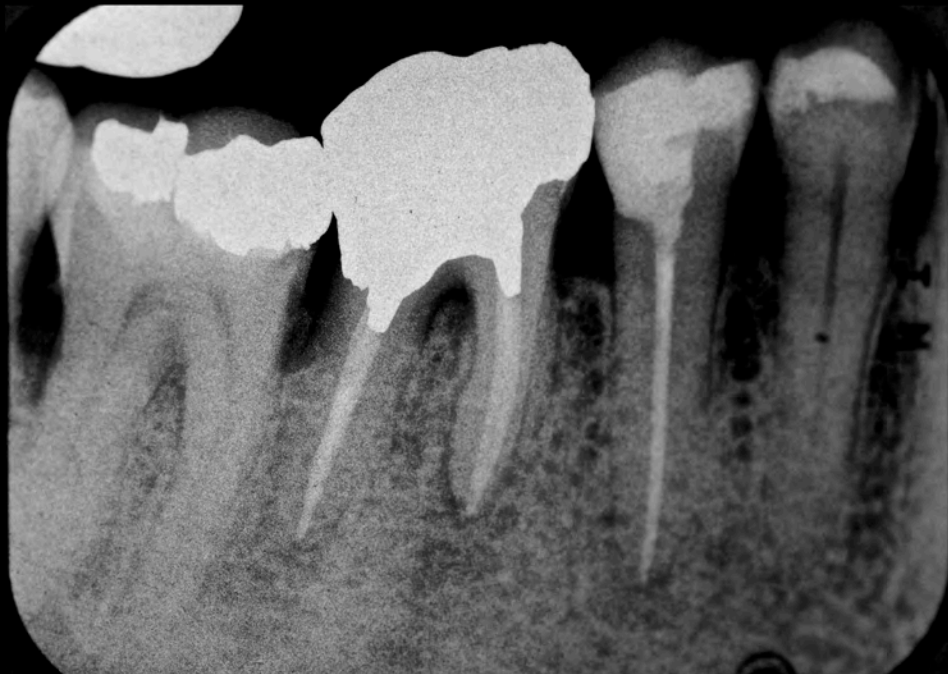
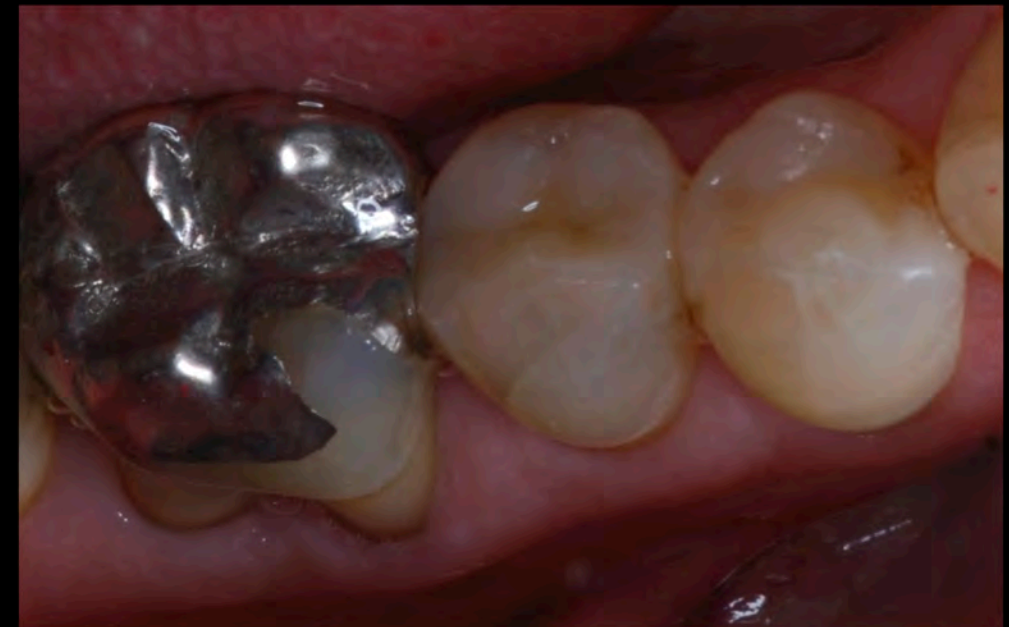
Subsequent radiographs taken on 15/3/11 (top right) and 20/10/11 (bottom left) show resolution for the apical pathology with bony infill. Unfortunately the same radiographs also show a possible deterioration of the bony levels and some subgingival calculus. 46 in particular would greatly benefit from a crown, indeed the amalgam restoration should have had full occlusal coverage.

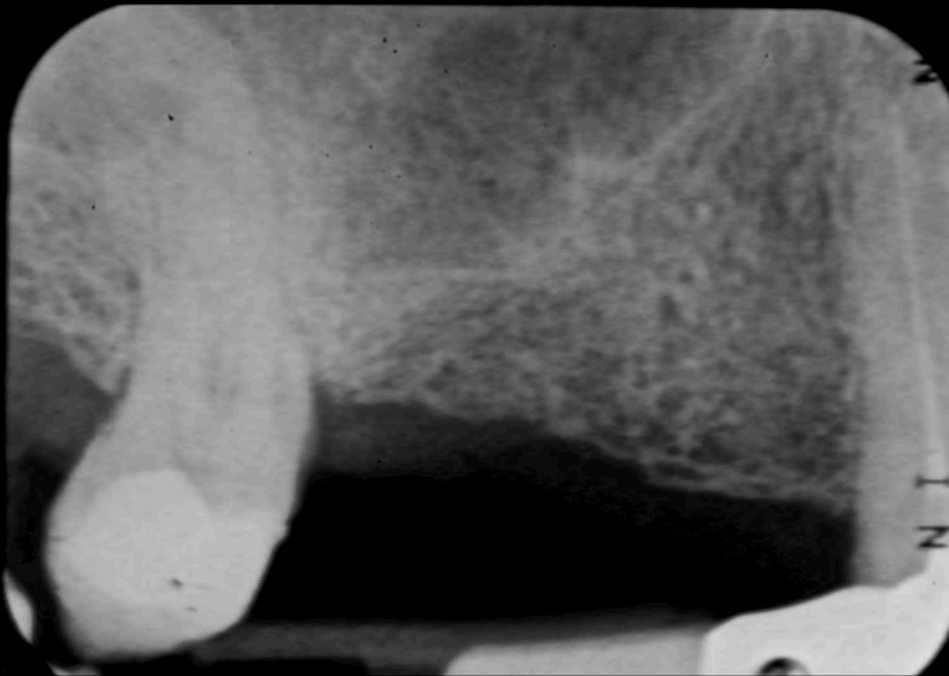
Root Treatment and Restoration of 17

Existing restoration was removed revealing numerous cracks extending into dentine. WL of MB1, DB, and P canals were established with apex locator and verified with a radiograph. MB1 MAF 40 @ 20.5mm DB MAF 40 @ 21mm P MAF 55 @ 16.5mm

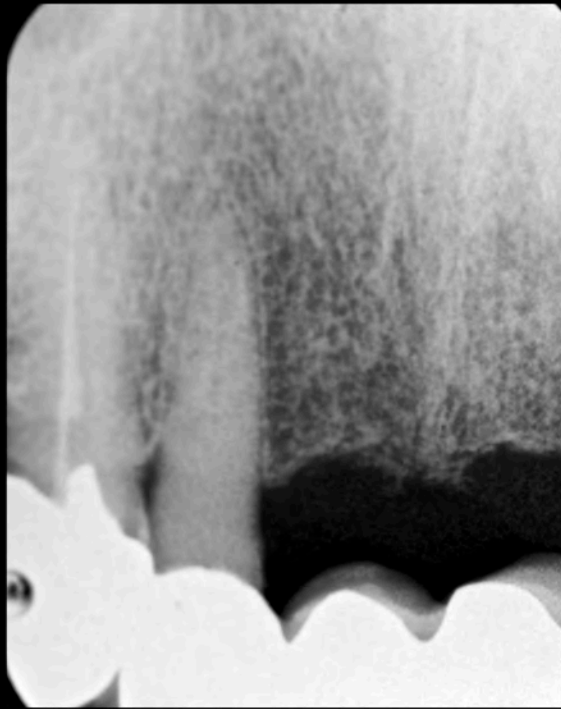
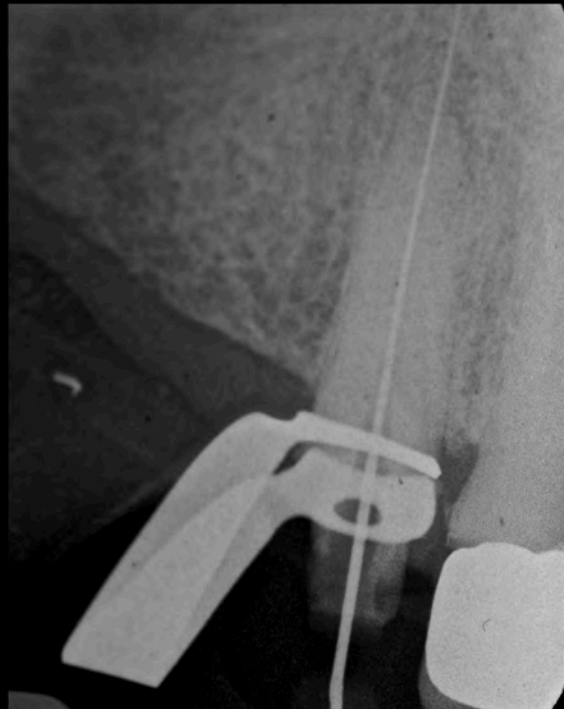
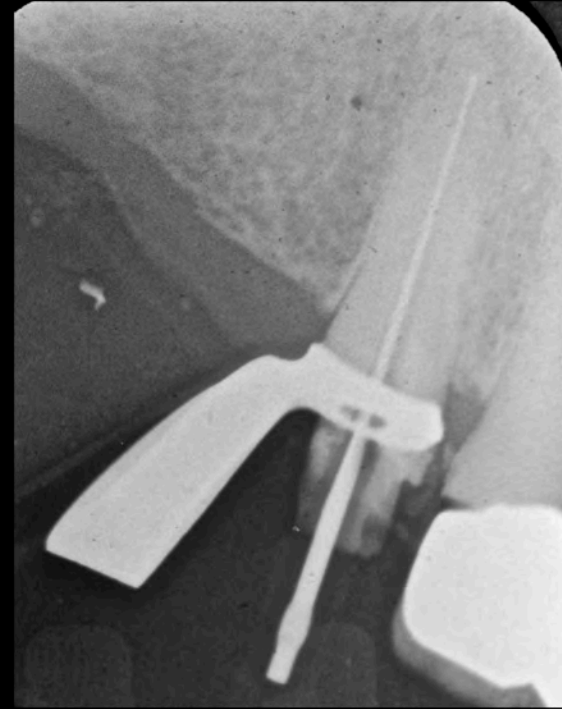
Re-Root Treatment and Restoration of 13

13 had the old gutta percha removed, the apex locator was not giving a consistent reading so the WL was determined radiographically, canal was worked to MAF 50 @ 21 mm and obturated via cold lateral condensation, 13 was then prepared for a duralay cast post. The post RCT radiograph has been misplaced.

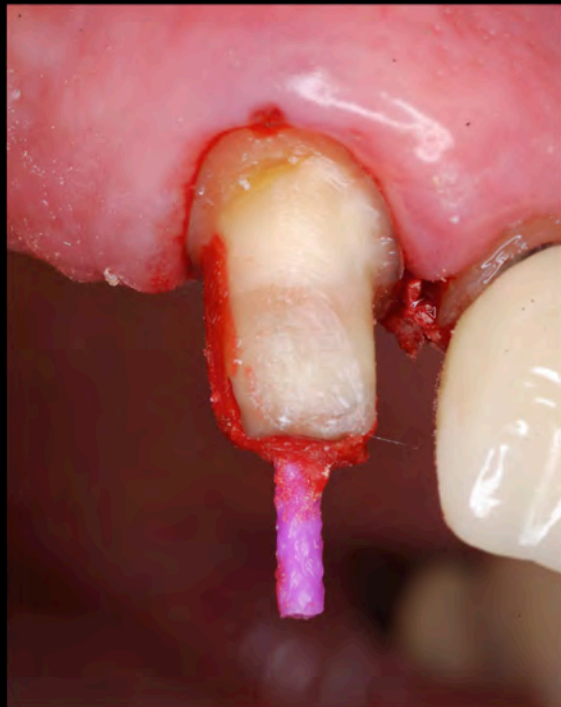
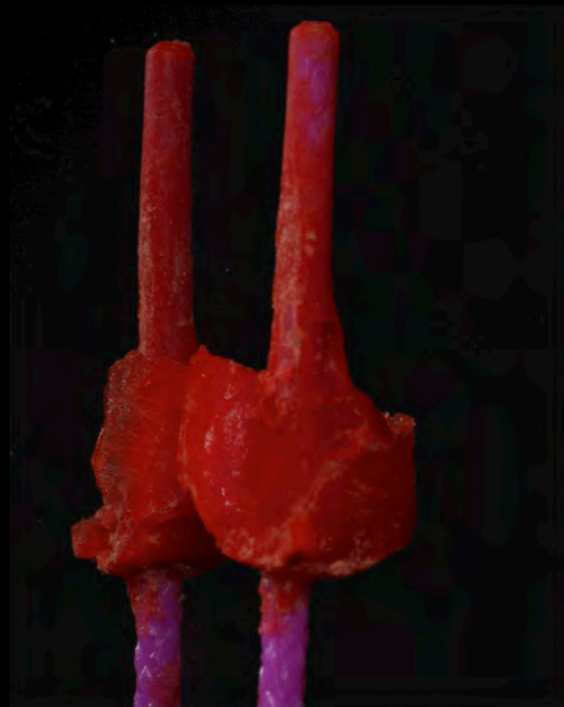
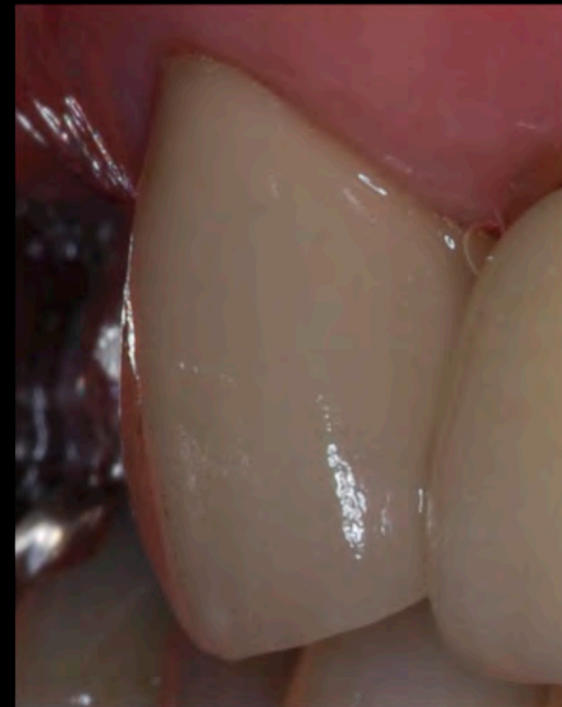
13 was temporised with cavit and the cast post was inserted (zinc phosphate) 4 days later and a provisional restoration constructed. The final PBMCr shade 2R2.5 non-precious (ni free) with metal palatal backing, distal rest seat, guide plane, and canine guidance was cemented with zinc phosphate in conjunction with the other crowns.

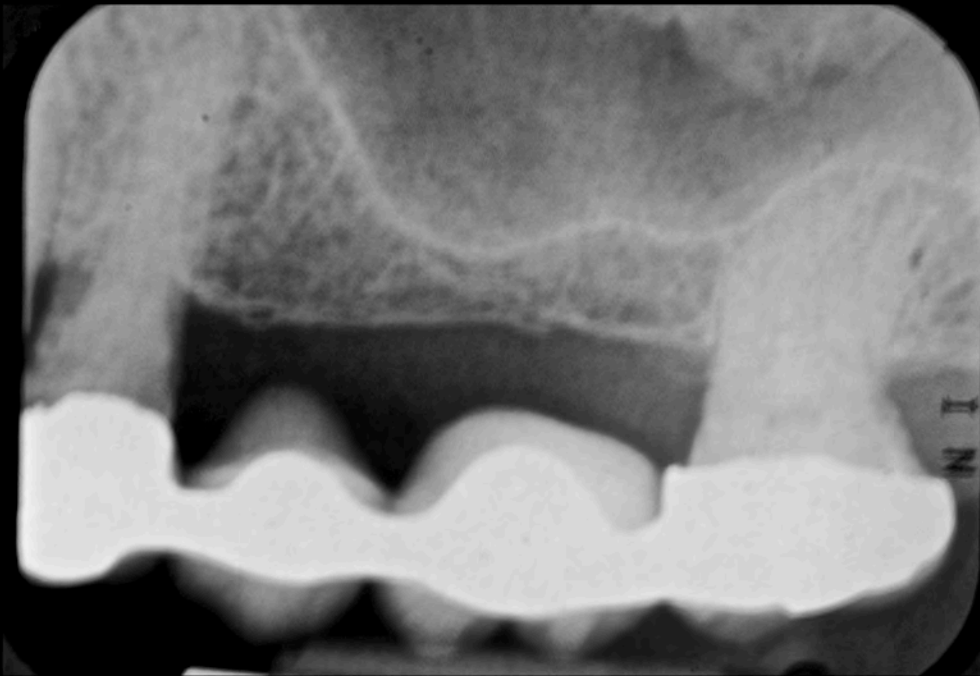
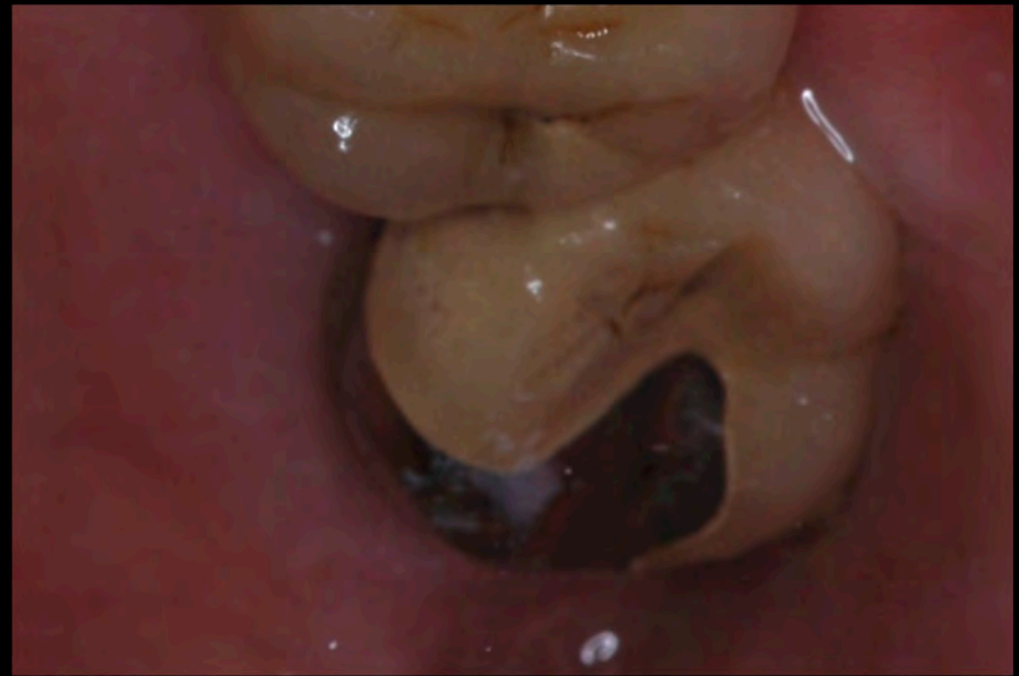
Restoration of 27

27 was retaining a 4 unit bridge, there was a NWSI on the DL cusp. The bridge was removed without LA and vitality was verified and lack of caries confirmed. A provisional bridge was constructed until the next appointment at which the tooth was prepared for full metal crown.

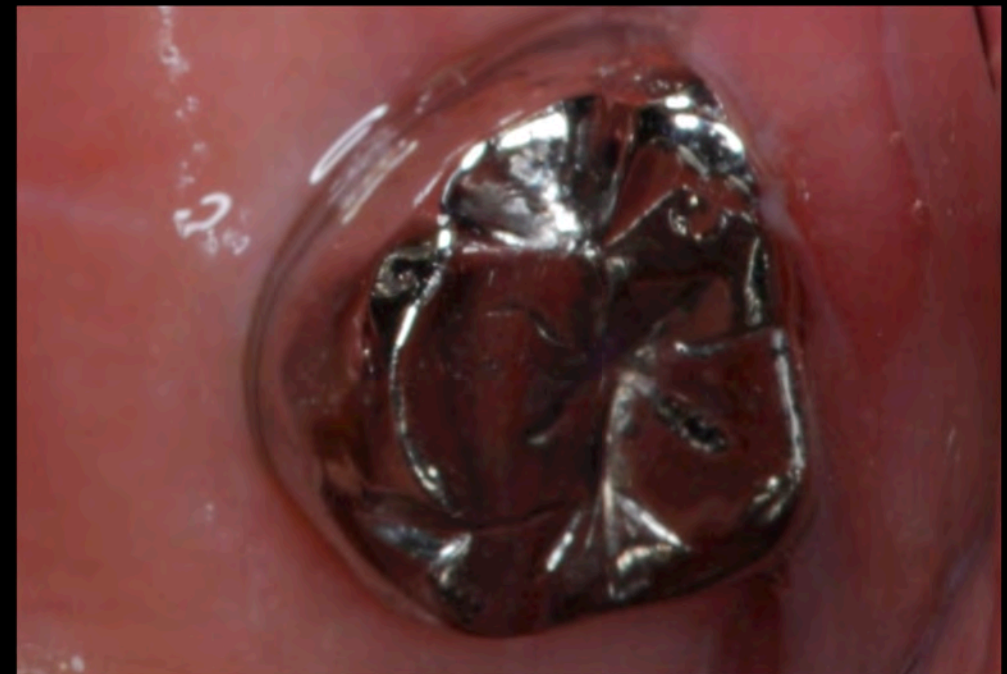
Non-precious metal (Ni-free) was chosen for cost reasons, gold would have been a better choice. A mesial rest seat and guide plane were incorporated into the design however due to a restricted vertical height I was unable to eliminate the NWSI

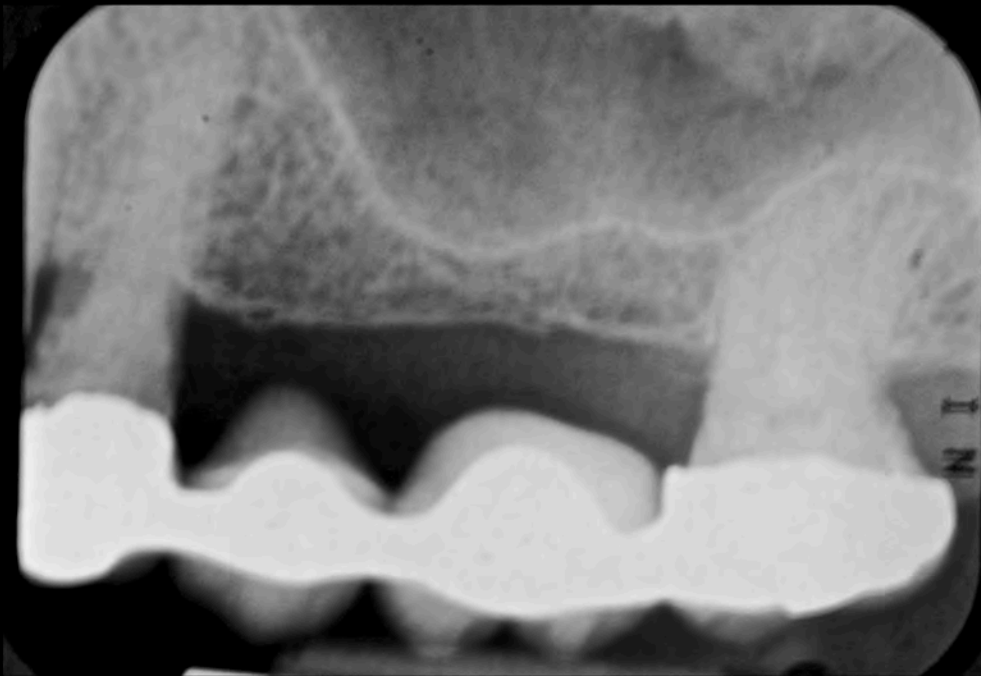
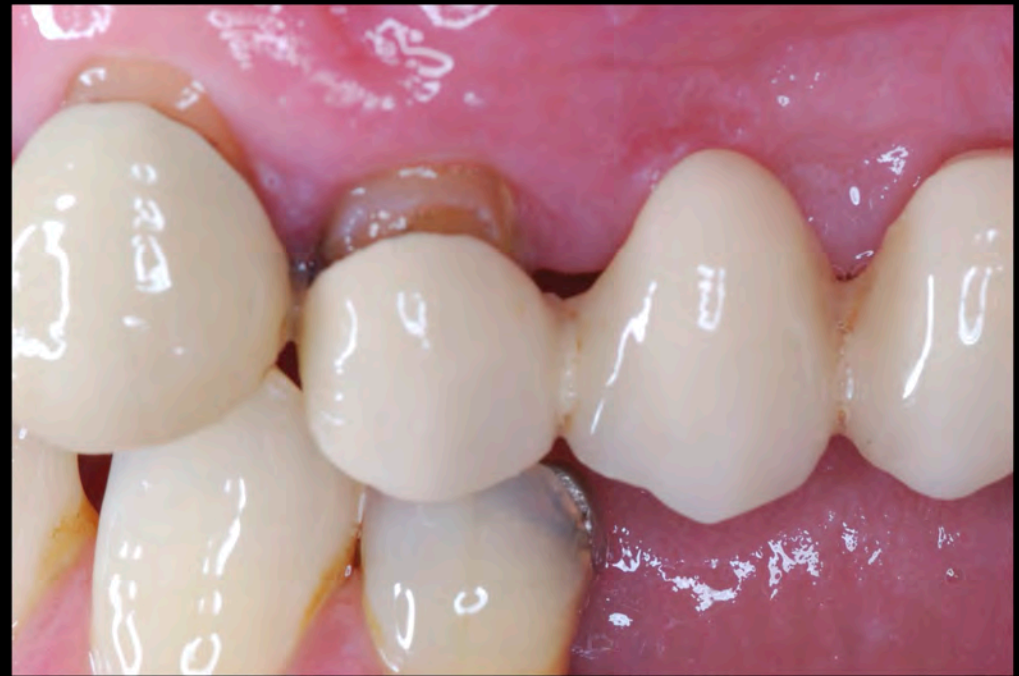
Restoration of 24

24 was a retainer for a four unit bridge however the bridge had decemented on this tooth, originally it was intended to construct a PBMCr on this tooth however when the bridge was removed there was very little coronal dentine left. RCT was attempted however I was unable to locate the canal.

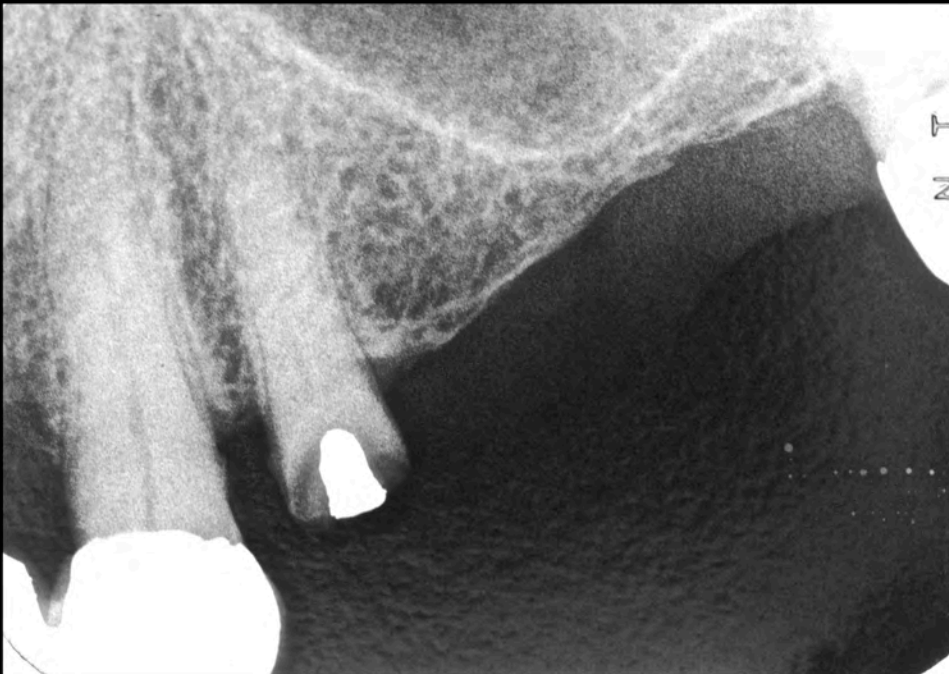
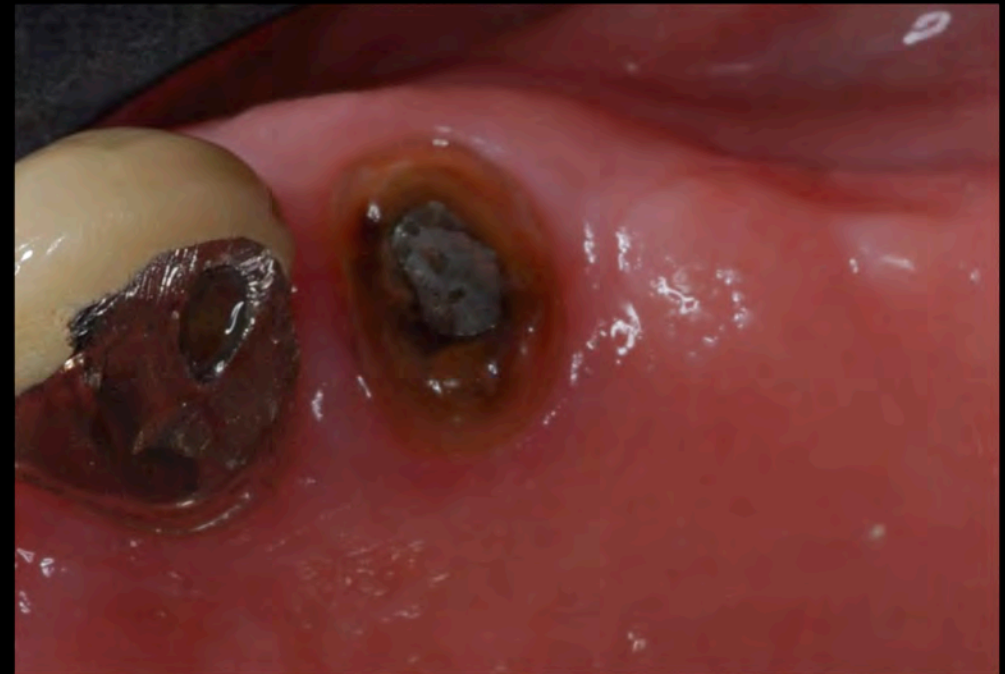
While crown lengthening could have been considered - given the short root and likely pressures as an RPD abutment the decision was made to place an occlusal amalgam and use as an overdenture abutment and xla if it became symptomatic.

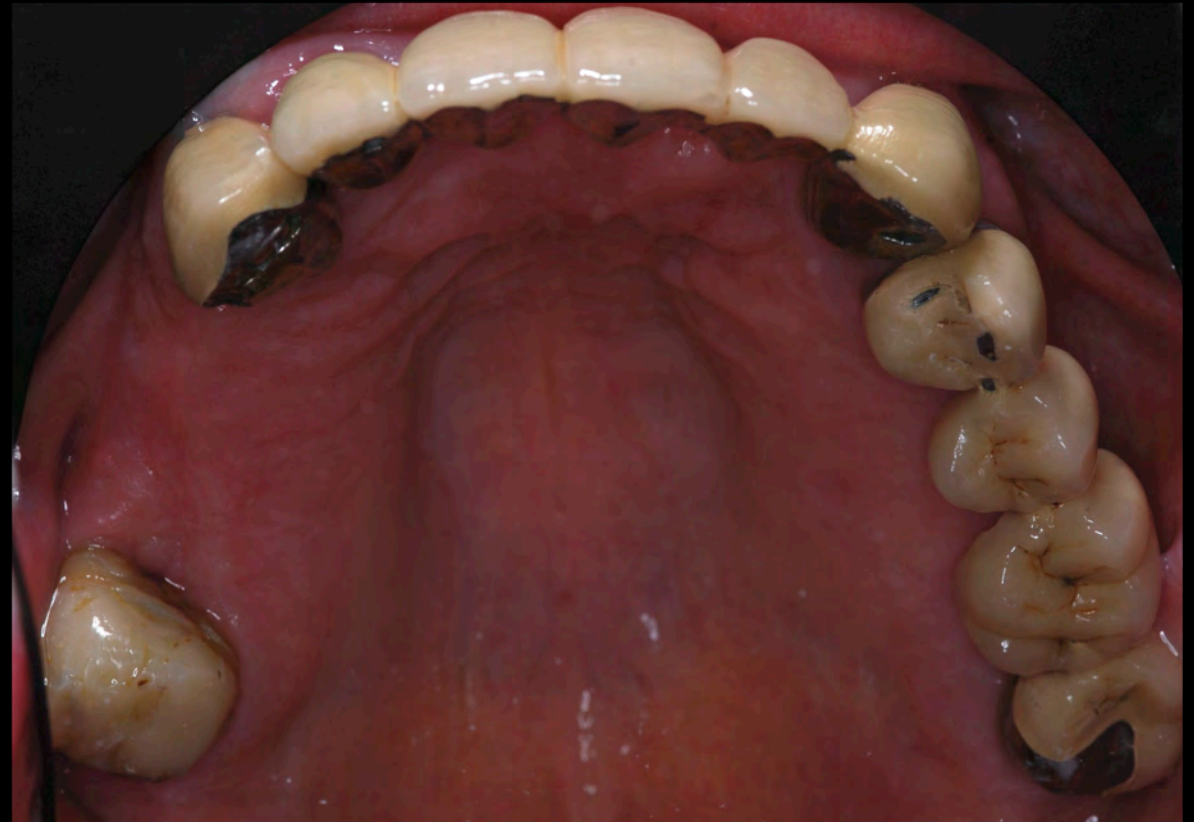
Metal crowns were constructed on 17,27 and PBMCr on 13 incorporating appropriate rest seats, guide planes and contours for clasping for the final denture. The lab was sent a copy of the final denture design to aid their construction. (see appendix) Also at this stage it was decided to construct an acrylic denture as a short term measure while the final denture was being constructed.

The acrylic denture would also function as a spare denture should it become necessary.

Acrylic denture was designed with the acrylic extending up to the gingival margins as this would facilitate the addition of the teeth of the anterior bridge in the case of failure. Tooth coloured clasps were incorporated.

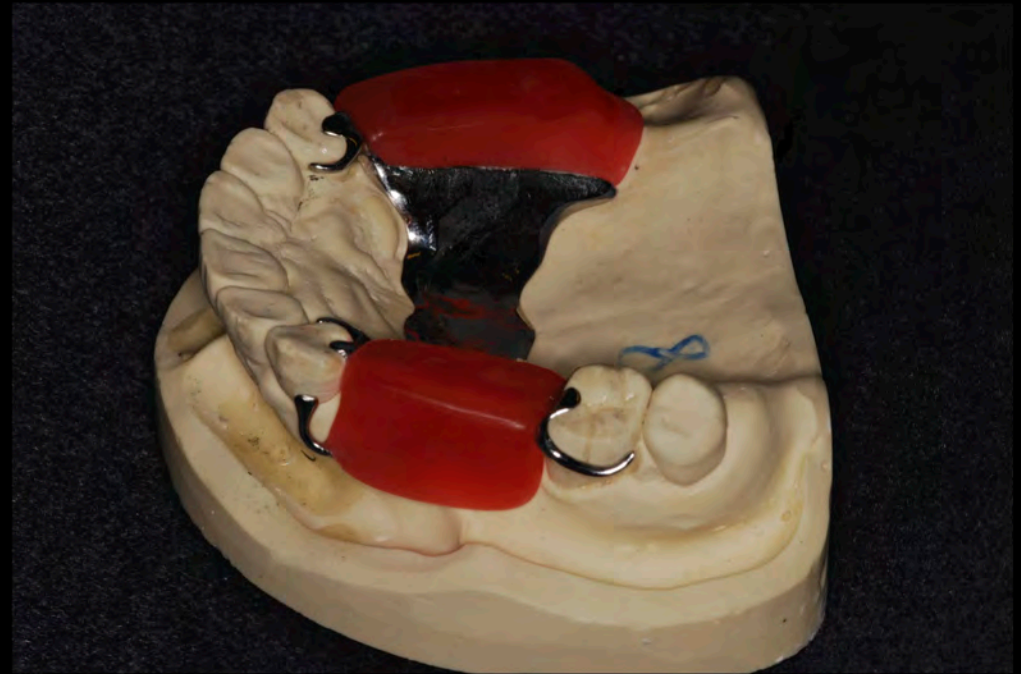
Construction of denture

Master impressions were taken in a medium bodied addition cured silicone in a rigid special tray, the metal framework was tried in to verify fit and wax registration rims were incorporated onto the framework (as seen on a similar case above) and bite registration was carried out at the second appointment along with a facebow registration

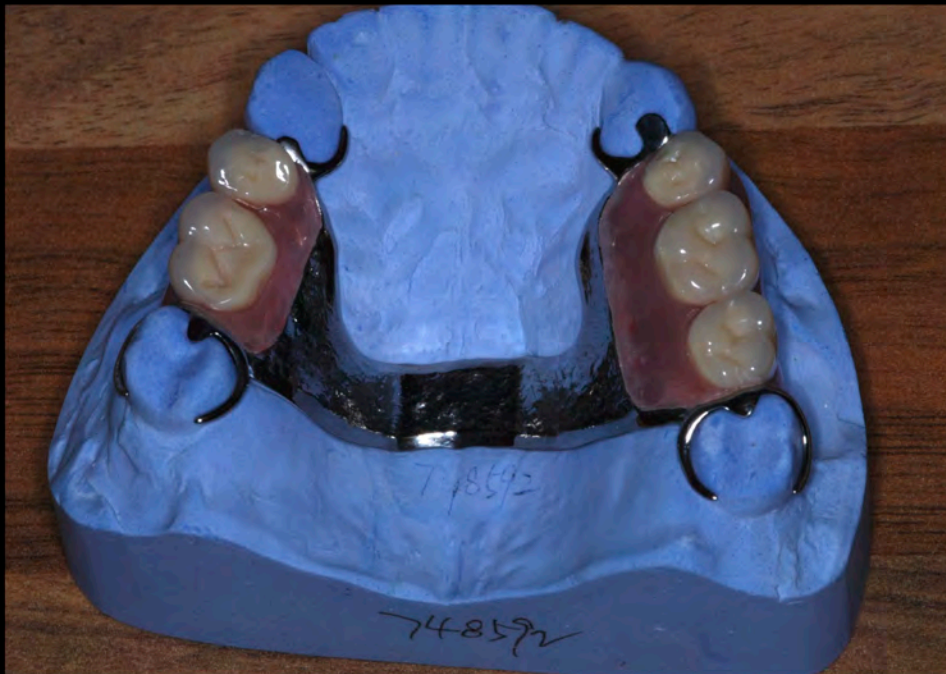
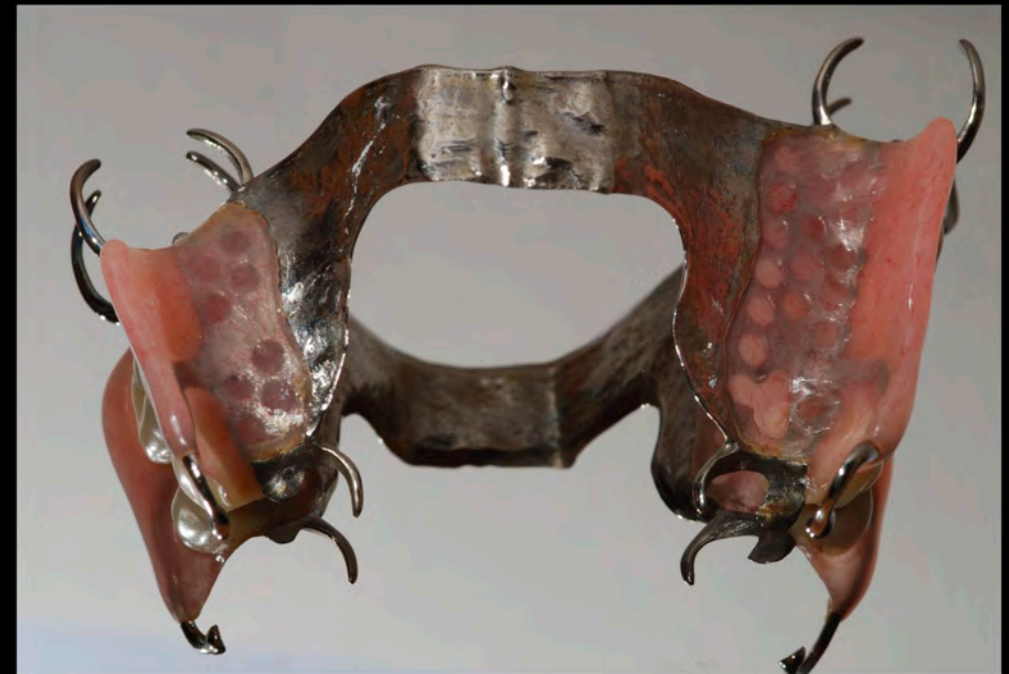
Final denture at insert appointment, fit was excellent though occlusion was refined at insert appointment to ensure group function in lateral excursions thus reducing the loading on 13 and 23
