Mrs X

Severe tooth wear and  
loss of posterior support  
treated with anterior  
crown/bridge work  
incorporating features to  
facilitate CoCr denture

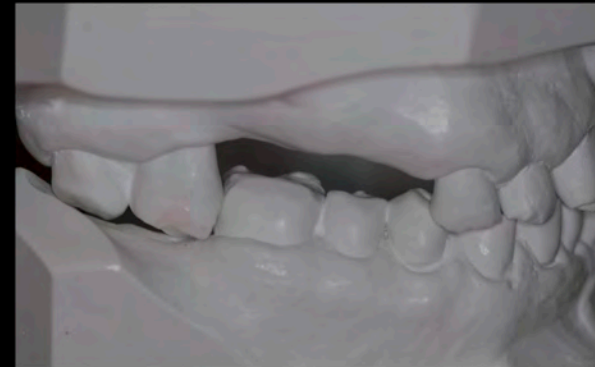
It was not possible to determine if RCP = ICP as the severely over erupted 17 interfered with the 46 when it was attempted to retrude the mandible

Wear facets were evident on nearly all the teeth with cupping indicative of acid erosion present on many teeth.

Group function was seen on both right and left lateral excursions with a working side interference on right lateral excursions seen on the 17.

Posterior occlusion unstable

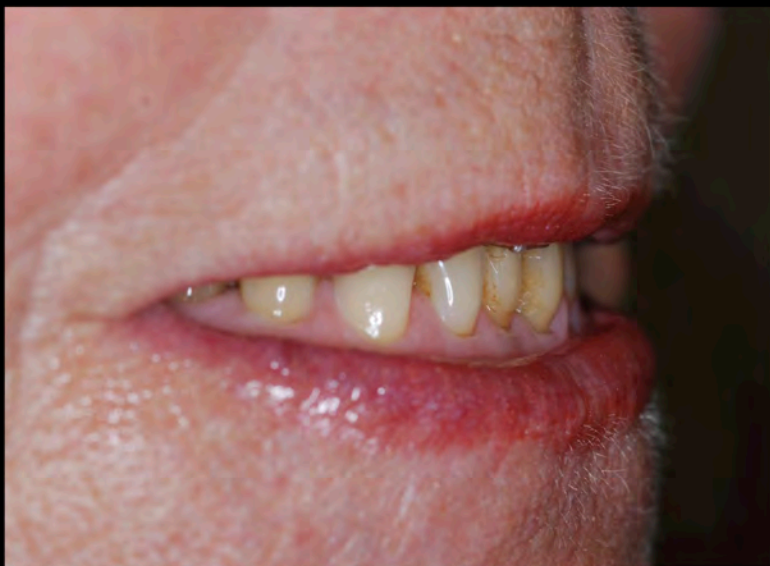
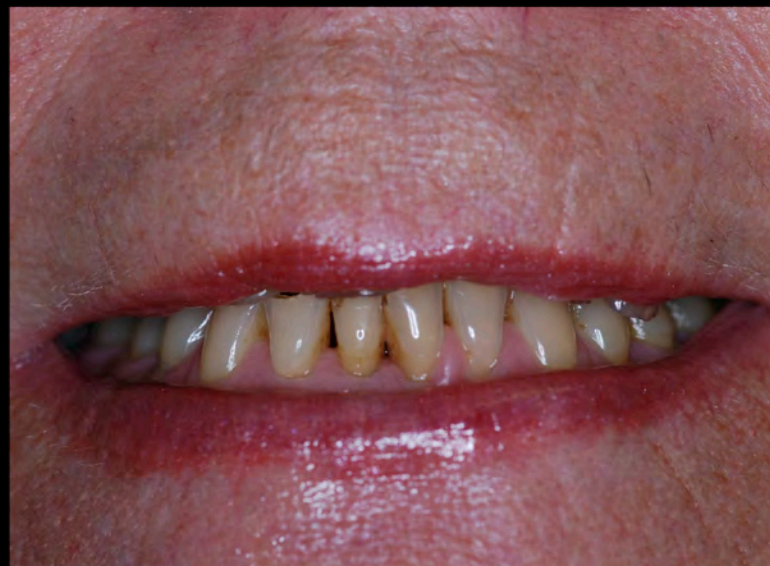
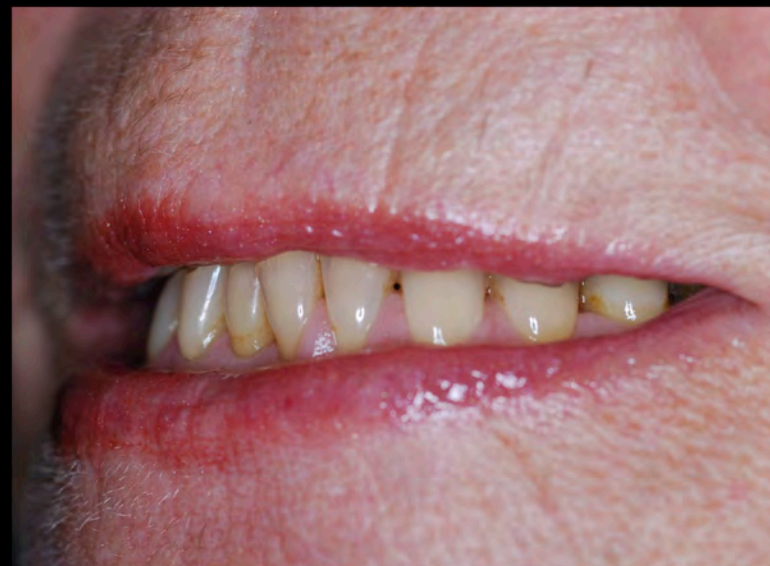
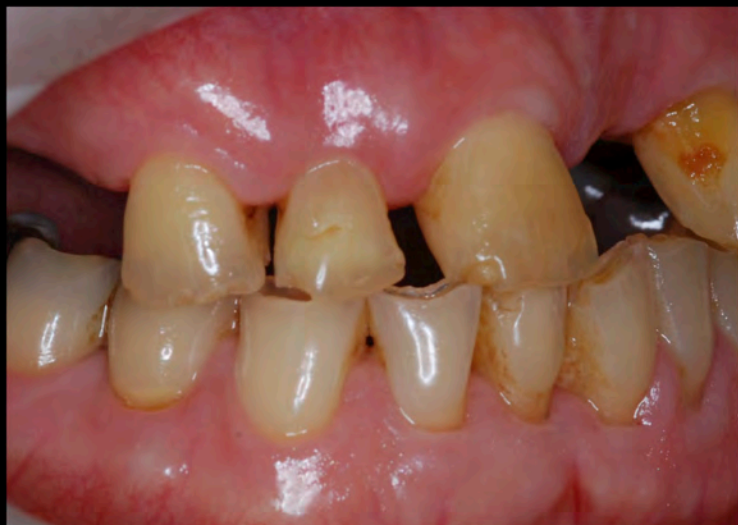
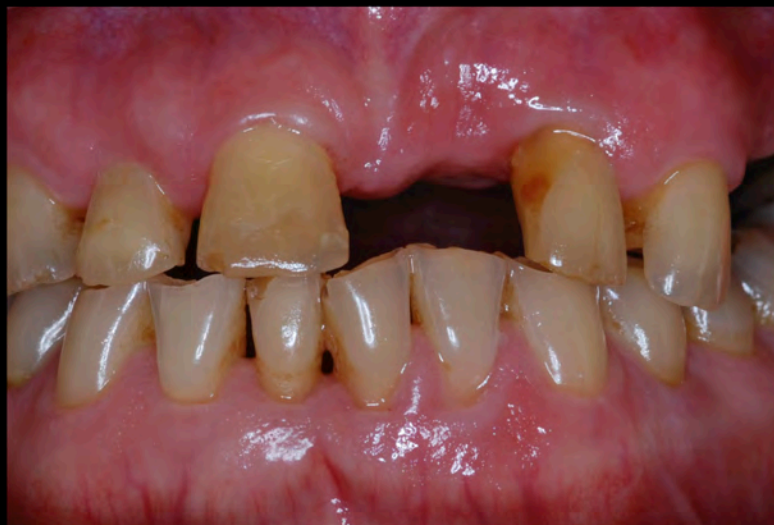
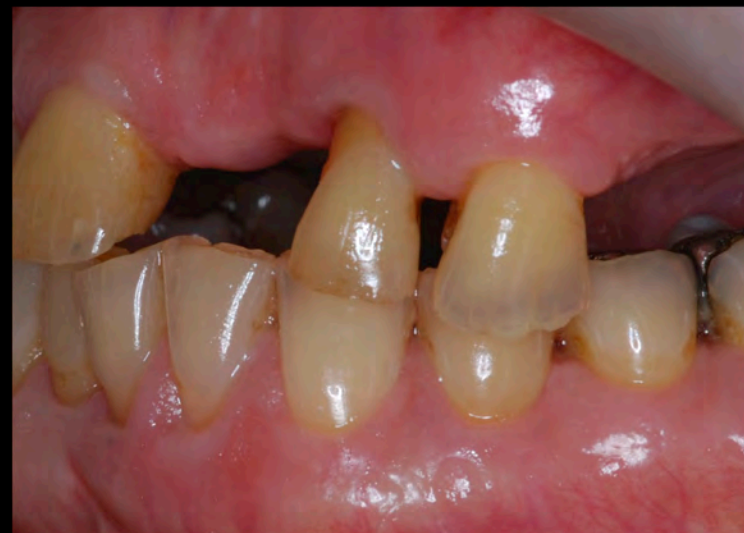
## Intra Oral Shots 26/4/10

- Soft tissues healthy
- Advanced toothwear of both upper and lower teeth evident, due to both erosion and attrition. Has an upper acrylic denture that she can not tolerate.
- all upper teeth respond positive to endo frost

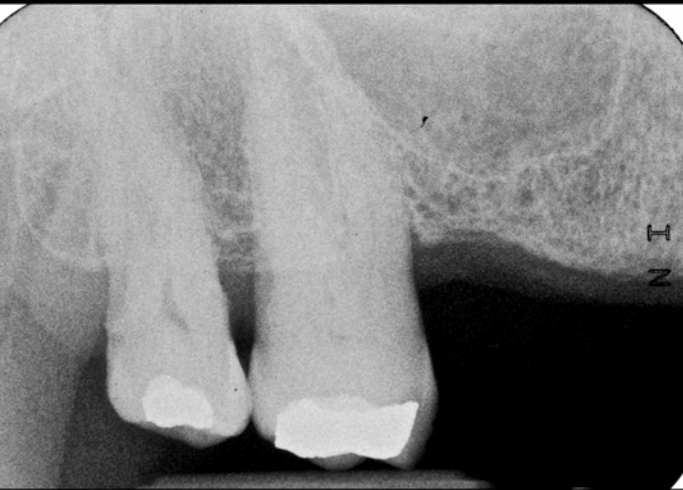
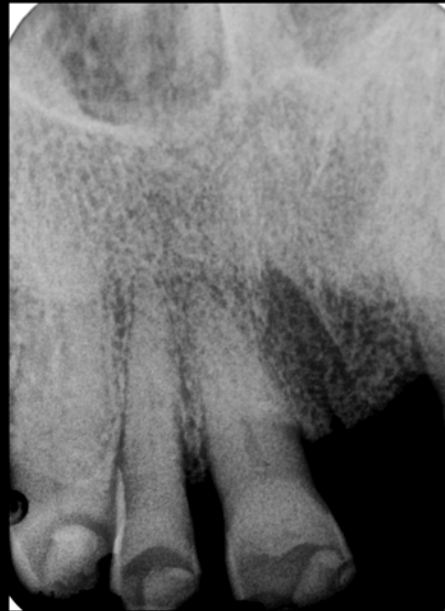
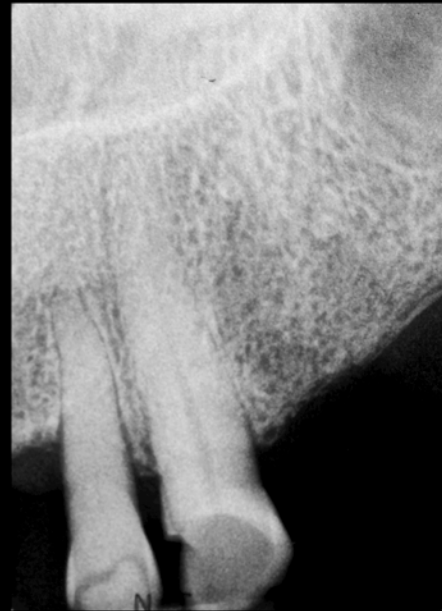
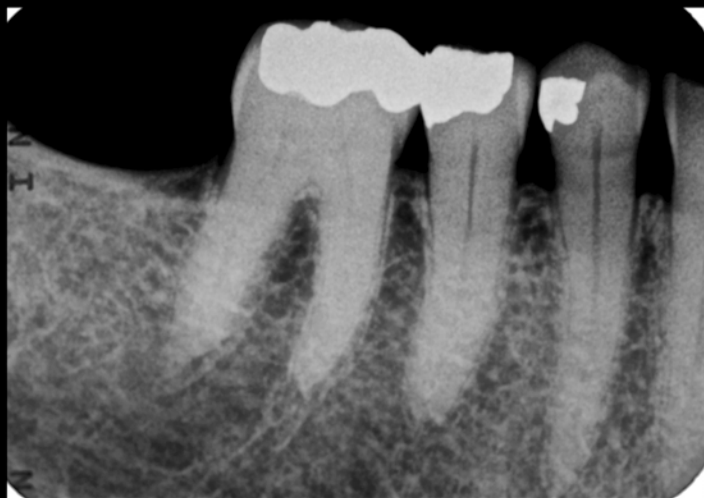
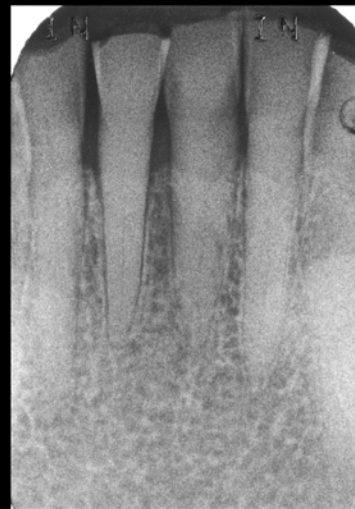
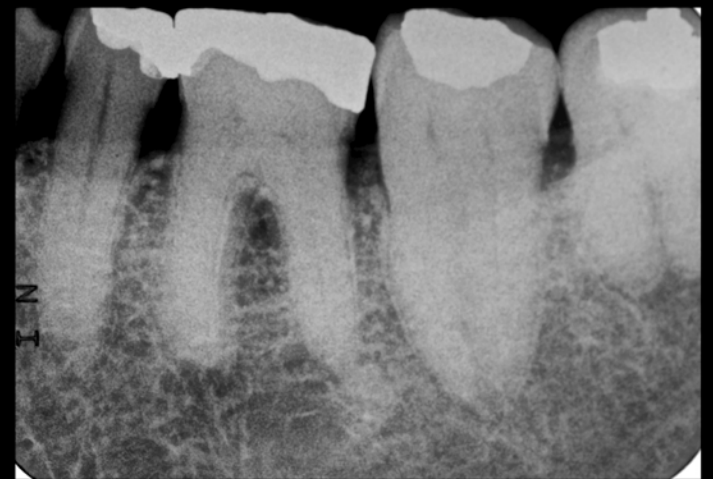
# Radiographs - taken 24/6/10

- Generalised bone loss was evident, 2mm of bone loss on the mandible and up to 7 mm on the maxilla.
- Some deposits of interproximal calculus were evident
  - Generally the teeth had long roots
  - no peri-apical pathology was noted

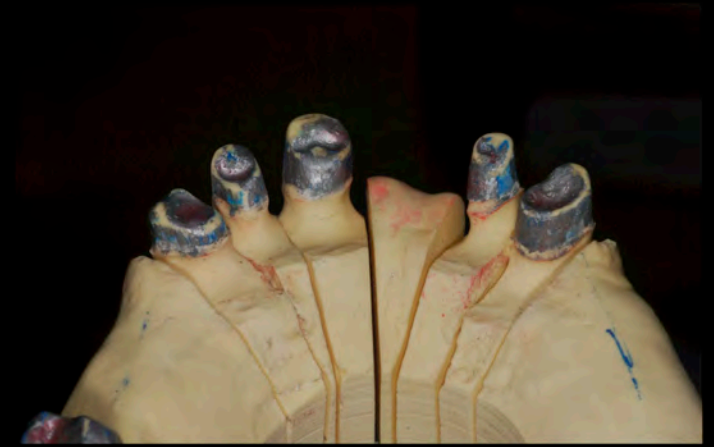
# Photos of Labwork

The lab was instructed to construct a non precious metal crown 17 with a guide plane, mesial rest seat, and appropriate contours for clasping. Metal copings were also constructed for the crowns 13,12,23 and bridge 11- 22. These were to have distal rest seats on 13 and 23, be at the OVD described by the registraton rim, with a flat centric stop, canine guidance and gentle rises into anterior guidance. The fit of these copings was verified intra orally before the porcelain was added. It would have been a good idea to have the palatal surfaces constructed in metal so that the guidance could have been verified at this stage. It was decided to cut the metal back buccaly at the margins for better aesthetics.

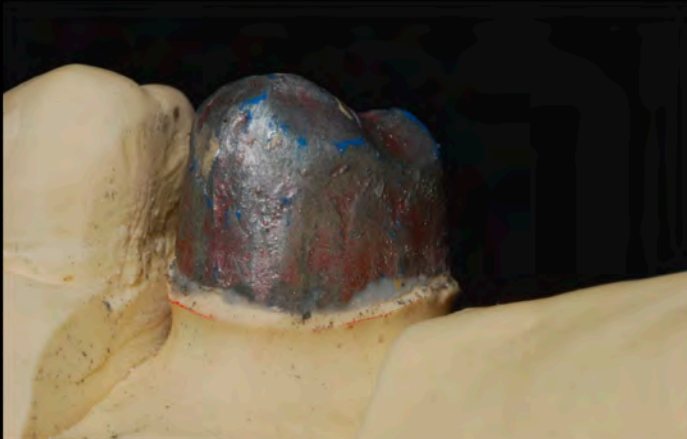
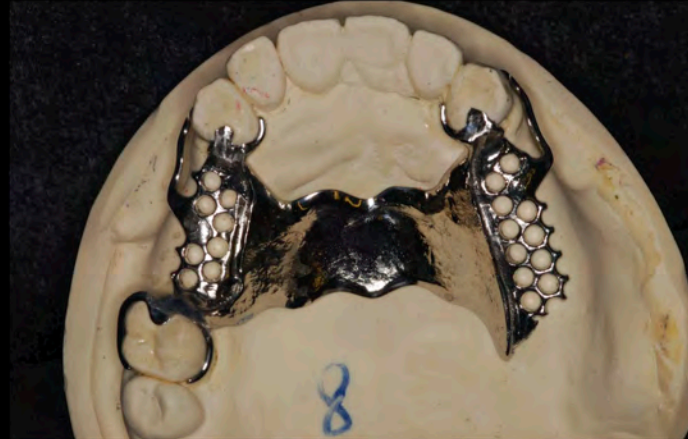
Despite not constructing the palatal surfaces in metal the guidance was good and the crowns were inserted with zinc phosphate. Unfourtnatley when the denture was constructed a WI occured on the metal framework where it clasped the 17. It was decided to go ahead and construct the denture and should the WI give trouble extract 17,18 and construct a new denture.
