**Oceanlinx Wave Energy Converter Barge
PK Gateway Port Kembla NSW 2505
OHS System Review**

National Safety Council of Australia (NSCA) was engaged by Oceanlinx Limited to carry out a review of the Wave Energy Converter Barge, located at the PK Gateway Dock facility Port Kembla on the 18th of November 2008

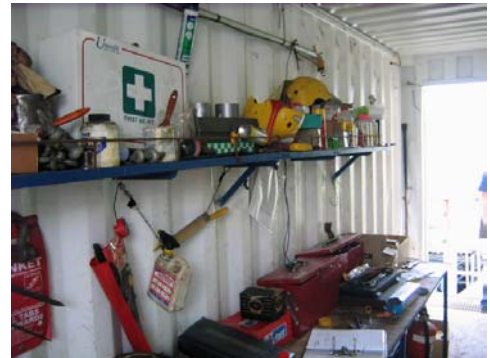
Housekeeping on the barge was good with limited quantities of spares and consumables on board. Workshop areas were somewhat untidy, see fig. 1 and some of the plant and equipment such as drills and compressors were not "Industrial Grade" but were tested and tagged.

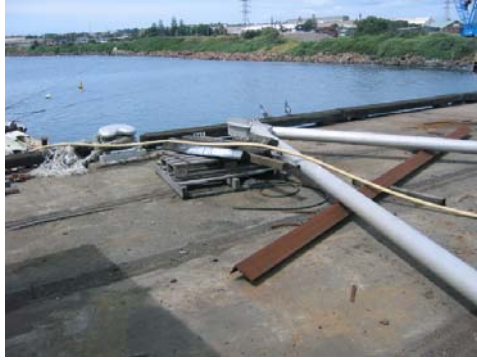
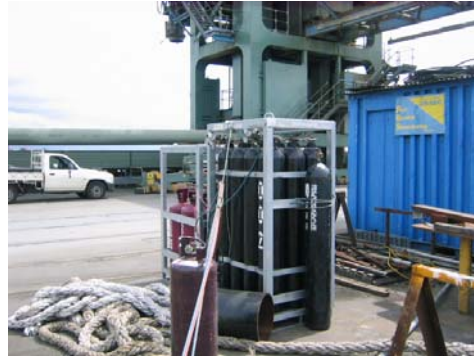
Housekeeping on the wharf was of a poor standard, with numerous serious Slip trip and fall Hazards. A number of these were created by other businesses that use the facility.

It is recommended that a meeting be arranged with Oeanlinx Management and the Port Authority to ensure safe use of the Wharf for all users and to remind them of their Duty of Care responsibilities.

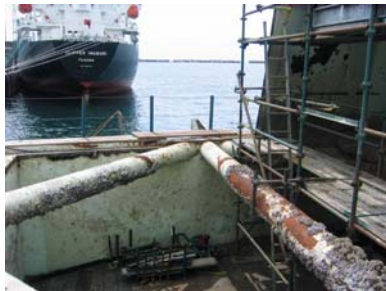
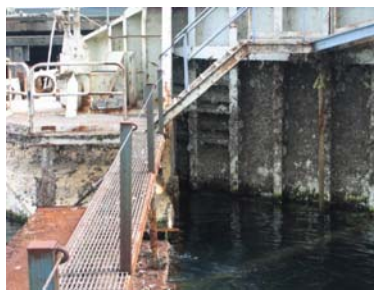
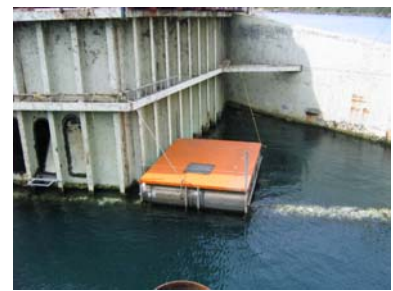
Scaffolding was in use throughout the Barge for working at height tasks. It appeared to be well erected by competent persons; however a number of deficiencies were observed where barricading was required to prevent falls. Continuous improvement and vigilance in this area is mandatory.

The “Pontoon” vessel, used to access areas near the waterline has limited fall protection and requires a risk assessment to identify all hazards while in use.

A full review of working at height activities be undertaken to minimise the significant risks in this area. An area of concern is the lack of barricading to prevent access to areas that have no fall protection in place.

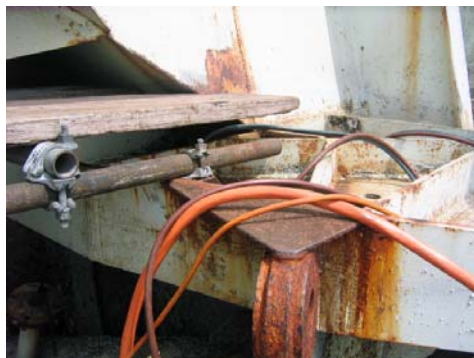
I observed a number of areas of concern with regards to poor routing and protection to both Electrical lead and Oxy Acetylene hoses. Suspension hangars were available but not deployed.

The boat ramp winch had exposed battery terminals and poor cable routing.

Ensure all Contractors using this equipment are operating to the highest standards and they submit comprehensive JSA's and SWMS to Oceanlinx Line Management

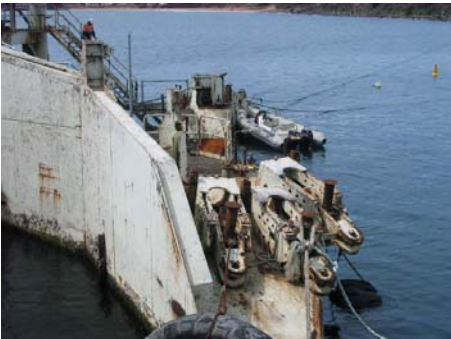
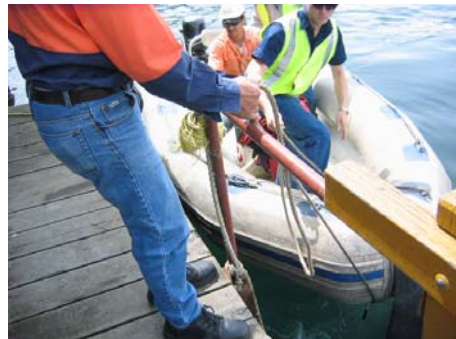
The procedure for getting on and off the inflatable boat presents a number of risks to persons. There needs to be a documented procedure to minimise risks. This is particularly so when the Barge is deployed and its boat ramp is in use.

It is recommended that a comprehensive documented procedure be in place particularly when the barge is in operation. The boat should only be operated by competent persons and access to the Barge should ideally be limited to only approved and essential personnel. The wearing of life vests at all times is essential.
