OUR REF: Waterside-2021-22/Fishkill

## **WATERSIDE ESTATE LAKES MONITORING –LATERAL 2.2 FISHKILL INVESTIGATION**

Please find below the results and discussion report on the Fishkill on Lateral 2.2, which occurred in the first week of **February 2022**.

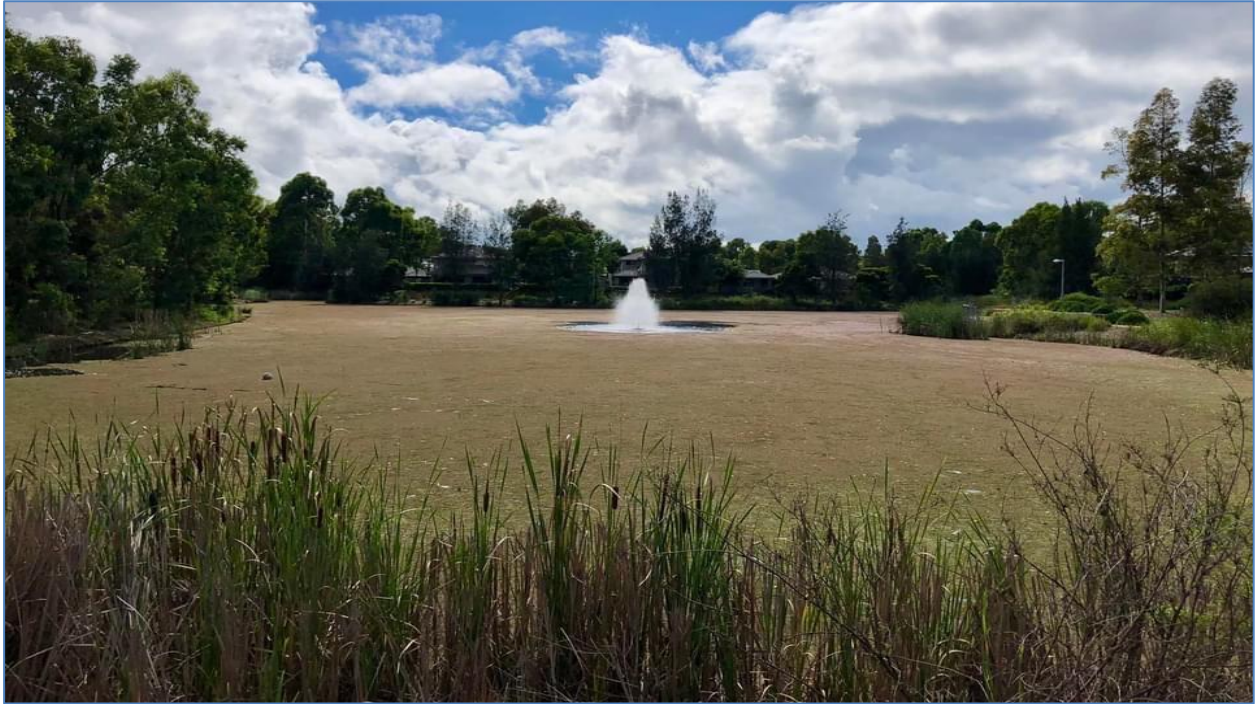
**Figure 1** Lateral 2.2 – a photo showing the fountain in operation. The water surface is covered with azolla growth

- ▶ Two floating aquatic species (*Azolla*, and possibly duckweed - *Lemna*) thrive in the Lateral 2.2 (**Figures 1-2**). Their undesirable visual effects have led to resident complaints in the past. These are periodically removed by harvesting and occasionally treated with an aquatic herbicide (Diquat – Reward®). The last spraying occurred on the 28-29<sup>th</sup> of January.

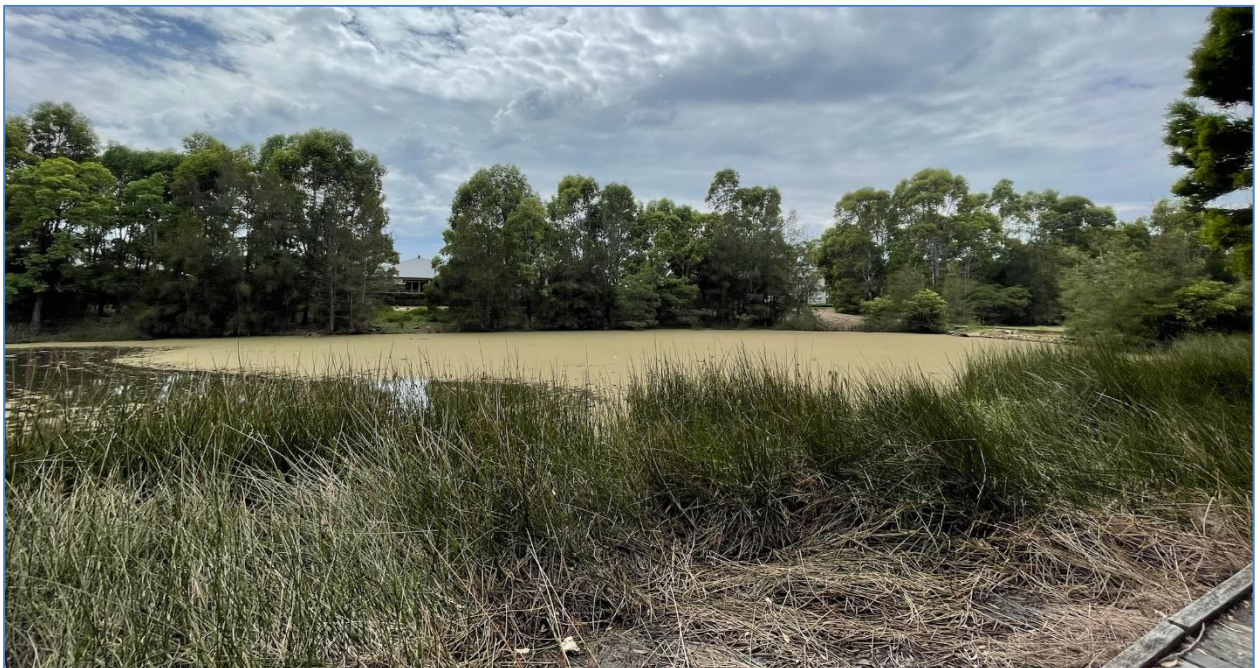
**Figure 2** Lateral 2.2 – another view showing the water surface covered with azolla growth

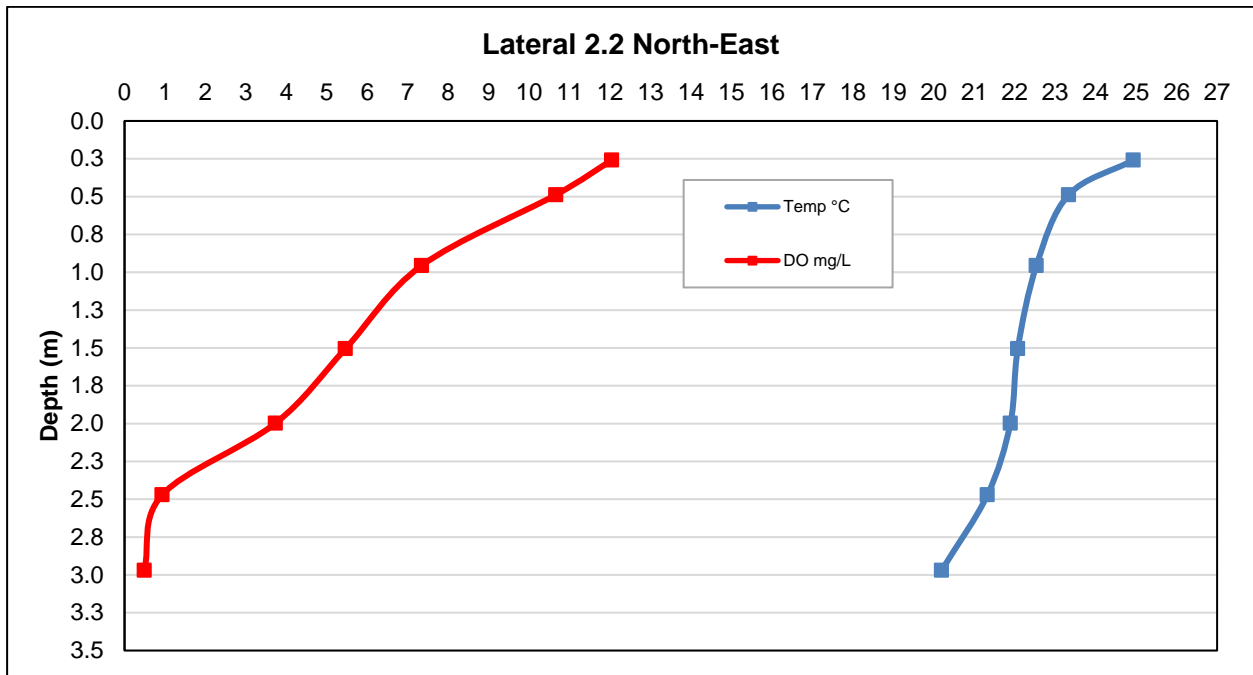
The surface water temperature on 8<sup>th</sup> February 2022 was about 25.0 °C and the bottom temperatures were about 5 °C lower than the surface.

Dissolved oxygen levels decreased rapidly with depth to be very low at the bottom. Mixing was not evident and this may have caused the water body to be oxygen depleted for many days. Low DO levels cause stress to fish.

**Figure 4 – Vertical profile for Lateral 2.2 North-East – 8<sup>th</sup> February 2022**

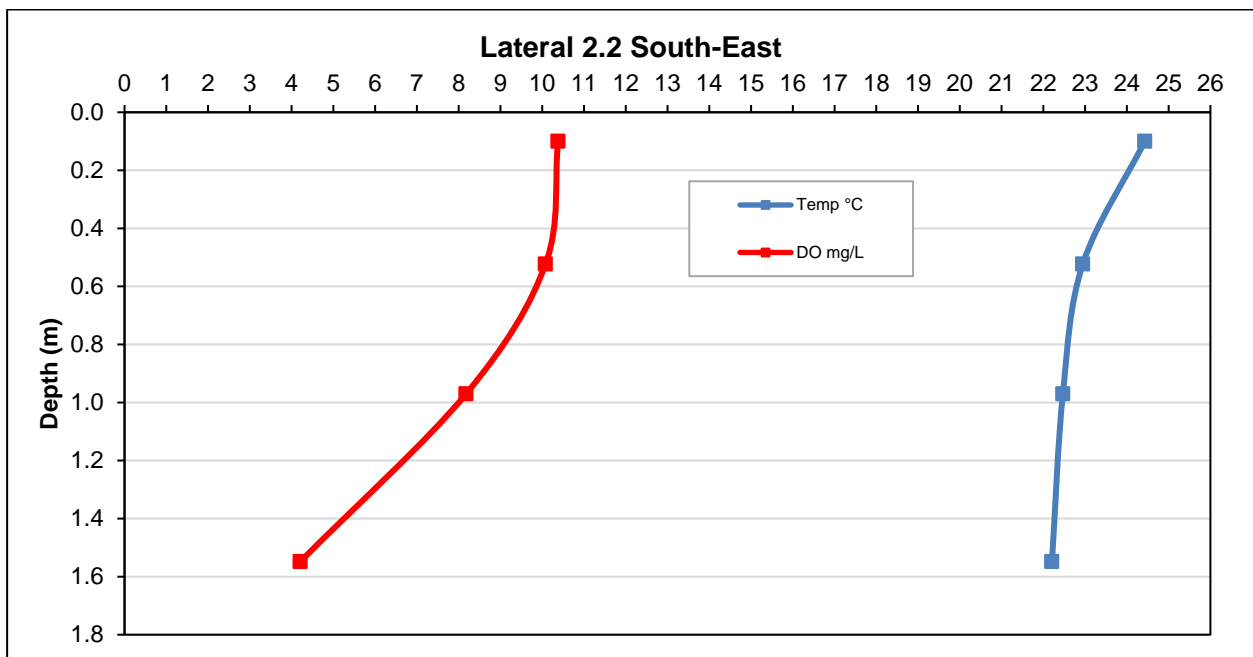
**Figure 5 - Vertical profile for Lateral 2.2 South-East – 8<sup>th</sup> February 2022**

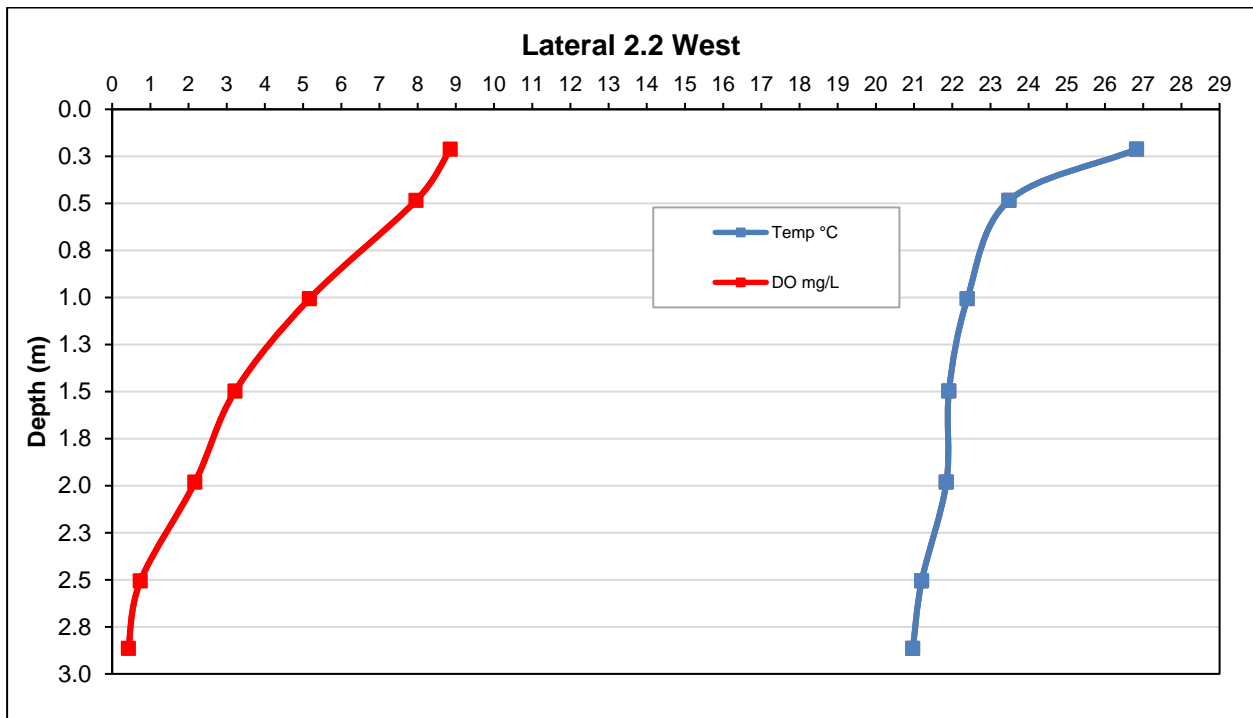
**Figure 7 - Vertical profile for Lateral 2.2 West – 8<sup>th</sup> February 2022**
