Report on the investigation into
a release of phosphine gas during
cargo discharge on board

Arklow Meadow

Warrenpoint, Northern Ireland
on 5 December 2012

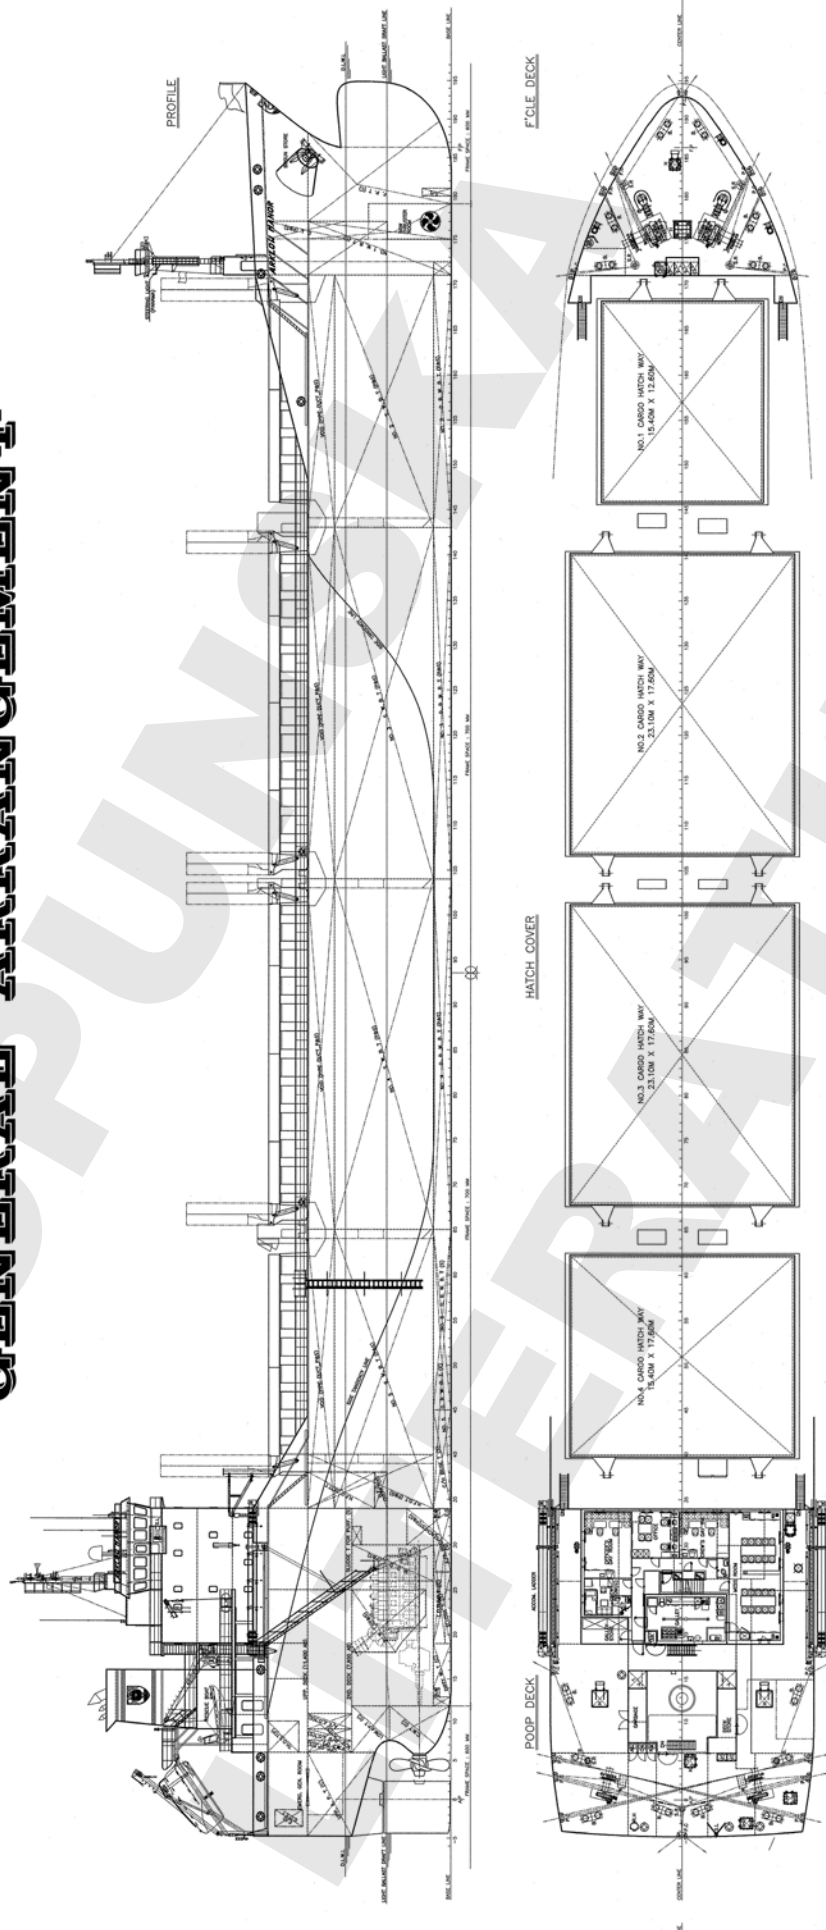
Figure 1: Extract of General Arrangement

The FIC inspected *Arklow Meadow*'s four cargo holds (**Figure 1**) and found them to be in a satisfactory condition and gas tight. He then fitted a system of hoses and electric fans into each hold which were to be used to re-circulate the fumigant during the forthcoming passage. The control switches for the electric fans were sited on the main deck.

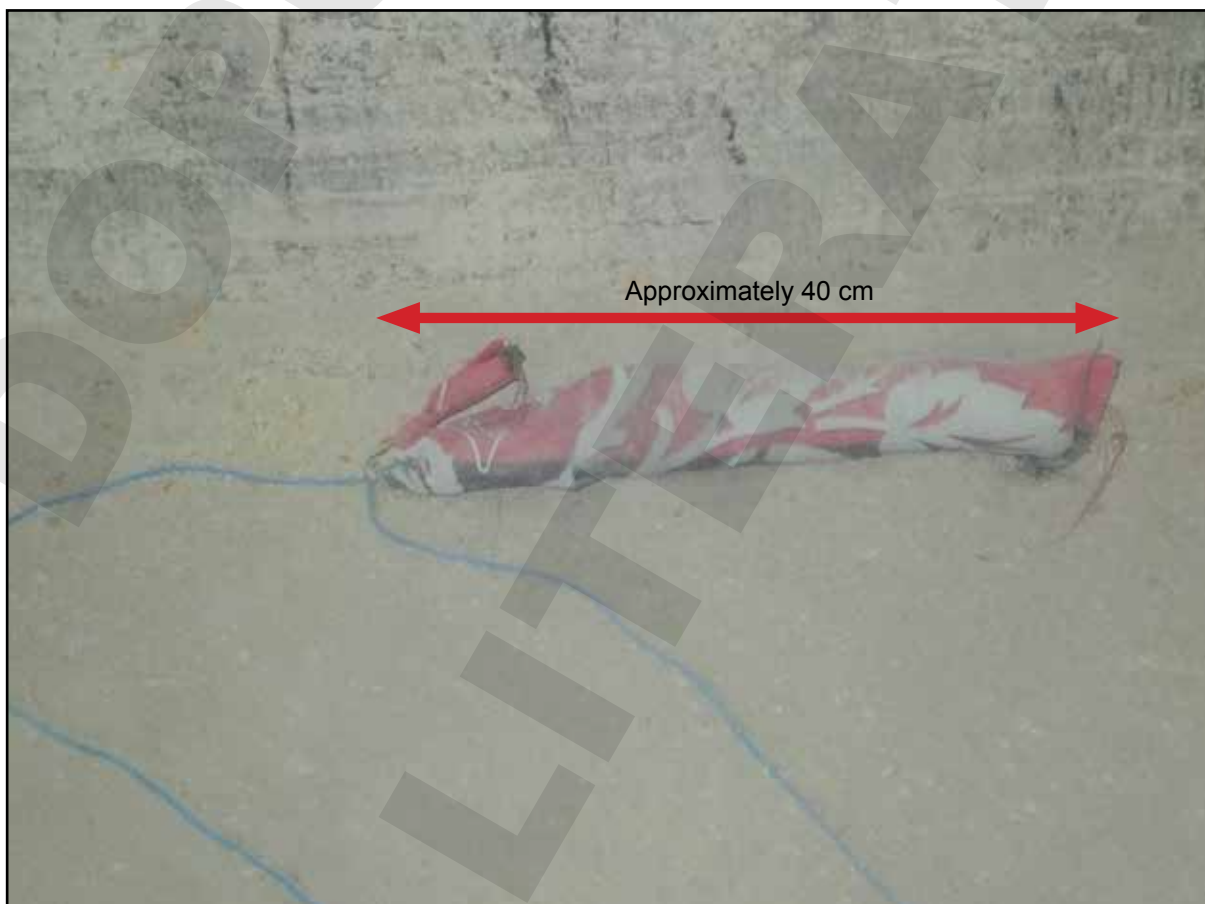
Figure 2: Fumigant 'sock' or retainer

The fumigators placed the fumigant on top of the maize cargo in each hold in turn, with the ship's crew closing each hold hatch cover on completion. The fumigant was contained in synthetic fabric retainers or 'socks' (**Figure 2**). The socks were approximately 40cm long and contained about 250g of aluminium phosphide pellets; each pellet weighed 3g. The socks were tied to small diameter polypropylene ropes with between six and eight socks attached to each rope (**Figure 3**). The ropes were laid athwartships across the cargo and tied off by the port hatch coamings. Three ropes of fumigant were used in holds 1 and 4, and five ropes of fumigant were laid in holds 2 and 3 (**Figure 4**). A total of 110 fumigant socks containing 82.5kg of aluminium phosphide tablets were placed on top of the cargo. The FIC calculated that the minimum time required for the fumigant to fully disperse and expire was 168 hours.

Fumigant pellets are designed to react with moist air to produce phosphine. However, the fumigant pellets on board *Arklow Meadow* were tightly packed in the synthetic fabric socks (**Figure 2**) and it is likely that the pellets towards the centre of the socks had little or no exposure to the water vapour in the atmosphere until they were agitated when the socks were moved either by hand or by the crane grab. Furthermore, as the maize cargo had a middle moisture content of 11.5%, it was relatively dry (in the UK, grain cargoes are stored with a middle moisture content of around 14.5%) and the resulting relative humidity in the sealed cargo holds was possibly too low to trigger the generation of PH^3 .

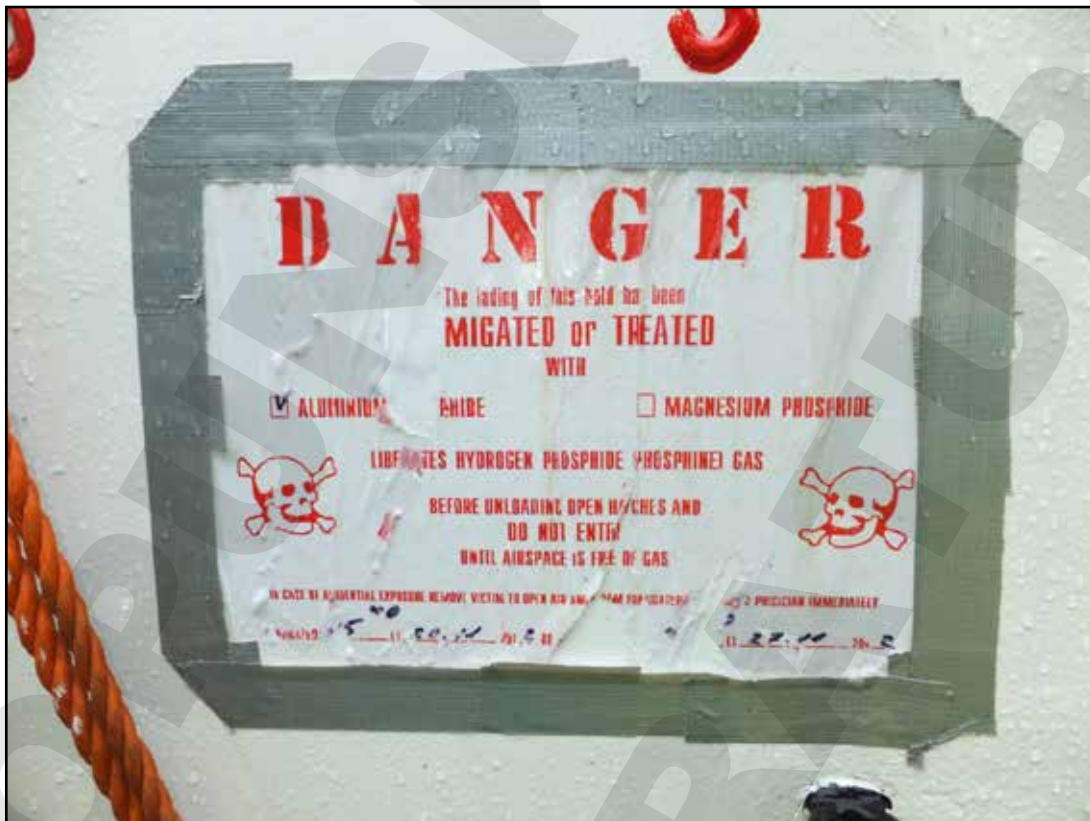
Figure 5: Fumigation warning notice

When all of the hatches were secured, the FIC placed warning notices by the hold access points (**Figure 5**) and switched on the recirculation fans. The FIC then gave the following documentation (**Annex C**) to the master:

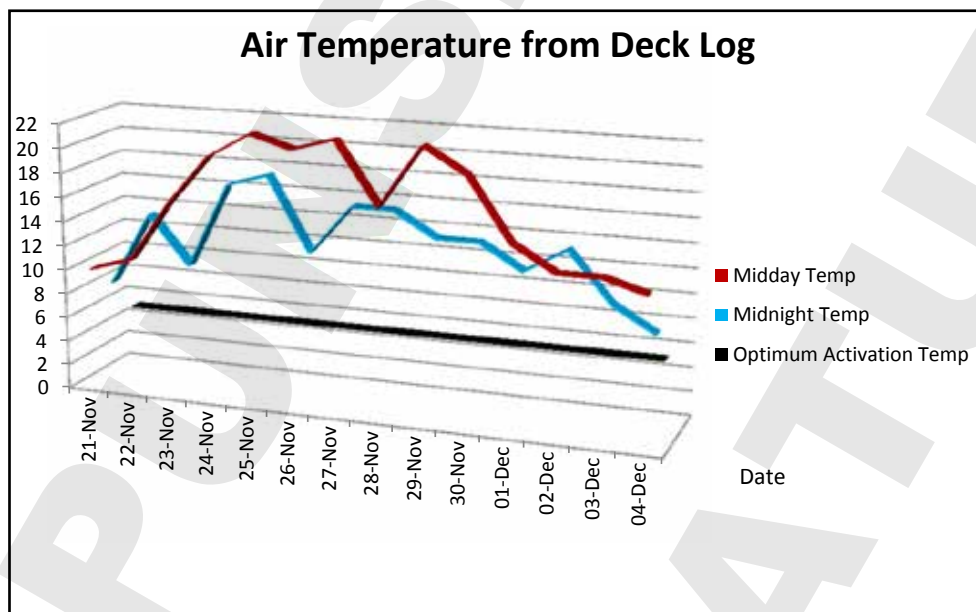
Figure 6: Midday and midnight air temperatures

Arklow Meadow sailed from Nika-Tera at 0700 (UTC+2) on 21 November 2012. The chief officer switched off the re-circulation fans in the cargo holds after they had been operating for 72 hours. He then switched the fans on at 0800 each morning and then off at 1600 each evening. The midday and midnight air temperatures recorded on board during the voyage are shown in **Figure 6**. The daily mean sea temperatures are shown in **Figure 7**.

It is evident from the exposure times recommended by the manufacturer of the aluminium phosphide used on board *Arklow Meadow* (**Paragraph 1.6**), that temperature is a key factor in the speed and effectiveness of the fumigant in generating PH^3 in cargoes in transit. In this case, the temperature of the maize cargo was 10°C when loaded on board *Arklow Meadow*, and the air and sea temperatures generally remained above this temperature during the vessel's 14 day voyage (**Figures 6 and 7**). Therefore, although the FIC's estimate, that the exposure time required was 7 days, was possibly optimistic, the aluminium phosphide should nevertheless have been fully broken down and inactive by the time the vessel arrived off Warrenpoint if its decay was dependent on temperature alone.

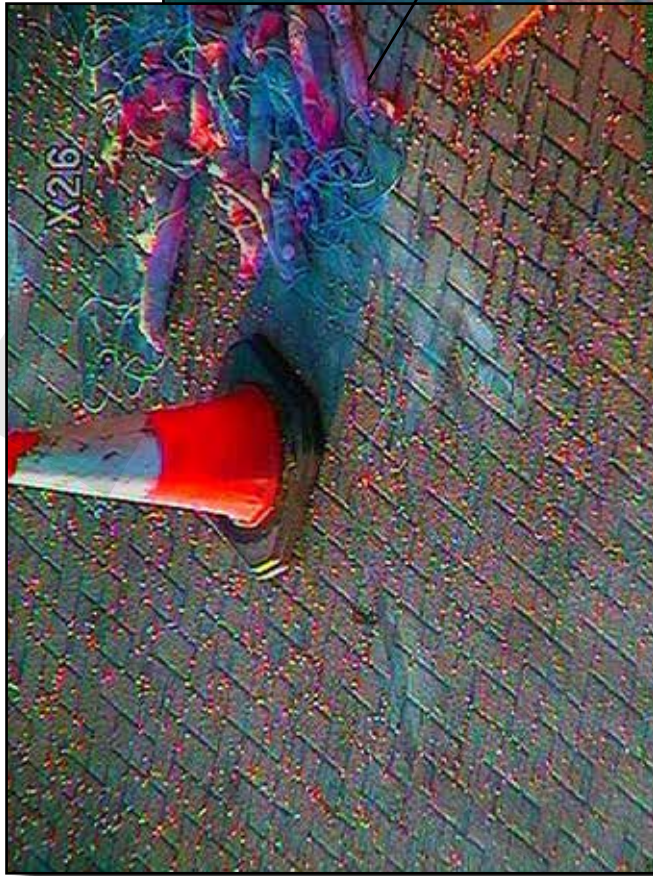
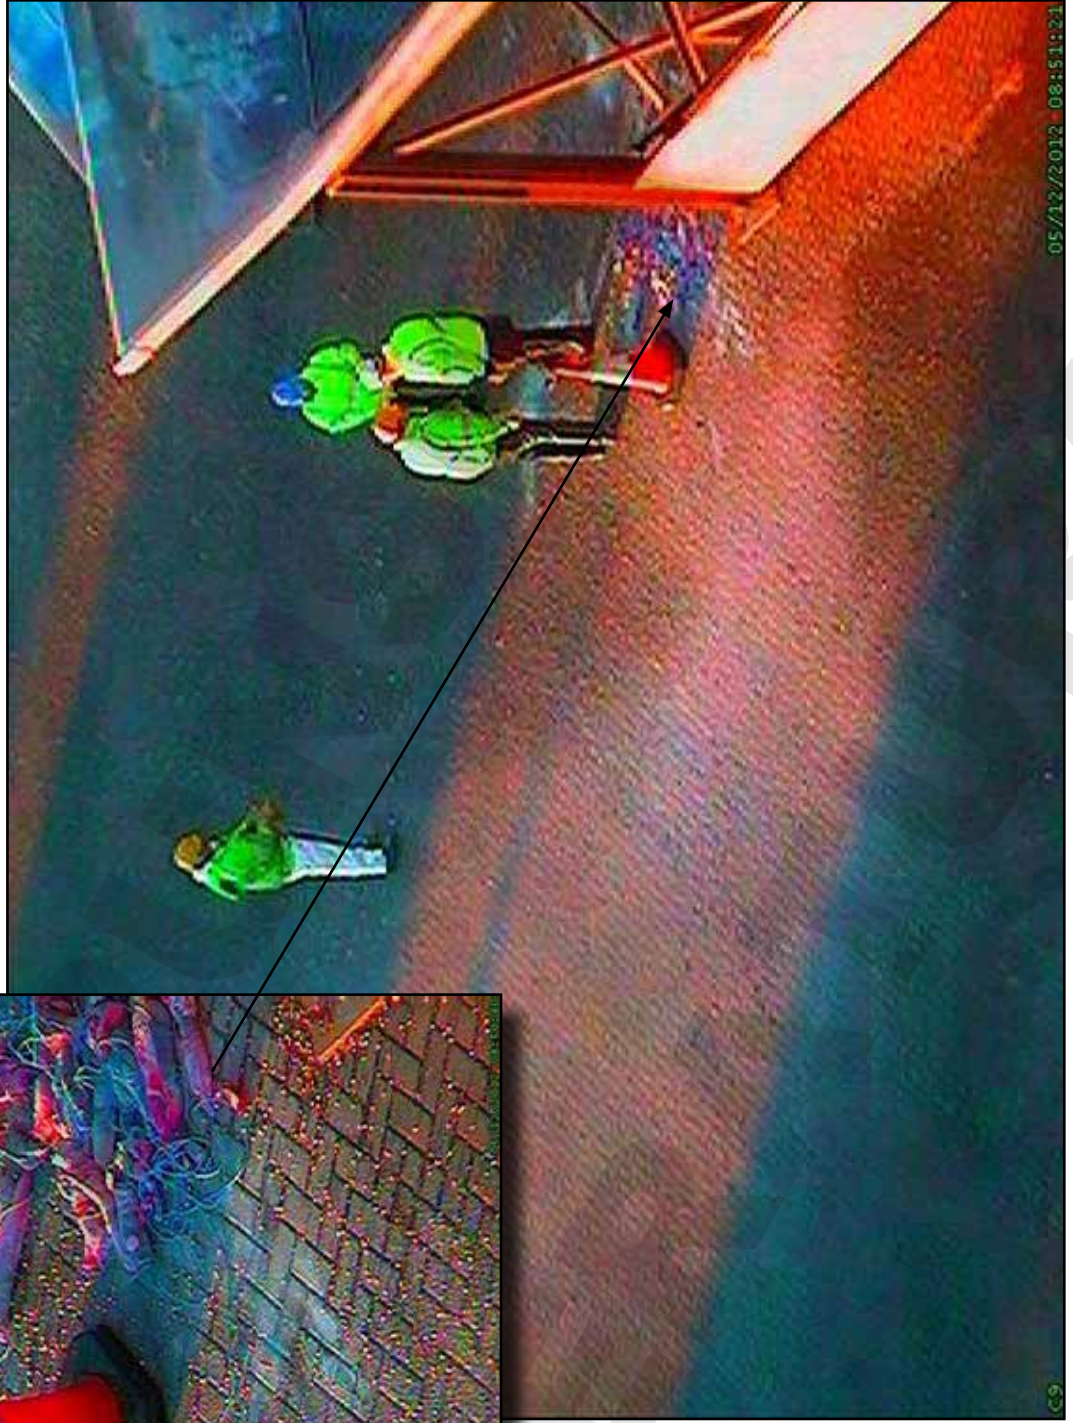
Figure 9: Fumigant socks on the ground

The operations manager and a number of stevedores gathered around the spilled residue. They were aware that the maize cargo had been fumigated so the operations manager informed the harbourmaster of the situation via Very High Frequency (VHF) radio. The operations manager also stopped the discharge of cargo from *Arklow Meadow* and instructed the stevedores to cordon off the spillage.

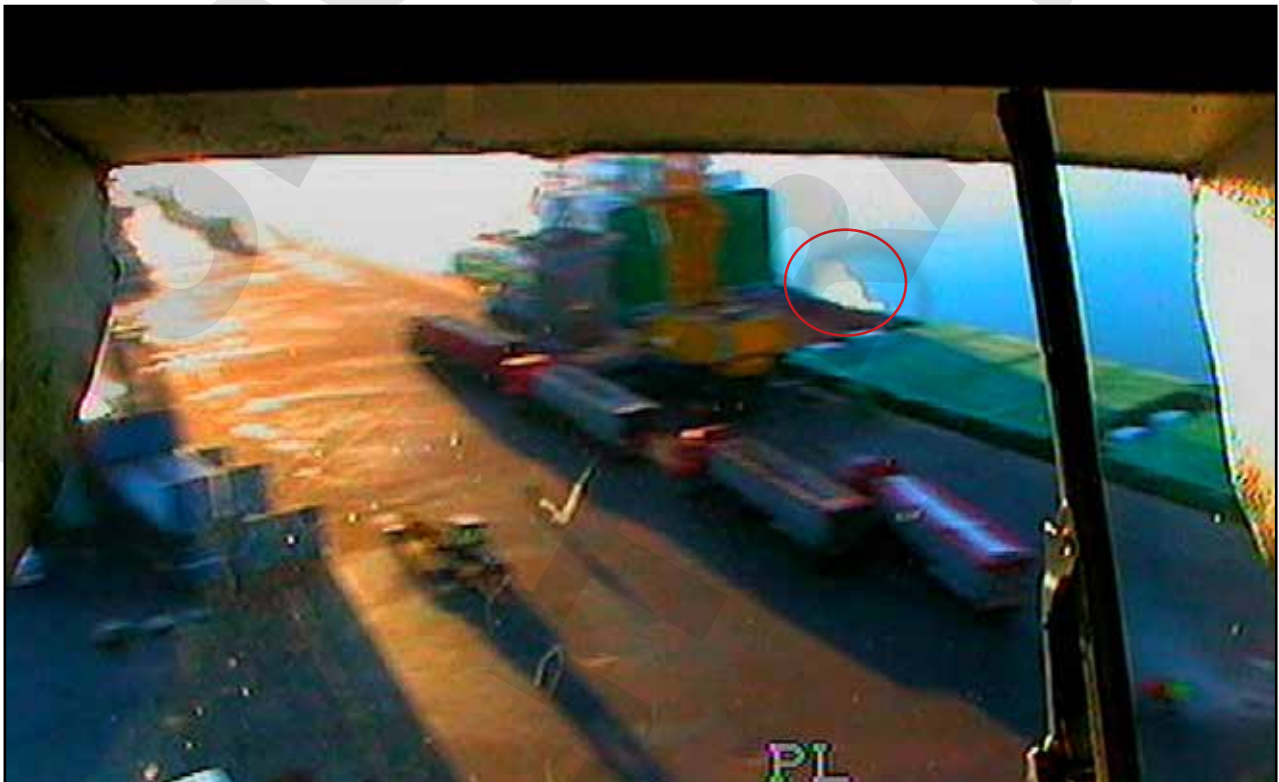
Figure 10: Smoke from fumigant socks inside a bag on *Arklow Meadow*'s port side

The smoke generated by the socks on the deck and in the bag indicates the presence of large quantities of residual aluminium phosphide in the socks which produced sufficient phosphine to exceed 1.8% on the wet deck. This suggests that the formulation had not completely broken down.

With the fumigant still active, the failure to remove the fumigant residues from the cargo holds before cargo operations were started, and the subsequent incorrect handling of the fumigant residue that was eventually removed, resulted in the ship's crew and shore workers being exposed to high levels of PH³. The consequences of the crew's actions were that fumigant socks were inadvertently distributed into the shore hoppers and potentially into the food chain, and the fumigant socks that were placed onto the wet deck and then into the confines of a plastic bag soon reached their LFL and started to smoke.

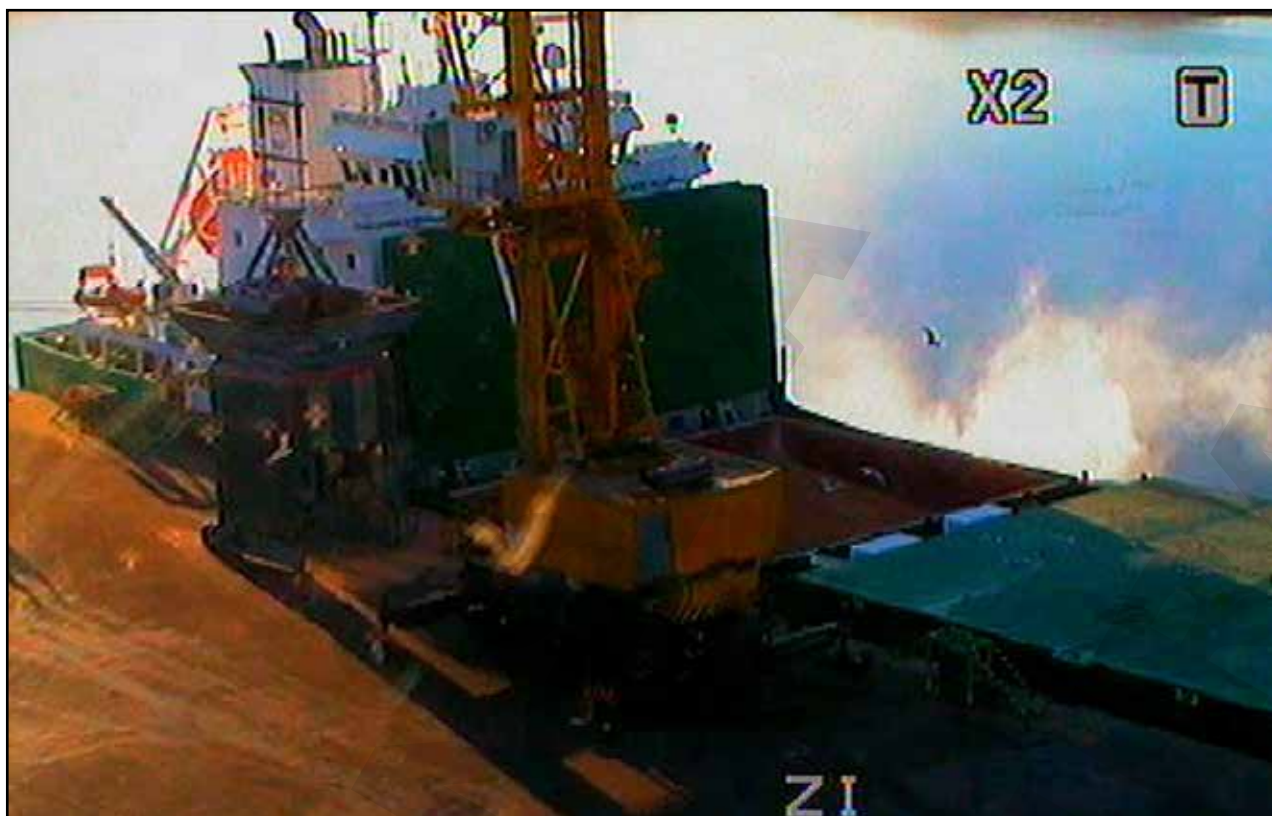
Figure 11: Denser smoke from bagged fumigant

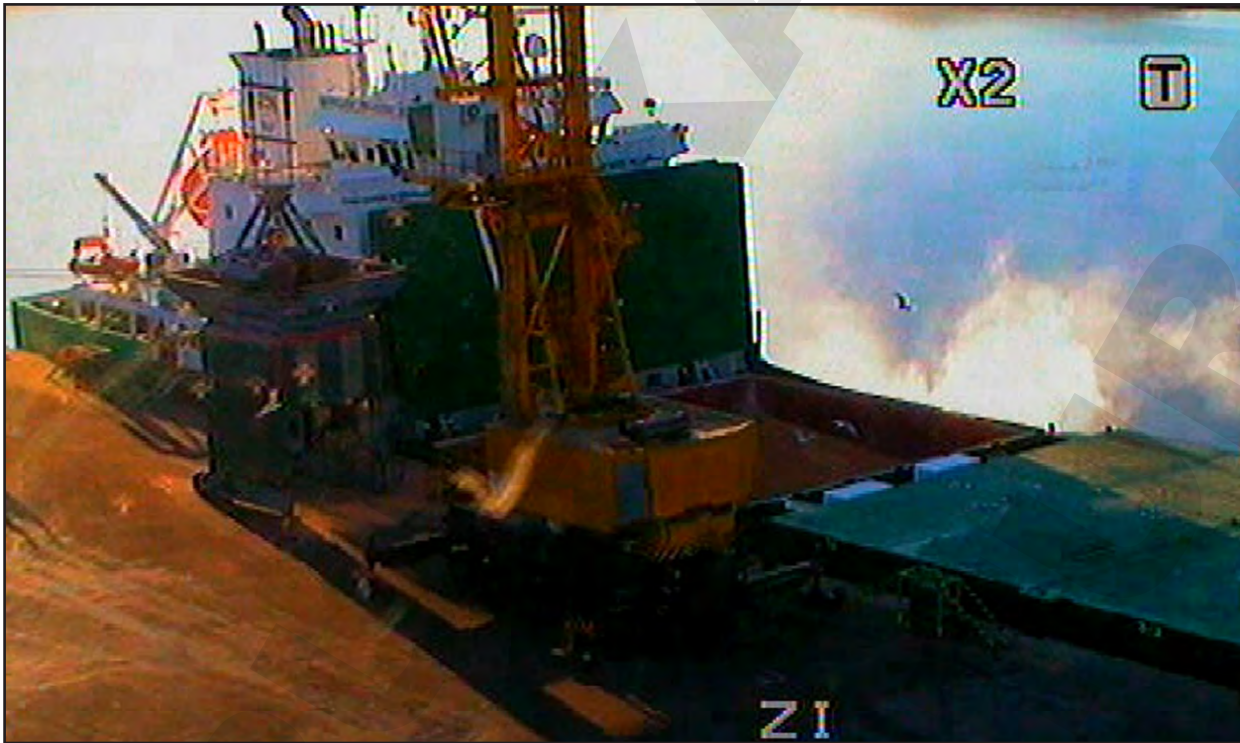
Arklow Meadow: smoke from fumigant residue during discharge of maize cargo

The fumigant retainers removed by the crew were initially placed on the wet deck, where they started to smoke. The smoking soon stopped when the retainers were moved to the holds' observation platforms. Meanwhile, a number of fumigant retainers had spilled onto the ground when they were being taken out of a hopper by a stevedore.

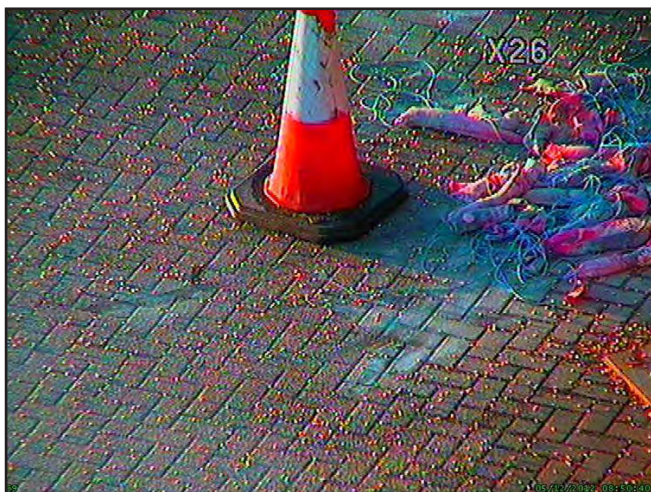
Figure 1: Fumigant retainers and spilled fumigant

At this point, cargo operations were stopped and the spilled fumigant on the quay (**Figure 1**) was cordoned off. The fumigant retainers that remained by the vessel's holds were also collected and placed inside plastic bags. However, these soon started to smoke, so the crew were evacuated ashore. The local fire brigade was alerted and they reacted quickly to arrive on the scene. A 50 metre cordon was established around the vessel and houses and retail premises surrounding the port area were evacuated as a precautionary measure. Eight of *Arklow Meadow's* crew and a stevedore who had potentially been exposed to phosphine gas were taken to hospital for observation and decontamination.

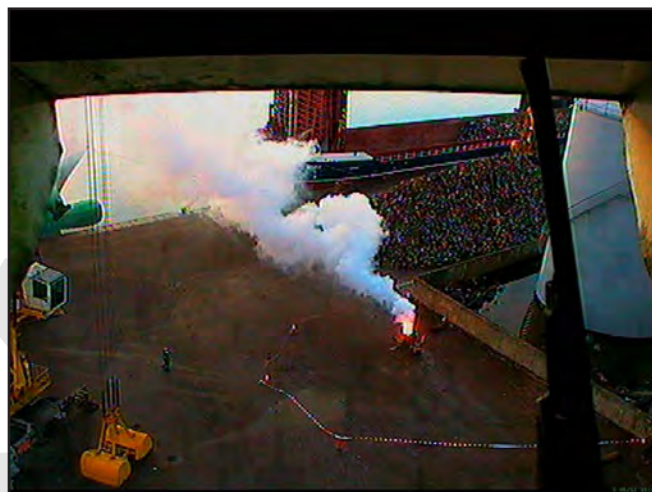
Figure 2: Disposal of the fumigant

A total of 89 fumigant retainers were recovered from the vessel and shore areas, leaving 21 fumigant retainers unaccounted for. The recovered retainers were neutralised by immersing them in water (**Figure 2**). It took 5 days for the level of phosphine gas in the vessel's cargo holds to reduce to an acceptable level.
