Water Quality Management: Case Study of Golden Horn (Halic) – Istanbul-Turkey

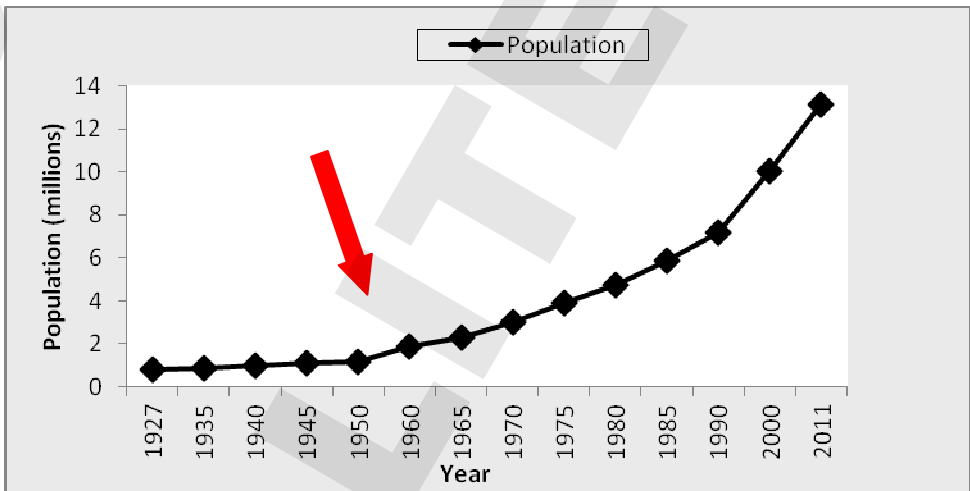
Figure 3. Population of Istanbul over time (TSI)

With the population explosion of Istanbul in the 1950's as depicted in Figure 3 and announcement of industrialization area of Halic region in 1954 after World War II, the Golden Horn became an ugly storage of grey city-sewage and industrial waste with a terrible odor as shown in Figures 4 and 5. One-third of the estuarine surface area was filled to accommodate factories and their associated tenements with no provision for stability, industrial or domestic waste disposal or treatment (Eroglu, 2001). By 1975, 696 industrial plants had hazardedly occupied a total of 1.6 km² along the estuary and nearby river shores. Metal smelting, electrical appliance, machinery, textile, wood, food and meat production facilities comprised 71% of this area, 28% was shipyards and docks, and 8% supported warehouses (Aksit, 1977, Coleman et al., 2009).

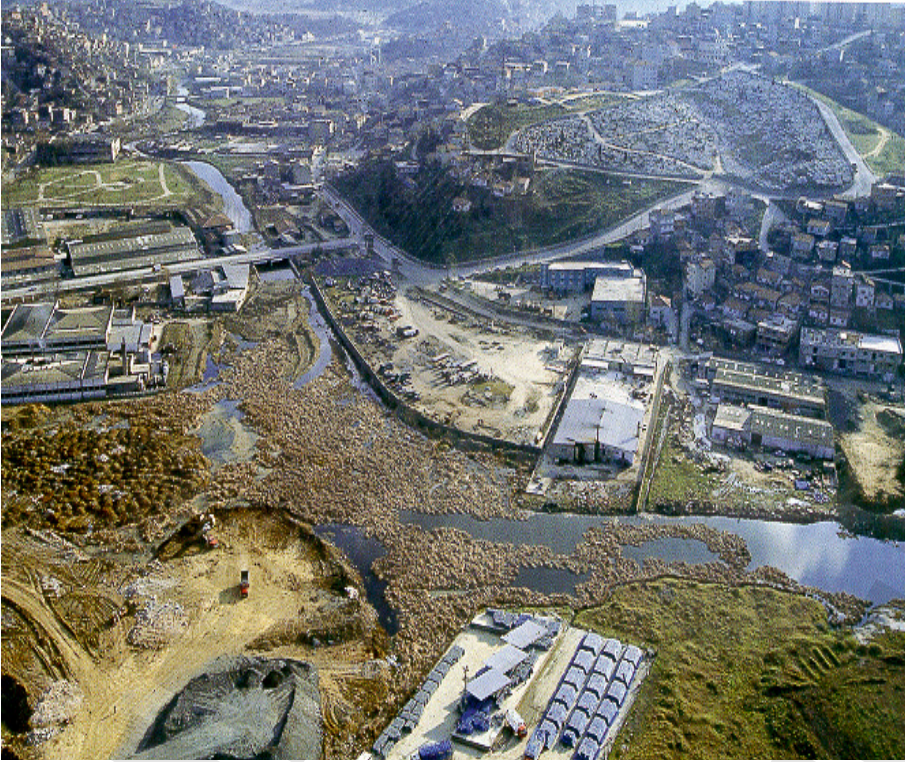
Figure 4. Figure showing Golden Horn (Halic) before restoration in 1996 (Ayan, 2008)

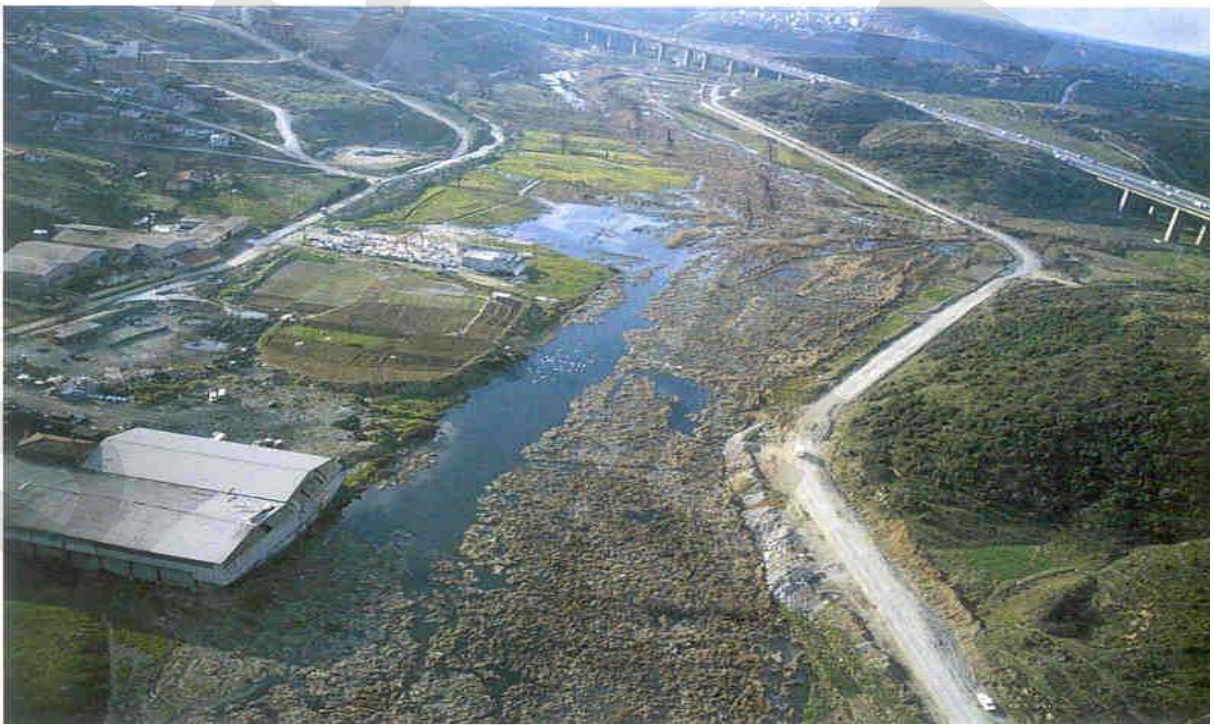
Figure 5. Figure showing Golden Horn (Halic) before restoration in 1996 (Ayan, 2008)

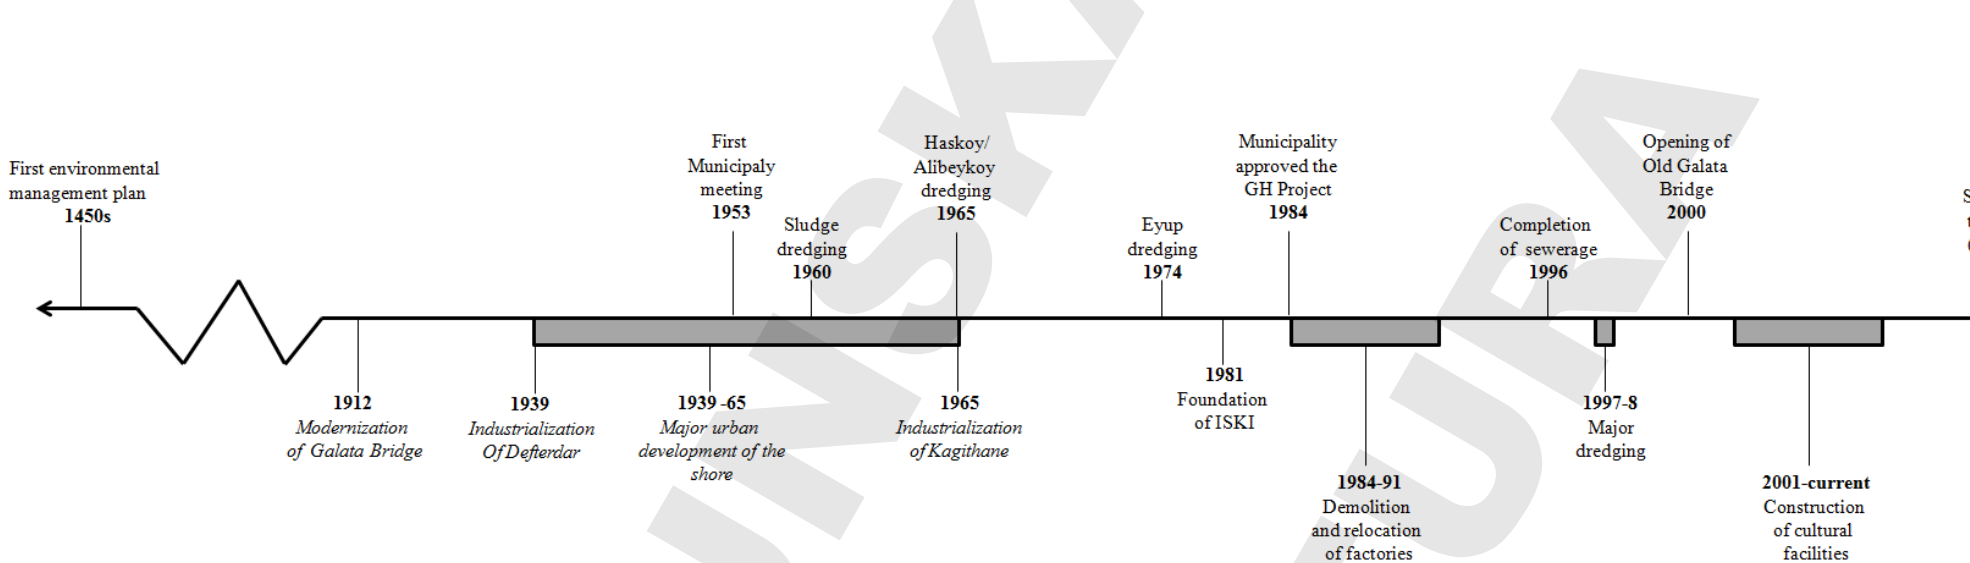
Figure 6. Figure showing the main causes of environmental problems (*italics*) and actions (regular font) taken by Greater Municipality of Istanbul and ISKI (Coleman et al., 2009)

The problems faced in Golden Horn were recognized early, beginning with a meeting in 1953 called to address foul odors in the estuary. However, the only significant action taken for decades included four localized dredging operations and a 1966 plan to limit construction of large facilities in the vicinity of the estuary (Coleman et al., 2009). A timeline showing main causes of environmental problems and action which were taken is depicted in Figure 6.

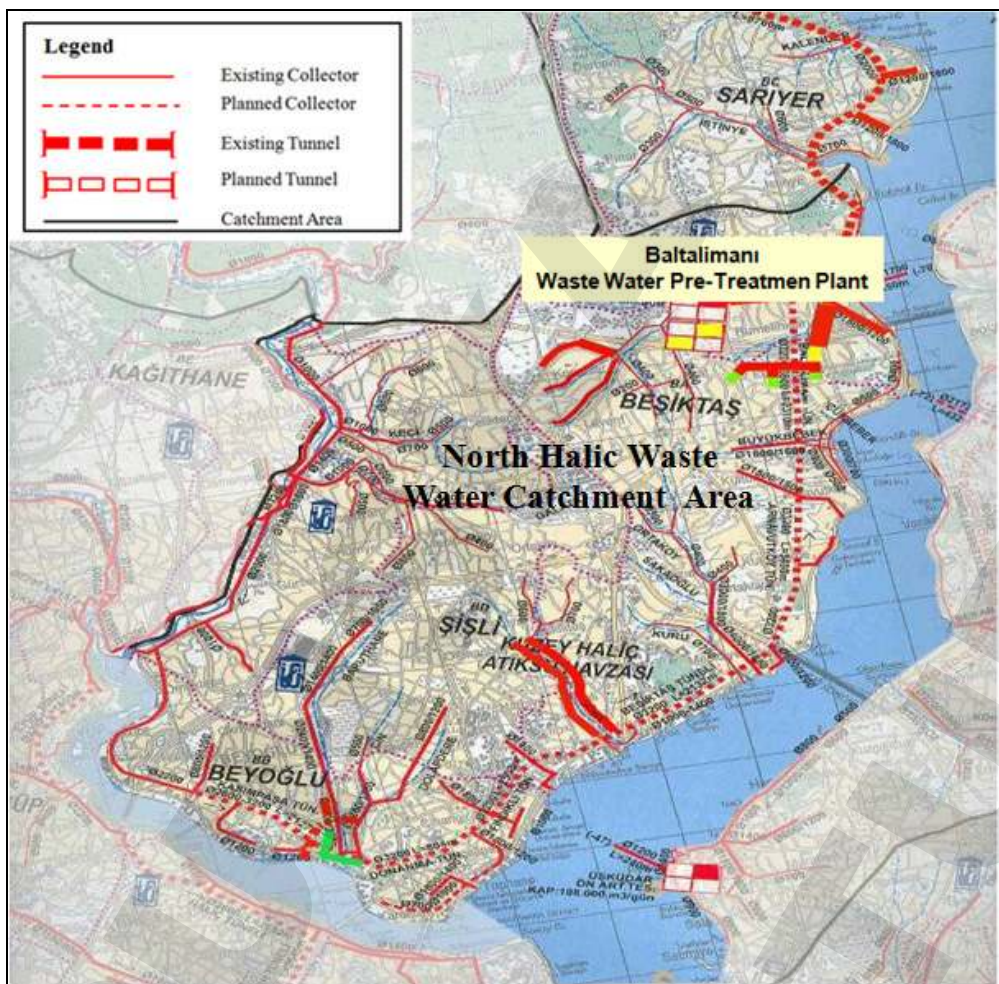
Figure 7. North Halic Wastewater Catchment Area (Ayan, 2008)

A number of wastewater collectors, wastewater collection tunnels, a wastewater pumping station, a sea outfall system and a wastewater pre-treatment plant have been constructed to avoid wastewater discharge to Halic. Existing and planned constructions of North Halic wastewater catchment area depicted in Figure 7 are as follows (ISKI):

- Kagithane Left Coast Waste Water Collector
- North Halic Wastewater Collectors and Tunnel
- Kabataş-Baltalimanı Wastewater Tunnels
- Baltalimanı Wastewater Pre-Treatment Plant (Figure 8.)
- Baltalimanı Sea Outfall System
- North Halic Wastewater Secondary Collectors
- Kagithane Wastewater Collecting System
- Cendere Wastewater Pumping Station
- Kemerburgaz-Gokturk Odayeri Wastewater Collectors
- Kasimpasa Storm Water Tunnels

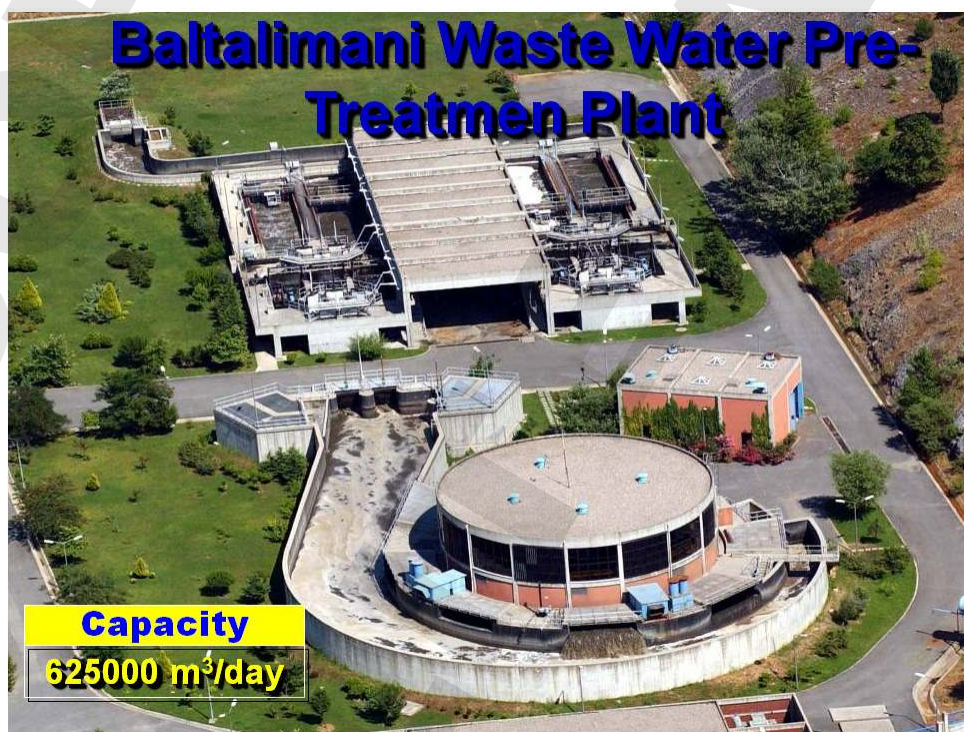
Figure 8. Baltalimani Wastewater Pre-Treatment Plant (Ayan, 2008)

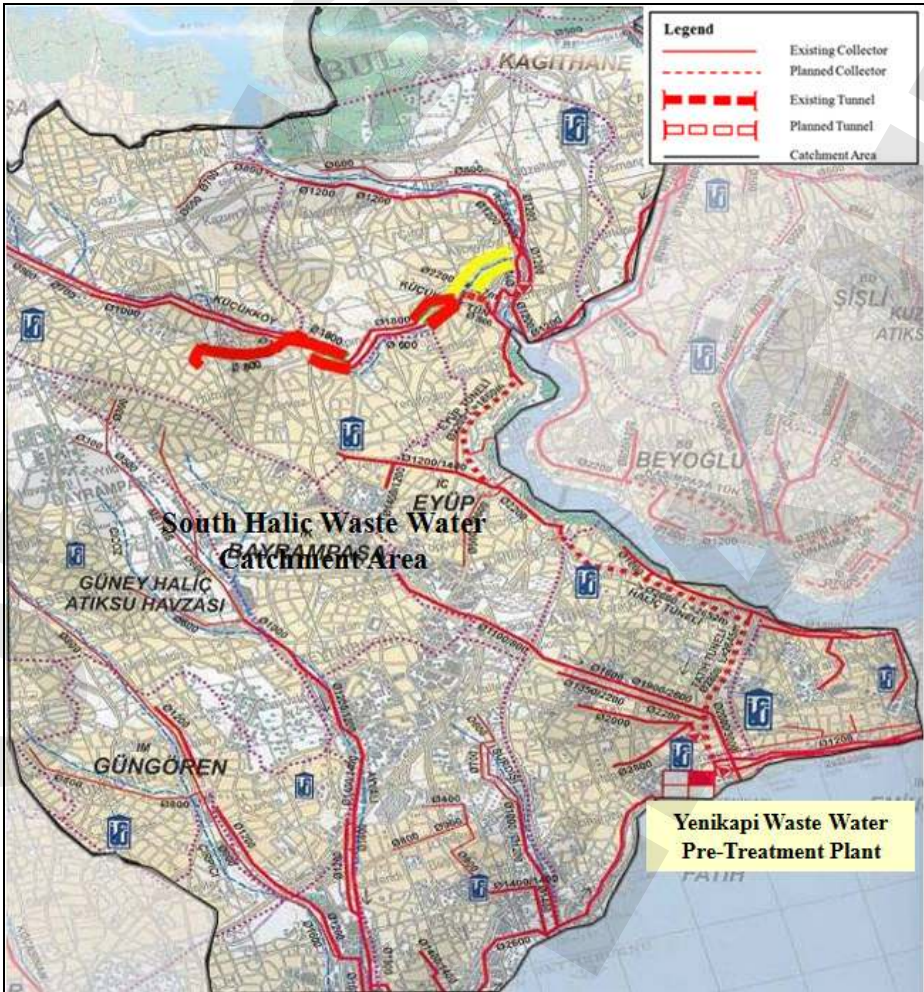
Figure 9. South Halic Wastewater Catchment Area (Ayan, 2008)

Existing and planned constructions of South Halic wastewater catchment area depicted in Figure 9 are as follows (ISKI):

- Zeytinburnu Wastewater Collectors and Pumping Station
- Alibeykoy River Coast Wastewater Collectors
- Kagithane Right Coast Wastewater Collectors
- Kucukkoy Wastewater Tunnel (Figure 10.)
- Unkapani-Ayvansaray Wastewater Collectors
- Eminonu-Unkapani Wastewater Collectors
- Yenikoy Wastewater Pre-Treatment Plant

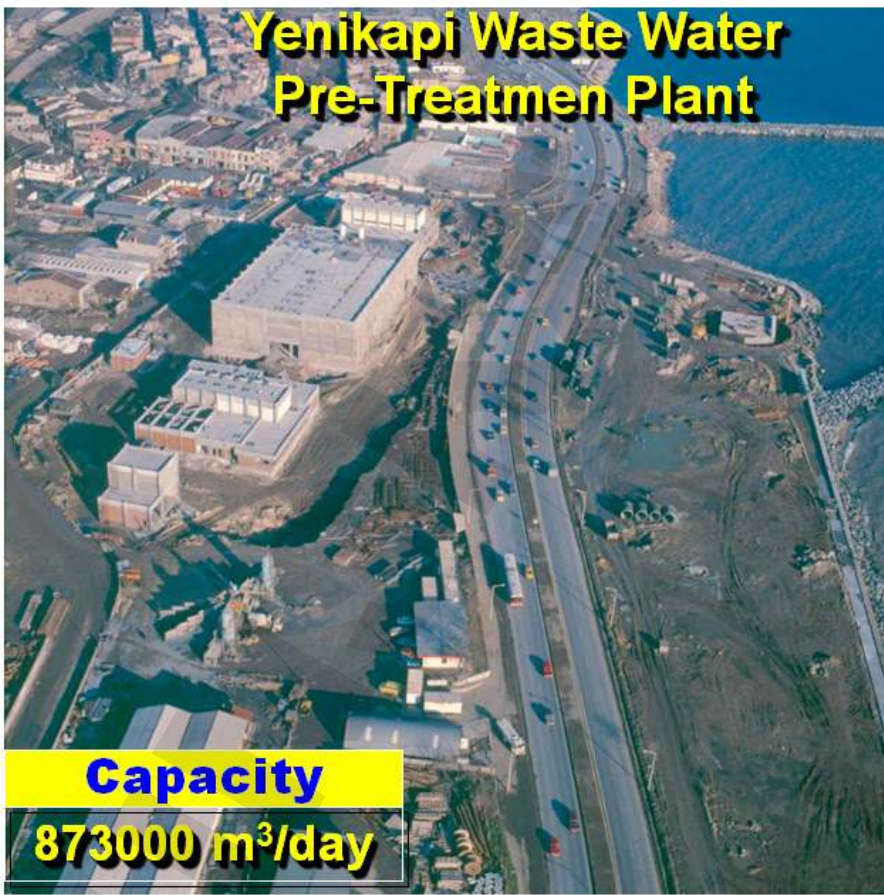
Figure 10. Yenikapi Wastewater Pre-Treatment Plant (©ISKI)

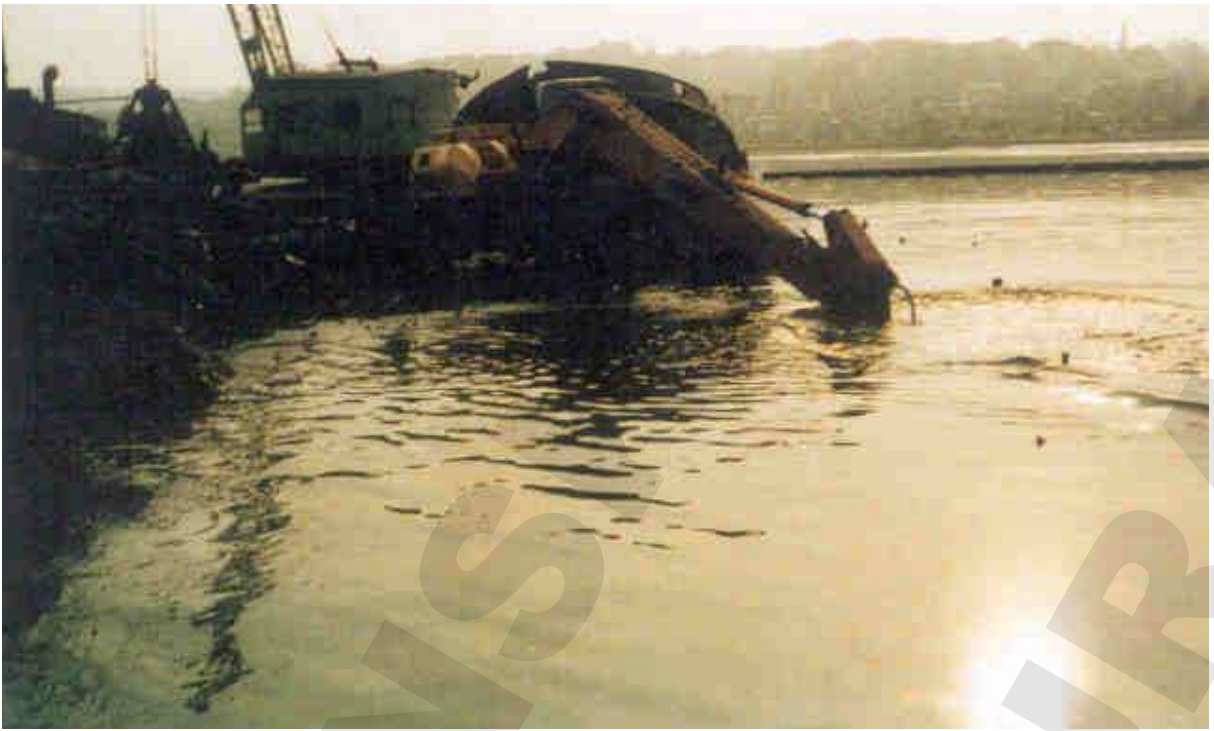
Figure 11. Sludge dredging actions in Halic (Ayan, 2008)

The Greater Municipality of Istanbul and ISKI carried out a sludge dredging project to restore biodiversity of Halic region with a cost of 653 million US \$ for 10 years. 5 million m³ sludge was dredged from Halic estuary at the end of this project and odor problems around Halic region were resolved. Sludge dredging actions are depicted in Figures 11-12-13.

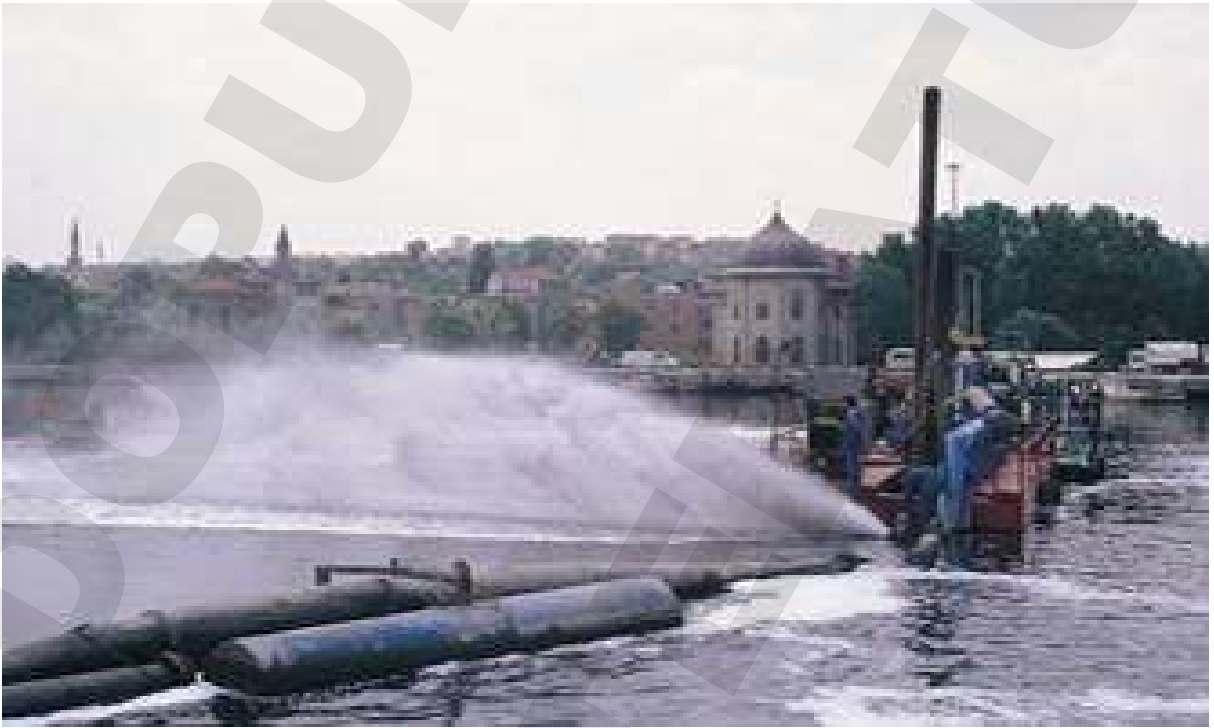
Figure 12. Sludge dredging actions in Halic (Ayan, 2008)

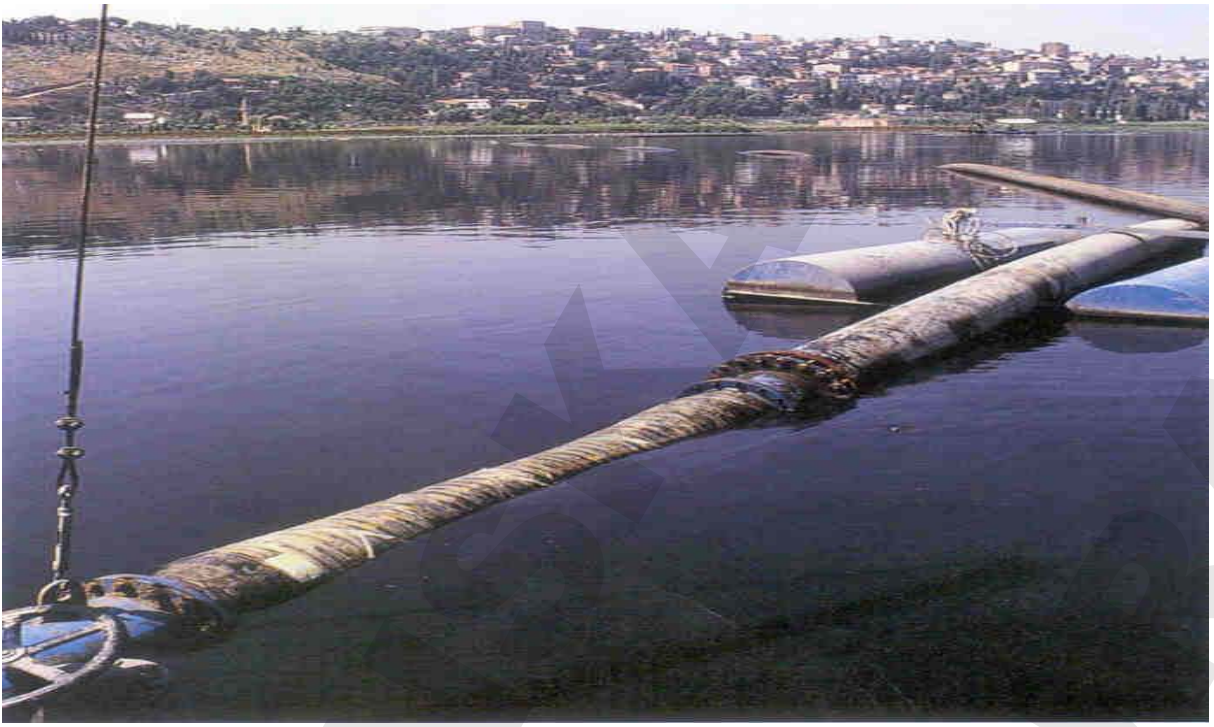
Figure 13. Sludge dredging actions in Halic (Ayan, 2008)

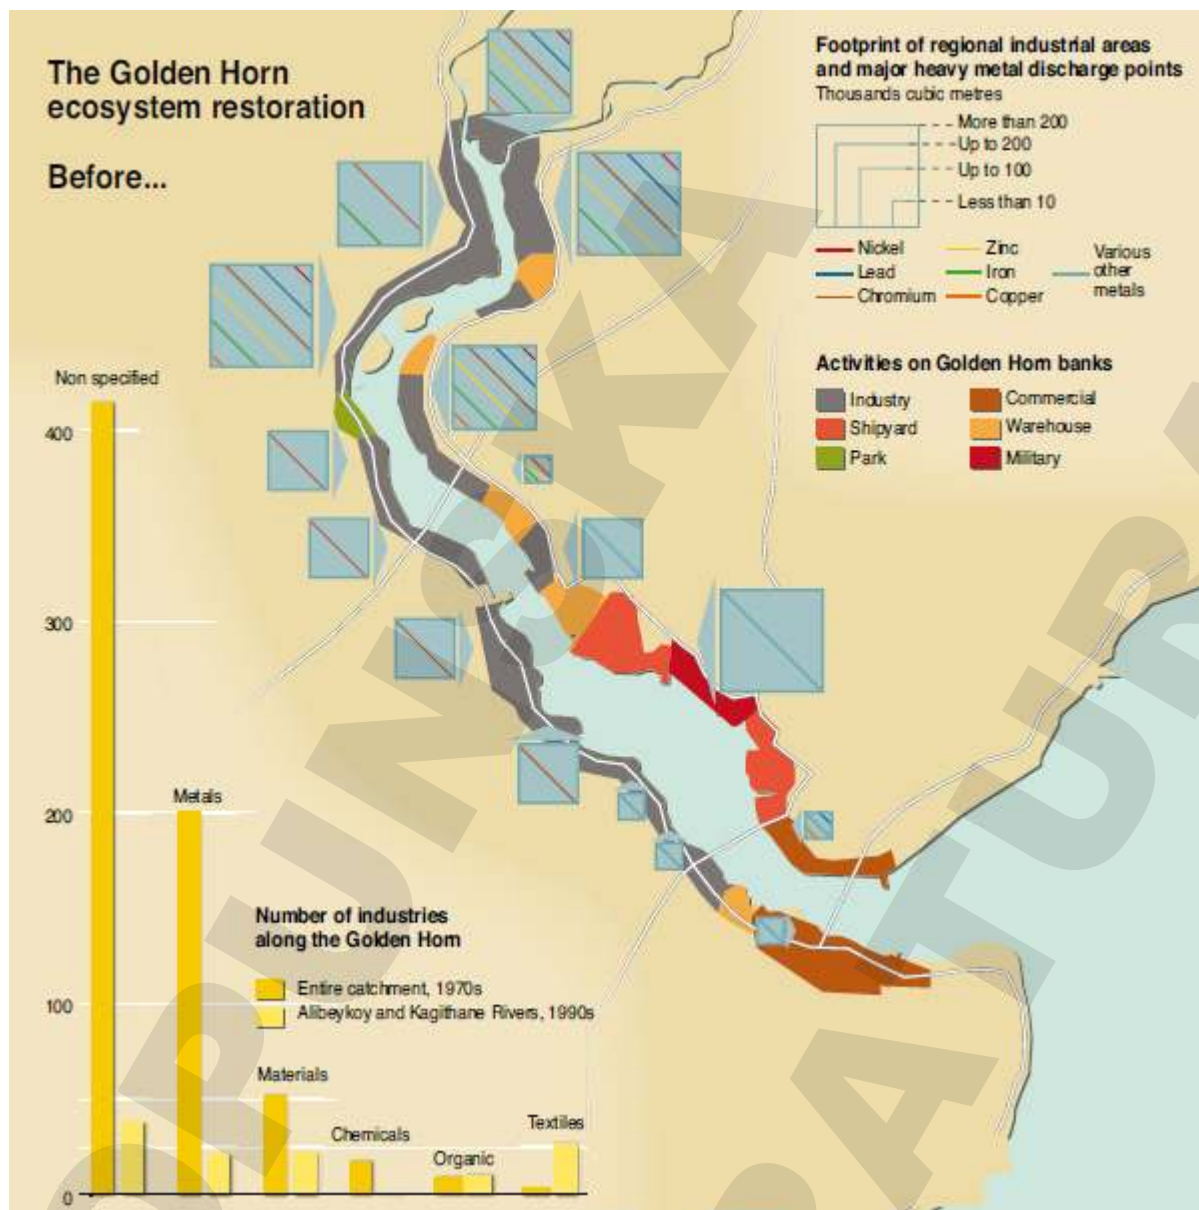
Figure 14. Halic (Golden Horn) before restoration project (Nelleman and Corcoran, 2010)

Actions taken by the Greater Municipality of Istanbul and ISKI have measurably improved water quality in the entire Golden Horn, even the formerly condemned inner area. Odor and biodiversity problems of Halic have been resolved and Halic's cultural and historical characteristics have been regained. Figure 14 is representing Halic region before restoration project while Figure 15 is representing Halic region after project.

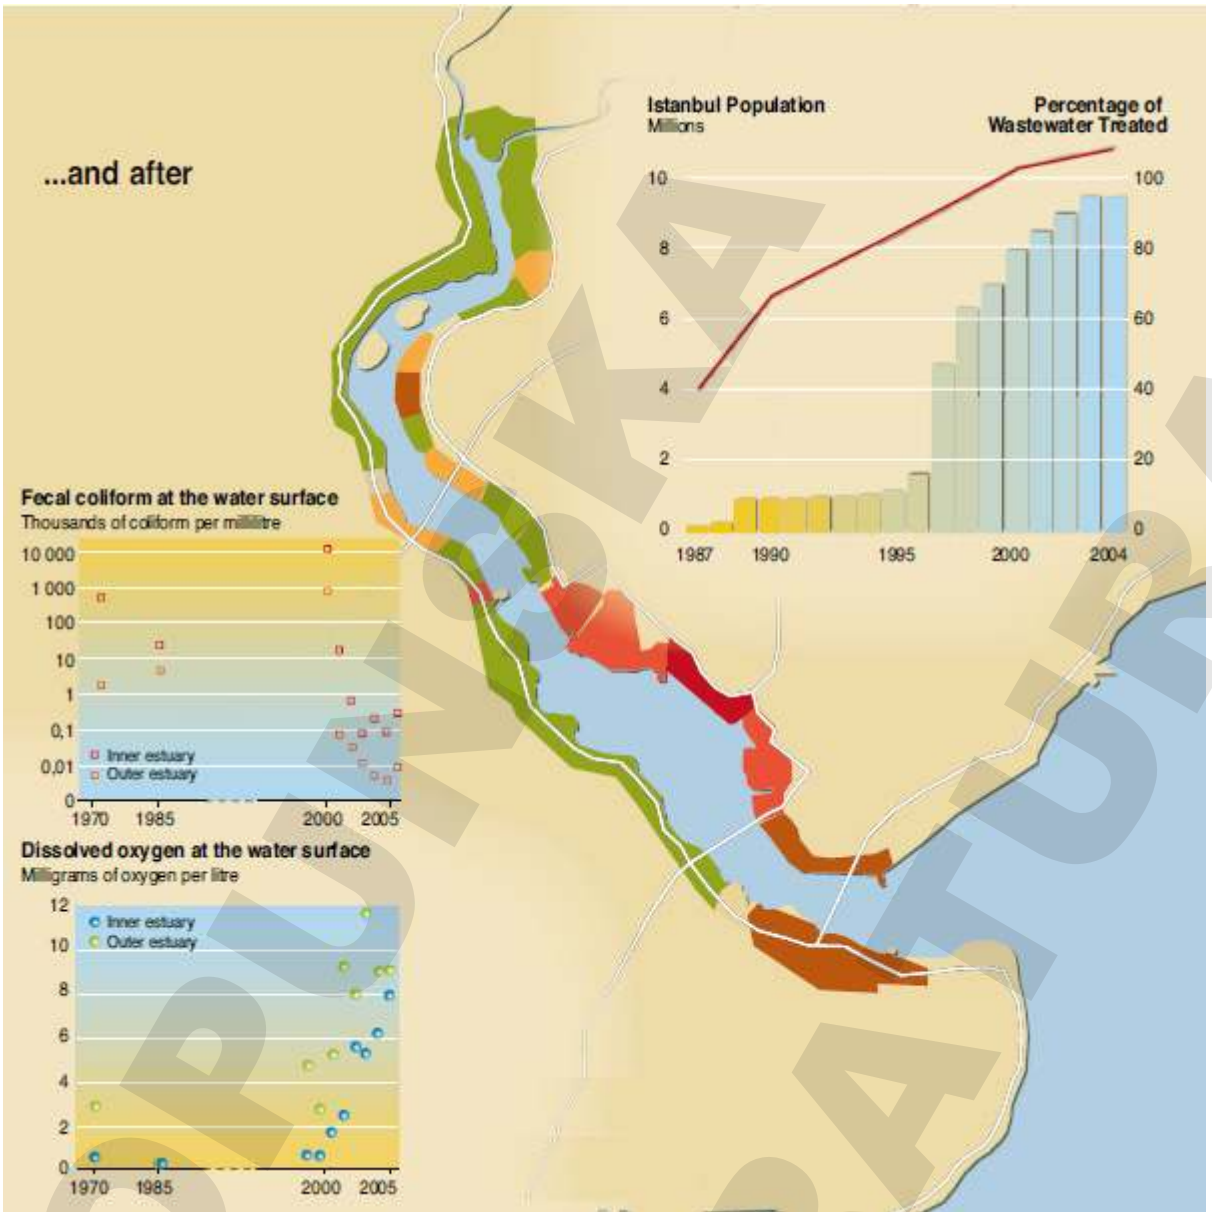
Figure 15. Halic (Golden Horn) after restoration project ((Nelleman and Corcoran, 2010)
