gallerie

Lake Mead Intake N. 3 – Chronicle of a World Record

This paper is focused on the challenges encountered during the TBM excavation of the Lake Mead Intake N. 3 Project (Contract No. 070F-01-C1) located approximately 20 miles (30 km) east of the Las Vegas metropolitan area in Nevada, USA.

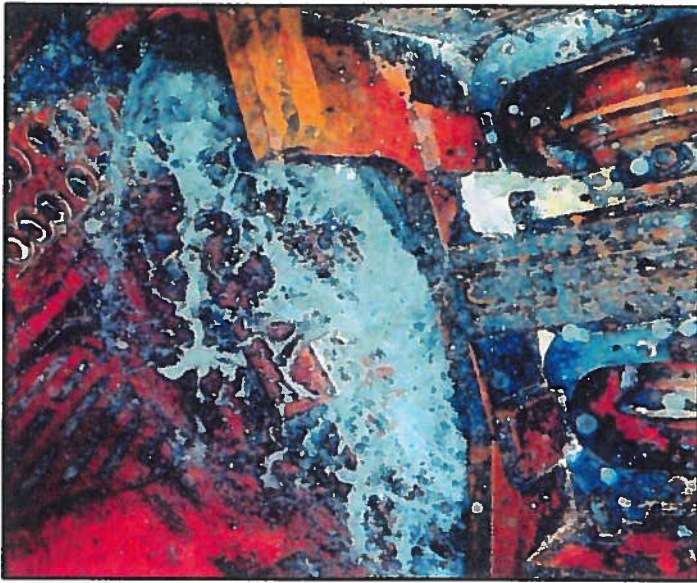
Fig. 4 – Water Inflow 4,000 gpm (910 m³/h) and the Cutterhead repair.

After completion of the third campaign, on February 19, 2013 a large-scale piezometric test was performed. At atmospheric pressure, the water inflow was 965 gpm (220 m³/h) and a face inspection was accomplished. We began cutterhead maintenance but stopped due to a local instability of the upper right part of the tunnel face. At that point, because of the low water inflow rate, maintenance of the slurry lines was performed. This included replacement of worn pipelines, valves, pumps and installation of a new hydraulic valve on the slurry return line.

During advance #251 to #253 some steel fragments were found on the magnet at the slurry separation plant. It was decided to stop the TBM from advancing to investigate the problem. On March 25, 2013 a piezometric test was performed. The pressure was successfully lowered to atmospheric and the face inspection showed that the central part of the cutterhead had severe damaged to the cutters and the cutter housing. The water inflow was measured to be approximately 4,000 gpm (912 m³/h) and the rock condition was stable. With the stable conditions at the face maintenance work was started. A niche was excavated (13 ft x 10 ft x 3 ft) in front of the cutterhead (Fig. 4) using small hand tools. Once the excavation was completed, the structural repair was performed. The water had to be panned away from the work area and ventilation had to be established for the cutterhead repair. Technicians from the TBM manufacturer were brought to site to oversee the repair. The central section of the TBM had to be repaired completely including the disc cutter housings, structure, wear plates and the cutters.

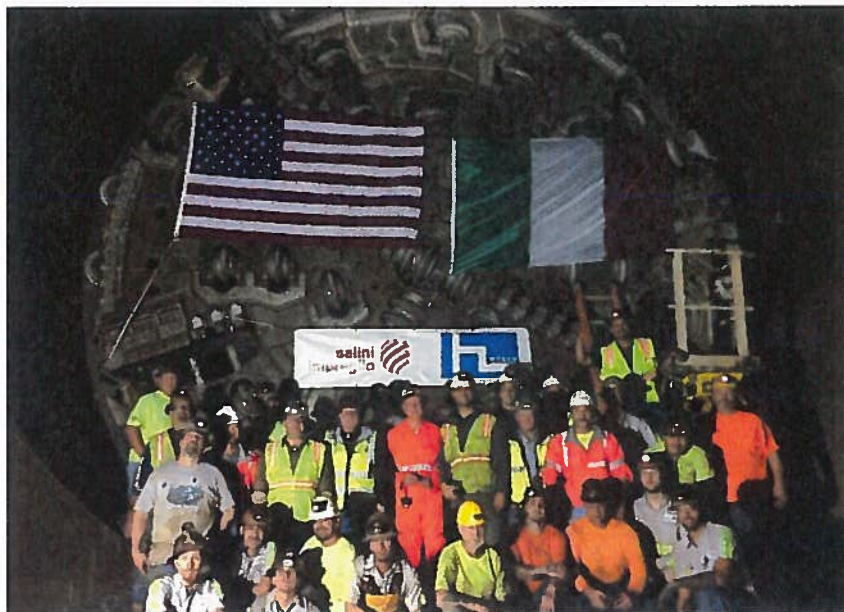
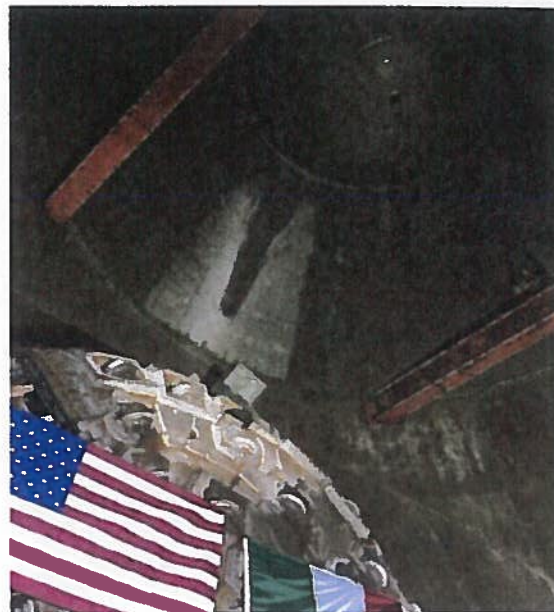
Fig. 10 – Dec 10, 2014 TBM S-502 breakthrough.

The Intake connection was a complete success (see figure 10), the TBM alignment was within a tolerance of ± 3 mm.
