(wafer2,0,8,-1,-1,2,1) Characteristics

- **Cell Size:** 10um
- **Times Accessed:** 35
- **Last Measurement:** 2022/April/03 at 02:04:52PM

Summary

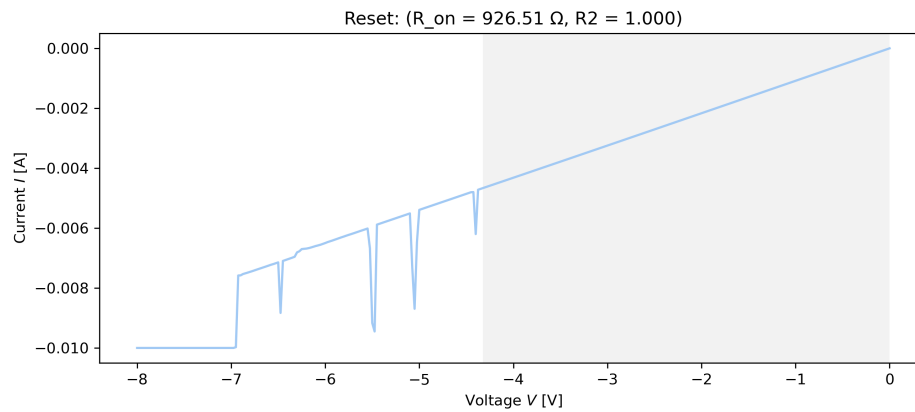
reset

- **Time:** 02:04:52PM
- **Icc:** 10.0mA
- **Voltage Range:** 0V \rightarrow -8V
- **Target Ramp Rate:** 1V/s
- **True Ramp Rate:** -0.627 V/s*
- **Cycle:** 18
- **Resistance:** 926.51 Ω
- **Linear Fit R2:** 1.000

GND probe, really weird stuff
