# (wafer2,2,0,-1,-1,0,0) Characteristics

- **Cell Size:** 15um
- **Times Accessed:** 8
- **Last Measurement:** 2022/March/23 at 04:34:50PM

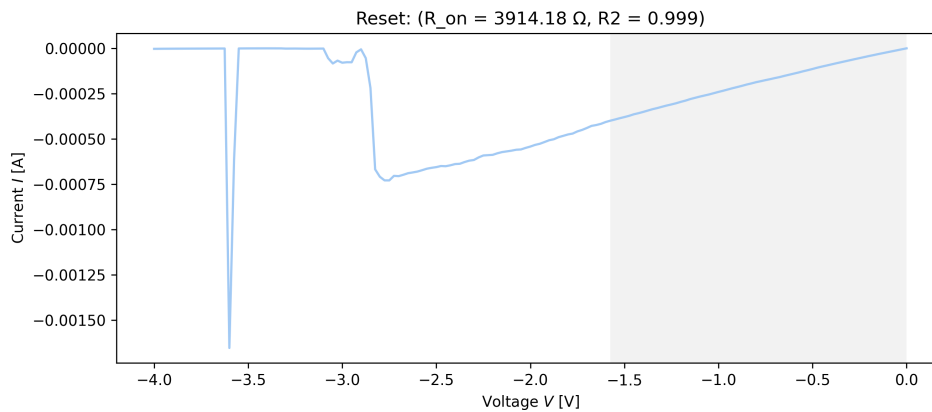
- **Time:** 04:34:03PM
- **I<sub>cc</sub>:** 6.0mA
- **Voltage Range:** 0V → -4V
- **Target Ramp Rate:** 1V/s
- **True Ramp Rate:** -0.556 V/s\*
- **Cycle:** 4
- **Resistance:** 3914.18 Ω
- **Linear Fit R<sup>2</sup>:** 0.999

reset success. Janky response in the higher voltages of the plot.
