**Design and Verification of the Hydraulic
Plantar Soft Tissue Reducer (HyPSTR):
Using Gated Magnetic Resonance Imaging to
Determine Mechanical Properties**

**Design and Verification of a Hydraulic
Device that Uses Gated Magnetic Resonance
Imaging to Determine Plantar Soft Tissue
Mechanical Properties**

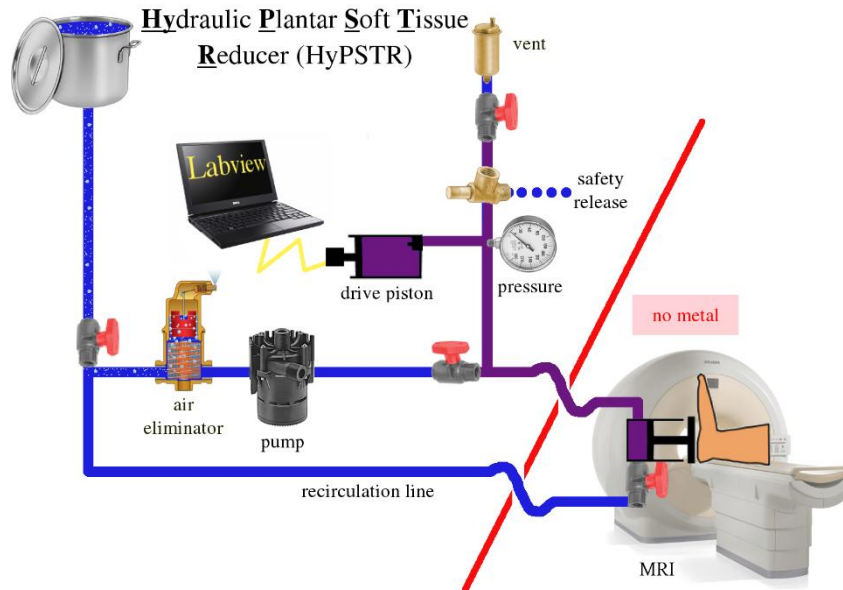
Figure 1. Instrument schematic showing fill and recirculation lines in blue and high pressure hydraulic lines in purple. Valves were closed to isolate the purple lines prior to testing.

A custom-designed, single acting, aluminum master piston/cylinder was attached to the actuator. The slave piston/cylinder was a similarly designed, single acting hydraulic system with equal bore diameter, but made of non-ferrous acetal plastic. A polycarbonate loading platen, threaded onto the end of the slave piston shaft, applied load to the plantar surface of the foot. The master and slave cylinders were connected via 9 m of 9.65 mm internal diameter, vacuum-rated nylon tubing that could withstand more than the 20 kPa negative pressure during the hydraulic retraction stage. Water was chosen as the hydraulic fluid because of its relative safety, availability, and ease of handling compared to various oils and gels. Once filled, a recirculating pump moved the water through a hydronic air eliminator (VJR075TM; Spirotherm, Glendale Heights, IL) to lower the dissolved gas under 50% to prevent entrained air bubbles from forming during system operation.

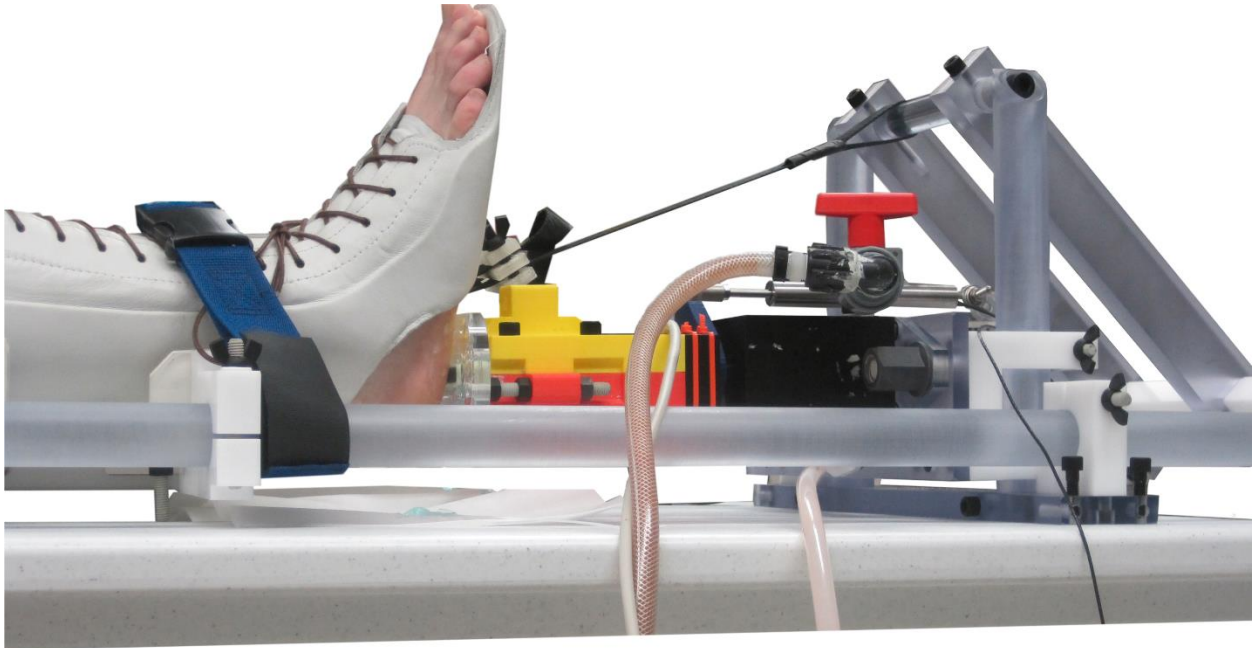
Figure 2. Subject's leg and foot was secured by the (white) ankle-foot orthosis that is attached to polycarbonate rails. The slave cylinder (black) is in series with an ultrasound probe held in ABS plastic (yellow and red) and with a polycarbonate platen. Note the ultrasound probe was used to validate the system and it was removed before any MRI scanning was conducted.

The test subject laid supine in an apparatus that supported the slave cylinder and loading platen and restrained the subject's foot, leg, and torso to minimize movement in the imaged volume that was not due to foot tissue compression (Figure 2). A hindfoot ankle-foot orthosis (American Artificial Limb, Seattle, WA) made from carbon fiber, leather, fiberglass, and Pe-Lite foam secured the lower leg while providing loading access to the heel via a cutout in the sole (Figure 3). This could be swapped for a second, forefoot ankle-foot orthosis that provided a backstop for the foot dorsum during forefoot testing. The slave cylinder could be adjusted in the anterior/posterior direction to align the loading platen with the center of the hindfoot or forefoot, and in the medial/lateral direction to adjust for left or right feet. To further minimize motion, the subject's torso was held in place with adjustable straps over the shoulders and around the waist

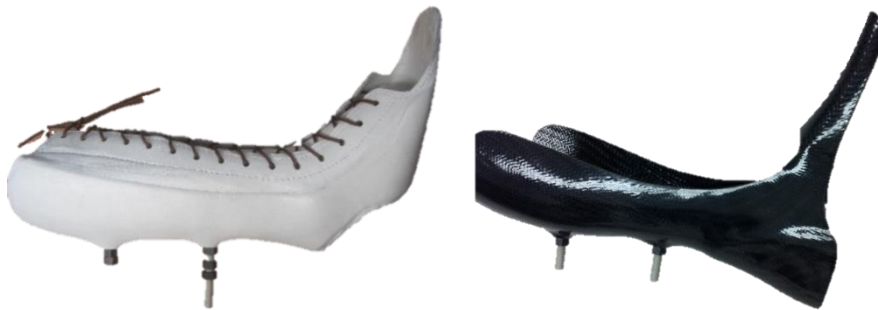
Figure 3. Hindfoot (white) and forefoot (black) ankle-foot orthosis. The bolts on posterior surface are for mounting to the HyPSTR loading frame.

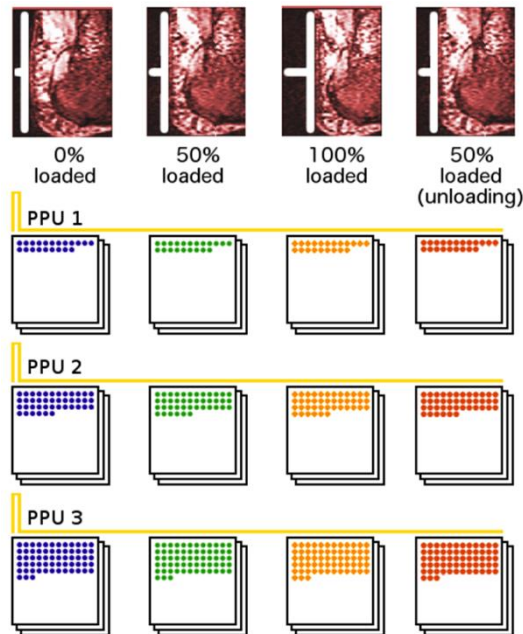
Figure 4. Gated MRI schematic showing 4 phase acquisitions for 3 cycles. The HyPSTR will collect approximately 16 phases over 250 cycles during subject trials.

In an MRI, moving tissue can be imaged with cardiac gating, where short image phase acquisitions are triggered by the subject's heartbeat. Only objects with a periodic or quasi-periodic motion can be imaged in this manner,²⁰ which, in this study, referred to the loading platen frequency. Instead of using a heartbeat, phase synchronization was accomplished with a 2 ms peripheral pulse unit (PPU) signal sent from LabVIEW with a serial-to-fiber optic signal converter (Versalink; Electro Standards Laboratory, Cranston, RI). A pulse was sent upon the initial movement of the actuator from its zero-position and was then repeated at a user specified interval until test completion. The 3.0T Philips Achieva MRI Control and Data Acquisition System (Amsterdam, Netherlands) received this PPU and initiated the phase recording protocol in order to capture small portions of an image volume at specific times during a loading cycle (Figure 4). These partial acquisitions from each cycle were combined to generate complete images at each phase. Typically, 16 phases were generated.

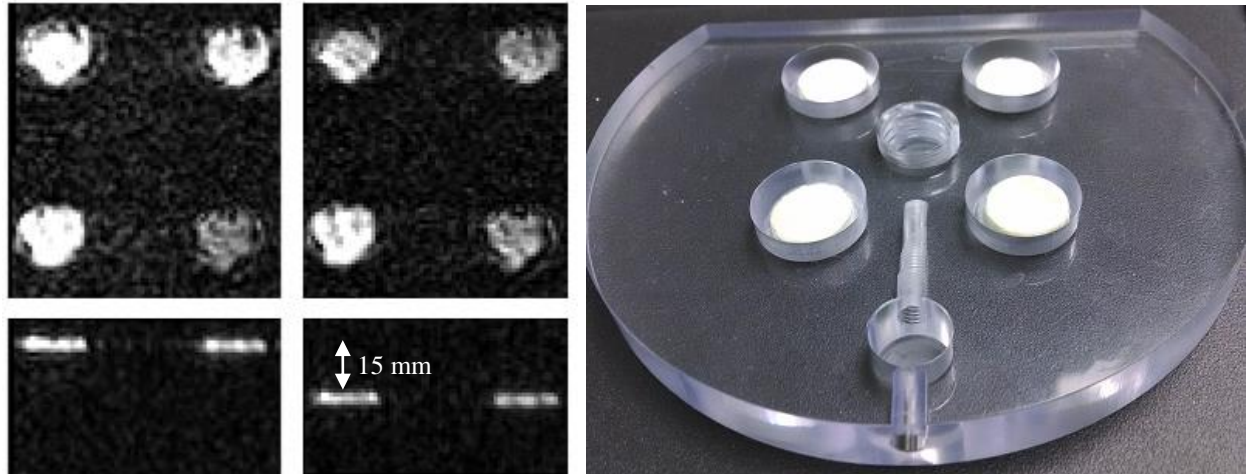
Figure 5. Platen markers from the starting position and the most extended position of a timing verification test. The platen is pictured on the right.

However, the fiduciary markers (and platen) were not exactly in the center of the image volume (Figure 5), and since the gated MRI acquisitions progressed from one side of the volume to the other, the amount of accumulated time error from the PPU phase offset was not simply the average over 78 cycles. Instead, the number of slices in the image volume were counted (in this case, 39) and divided by 78. This gave the fraction of a slice (in this case, 0.5) acquired by each pass of the gated MRI. The average PPU phase offset for the MRI scan was then found by taking

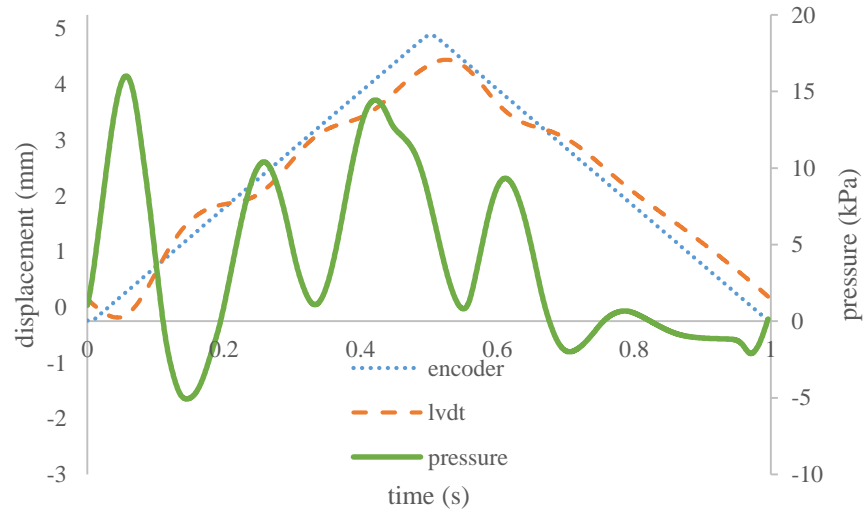
Figure 6a. Average of 240 triangle-wave cycles at 1 Hz and 5 mm actuator displacement. The ringing in the pressure signal (green) was indicative of a water-hammer. The sharp turnaround of the platen at each maximum and minimum position was too extreme for this hydraulic system.

The triangle-wave tests showed problems with the quality of the pressure signal at 1 Hz (Figure 6a); due to the rapid starting and stopping of the water column, a water hammer was observed. As such, 6 Hz speeds were never explored and instead, slowing the motor to 0.2 Hz and implementing a sine wave produced usable pressure data (Figure 6b). The 10 mm unloaded cycling tests were very accurate and repeatable, both within trials and between cycles, however there was some displacement loss, as the maximum slave platen movement was 9.68 ± 0.0076 mm, 9.65 ± 0.0082 mm, and 9.66 ± 0.0078 mm for the three separate trials. Further investigation showed that, due to machining inconsistencies, the master hydraulic piston diameter was approximately 96.5% as wide as the equivalent slave piston component. Hence the maximum displacement for the slave piston should be approximately 9.65 mm; all trials were

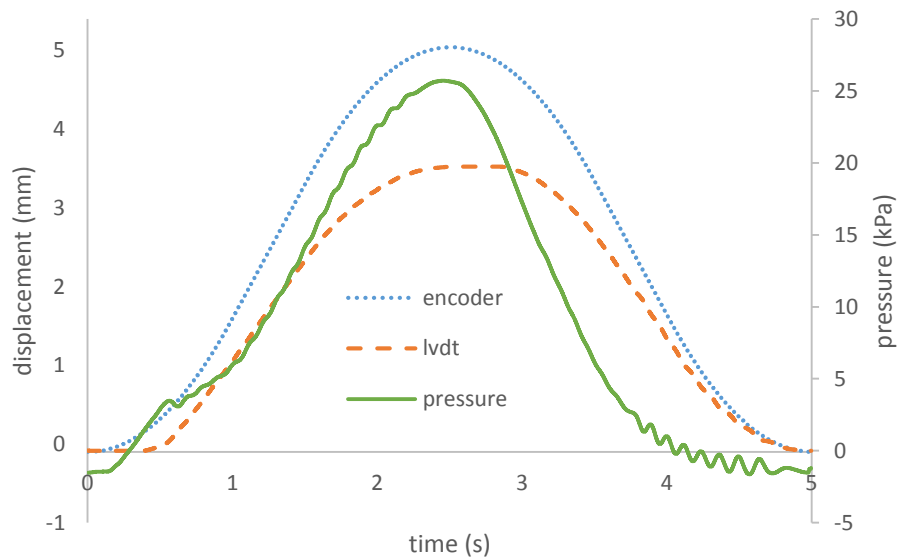
Figure 6b. Average of 240 sine-wave cycles at 0.2 Hz and 5 mm actuator displacement. The pressure signal ringing almost completely disappeared. The oscillations to the left of the maximum and minimum peaks were likely from the piston not being able to move smoothly past its friction point at slower velocities.

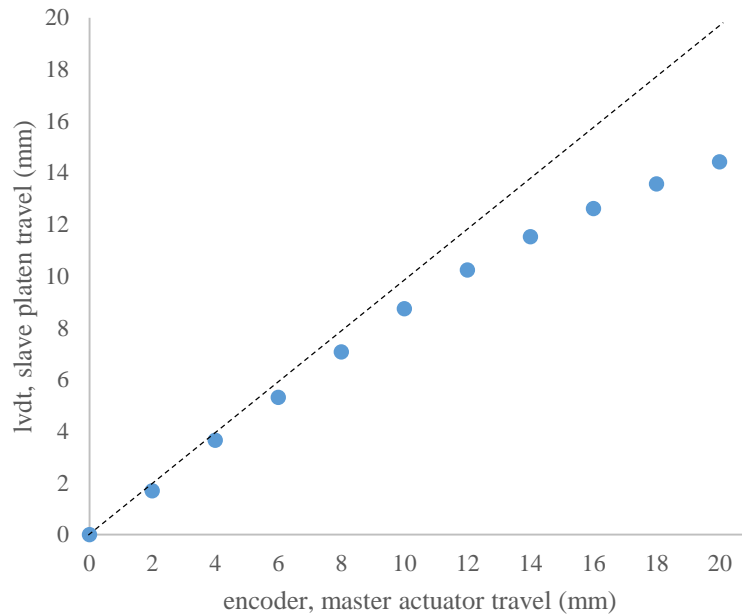
Figure 7a. Slave cylinder displacement vs. master cylinder displacement. Non-linear displacement loss occurred between the actuator and platen. Though the hydraulic components were chosen to be as rigid as possible, some system compliance still existed.

As load was incrementally increased against the silicone pads for the stepped pressure test, the encoder and LVDT measured a near-linear relationship between the master and slave displacements up to 8 mm (Figure 7a, b). Due to system compliance, non-linear losses occurred at the higher pressure values, where a 20 mm master displacement moved the slave platen only 14.3 mm. For each set of six stair-cases, the first stair-case was considered a pre-conditioning phase (i.e., the results were different from the other 5) and not included in displacement averaging, thus 15 stair-case profiles remained (Figure 7b).

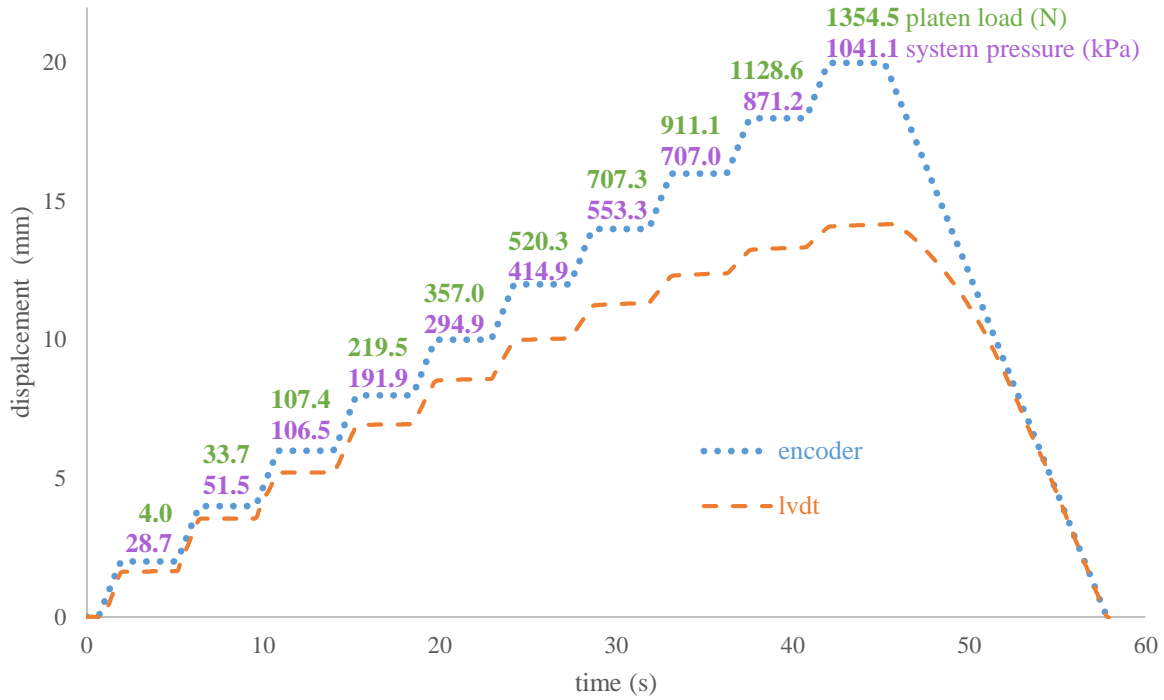
Figure 7b. Slave platen and. master cylinder displacement. The displacement loss was non-linear, becoming more significant with increasing master movement. It was approximated with a polynomial and used to calculate motor parameters for future tests.

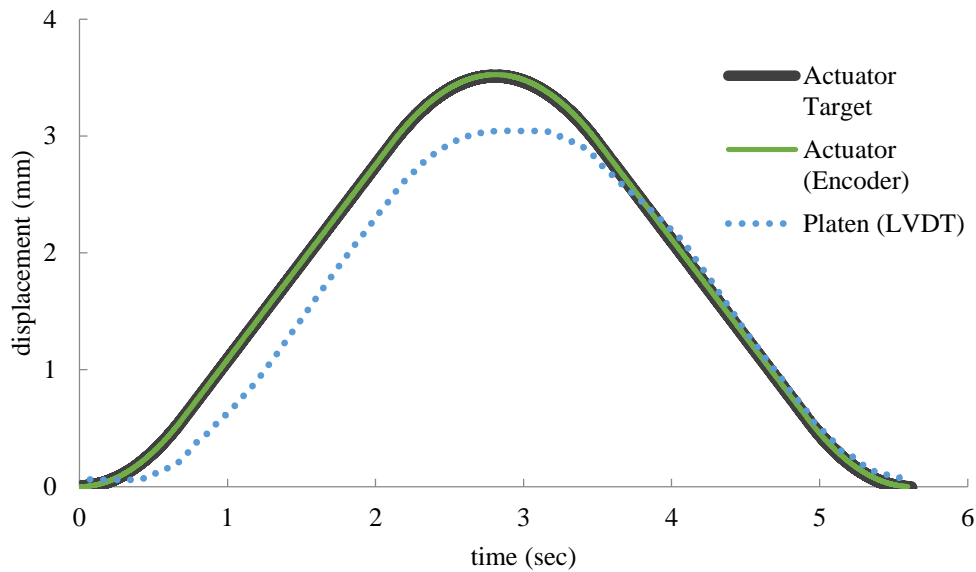
Figure 8. Overlap of the target sine wave used to set the motor control parameters and resulting encoder movement. The encoder path is nearly identical to the prescribed curve

(shown with an exaggerated thickness). The actuator/encoder had to move 3.526 mm to make the slave platen move 3.000 mm due to system compliance.

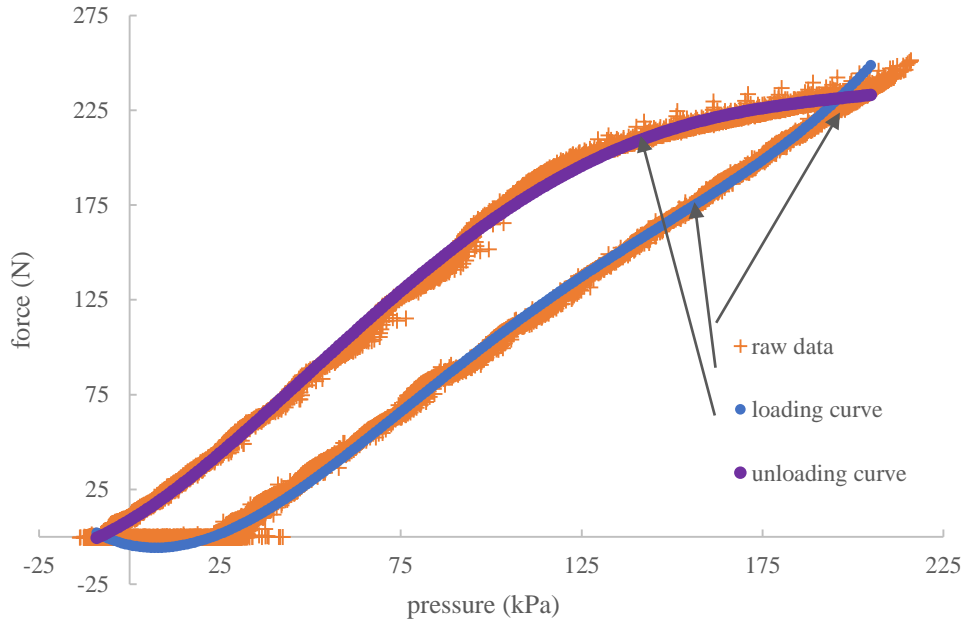
Figure 9. Pressure to force calibration curve from the 7-mm loaded verification test.

the slave cylinder. Pressure-to-force calibration curves showed different patterns for loading vs. unloading (Figure 9). The effect of the static friction can be seen again on the bottommost and topmost parts of the loading curve, where changes in pressure did not immediately change the applied force.

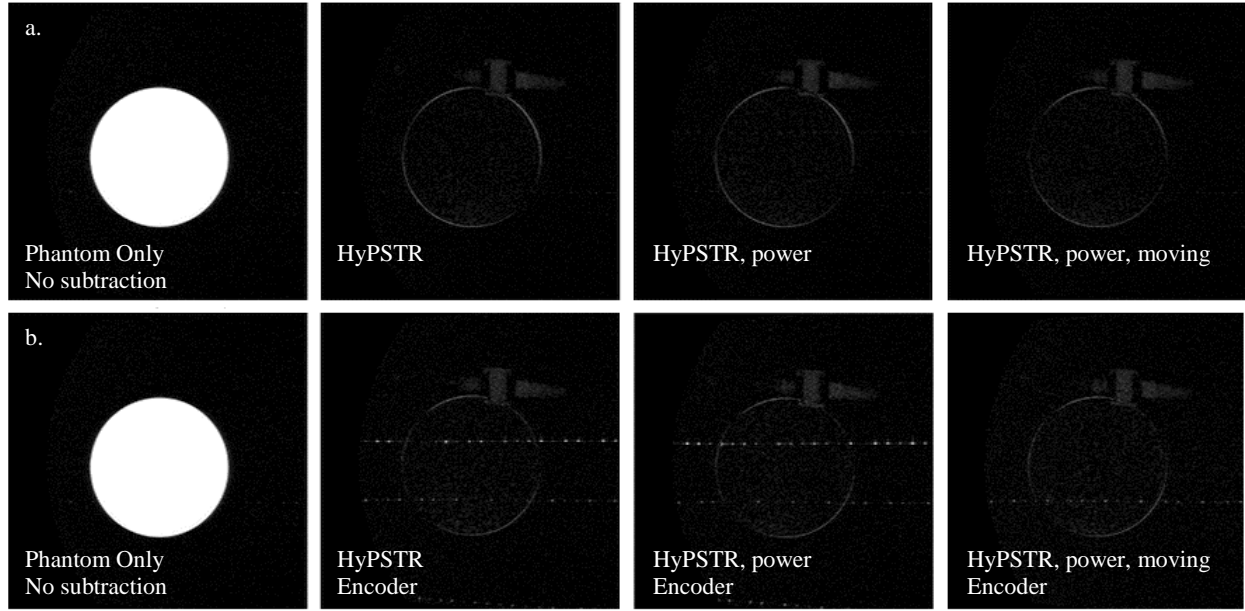
Figure 10. The leftmost images are of the control phantom without any hardware in the MR core. The darker images are subtractions from the same phantom, but different system configurations. Top row (a) is without the encoder, bottom row (b) is with the encoder. Second column is just hardware; third column is hardware plus power; fourth column is hardware, plus power, plus actuator motion.

MRI imaging with a cylindrical phantom container in the acquisition volume showed no major artifacts (Figure 10a). The noncircular, grey shapes in the background were thought to be areas of water in the plumbing fittings and are located outside of the foot image volume. For comparison, a temporary addition of two 5 VDC copper wires to power an MRI-compatible encoder caused two parallel line defects to appear (Figure 10b). Numeric subtractions between summed image pixel intensities showed a difference of approximately 5% without the encoder, 7% with it (Table 2). The pixel quality observations did not indicate any significant artifacts, as confirmed by two radiologists.
