# Vibration Analysis

## *Case Study – Gas Recycle Fan*

## Vibration Analysis – Gas Recycle Fan

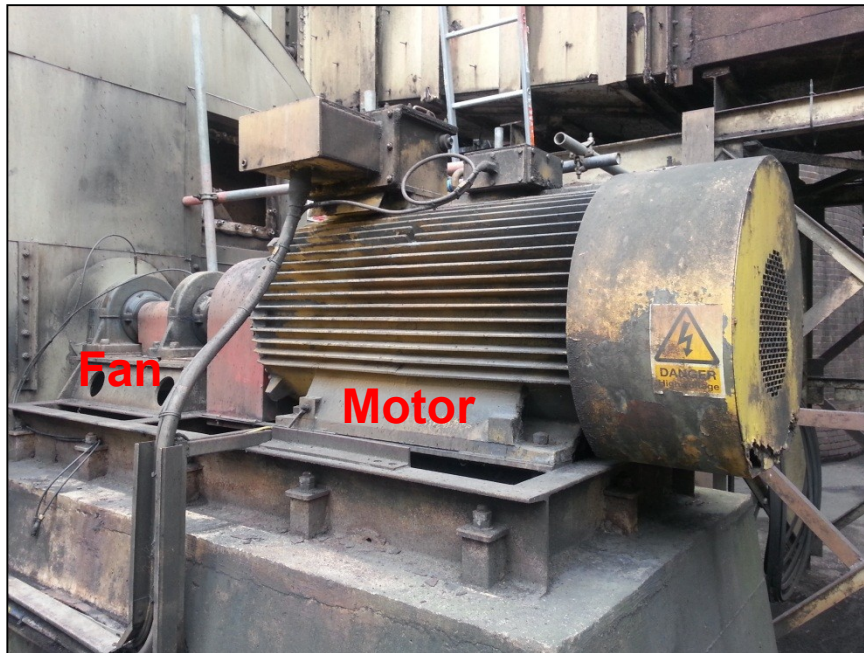
- The Gas Recycle Fan is part of an Animal Feeds Dryer Plant
- It is critical for the operation of the Dryer Plant. Failure will result in Dryer Plant shutdown
- Monthly Vibration readings are taken throughout the operation period.
- In Sept 2012 it was noticed an increase in vibration levels in the 3-4XRPM band on the motor NDE horizontal reading

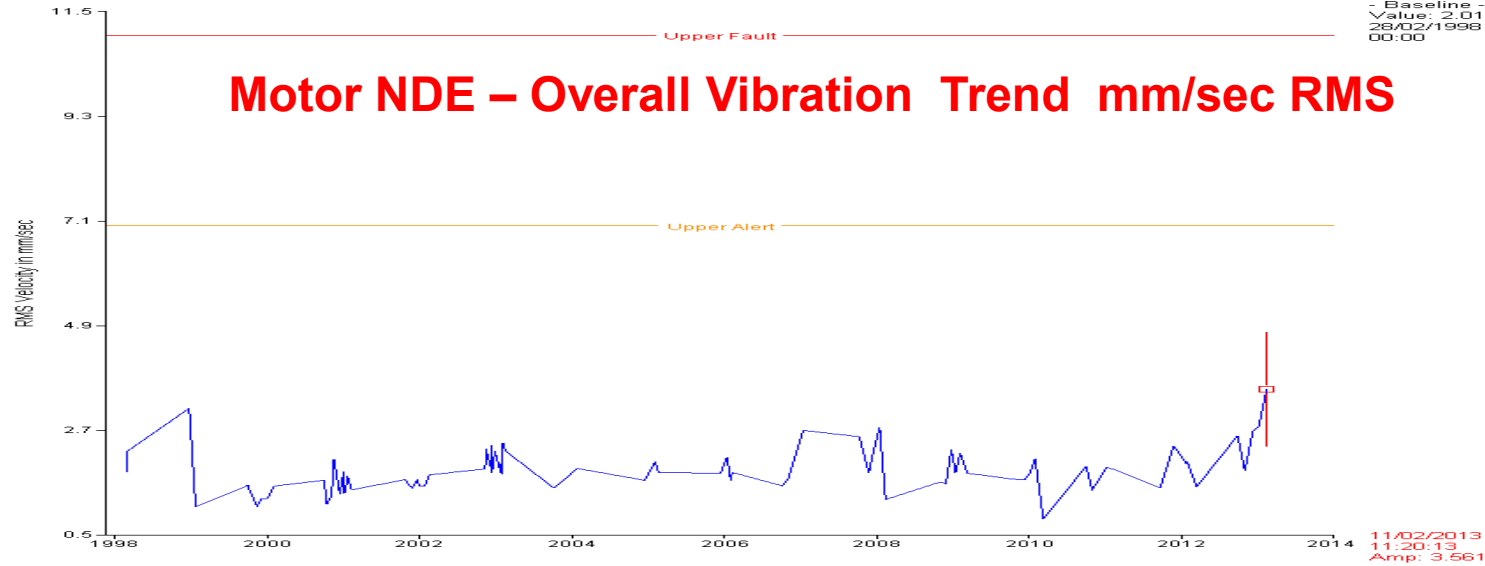
## Motor NDE – Overall Vibration Trend mm/sec RMS

DRAF - DRIERS / 38FANS618M - GAS RECYCLE FAN  
1H - MOTOR NDE HORIZONTAL

Overall Value  
- Baseline -  
Value: 2.019  
28/02/1998  
00:00

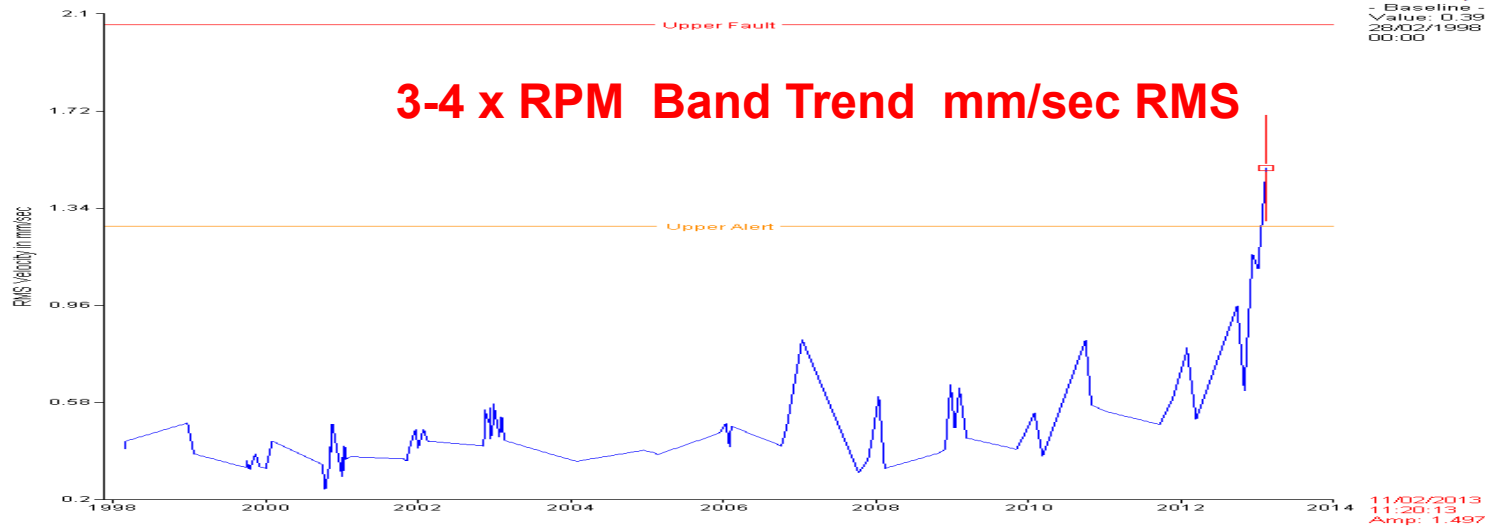
## 3-4 x RPM Band Trend mm/sec RMS

DRAF - DRIERS / 38FANS618M - GAS RECYCLE FAN  
1H - MOTOR NDE HORIZONTAL

3-4xrpm/loose  
- Baseline -  
Value: 0.397  
28/02/1998  
00:00

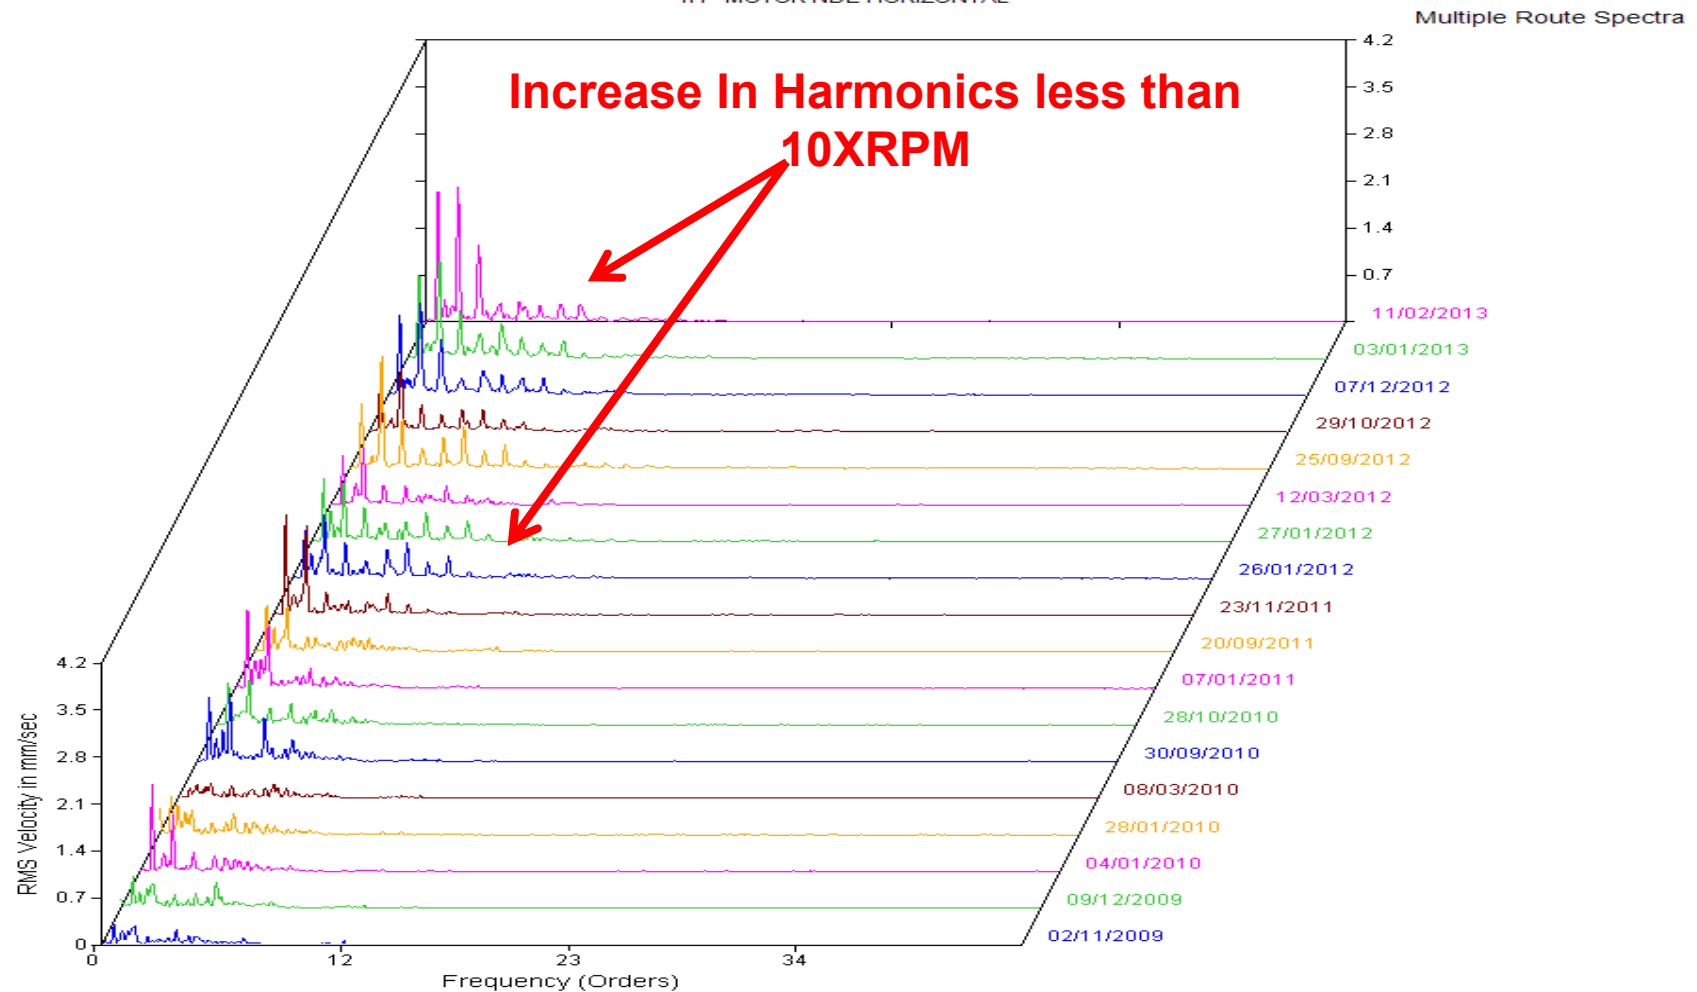
**Multiple Spectrum History Plot- Motor NDE Horiz**

DRAF - DRIERS / 38FANS618M - GAS RECYCLE FAN  
1H - MOTOR NDE HORIZONTAL

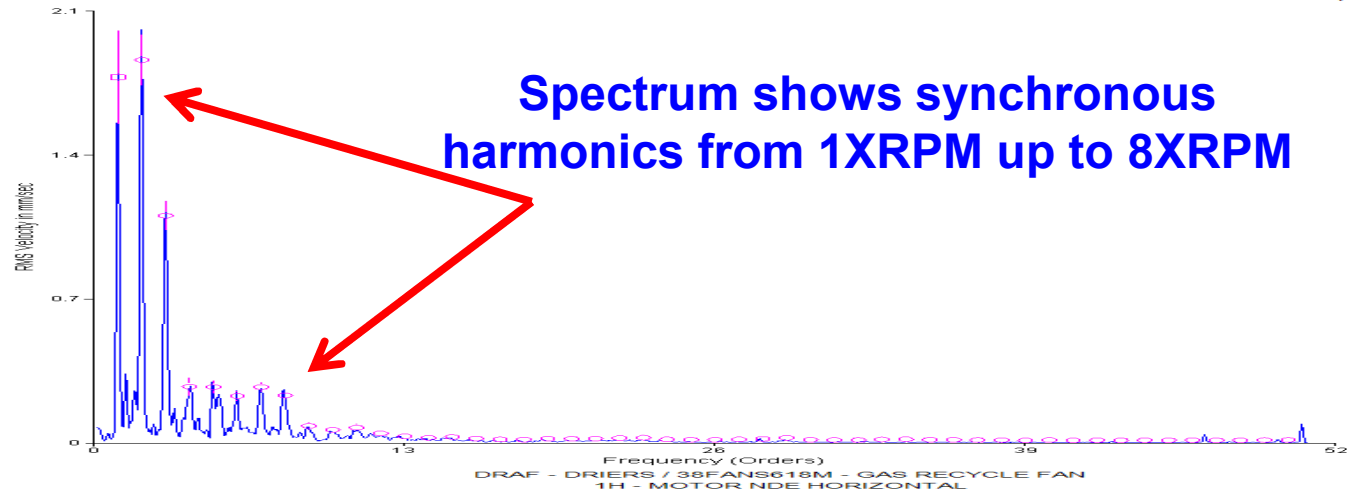
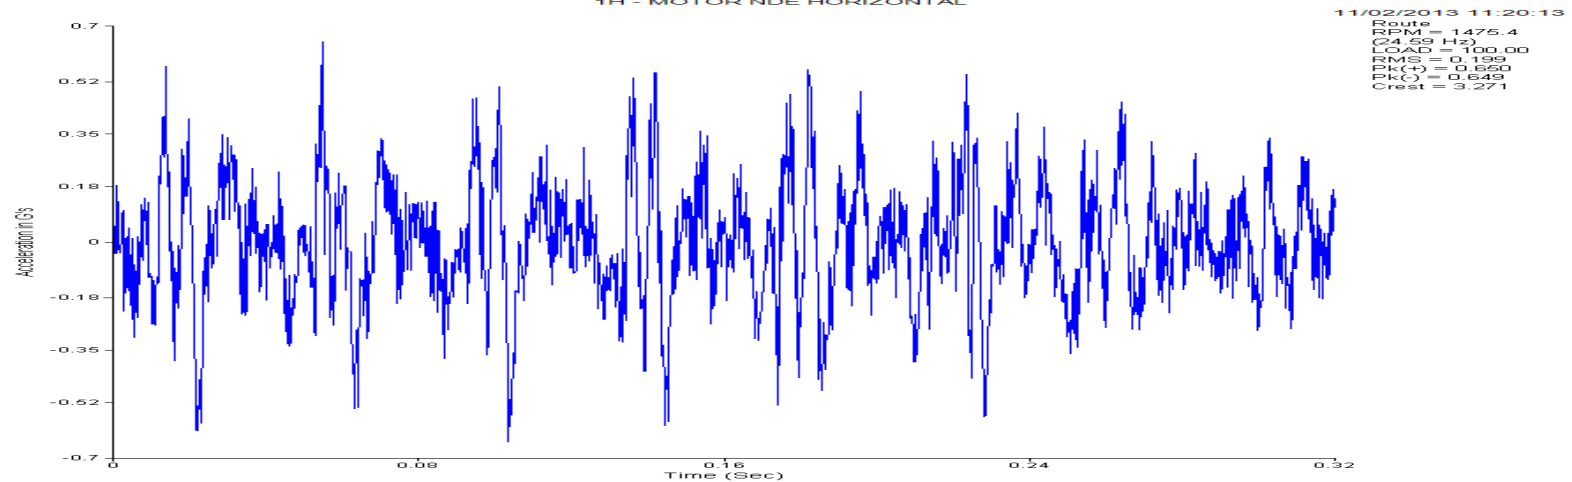
**Spectrum & Waveform - Motor NDE Horiz**

DRAF - DRIERS / 38FANS618M - GAS RECYCLE FAN  
1H - MOTOR NDE HORIZONTAL

11/02/2013 11:20:13

Route  
3.561 V.DG  
RMS = 3.657  
LOAD = 100.00  
RPM = 1475.4  
(24.59 Hz)

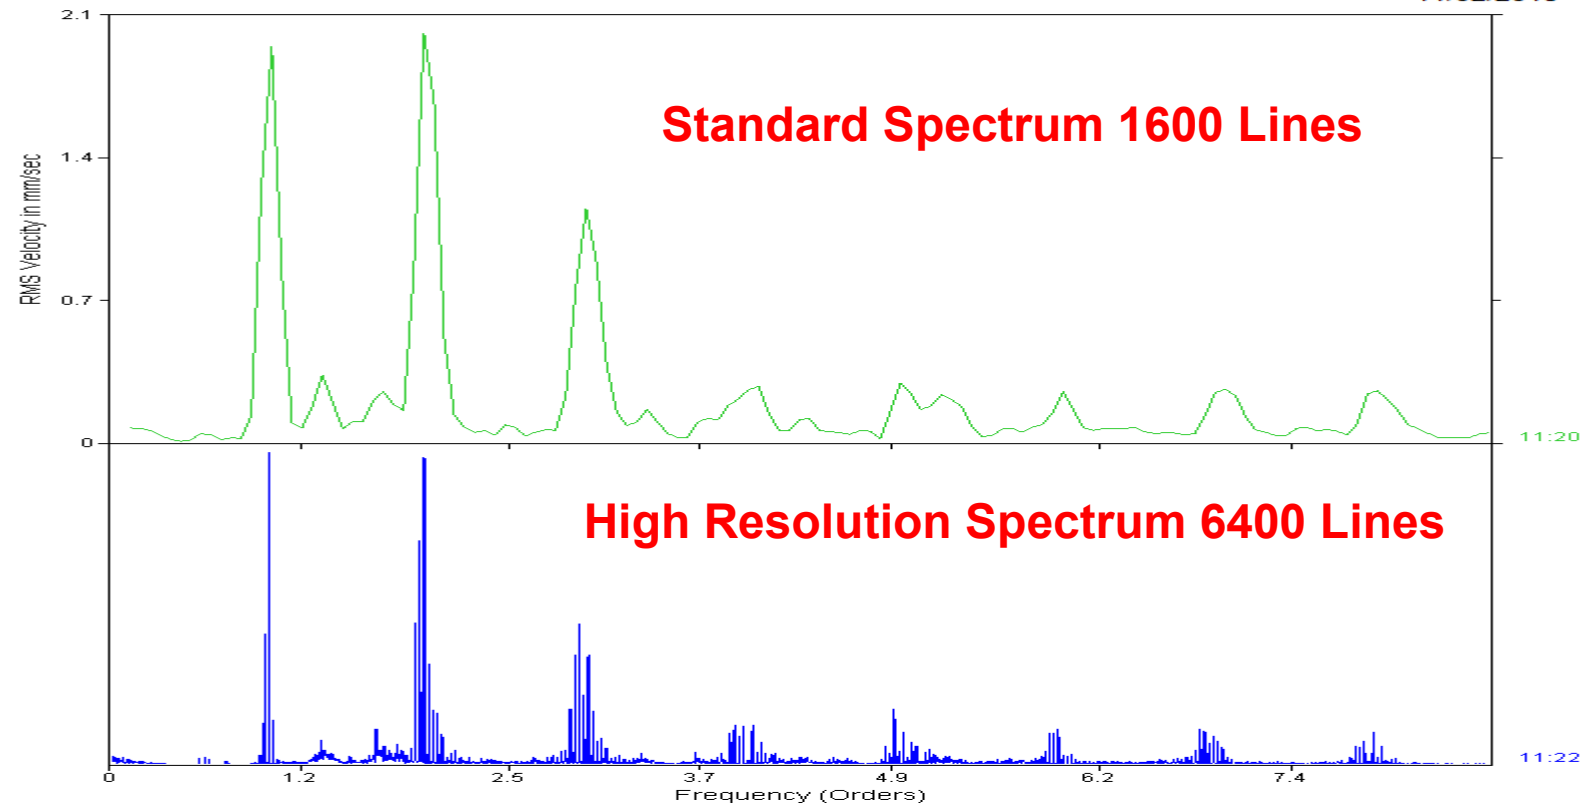
11/02/2013 - Multiple Spectra

**High Resolution 6400 Line spectrum shows clear sidebands  
surrounding the 1-8 XRPM harmonics**

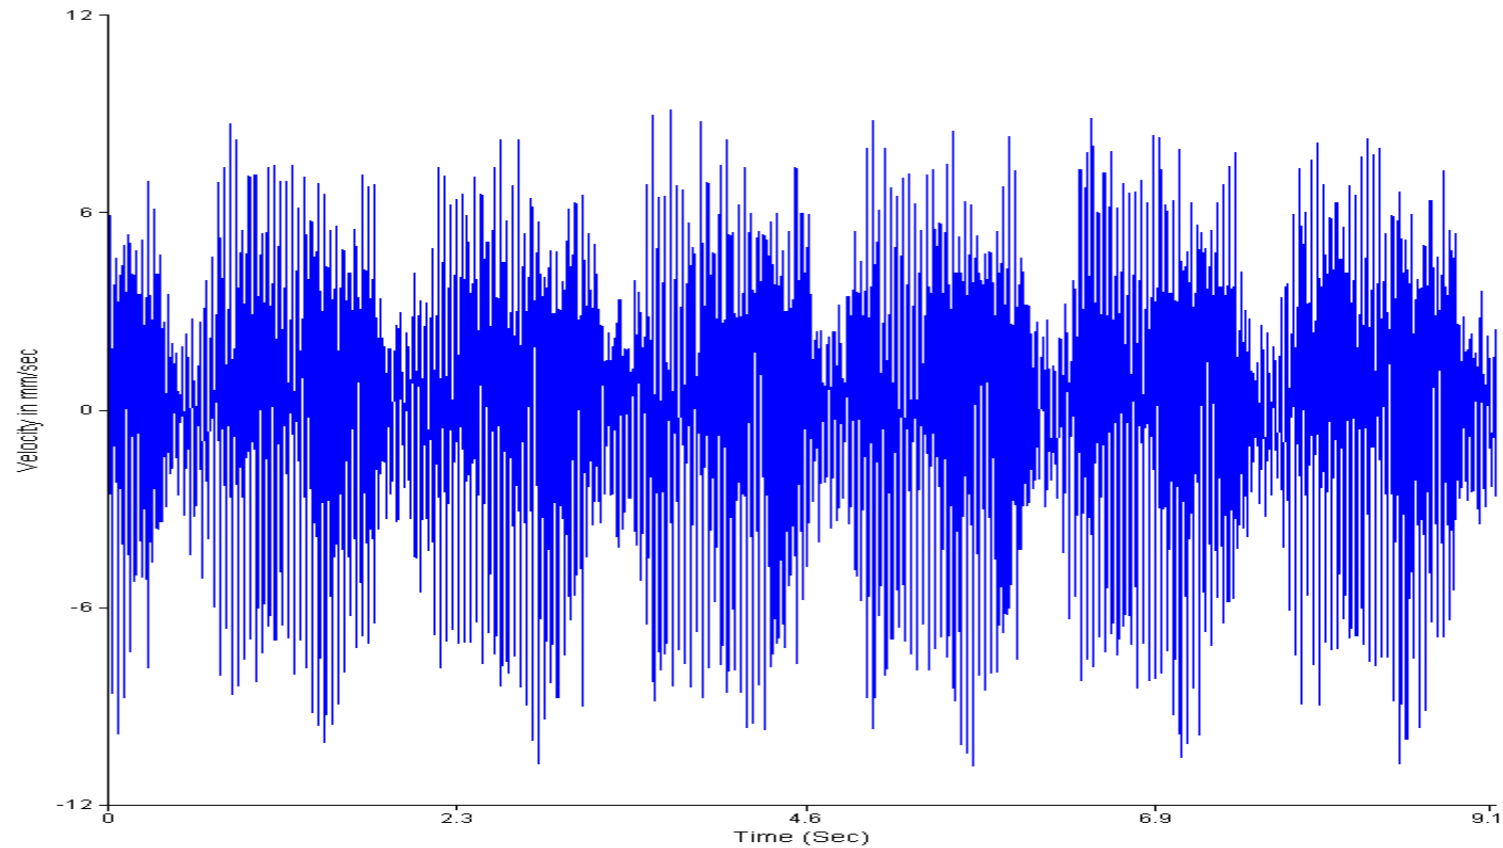
Analyze  
RPM = 1490.5  
(24.84 Hz)  
LOAD = 100.00  
RMS = 3.364  
Pk(+) = 9.884  
Pk(-) = 11.77  
Crest = 3.461

**Extended Time Waveform clearly shows a regular “Beat” is present,  
this was also audible.**

40 Cycles per min matches the spacing of the modulation sidebands surrounding the 1xRPM harmonics. This is also the frequency of the “Beat”

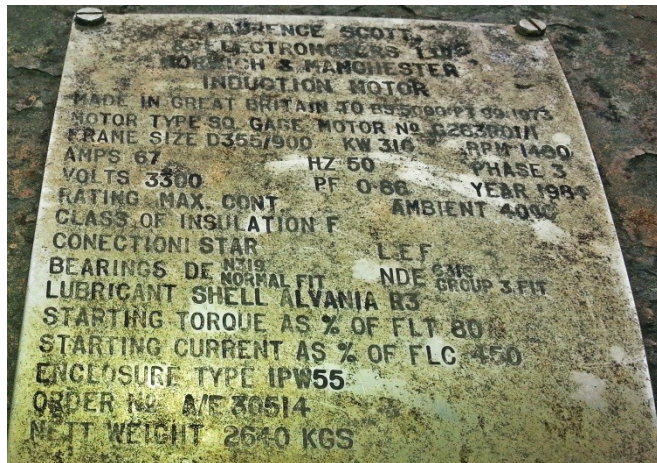
- Induction Motor
- Power 315 KW
- 1500 RPM.
- Actual Running Speed 1490 RPM
- 4 Poles
- Rolling Element Bearings

LAWRENCE SCOTT  
ELECTROMOTORS LTD  
NORWICH & MANCHESTER  
INDUCTION MOTOR  
MADE IN GREAT BRITAIN TO BS5000 PT 00:1973  
MOTOR TYPE SQ. GASE MOTOR NO. 0263001H  
FRAME SIZE D355/900 KW 315 RPM 1490  
AMPS 67 HZ 50 PHASE 3  
VOLTS 3300 PF 0.86 YEAR 1984  
RATING MAX. CONT. AMBIENT 40°C  
CLASS OF INSULATION F  
CONNECTION STAR L.E.F.  
BEARINGS DE N319 NDE G10 GROUP 3 FIT  
LUBRICANT SHELL ALVANIA R3  
STARTING TORQUE AS % OF FLT 80  
STARTING CURRENT AS % OF FLC 450  
ENCLOSURE TYPE IPW55  
ORDER NO. A/E 30514  
NET WEIGHT 2640 KGS

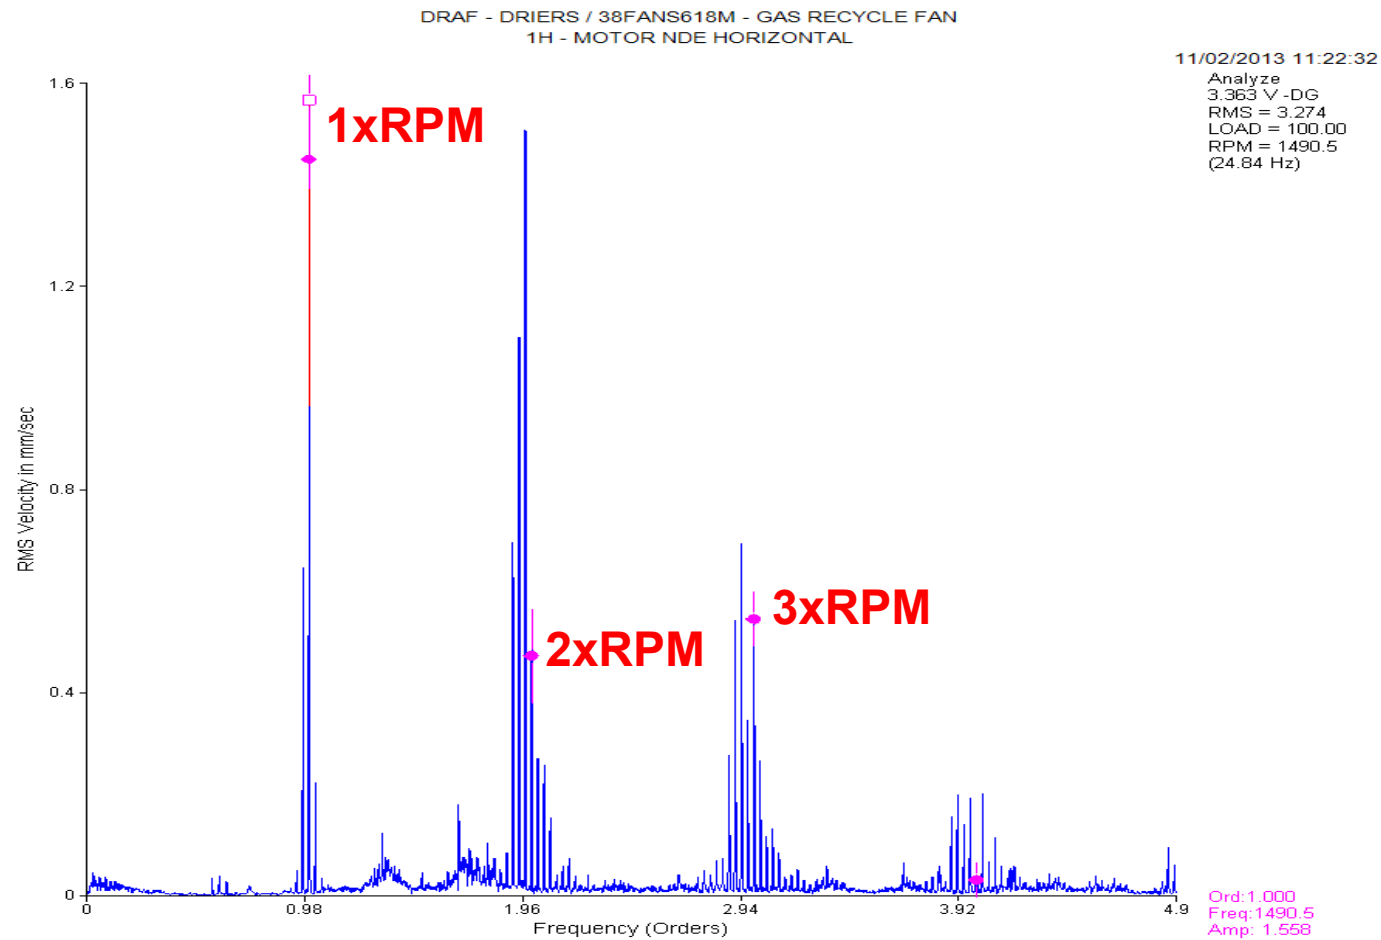
**High Resolution spectrum shows run speed harmonics surrounded by modulation sidebands**

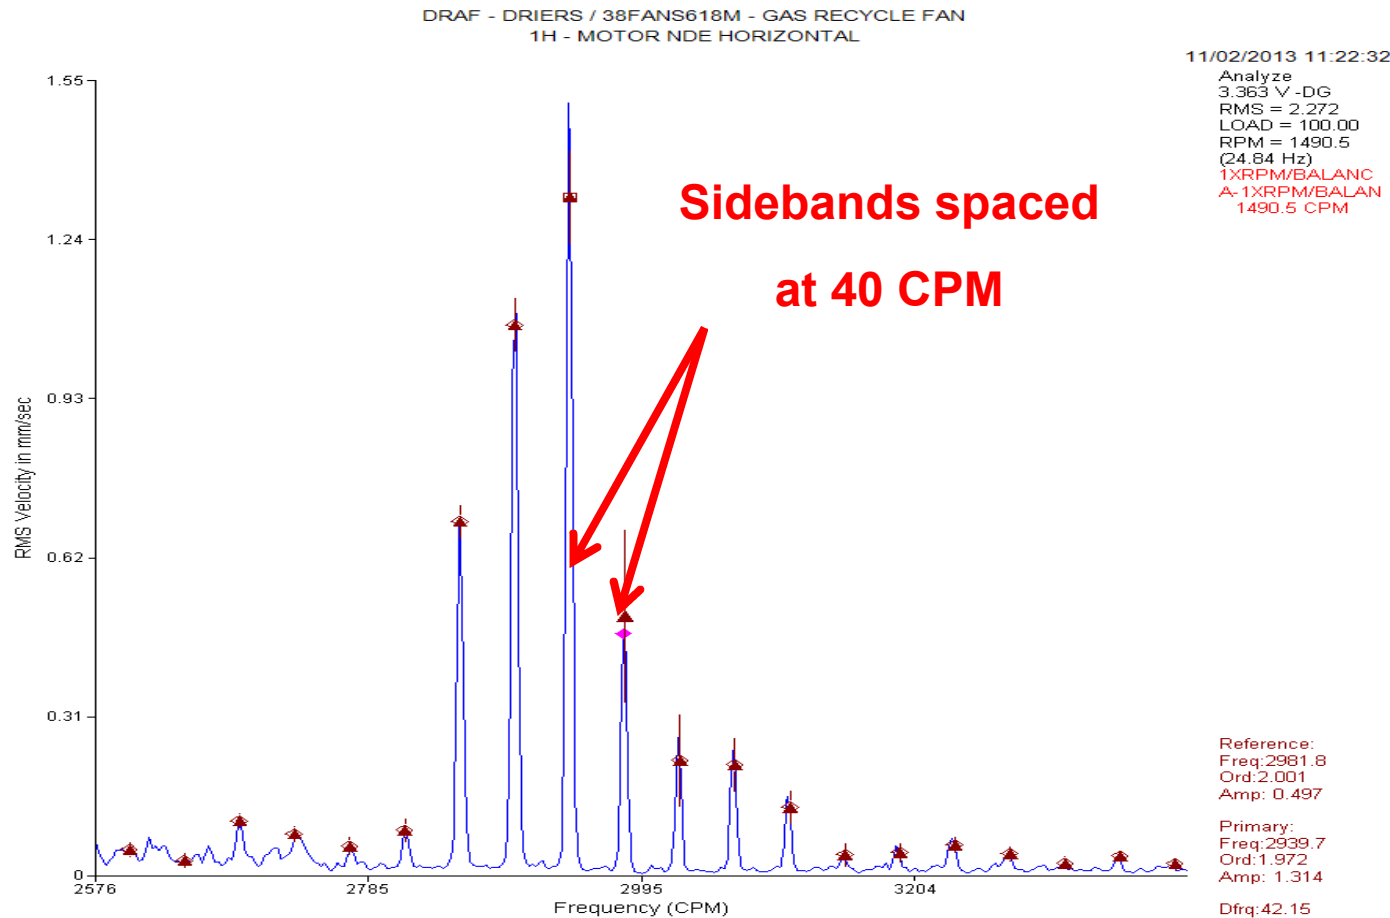
Sidebands measured at 40 CPM (Cycles Per Min)

Suspected Rotorbar Problem

Rotorbar Defect Freq = No. of Poles x Slip Frequency

1500 RPM – 1490 RPM = 10 CPM Slip Frequency

4 Poles x 10 CPM Slip Freq = 40 Cycles Per Min
