How to fix the pins that moved from an X230 charging adapter module

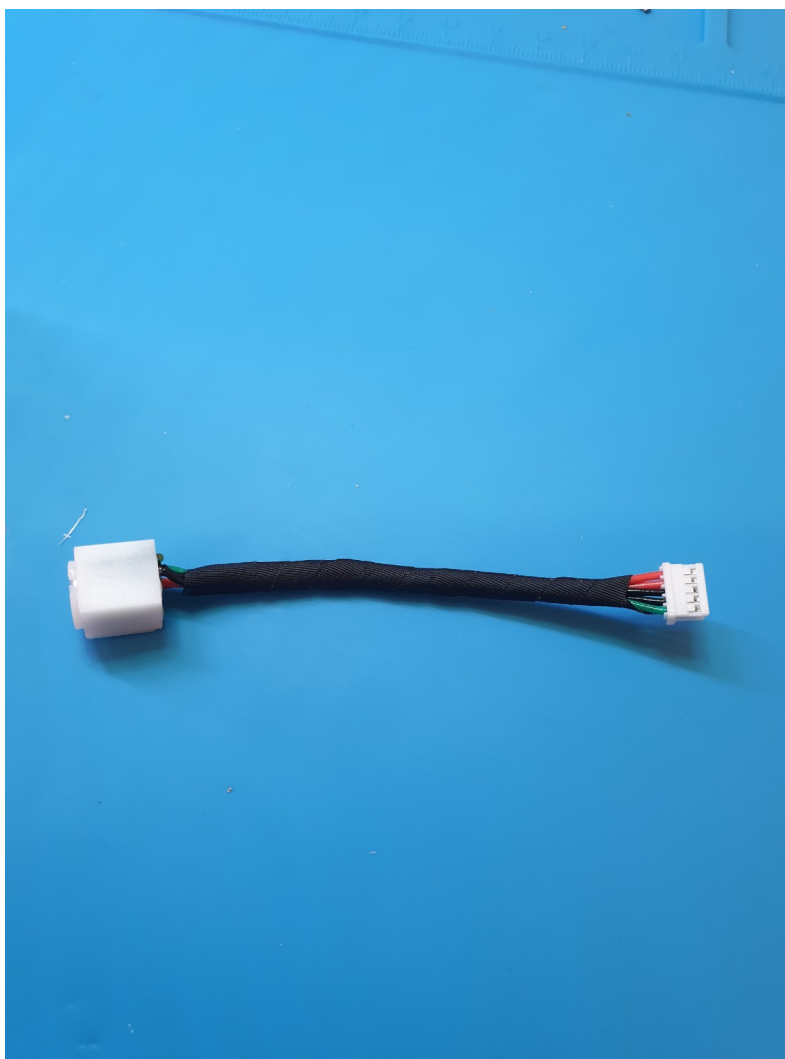
1. Take the module

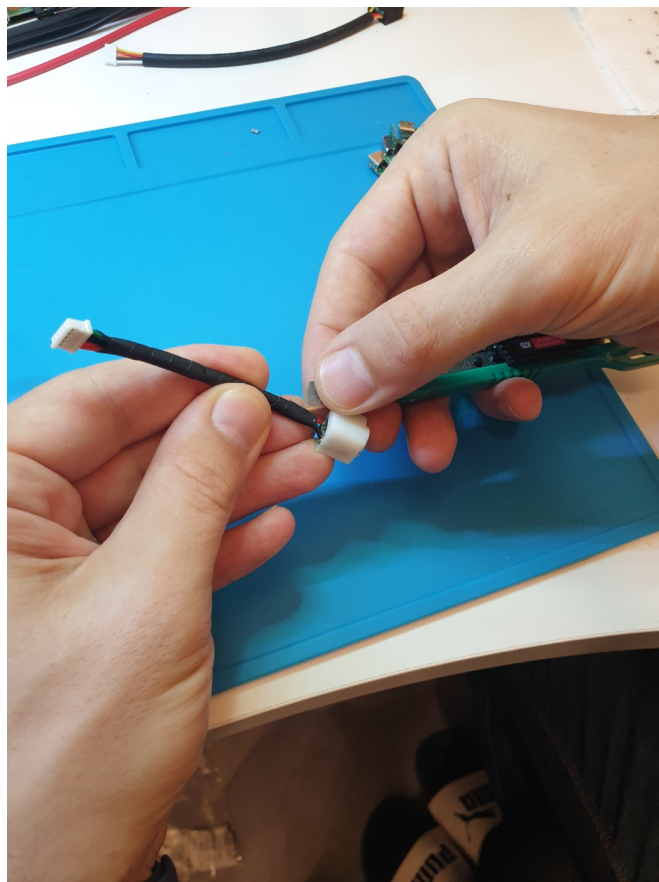
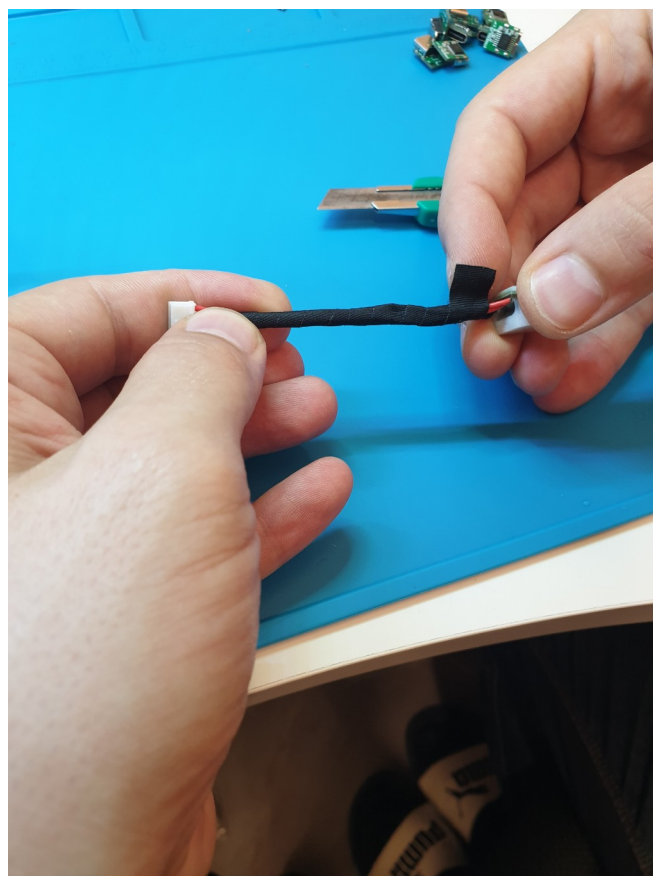
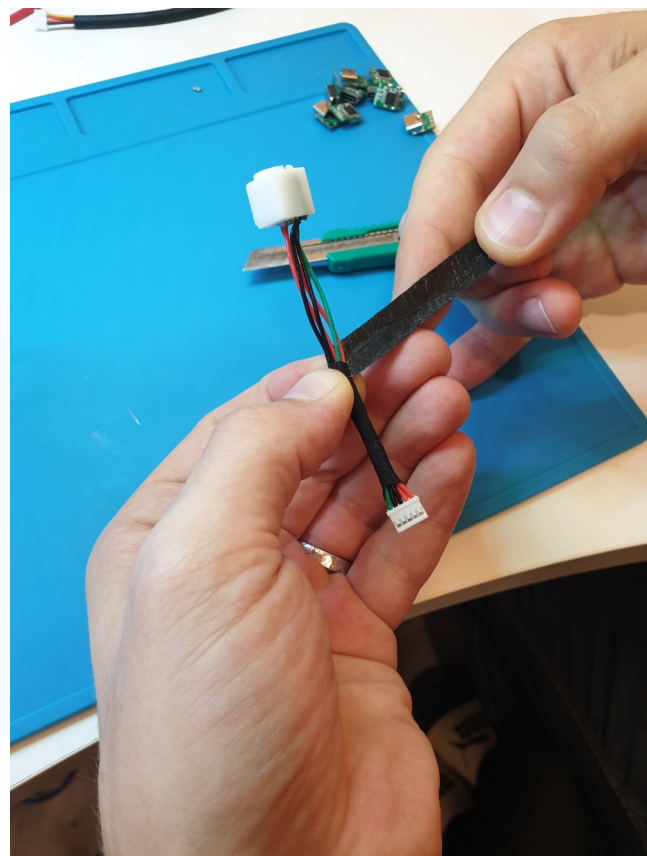
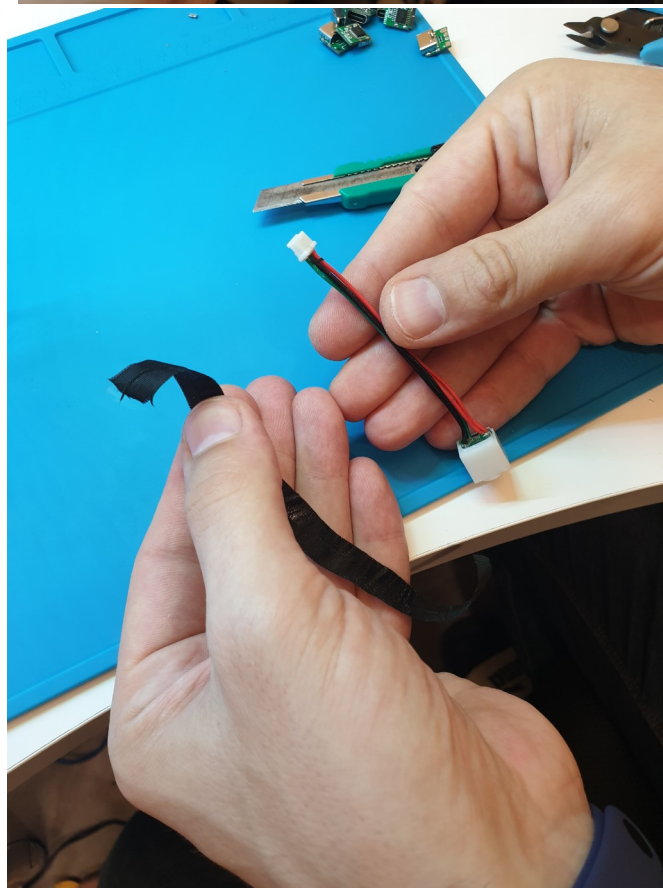
2. Using an exacto knife unwrap the black thermal tape from the wires(please be careful when removing it as you will put it back at the end of the process)

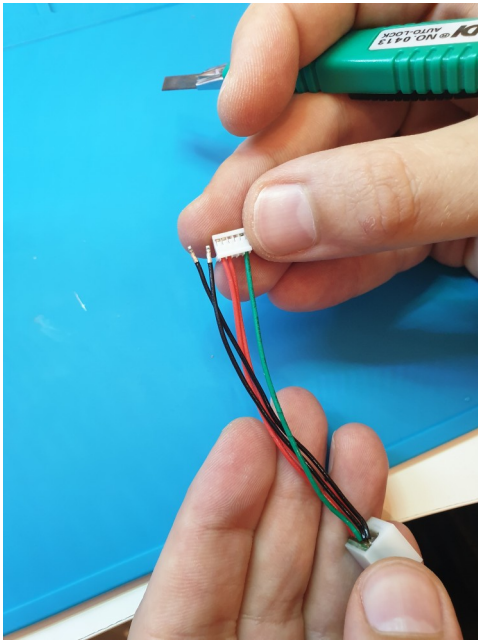
3. You should have something like this now :

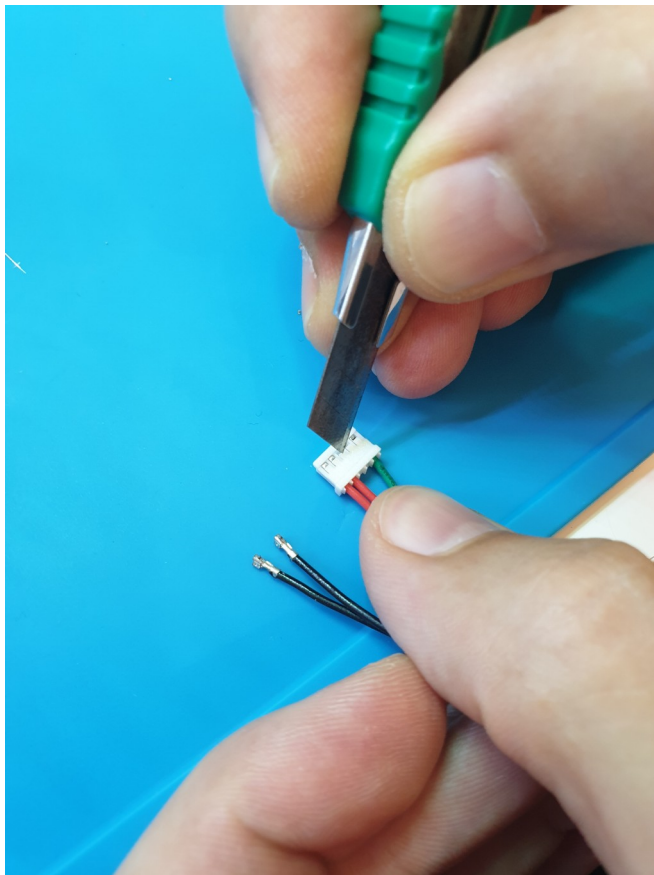
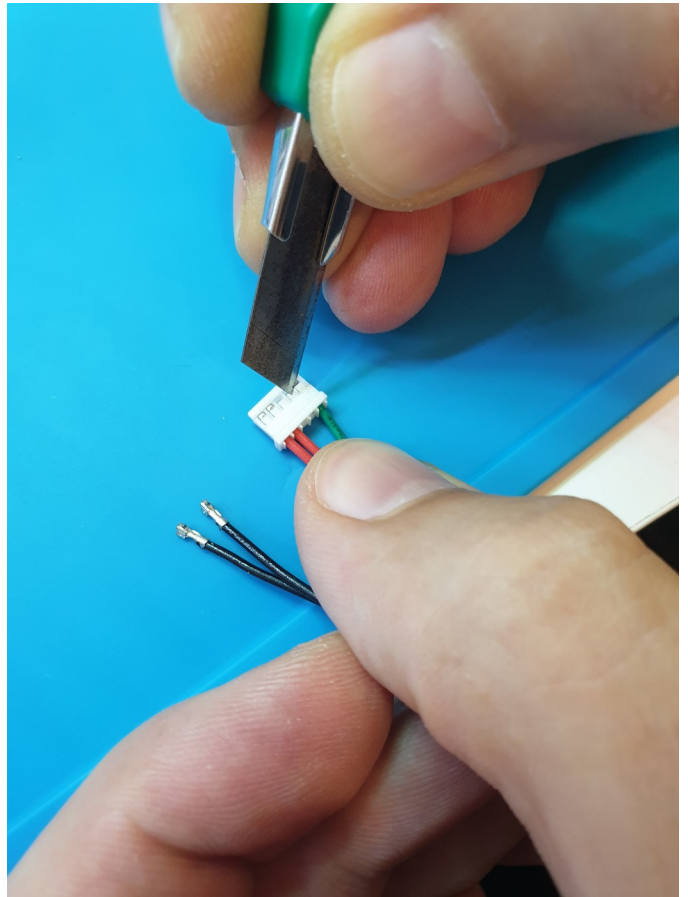
4. Using the exacto knife, please gently press the little white plastic tabs as shown in the pictures below.

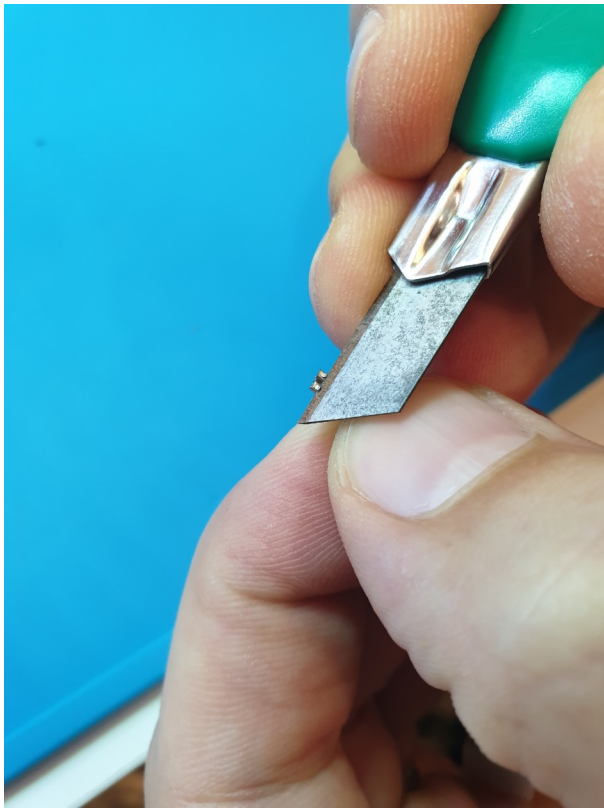
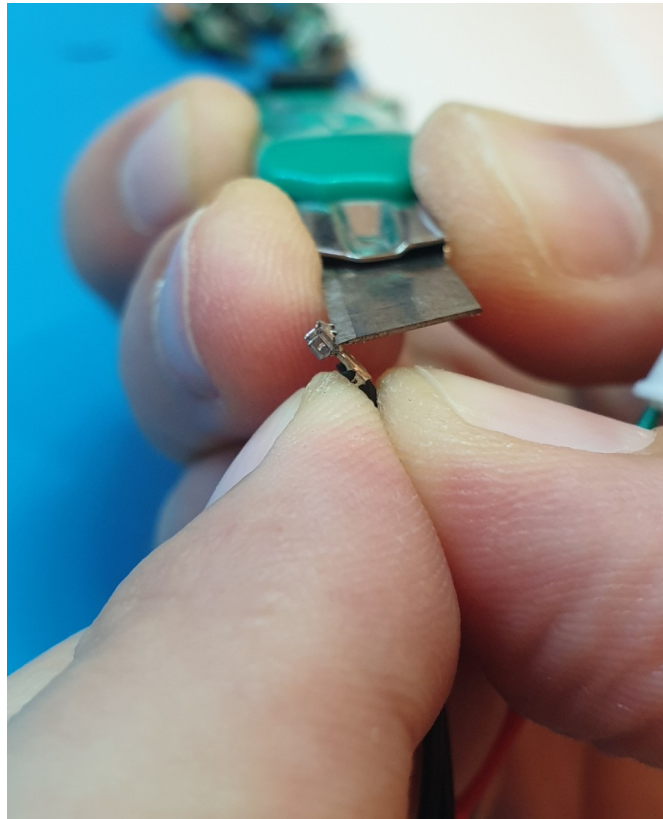
5. Now take the wires that are outside of the white 5pin connector and check their metal tabs(clips) to be lifted enough so they can grab the plastic tabs when inserted back in the plastic connector.(45 degree angle is good)

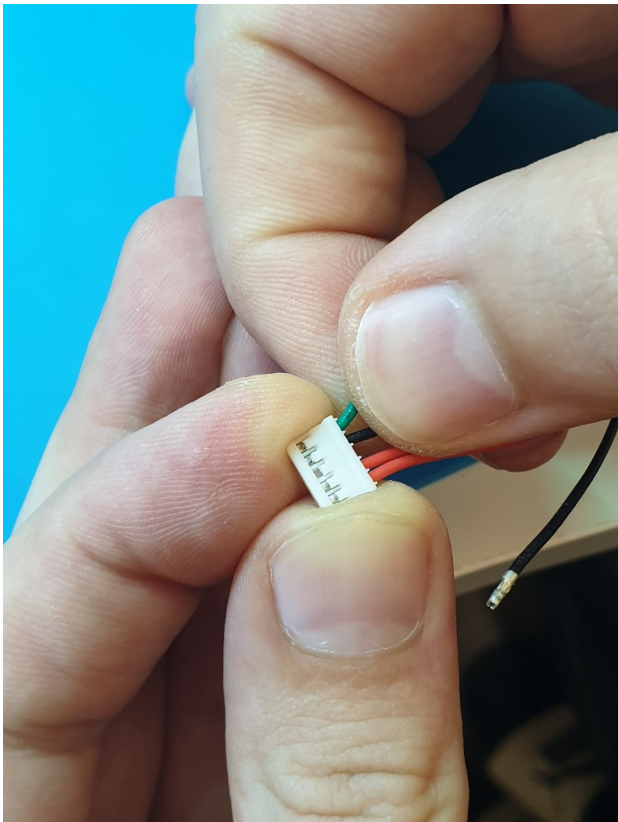
6. Now push the metal clips into the holes of the 5pin connector as shown below. The metal clip from the wire should be pushed to reach above the plastic tabs. Please keep the colour order just like in my pictures. It might be a little difficult to push them in, you can use a tweezer to do this step or just slowly push the wires in until the metal clip reaches its place. Do this for all the wires that are out.

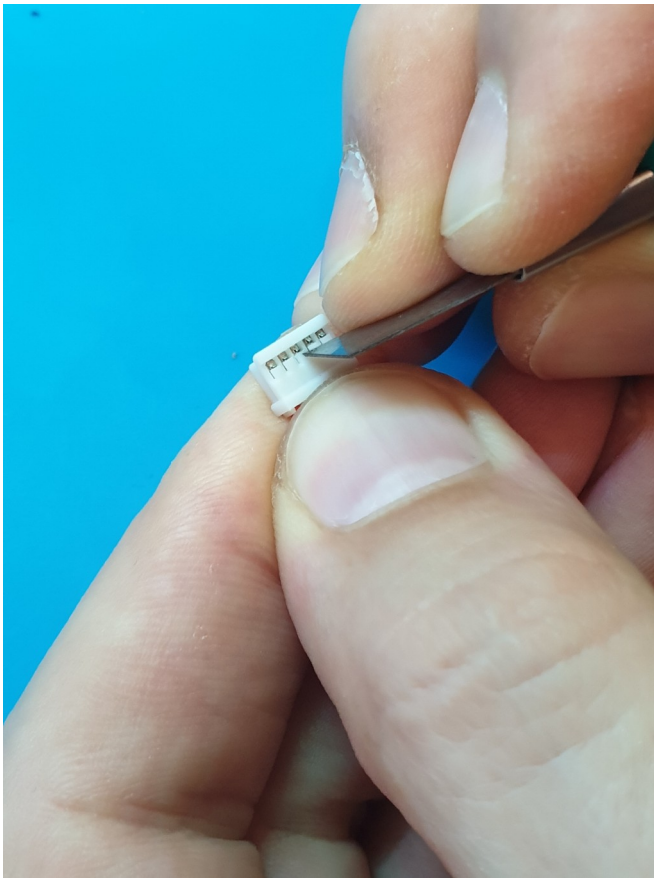
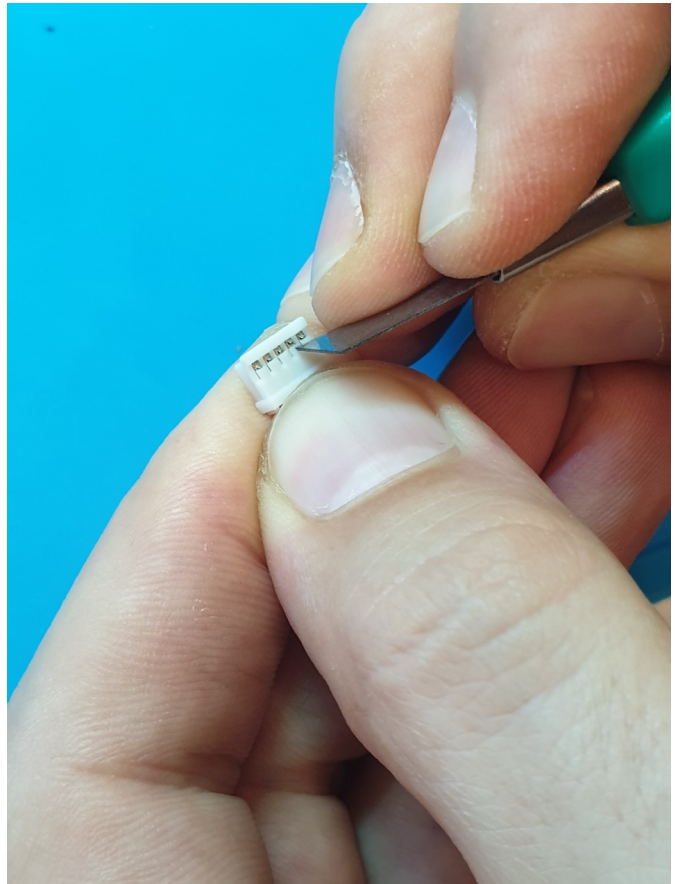
7. Please gently press the plastic tabs of the 5pin plastic connector under the metal clip (just gently to make sure the metal clip will stay in place)

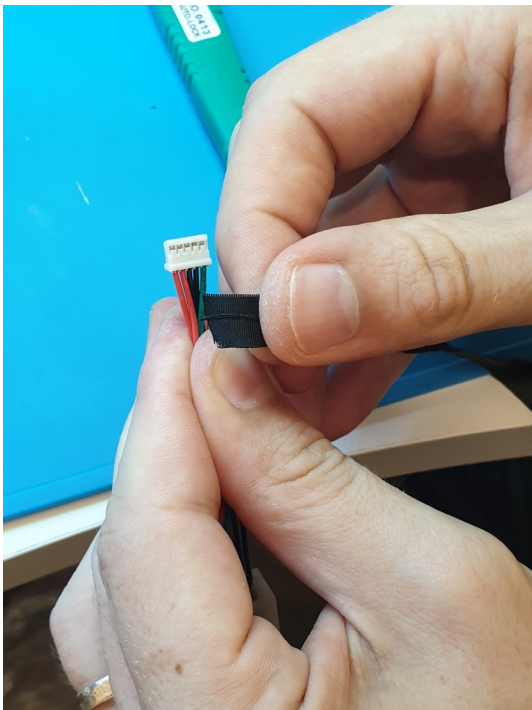
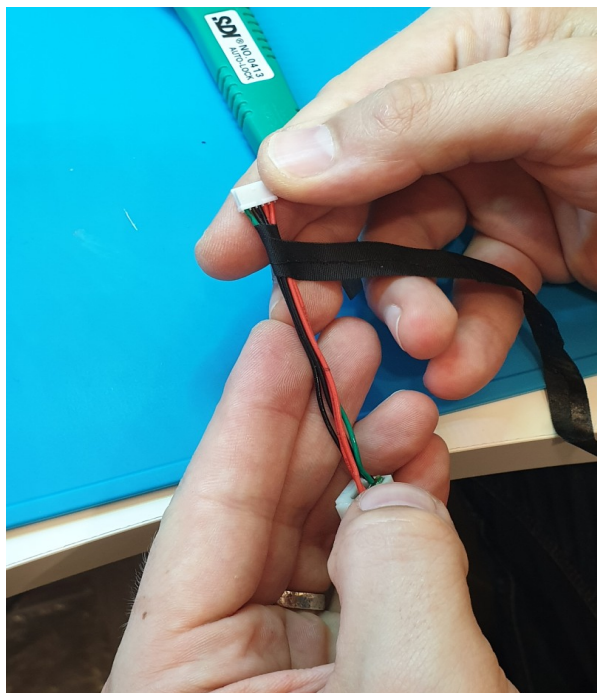
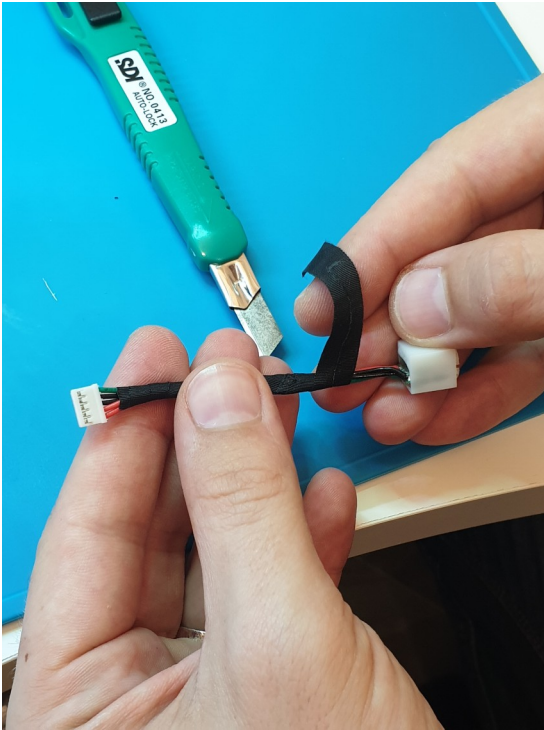
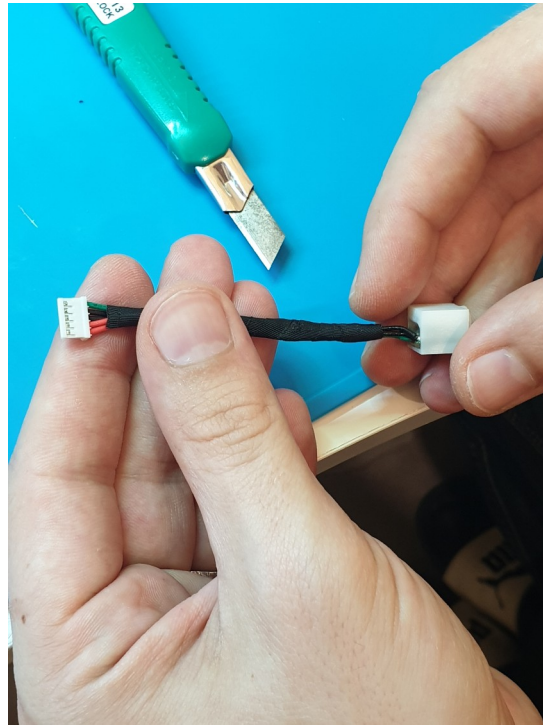
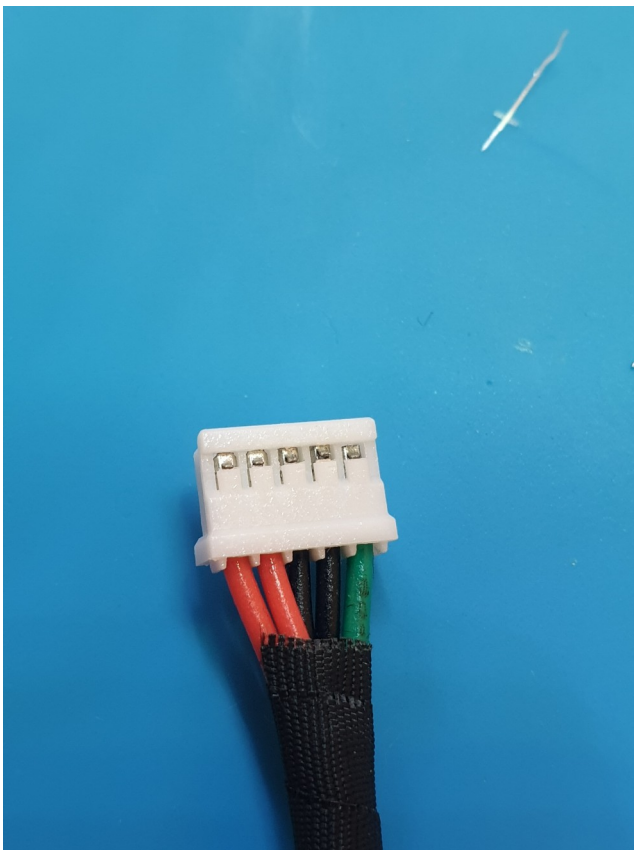
9. Wrap the protection black tape like shown below :
