Gear Testing Results

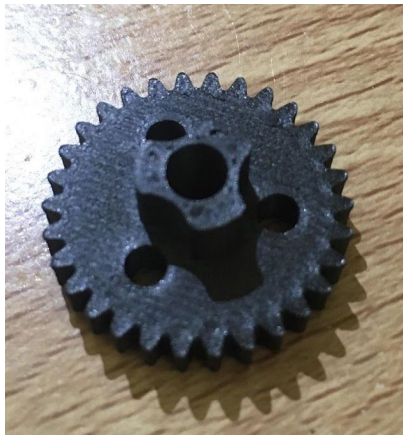
Before

3D Printed Onyx Gear:

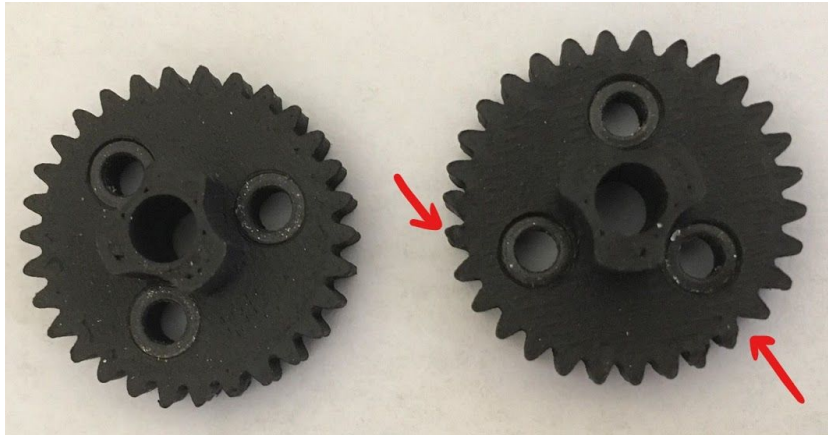
After

There are notable deformation in the teeth. The outer circles were created by the pressure of the heads of the screws when screwed in. This shows that the material can be deformed by something as little as hand tightening screws with a screwdriver.

Trial	Max Torque	Notes
1	5.6 N*m	Teeth deformed
2	N/A	Was not assembled properly and bent without reading a torque
3	5.8 N*m	Teeth deformed

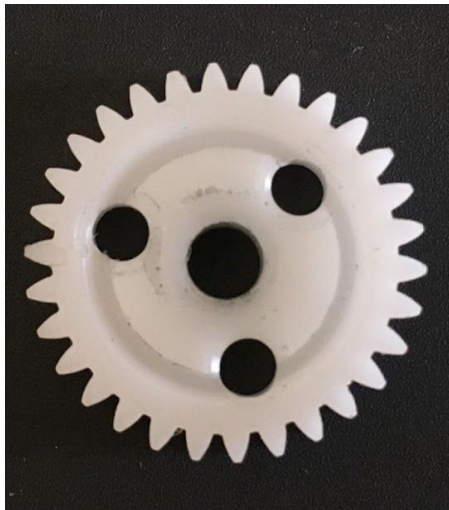
Before

Acetal Gear:

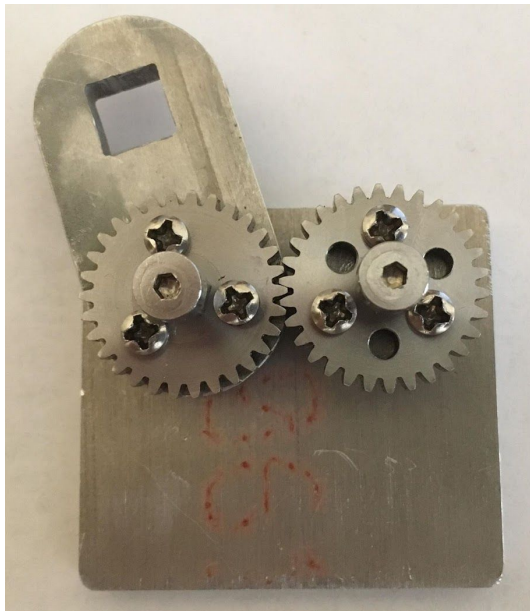
Stainless Steel Gear:

I ran each test applying more torque each time but the maximum torque the teeth can withstand before breaking is likely much larger than I can apply by hand. The maximum measured torque of the steel gears is more than twice that of the 3D printed gears and almost more than twice that of the acetal gear.

Trial	Max Torque	Notes
1	9.2 N*m	Did not break
2	13.5 N*m	Did not break
3	14.3 N*m	Did not break
