# Predicting Earthquake Damage in Nepal

## Microsoft Professional Capstone : Data Science

Anurag Sareen, April 2018

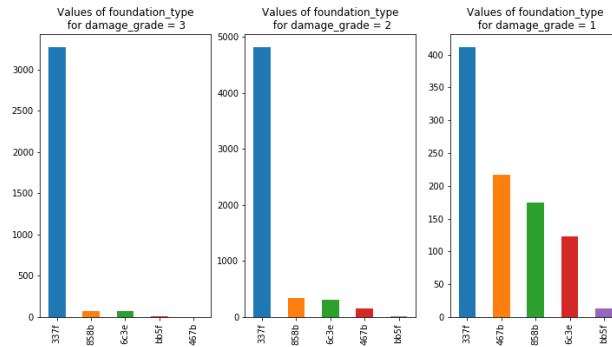
- Most of the damage was done where the foundation\_type was 337f

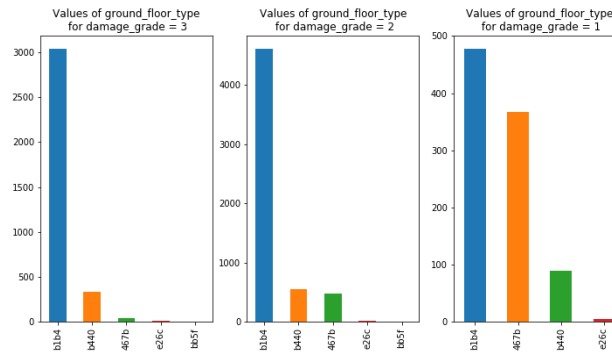
- Most of the damage was done where the ground\_floor\_type was b1b4

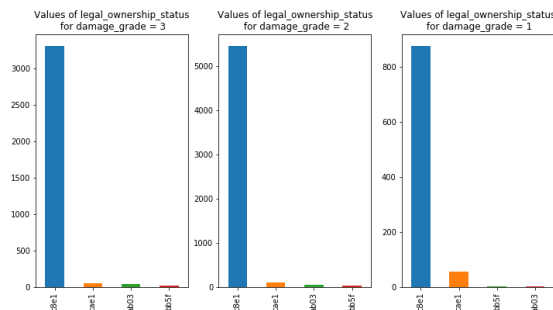
- Most of the damage was done where the legal\_ownership\_status was c8e1

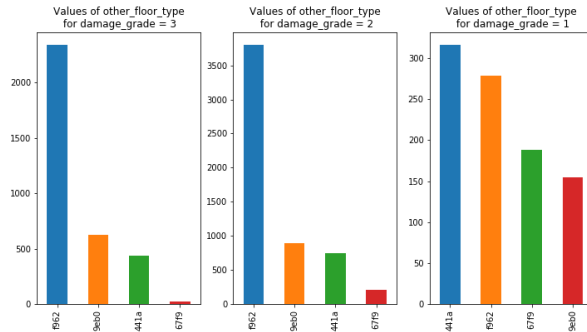
- Most of the damage was done where the other\_floor\_type was f962

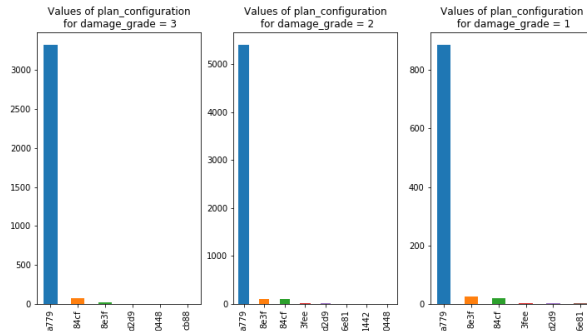
- Most of the damage was done where the plan\_configuration was a779

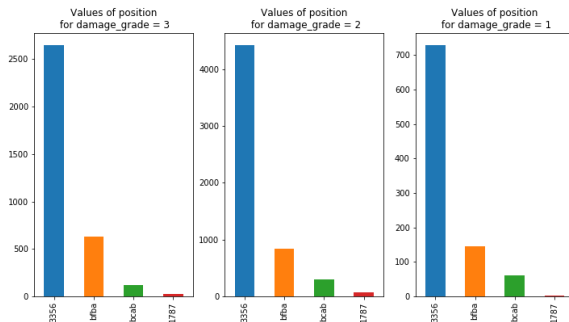
- Most of the damage was done where the position was 3356

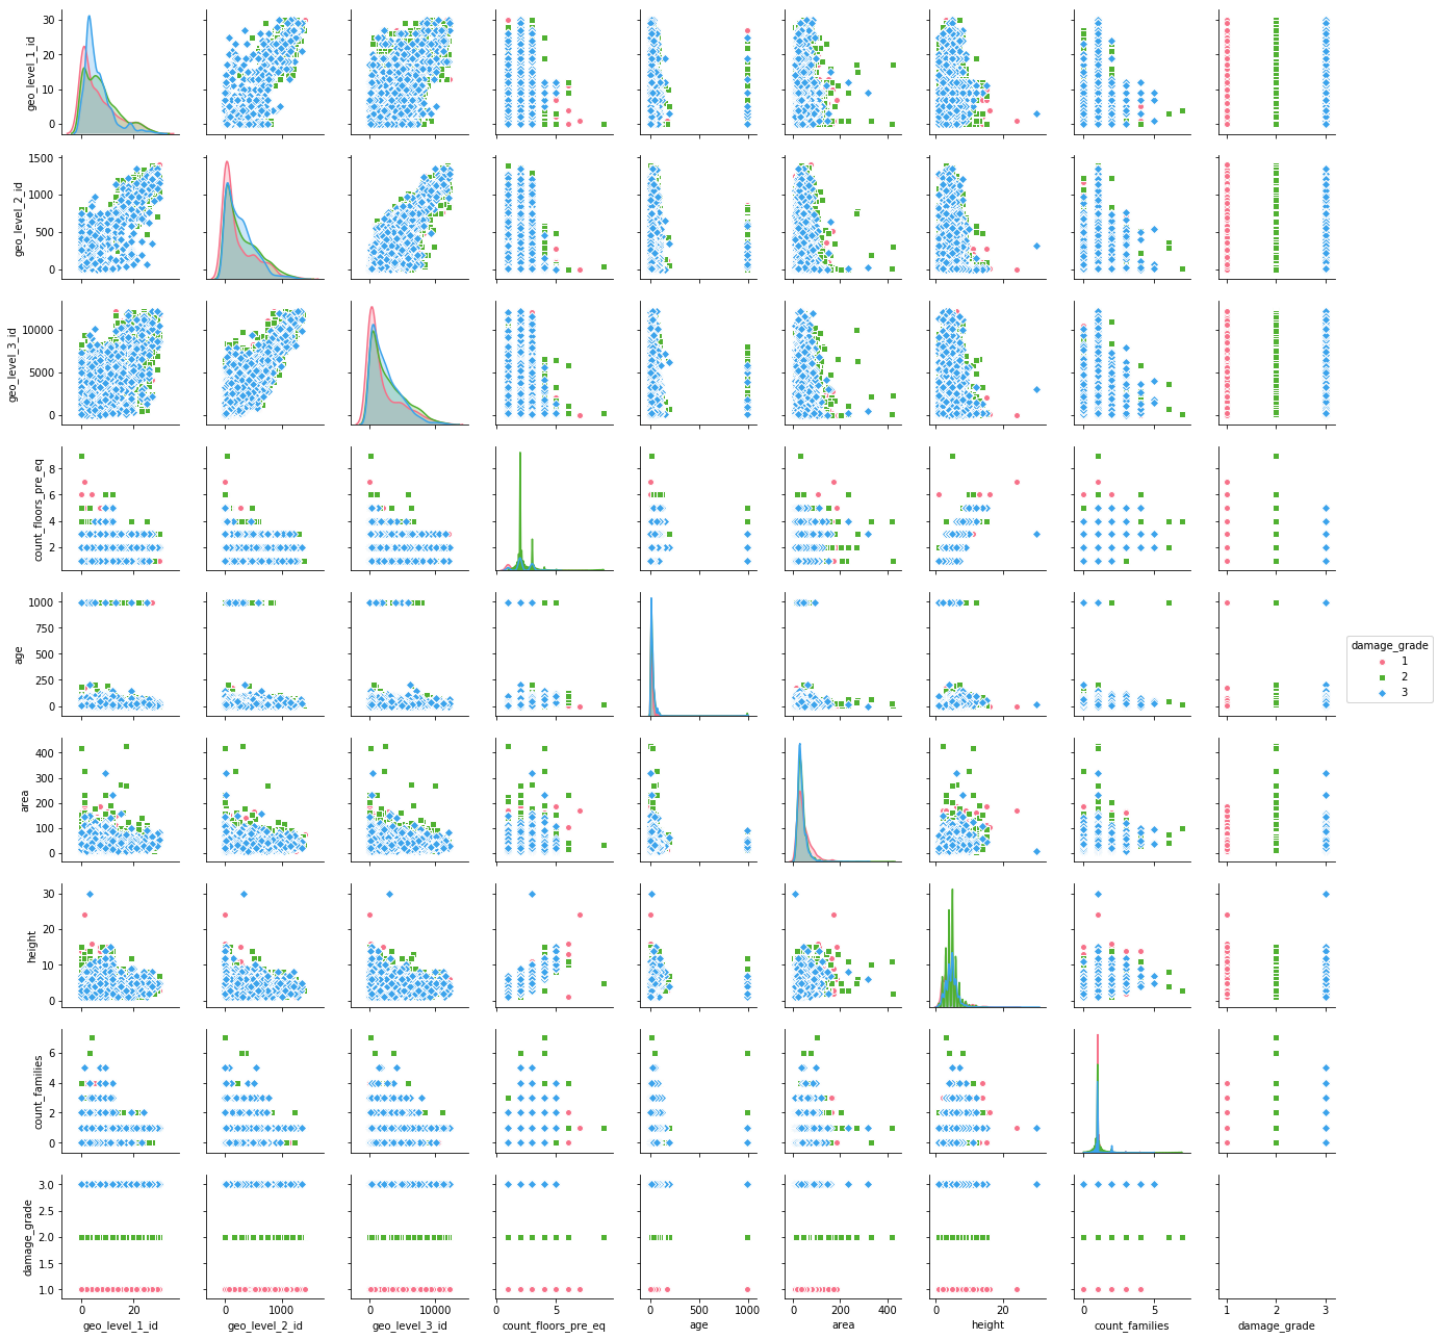
The following scatter-plot matrix was generated initially to compare numeric features with one another. The key features in this matrix are shown here:

- There was a positive relation between geo\_level\_2\_id and geo\_level\_3\_id
- There was a positive relation between count\_floors\_pre\_eq and height

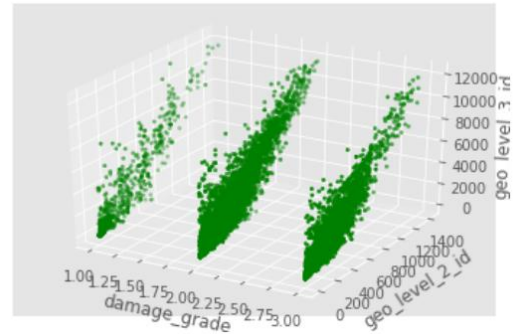
3d plots were also created to show relationship between various features. From these plots, it can be seen that damage was mostly done to buildings with small area and newer buildings. It was also observed that most of the damage was done to regions with lower geo level ids
