Contaminated Corn Detection and Removal System

Eric Almeida | Nathan Klassen | Marek Niewiadomski | Tiffany Montoya

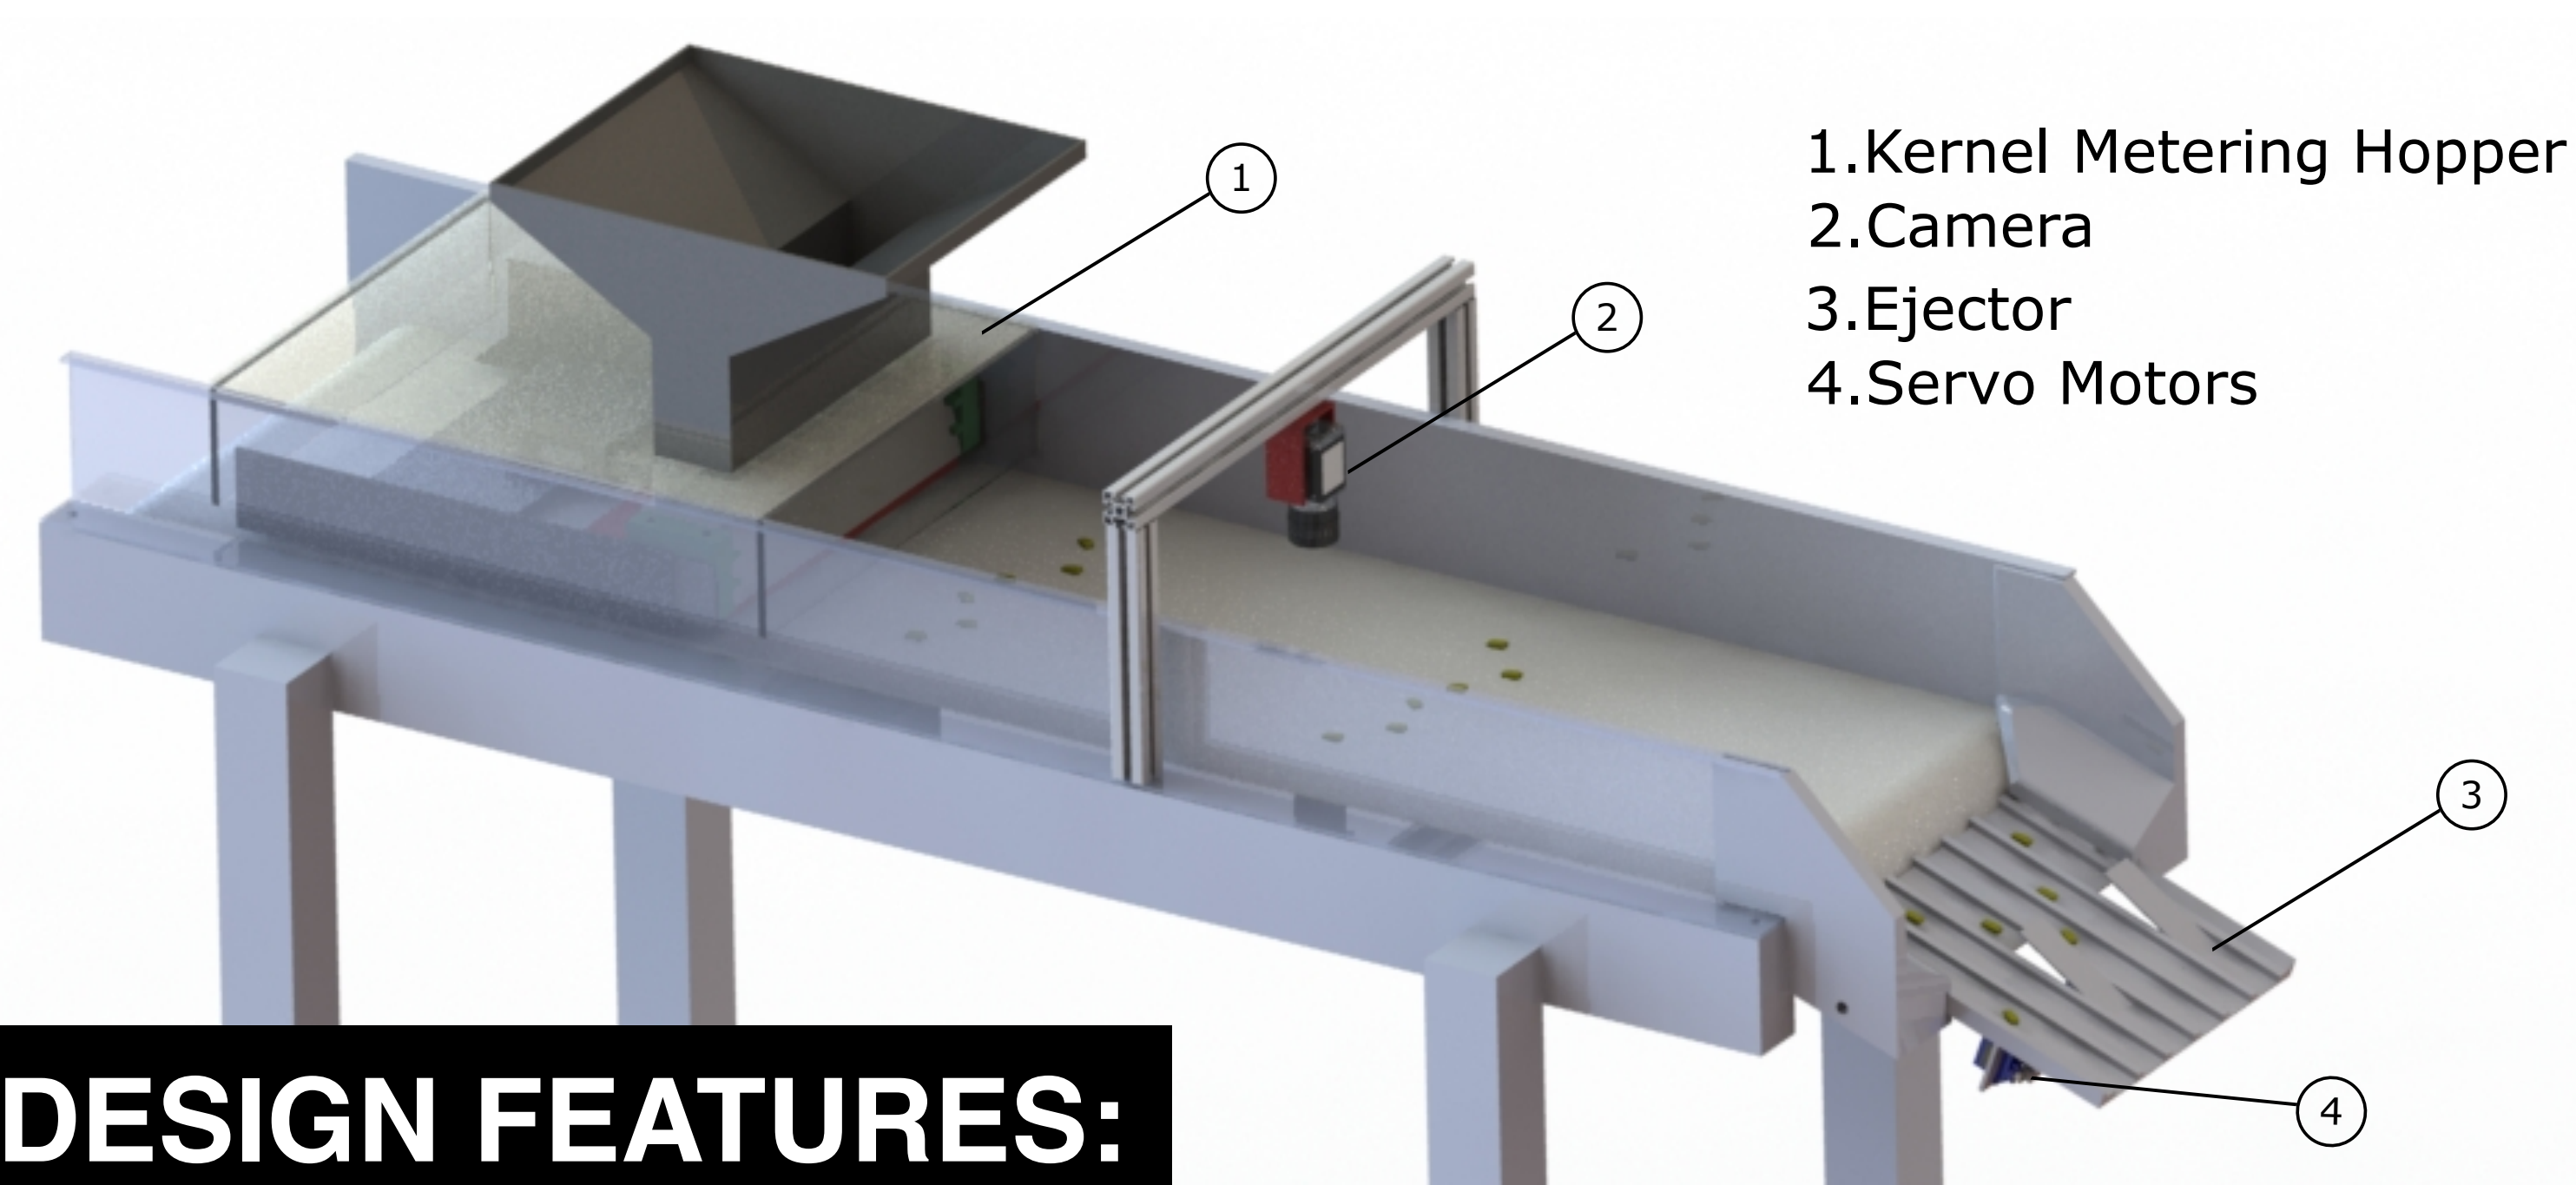
- Precise machine vision tools and software used for identification of DON infected kernels.
- Custom fixtures designed to position and sort kernels using gravity.
- Identification and removal accuracy > 95%.
- Scalable prototype that can be used in industry.

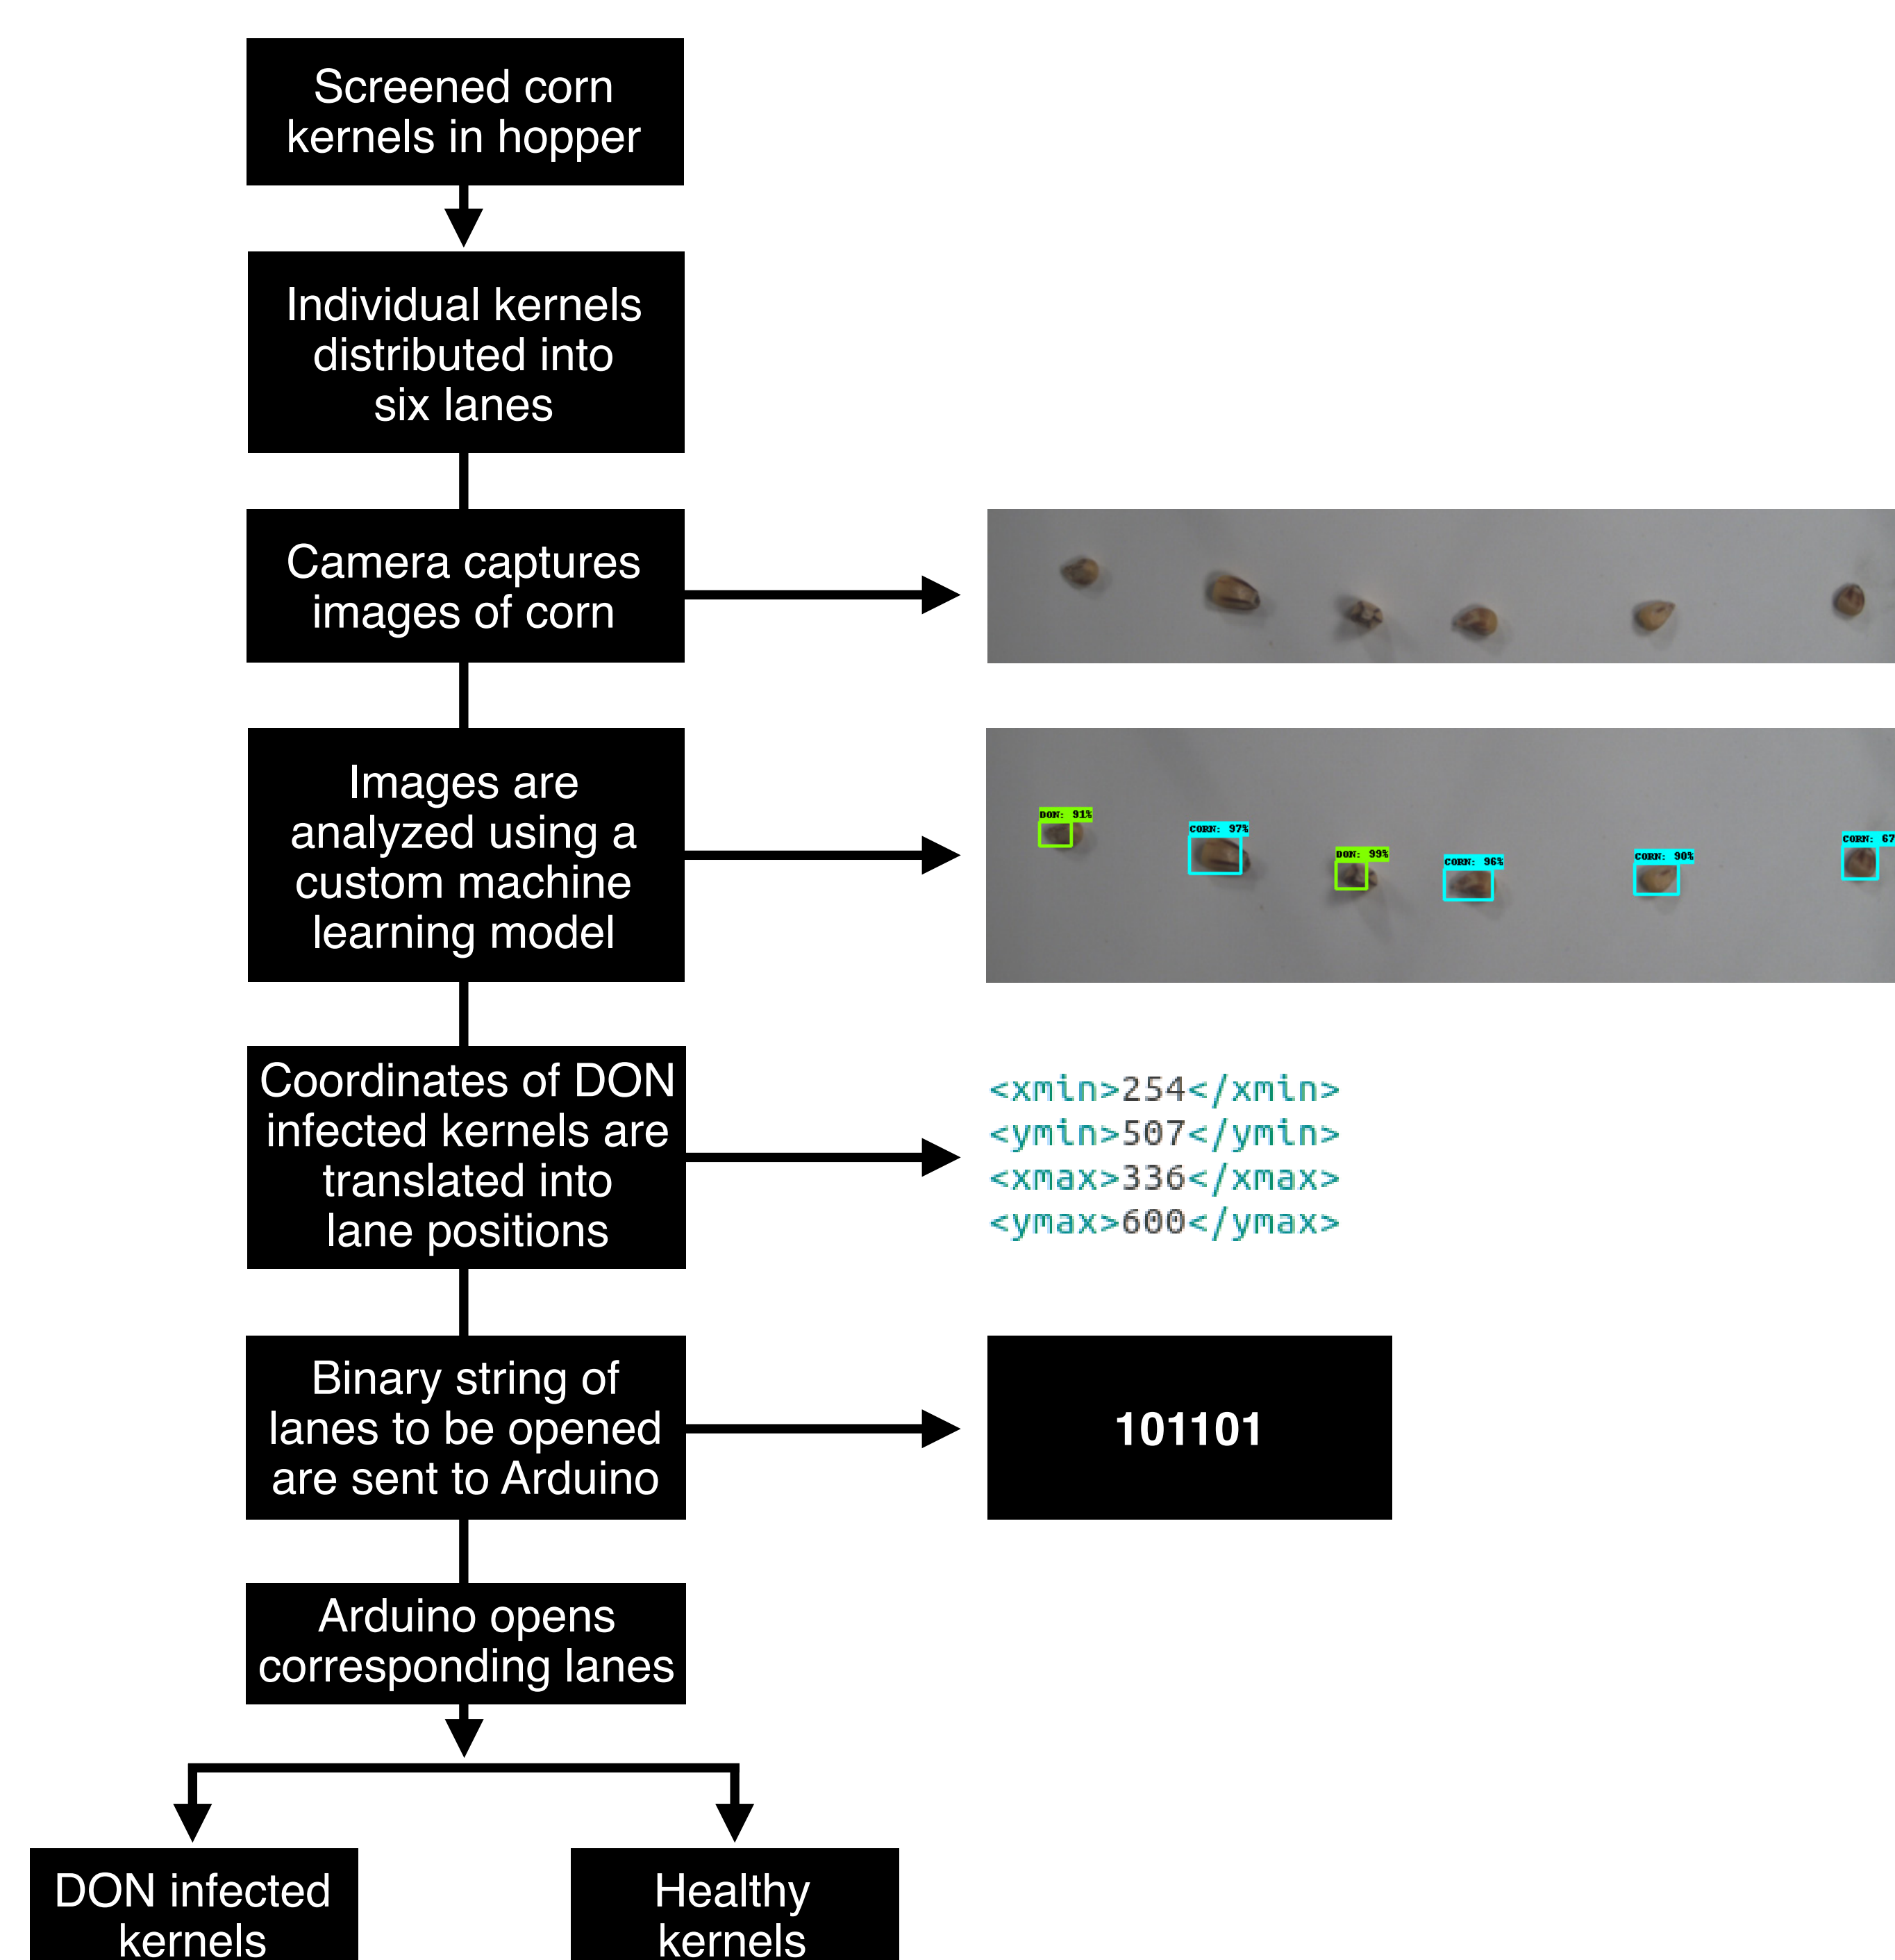
Mechanical: Kernel metering hopper and ejector mechanism 3D printed using biodegradable and food safe filament known as Polylactic Acid (PLA).

Electrical: System requires six servo motors, one linear actuator controlled by Arduino Mega 2560 & DFK 33UX178 high resolution camera mounted flawlessly to an industrial food-grade conveyor belt.

Software: Predominantly written in Python, it analyzes camera images and identifies lanes corresponding to infected kernels. The Arduino receives lane information from the Python program opening the ejector gates using a servo motor.
