**2022 DRY WEATHER FLOW SOURCE INVESTIGATION
REPORT**

**Submitted to:
City of Encinitas
Public Works Department
160 Calle Magdalena
Encinitas, CA 92024**

**Submitted by:
WSP USA
San Diego, California**

November 2023

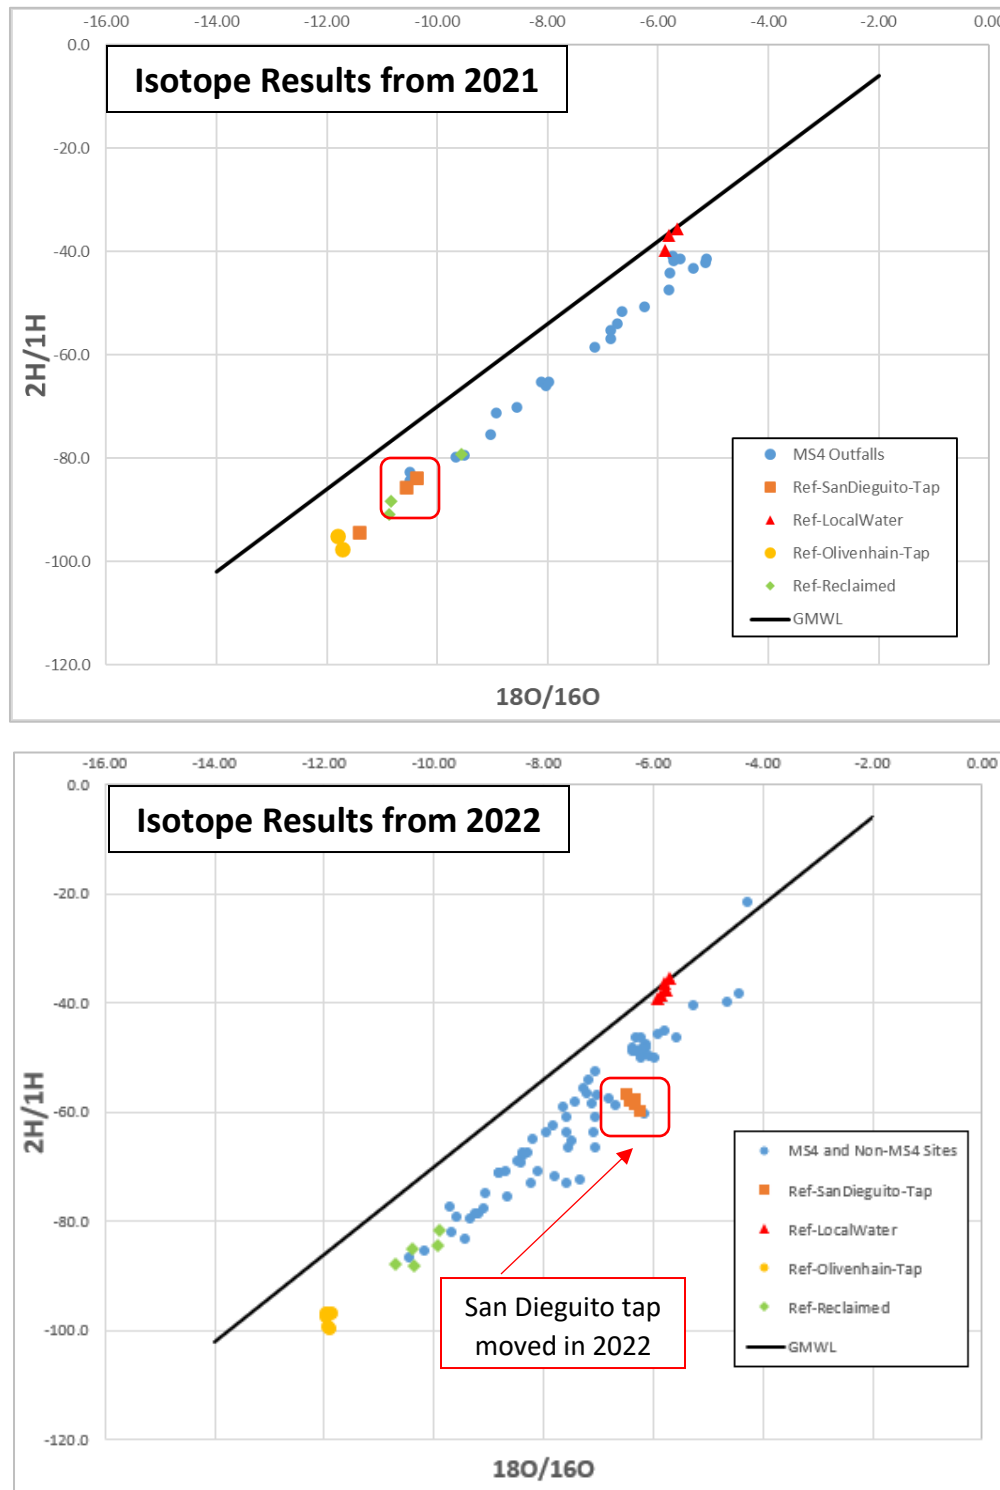
Figure 3-3. Isotope Mixing Diagrams for 2021-22 Monitoring Years. Ref-LocalWater samples showed good end-member separation from both Olivenhain and San Dieguito tap reference (circled in red) and Reclaimed reference in 2021 (TOP). However, in 2022, the San Dieguito Tap reference end member (circled in red) moved to the top right (BOTTOM).

In 2022 the San Dieguito Water District changed to more local water supply, which is isotopically similar to local groundwater and shows a high amount of evaporation in the isotopic signature. This complicates the use of IEMMA for outfalls receiving runoff from San Dieguito tap sources since the local groundwater and tap water are isotopically similar (both in the upper right quadrant of the mixing diagram) and different from Olivenhain Water District tap water (lower left quadrant of mixing diagram). While this makes it more difficult to distinguish between San Dieguito tap water and local groundwater, it did allow for the separation between tap and reclaimed water end members, if local groundwater could be ruled out as a potential source. For outfalls receiving a mix of tap water from both Olivenhain and San Dieguito water district, and/or reclaimed water, no assessment could be made from isotope data because all end members were not adequately separated.

In 2021 isotopic end members for both Olivenhain and San Dieguito tap water references and reclaimed water reference clustered near each other on the isotope mixing diagram (lower left quadrant). In that case the tap water and reclaimed water end members could not be separated, and so were analyzed as a single “anthropogenic” source distinguishable from local groundwater. All three sources were analyzed as a single source and used to calculate the %TAP results. Geochemistry data collected in 2021 was used to determine if reclaimed water was present at outfalls but the results were not conclusive due to the confounding presence of wash water in the MS4 (high boron, high MBAS) and inconclusive results from Piper diagram analysis. In 2022, however, the San Dieguito tap and reclaimed water end members were separated and could be analyzed for %TAP vs %RECLAIMED if local water could be excluded as a potential source.

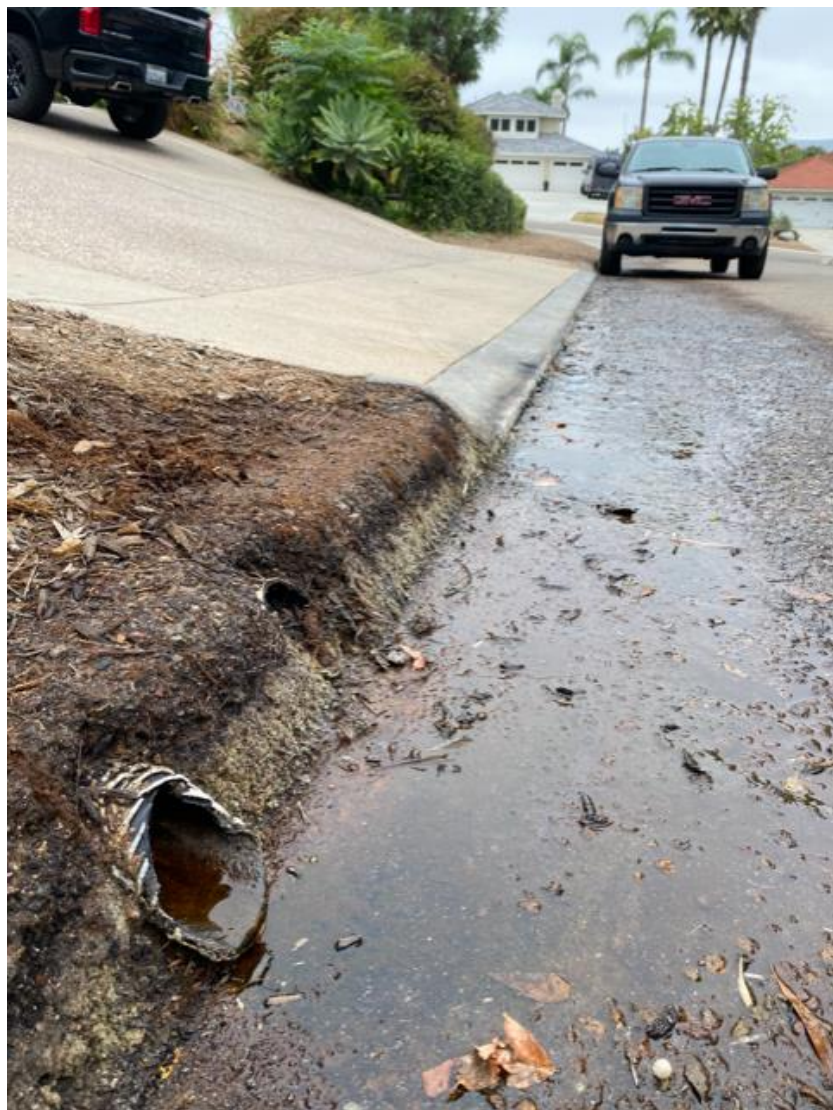
Figure 3-4 . 776 Corinia St. Water flowed from french drain in curb. This site was added later; only one site visit was made.

776 Corinia St was added at the end of the monitoring period so only one sample was collected on 10/6/2022. This site lies entirely in the Olivenhain Water District, and it was assumed no reclaimed water is in the drainage area. There is nearby reclaimed water use to the west on Glen Arbor Dr., but it's assumed this does not reach the sampling site via curb flow on Mountain Vista Dr. Flow <0.5gpm was discharged from the property through a small French drain. %TAP was 20% suggesting this is mainly local groundwater seeping out, with a small amount of tap water likely due to irrigation tap water infiltrating through the ground.

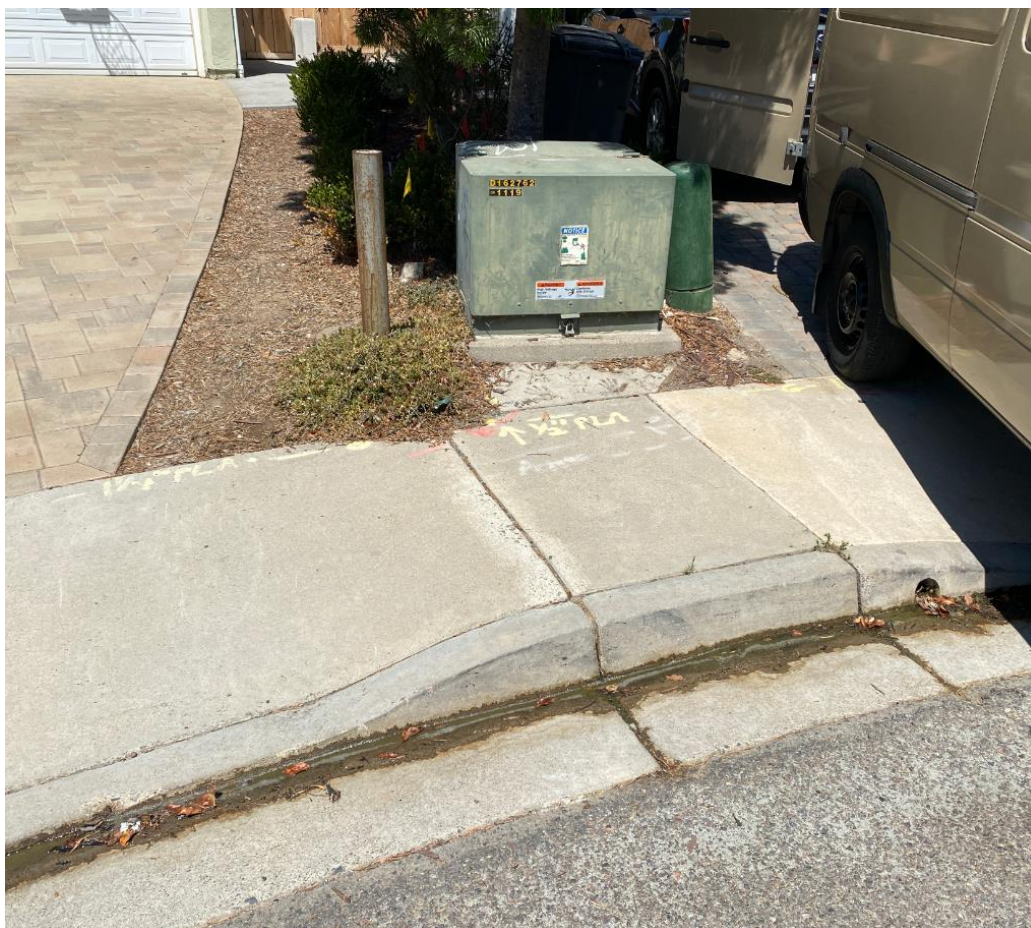
Figure 3-5 . Dunsmore Ct. Several french drains had trickle flows or ponded water in the curb. One french drain at 460 Dunsmore Ct had intermitten higher flows (1-5gpm).

Dunsmore Ct is an intermittent discharge from a French drain at 460 Dunsmore Ct. During one site visit this site was dry and no sample could be collected. Two samples were collected during flowing water (<0.5 gpm), and two were collected during ponded water (four total samples). The two ponded samples showed clear isotope signature of evaporation and were corrected to calculate the %TAP. Results showed %TAP varied from 85% in August to 49% in October with a clear seasonal trend towards more local water.

At Dunsmore Ct and Raphael Ct the French drains discharging to the curb were assumed to be groundwater seeping from the hillside behind the homes, but the %TAP results were over 50% indicating a significant amount of tap water may be contributed by irrigation in the uphill areas. The flows at these two sites were also intermittent with several observed discharges > 5 gpm which indicates an anthropogenic source. The City could recommend to the homeowners that this water is better used for irrigation on their properties and reroute this nuisance flow.

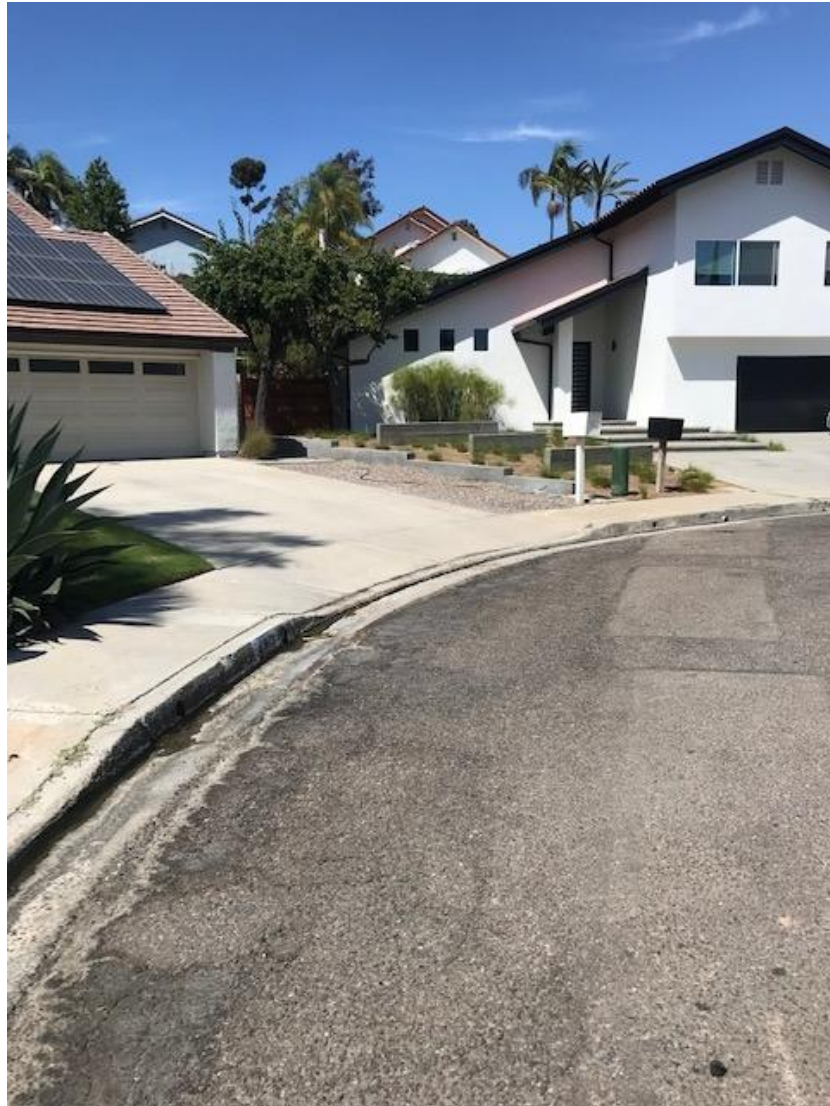
Figure 3-6 . Raphael Ct. Intermittent periods of high flow were observed but most sampes were taken in ponded water remaining in curb.

Raphael Ct is a discharge from a series of French drains from several homes at 426 – 443 Raphael Ct. A landscaper at the site suggested that the observed higher flows (5-10gpm) are likely due to a sump pump at 442 Raphael Ct that accumulates over-irrigation from the homes on Tzena Way. The final site visit on 10/3/2022 was dry, so four samples were collected. Three were collected when the flow was approximately 0.5-1 gpm, and one sample was collected on 9/20/2022 during a higher flow of 5-10 gpm. %TAP results varied from 75% in August to 44% at the end of September. Similar to Dunsmore Ct nearby, there was a clear seasonal trend toward more local water later in the monitoring period.

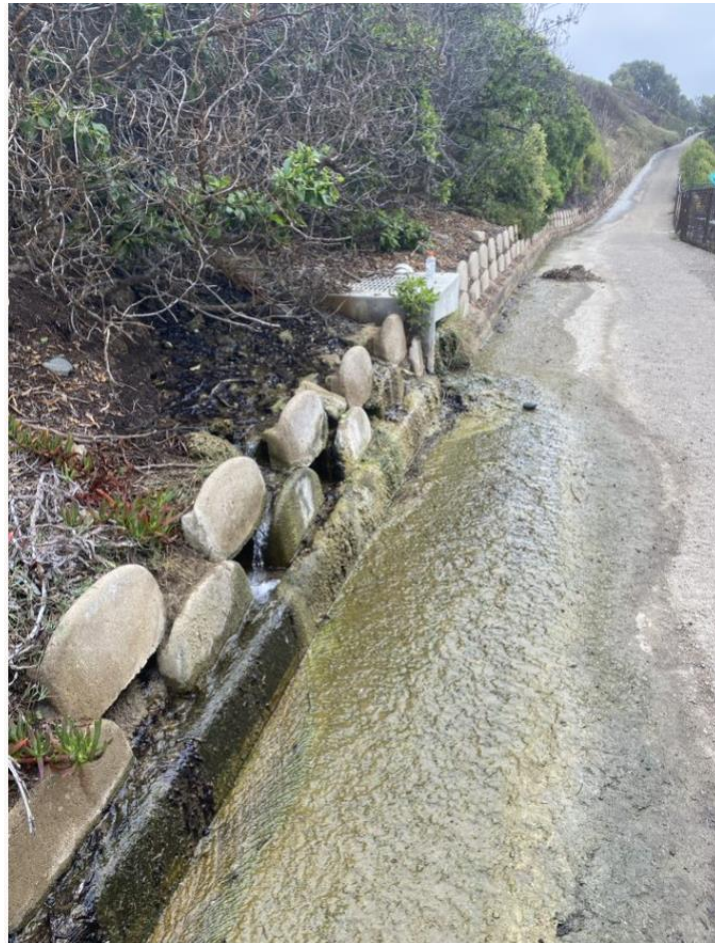
Pipes Ramp is not near reclaimed water or MS4 infrastructure (on the GIS layer) but there are some drainage pipes immediately upstream of the sampling point conducting approximately 5-8 gpm during the monitoring period. On the hillside is a junction box joining several pipes in a non-standard configuration. One pipe was an approximately 4-inch diameter cast iron pipe inside of a larger corrugated metal pipe. Another clay pipe appeared to be approximately 3 inch diameter.

While these could be French drains it wasn't clear what they would be draining from or where they originated. The pipes accounted for the majority of the flow but there were many seeps evident in the hillside. The isotope results indicated a mix of San Dieguito tap water and local groundwater. %TAP varied from 43-57%, with an average of 52% and STD of 5%. These results suggest there is some consistently flowing tap source mixed with groundwater seeping out of the hillside. Further investigation of the potable water infrastructure in this area should be conducted to determine the source of the San Dieguito tap water flowing to this site.

Figure 3-7 . Pipes Ramp. Water flows from pipes further up the hillside to this concrete structure and from seeps in the hillside along the length of the pedestrian path.

The isotope results for Pipes Ramp were also remarkably similar to 163SWOUTL. Since both sites are near each other it may be possible that the unknown pipes on the hillside are somehow connected to the MS4 or the same flow source as 163SWOUTL. Further reconnaissance would be needed to make that determination.

The isotope results for Pipes Ramp and 163SWOUTL were remarkably similar. Further investigation into the junction of pipes on the hillslope above would be needed to determine the potential source of water but these results suggest it may be an unmapped storm drain or leaking potable water source.

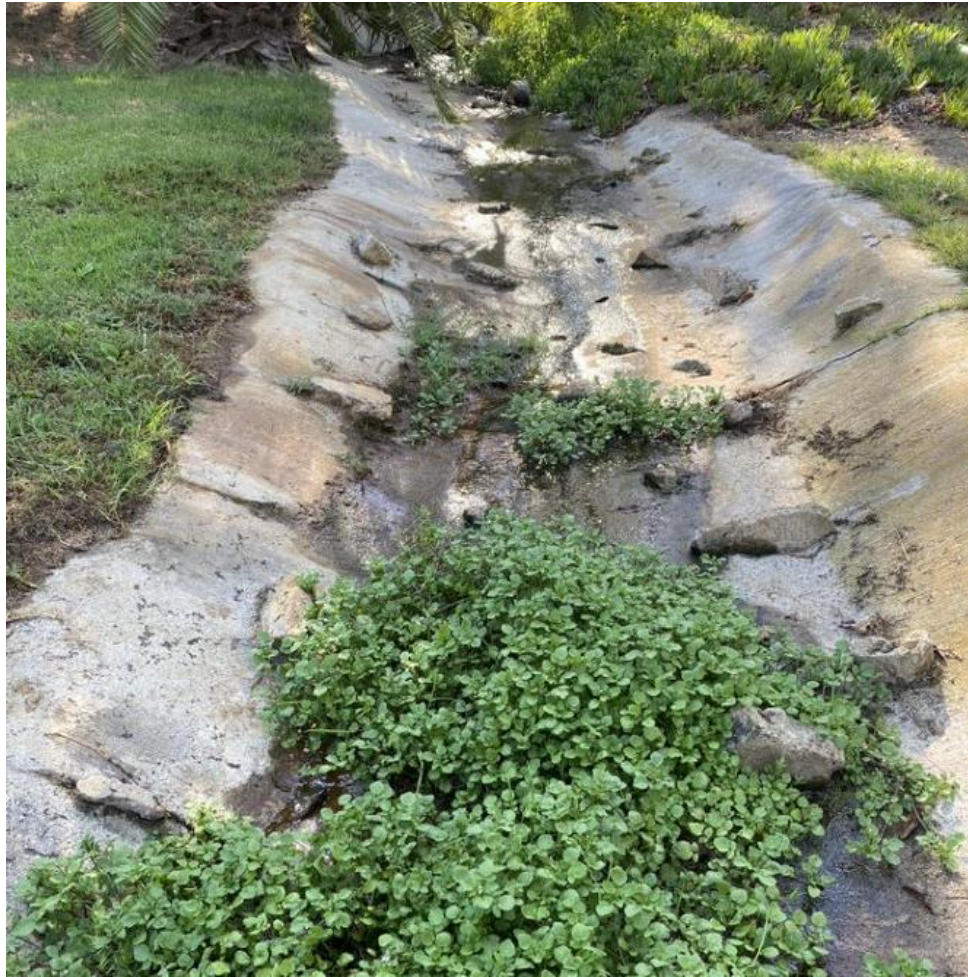
Figure 3-9 . Woodgrove HOA. This small concrete channel had numerous cracks with water seeping up from the below. Intermittent periods of flow from upstream were observed during sampling.

A small seep in the channelized drainage downstream of an MS4 outfall in the Woodgrove HOA was sampled five times. Some flow may be intermittently emitted from the MS4 outfall but during sample visits it was not observed. The small trickle flow from cracks in the channel was consistent throughout the monitoring period. No reclaimed water infrastructure is present in the watershed and isotope results appeared to be a mix of San Dieguito tap and local groundwater, with a high amount of evaporation consistent with the open concrete channel sampling location. %TAP varied from 27-53% with an average of 39% and STD of 9%.

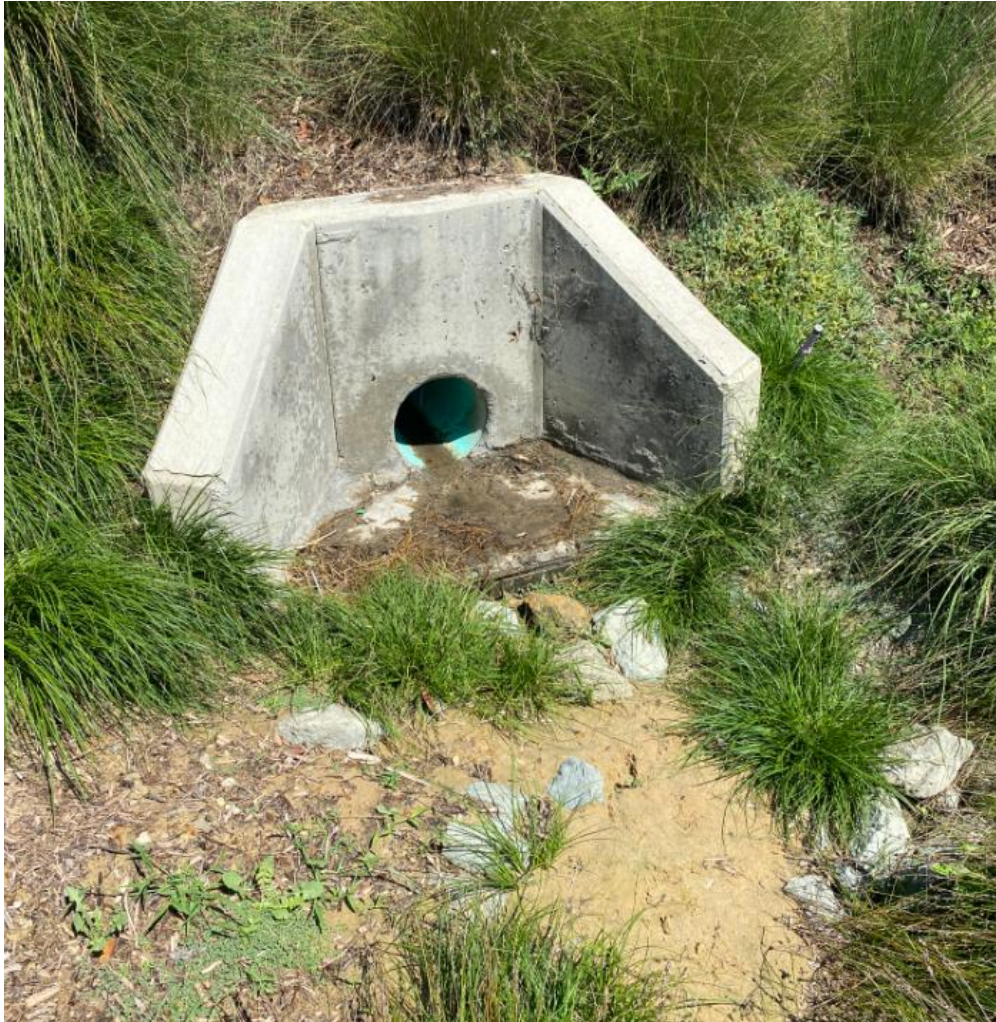
Figure 3-10 . Blue Crest. An 8 inch pipe enters a retention basin adjacent the neighborhood. Intermittent flow was observed.

A drainage pipe entering the retention basin on the southwest corner of Blue Crest neighborhood was visited 5 times for sampling. During two site visits the conveyance was dry, and isotope results for one sample were outside the mixing diagram, above local water likely due to excessive evaporation. Isotope results from two samples indicate a mix of reclaimed (23%) and SDG tap (average 77%). There is reclaimed water at this property so the results are plausible but an investigation into how reclaimed water is entering the conveyance is recommended.

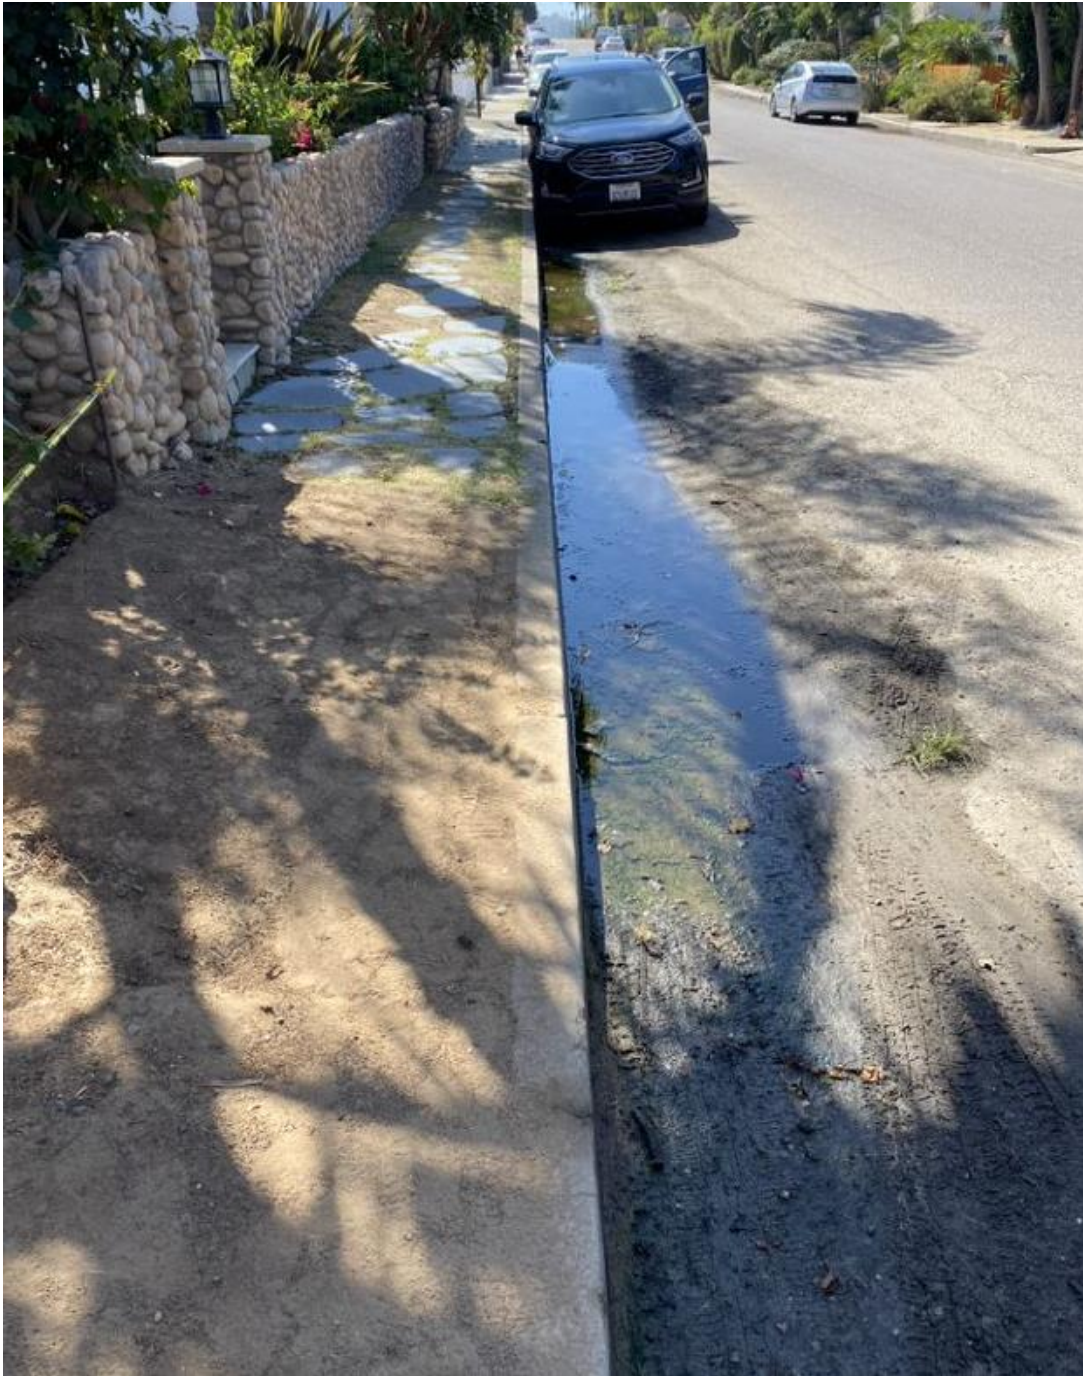
**Figure 3-11 . 2313 Manchester. Water seeped out of a french drain and curb joints.
Ponding persisted until late September, then was dry.**

Results for 2313 Manchester were difficult to interpret. The sample collected on 8/4/2022 appears to be 100% tap, and then off of the mixing line towards the 2021 San Dieguito end member on 8/23/2022, then somewhere between those two in September samples. This site dried up by 10/3/2022 sampling visit. The %TAP results for this site do not seem reliable and are not reported.

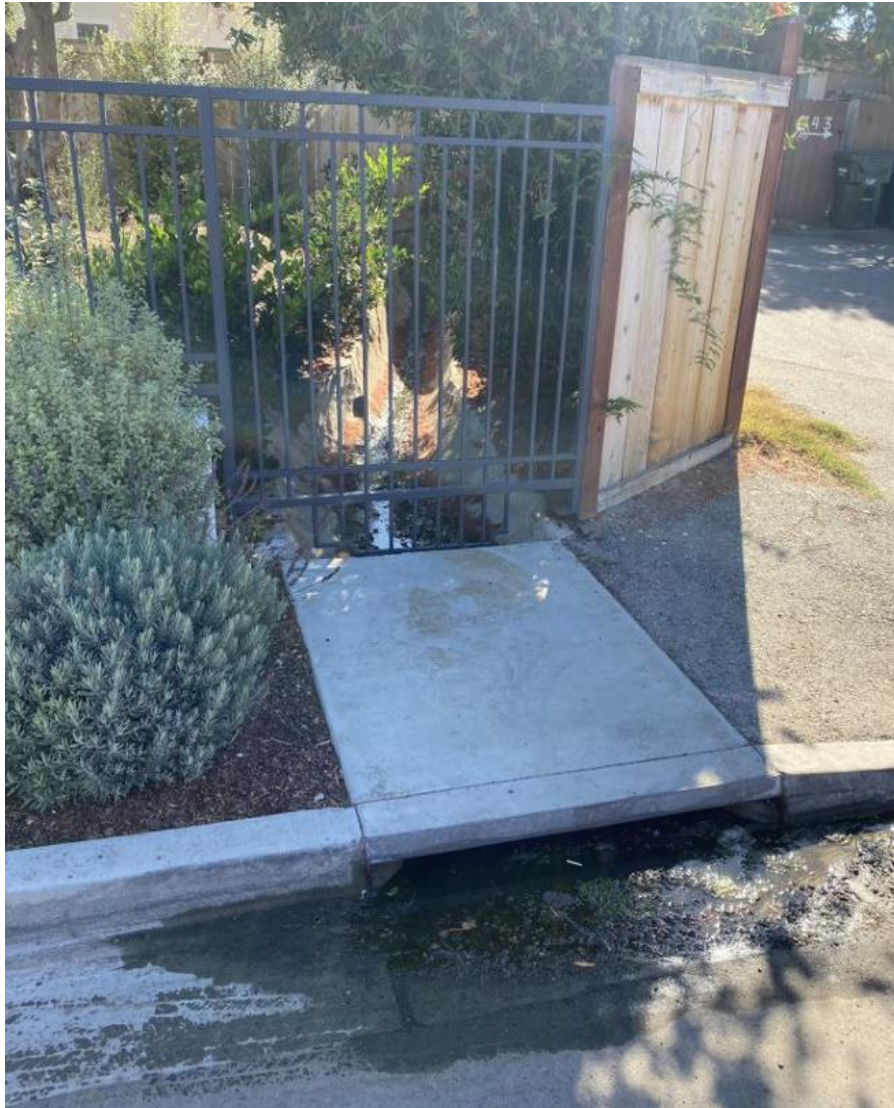
Figure 3-12 . Bracero Rd. A small concrete drainage channel runs between several houses, discharging onto Bracero Rd.

Bracero Rd isotope results appear to be a mix of reclaimed and SDG tap but there is no plausible source of reclaimed water draining to the sampling site. Local groundwater may also be a source, but the shift in end member for San Dieguito tap confounds the possibility of quantifying groundwater contributions. There are reclaimed water pipes both uphill and downhill from the site but none nearby or in the assumed contributing watershed area. A possible explanation is that the 2021 San Dieguito isotope end member was very similar to the reclaimed water end member and stored or slowly flowing 2021 San Dieguito tap water may be contributing to the water present at the Bracero Rd. sampling site, shifting the sample results towards the reclaimed end member and making it appear as though reclaimed water is present. However, no temporal trend towards the 2022 San Dieguito tap end member consistent with this changing source was evident and the amount of flow was similar throughout sampling. Further field reconnaissance would be helpful for this site to assess where water is entering the channel. %TAP varied from 0-41% and

%RECLAIMED varied from 58-100%, but results for this site are too uncertain to make any strong conclusions or recommendations other than to investigate further for sources of reclaimed water.

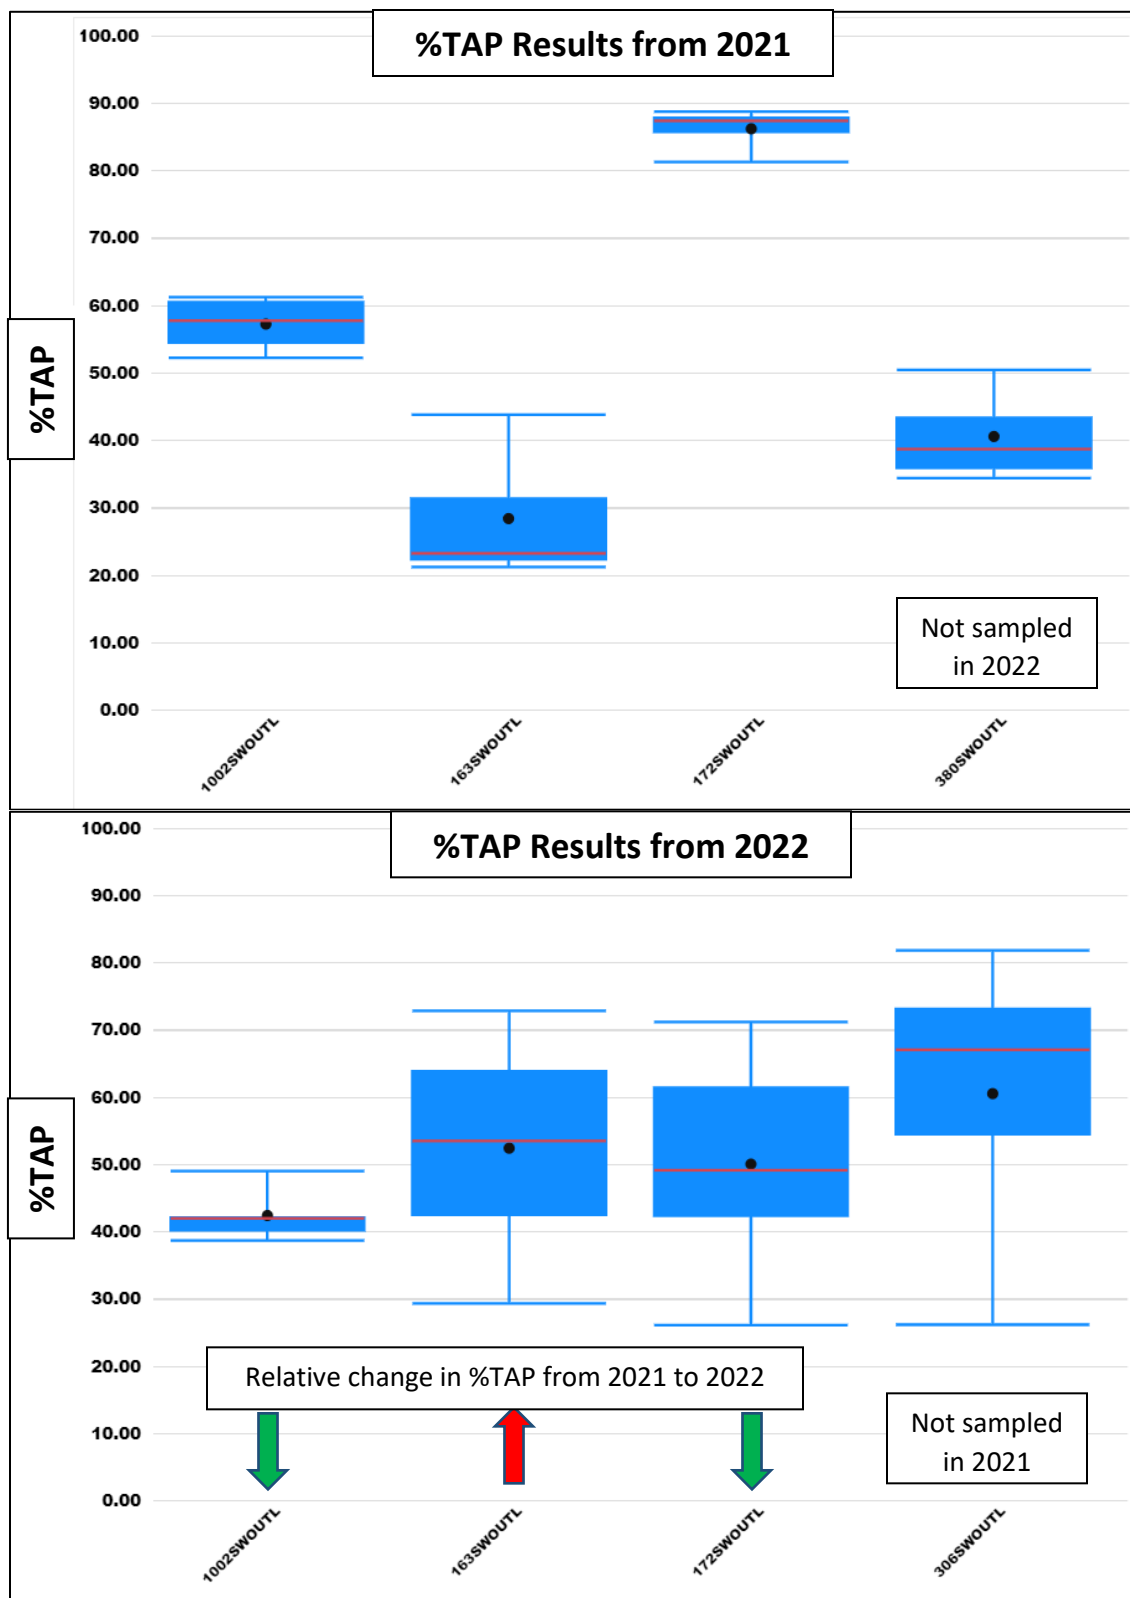
Drainage areas for 1002SWOUTL and 172SWOUTL are mainly served by Olivenhain water district but also include some areas served by San Dieguito Water District. %TAP at 1002SWOUTL and 172SWOUTL was lower in 2022 but this may be due to the influence of San Dieguito tap reference resembling local water and skewing the %TAP lower. 380SWOUTL received water from all four reference waters and no assessment could be made. At 306SWOUTL flow monitoring showed there was no baseflow and therefore no local groundwater, so an assessment could be made of %TAP vs %RECLAIMED. All isotope sampling results from 2022 are considered less certain than in 2021 but since all MS4 sites showed mostly similar patterns and magnitudes of flow in both years and isotope results were generally similar to last year (some mix of tap and groundwater), flow sources at these MS4 sites are assumed to be relatively unchanged from 2021 to 2022.

Figure 3-13. Plot of Isotope Analysis %TAP results for MS4 sites in 2021 (TOP) and 2022 (BOTTOM)
