Pipeline Intrusion Detections System for Guangdong Natural Gas Pipeline

CASE STUDY

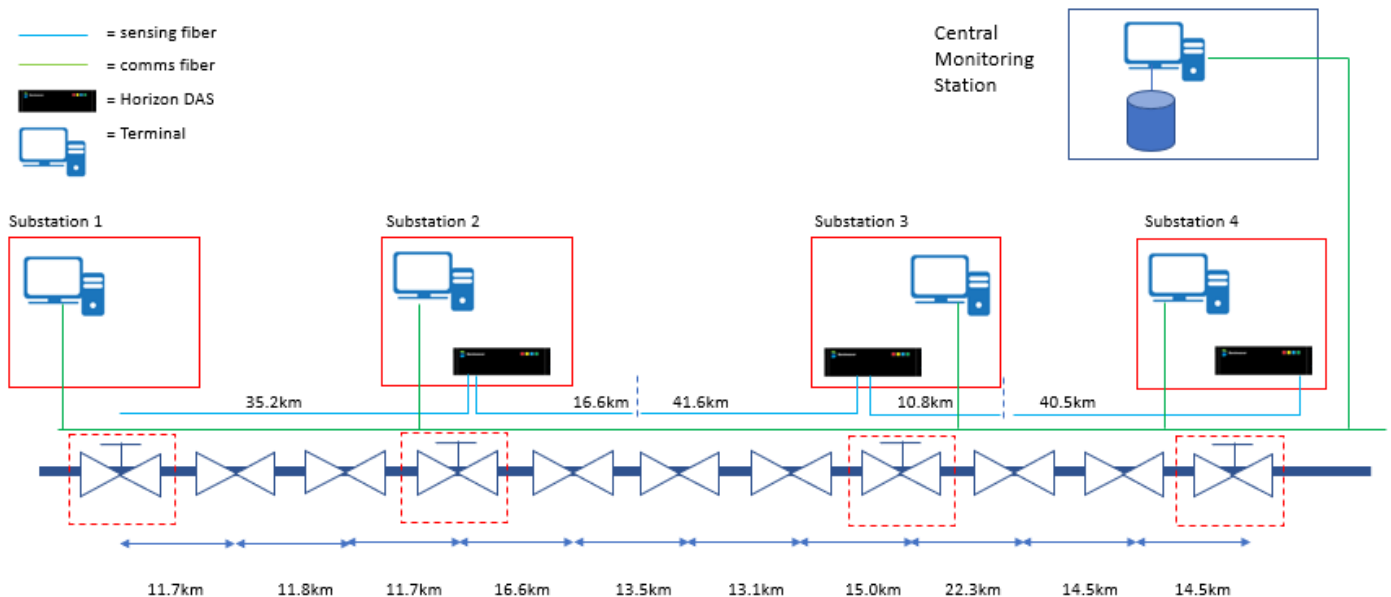
Figure 2- Overview of System Architecture

Kifta supplied multiple Horizon Distributed Acoustic Sensing (DAS) systems, plus Kifta's Maxview integration software to comprise the Pipeline Intrusion Detection System. These Horizon DAS units utilised one of the spare optical fiber cores within the existing telecoms fiber optic cable. These units were located at block valve stations along the pipeline route as detailed in the diagram below.

Two of the systems were configured in double ended configuration, and the third system in single ended mode.

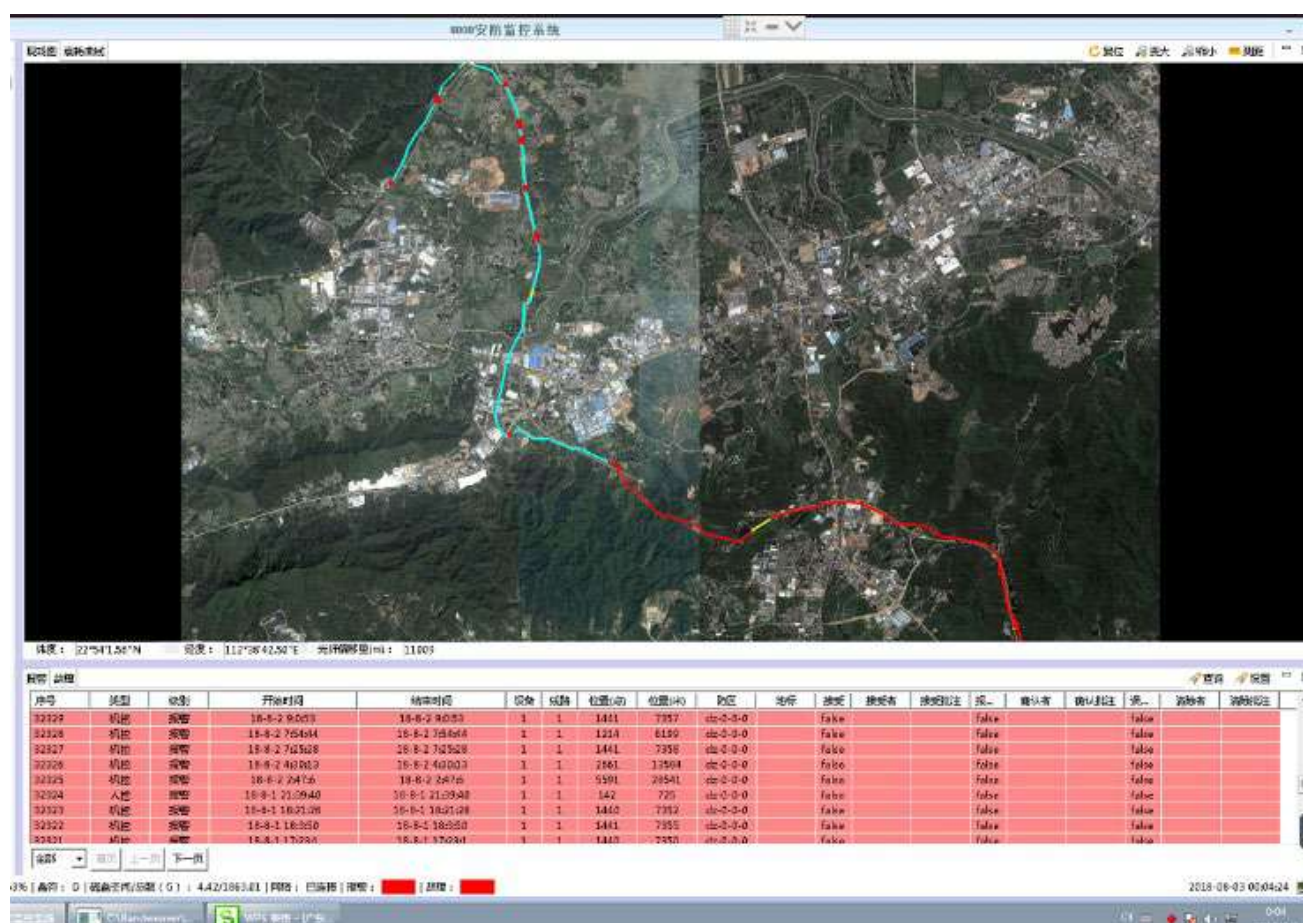
Figure 4 - Screenshot of map software

At the installation phase, the key tasks included reviewing the Optical Time Domain Reflectometry (OTDR) traces supplied by the telecoms integrator. These traces were then used to plan the system design and placement. Once the system locations are finalised, then the equipment is installed in each of the respective control rooms. Each system is then configured by the engineer with a preliminary configuration of the detection algorithms and maps within the software.

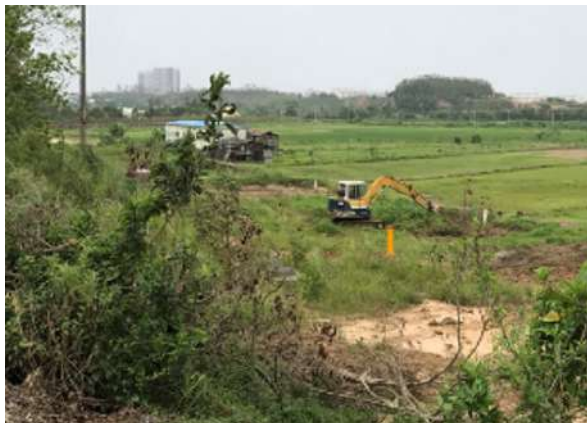
Figure 6 - Photos taken by patrol on site post alarm

In one specific case, there was mechanical excavation activity directly above the pipeline. The excavator dug to a depth of 0.3m and damaged one of the control cables above the pipeline. The Horizon DAS alarmed and the patrol was deployed to the site before the machinery proceeded to the level of the pipeline (at a depth of 1.5m) and catastrophic damage was narrowly avoided.

Photo of excavator near pipeline

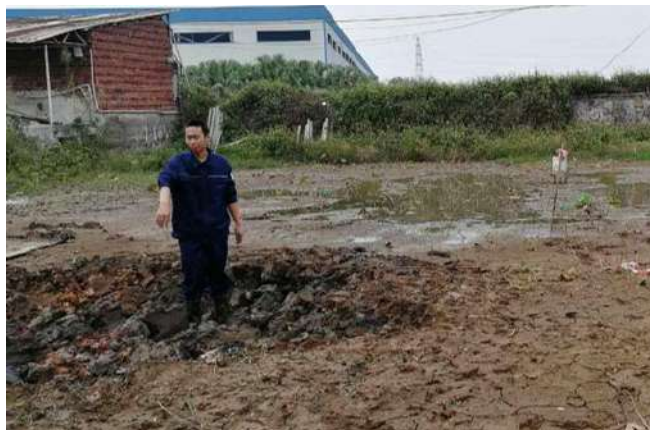
Photo of damage directly above pipeline
