# dacl10k: Benchmark for Semantic Bridge Damage Segmentation

## Abstract

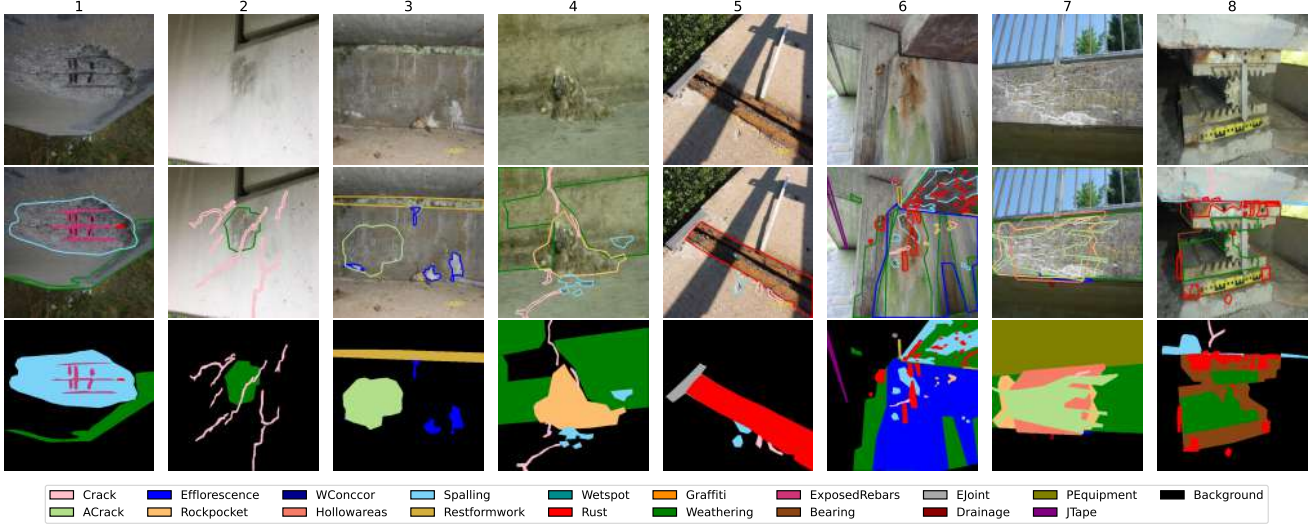
Figure 1. Example annotations from dacl10k. Top row: original image. Middle row: polygonal annotations. Bottom row: stacked masks. The following classes are abbreviated: *Alligator Crack* (ACrack), *Washouts/Concrete corrosion* (WConccor), *Expansion Joint* (EJoint), *Protective Equipment* (PEquipment) and *Joint Tape* (JTape). From left to right, the images display the individual classes: 1. *Weathering, Spalling, Exposed Rebars, Rust*; 2. *Weathering, Crack*; 3. *Alligator Crack, Restformwork, Efflorescence*; 4. *Weathering, Crack, Spalling, Rockpocket*; 5. *Crack, Rust, Expansion Joint, Spalling*; 6. *Weathering, Rockpocket, Spalling, Efflorescence, Crack, Rust, Restformwork, Joint Tape*; 7. *Weathering, Protective Equipment, Rockpocket, Efflorescence, Crack, Hollowareas, Alligator Crack, Drainage*; 8. *Weathering, Spalling, Crack, Rust, Bearing*.

According to the definition of Cordts *et al.* [12] our dataset comprises coarse pixel-level annotations. We border each defect and object on a given image with one polygon (shape) and assign its label. Furthermore, we include polygons of the same class that overlap with each other in one shape. With respect to inspection standards and application, for all the defect classes, it is not important to differentiate between instances of a given class. Instead, their size and localization on a class-basis is important. Thereby, we utilize the open-source labeling tool LabelMe [34, 41]. Example annotations are shown in Figure 1. It often appears that shapes of different damage or object classes overlap with each other, e.g., *Spalling* with *Exposed Rebars* covered by *Rust* (see example 1 in Figure 1). Consequently, the under-

The two main components during labeling are the class guideline and the annotation guideline. The class guideline clearly defines the visual appearance, most commonly occurrence and cause of each defect, *e.g.*, *Efflorescences* (see example 7 in Figure 1):

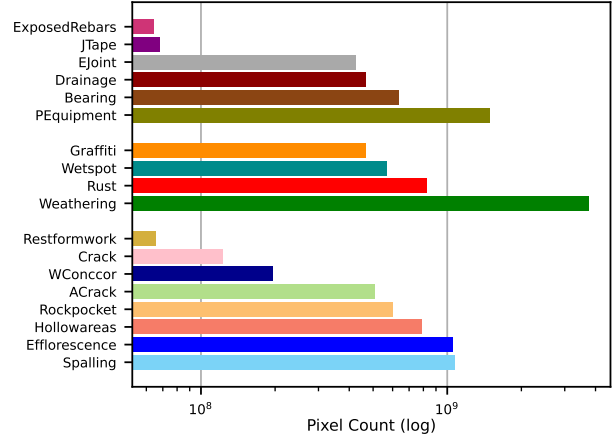
Figure 2. Pixel counts with respect to each class in dacl10k based on the original image sizes. The bars are arranged according to the group affiliation.

Regarding the pixel counts over the whole dataset (see Figure 2), it can be stated that *Weathering*, followed by *Protective Equipment*, are the most dominant classes with nearly four and 1.5 billion pixels. Within the range of 0.1 billion and 1 billion pixels, the majority of defects and objects with respect to the number of pixels can be found. Clearly underrepresented are the defects *Restformwork* (66 million) and the objects *Joint Tape* (68 million) and *Exposed Rebars* (65 million).

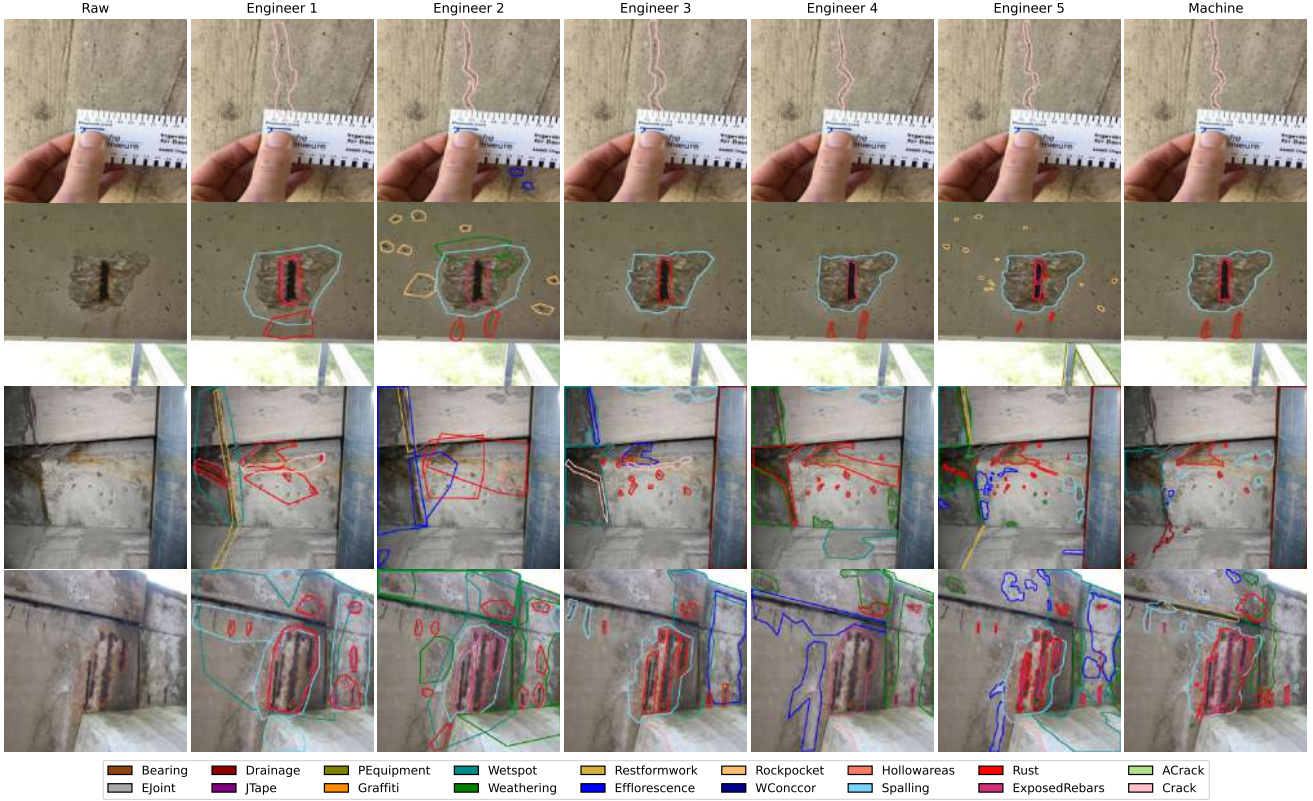
Figure 3. Qualitative evaluation of the best model on four samples (Raw) from the testdev split by comparing annotations of five civil engineers (Engineer 1-5) with the best model’s predictions (Machine). From top to bottom, the samples show: *Crack*; a few tiny cavities which are considered as *Rockpockets* and *Spalling*, *Exposed Rebars*, *Rust*; *Wetspot*, *Weathering*, *Efflorescence*, *Crack*, *Spalling*, *Exposed Rebars* and *Rust*; *Wetspot*, *Weathering*, *Efflorescence*, *Restformwork*, *Drainage*, *Rust*, *Spalling*.

neers with the network’s predictions. Therefore, we asked the five experts, two of whom perform bridge inspections frequently, to annotate four representative samples drawn from dacl10k’s testdev split. Two samples are considered easy and the others difficult to evaluate because of their low resolution, diversity regarding the lighting condition, camera pose as well as defect types and objects. After an introduction to the class guideline, the experts were instructed to annotate the images with the same quality they would expect an application to highlight defects during a close-up or hands-on bridge inspection. Compared to other inspection types, hands-on inspections require the highest quality with respect to defect classification, measurement and localization, which also includes the detection of *Hollowareas* by hammering the concrete surface. Regarding the differences among engineers, it can be stated that with increasing complexity of the samples also the variance of the chosen labels rises. Engineer 5 annotated at the highest quality level. Thus, especially his annotation is used as a qualitative benchmark for our baselines prediction. For the first two samples, which contain fewer classes compared to the last two, the prediction of the machine is better than the average annotation of the five engineers. Only in the second image the small cavities that are part of the defect *Rockpocket* and the *Protective Equipment*, which is overexposed, are not recognized. The last two images reveal the limits of our baseline. For the third sample the classes *Wetspot*, *Rust*

and *Drainage* are well predicted, whereas, areas of *Efflorescence* and weak *Spallings* are not segmented. *Weathering* is not present at all in the model’s prediction. On the last image the model doesn’t predict the defects *Crack* at the center bottom and the *Wetspot* which is located mainly on the wall. Furthermore, the model classifies *Restformwork* which is not present on the image, while *Spalling* and *Exposed Rebars* are correctly recognized. The remaining classes are partially classified.

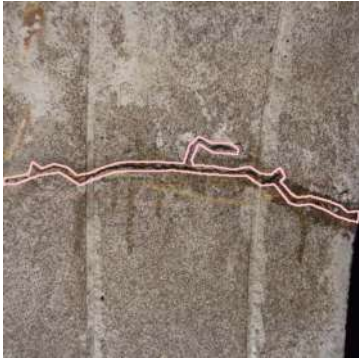
Damage	Visual appearance	Cause	Example
Crack	<ul style="list-style-type: none"> <li>Elongated and narrow zigzag line</li> <li>Clearly darker compared to the surrounding area or black</li> </ul>	<ul style="list-style-type: none"> <li>Concrete's tensile strength is exceeded</li> <li>Too high bending or shearing load</li> <li>Settlement of the substructure</li> </ul>

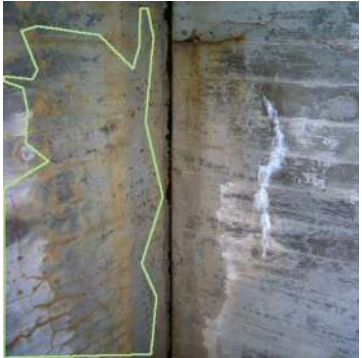
Alligator Crack (ACrack)	<ul style="list-style-type: none"> <li>Many branched cracks</li> <li>Mostly arbitrarily orientated</li> <li>Usually with a small crack width (compared to <i>Crack</i>)</li> </ul>	<ul style="list-style-type: none"> <li>Inadequate post-treatment or concrete recipe (shrinkage)</li> <li>Too high temperatures during hardening of the concrete</li> <li>Formation of expansive phases leading to a volume increase in the concrete as a result of chemical action</li> </ul>

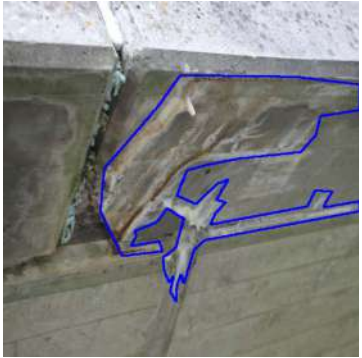
Efflorescence	<ul style="list-style-type: none"> <li>Mostly roundish areas of white to yellowish or reddish color</li> <li>Strong efflorescence can look similar to stalactites.</li> <li>Often appears in weathered (<i>Weathering</i>) or wet areas (<i>WetSpot</i>) of the building and in combination with <i>Crack</i> and/or <i>Rust</i></li> </ul>	<ul style="list-style-type: none"> <li>Dissolving of salts (calcium, sodium, potassium) from the cement stone or aggregate by humidity changes or water ingress, <i>e.g.</i> constantly running water through the building part or along its surface</li> <li>The salts consequently carbonate leading to the final visual appearance.</li> <li>Note: Water ingress can be caused by other defects imposing the draining of water, <i>e.g.</i>, <i>Restformwork</i> or damaged <i>Drainage</i>. <i>Efflorescences</i> are also called Calcium leaching.</li> </ul>

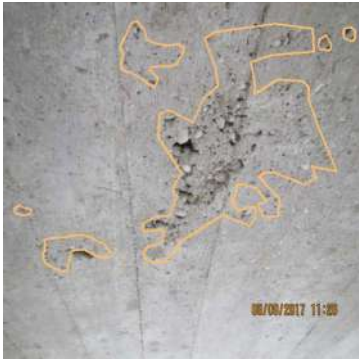
Damage	Visual appearance	Cause	Example
Rockpocket	<ul style="list-style-type: none"> <li>Visible coarse aggregate</li> <li>Often in tilts of the formwork and the bottom of building parts (opposite side from which the concrete is poured into the formwork)</li> </ul>	<ul style="list-style-type: none"> <li>Inadequate rheological properties (viscosity, yield point) of the concrete</li> <li>Appears due to bad compacting after having poured the concrete into the formwork. Therefore, insufficient deaeration of the concrete follows, causing areas where the cement paste didn't fill the volume between the coarse aggregate completely (<i>Rockpocket</i>).</li> <li>Note: Hence, the concrete cover of the reinforcement as well as the bond between the bars and the concrete is not provided or reduced. <i>Rockpockets</i> are also called Honeycombing.</li> </ul>

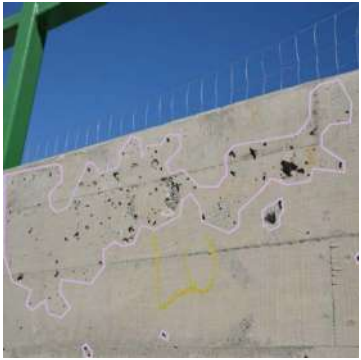
Cavity <sup>1</sup>	<ul style="list-style-type: none"> <li>Small air voids</li> <li>Mostly on vertical surfaces</li> </ul>	<ul style="list-style-type: none"> <li>Inadequate rheological properties (viscosity, yield point) of the concrete</li> <li>Appears due to bad compacting after having poured the concrete into the formwork. Therefore, insufficient deaeration of the concrete follows causing small "dots" on the surface.</li> <li>Note: At these spots the concrete cover is reduced. Cavities of usual size have no impact on the building assessment.</li> </ul>

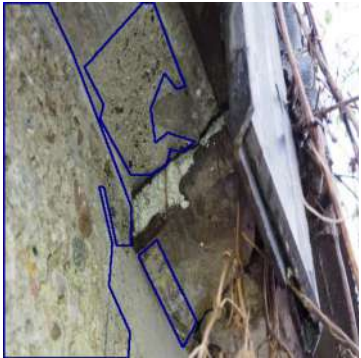
Concrete Corrosion (ConcreteC)	<ul style="list-style-type: none"> <li>Includes the visually similar defects: Washouts, Concrete corrosion and generally all kinds of planar corrosion/erosion/abrasion of concrete.</li> <li>Note: We summarize all these "planar corrosion defects" in this class because they are visually hard to differ. According to inspection standards they have to be subdivided which requires strong expertise in building defects.</li> </ul>	<ul style="list-style-type: none"> <li>Washouts appear on building parts that are constantly in contact with running water leading to the erosion of the concrete, e.g., abutment walls or bridge piers in rivers.</li> <li><i>Concrete corrosion</i> can appear as a result of frost-thaw cycles, loss in succession to chemical attacks or abrasion (mechanical or action of acid and salt solutions).</li> <li>Note: In dacl10k_v1 <i>Concrete Corrosion</i> (ConcreteC) was called "Washouts/Concrete corrosion" (WConccor).</li> </ul>

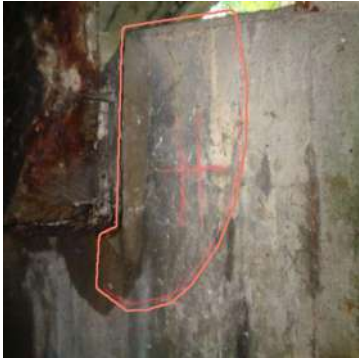
Damage	Visual appearance	Cause	Example
Hollowarea	<ul style="list-style-type: none"> <li><i>Hollowareas</i> are not visually recognizable but their markings made with crayons (mostly yellow, red or blue) during close-up/hands-on inspections.</li> <li>Note: The outer edge of the marking is considered as the boundary of the according area. We annotate every chalk marking that approximately forms a closed geometric figure. Single lines are not labeled as <i>Hollowarea</i> as they are often used for the marking of <i>Cracks</i>.</li> </ul>	<ul style="list-style-type: none"> <li>Corrosion of the subjacent reinforcement which leads to a volume increase surrounding the reinforcement bar and detaching of the concrete area that covers the bars.</li> <li><i>Hollowareas</i> are usually the preliminary stage of <i>Spallings</i> and <i>Exposed Rebars</i>.</li> <li>Note: Recognizing <i>Hollowareas</i> is very important as the falling concrete parts can cause severe damage. Therefore, hollow sounding areas are usually removed instantly.</li> </ul>

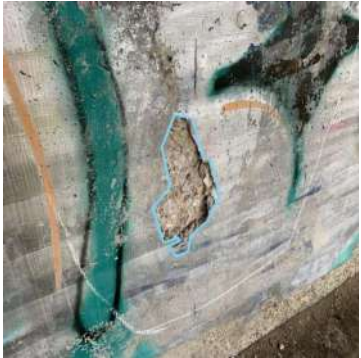
Spalling	<ul style="list-style-type: none"> <li>Spalled concrete area revealing the coarse aggregate</li> <li>Significantly rougher surface (texture) inside the <i>Spalling</i> than in the surrounding surface</li> </ul>	<ul style="list-style-type: none"> <li>Corrosion of the subjacent reinforcement leading to an increase in volume and consequent spalling of the concrete cover</li> <li>Frost-thaw cycles of intruded water (deeper than <i>Washouts/Concrete corrosion</i>)</li> <li>Impact from vehicles, damaging during assembly of the building part or removal of the formwork, manufacturing faults</li> </ul>

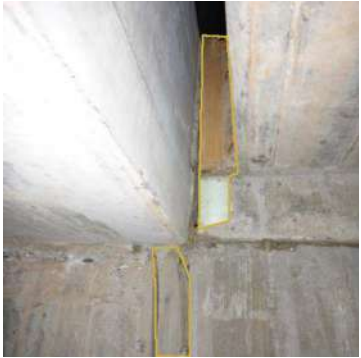
Restformwork	<ul style="list-style-type: none"> <li>Left pieces of formwork in joints or on the structure's surface</li> <li>Restformwork can be made of wood and polystyrene (PS).</li> <li>PS is often used as a placeholder in joints during concreting.</li> </ul>	<ul style="list-style-type: none"> <li>After the concrete hardening has ended, PS is often forgotten to be removed (e.g., in the joint between the abutment wall and the superstructure).</li> <li>Note: If <i>Restformwork</i> is not removed, water may be hindered to drain which can lead to other defects (e.g. <i>Spalling</i>, <i>Exposed Rebars</i>, <i>Rust</i>).</li> </ul>

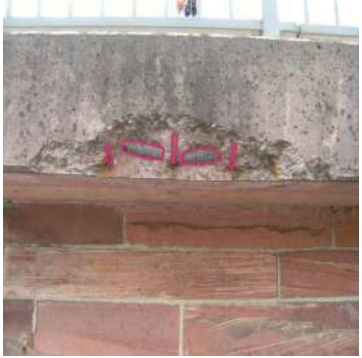
Object	Visual appearance	Functionality	Example
Exposed Re-bars	<ul style="list-style-type: none"> <li>Exposed Reinforcement (non-prestressed and prestressed) and cladding tubes of tendons</li> <li>Often appears in combination with <i>Spalling</i> or <i>Rockpocket</i>, and <i>Rust</i></li> </ul>	<ul style="list-style-type: none"> <li>In reinforced concrete structures, the reinforcement's task concerning the load transfer is to absorb the tensile forces.</li> <li><i>Exposed Rebars</i> occur due to insufficient concrete cover or corrosion and the consequent <i>Spalling</i> of the concrete cover.</li> <li>The reduction of the reinforcement's cross section due to <i>Rust</i> significantly influences the structural integrity of the according building.</li> </ul>

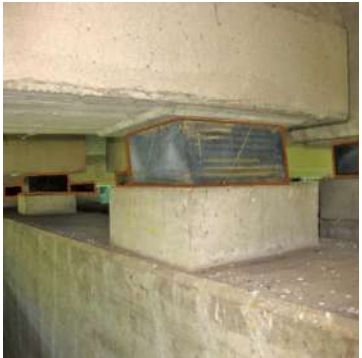
Bearing	<ul style="list-style-type: none"> <li>All kinds of bearings, such as rocker-, elastomer- or spherical-bearings</li> </ul>	<ul style="list-style-type: none"> <li>Bearings transfer the load from the superstructure to the substructure.</li> <li>Note: Bearings can show <i>Rust</i> and <i>Cracks</i> as well as deformation due to settlements in the abutments, overloading or creeping of the bridge. The deformation or damaging of bearings can result in load redistribution which is not considered in the structural design of the bridge.</li> </ul>

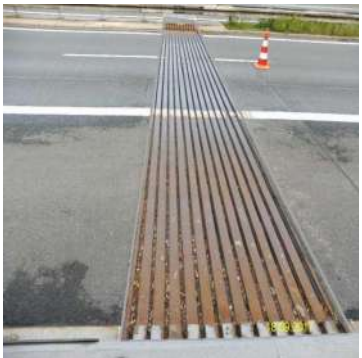
Expansion Joint (EJoint)	<ul style="list-style-type: none"> <li>Located at the beginning and end of the bridge</li> <li>Assembled cross to the longitudinal bridge axis</li> </ul>	<ul style="list-style-type: none"> <li><i>Expansion Joints</i> compensate the thermal longitudinal expansion of the bridge deck and superstructure.</li> <li>Note: Mostly, <i>Expansion Joints</i> are corroded (<i>Rust</i>) and weathered (<i>Weathering</i>) which hinders their ability to compensate the enlargements due to changes in temperature.</li> </ul>

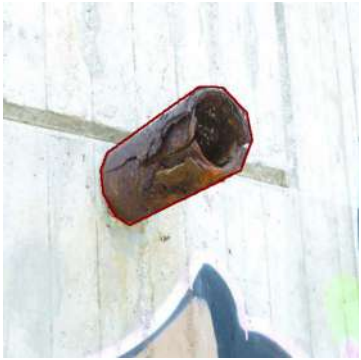
Object	Visual appearance	Functionality	Example
Drainage	<ul style="list-style-type: none"> <li>All kinds of pipes and outlets made of Polyvinylchlorid or metal mounted on the bridge.</li> </ul>	<ul style="list-style-type: none"> <li>The <i>Drainage</i> directs water (often contaminated with deicing salt) away from the bridge.</li> <li>The draining of water is important for the durability of the bridge. If the water can't drain properly, especially when it's contaminated with deicing salts, the bridge's deterioration is accelerated leading to defects, such as <i>Spalling</i>, <i>Exposed Rebars</i> or <i>Rust</i></li> </ul>

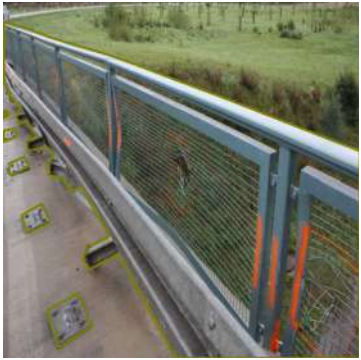
Protective Equipment (PEquipment)	<ul style="list-style-type: none"> <li>Railings, traffic safety features (e.g., steel rail, guide rails, impact attenuation device)</li> </ul>	<ul style="list-style-type: none"> <li>Geometric adequacy and structural capacity of the <i>Protective Equipment</i> is important with respect to the traffic safety.</li> <li>The rail types and installation heights and minimum clearances must be checked.</li> <li>Note: Mostly, they are corroded (<i>Rust</i>) or deformed due to vehicle impact.</li> </ul>

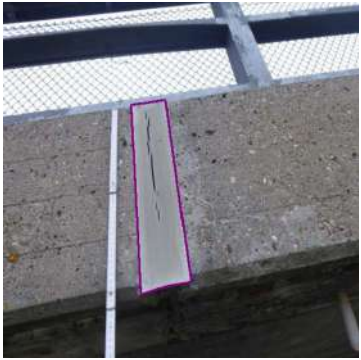
Joint Tape (JTape)	<ul style="list-style-type: none"> <li>All joints that are filled with elastomer or silicon</li> <li>Note: Originally, <i>Joint Tape</i> means an elastomer strap at the end and beginning of relatively small bridges.</li> </ul>	<ul style="list-style-type: none"> <li><i>Joint Tapes</i> compensate longitudinal enlargements due to changes in temperature (like <i>Expansion Joint</i>).</li> <li>Note: A <i>Joint Tape</i> is damaged when it's ruptured or twisted. <i>Joint Tape</i> is also called Bridge Seal.</li> </ul>

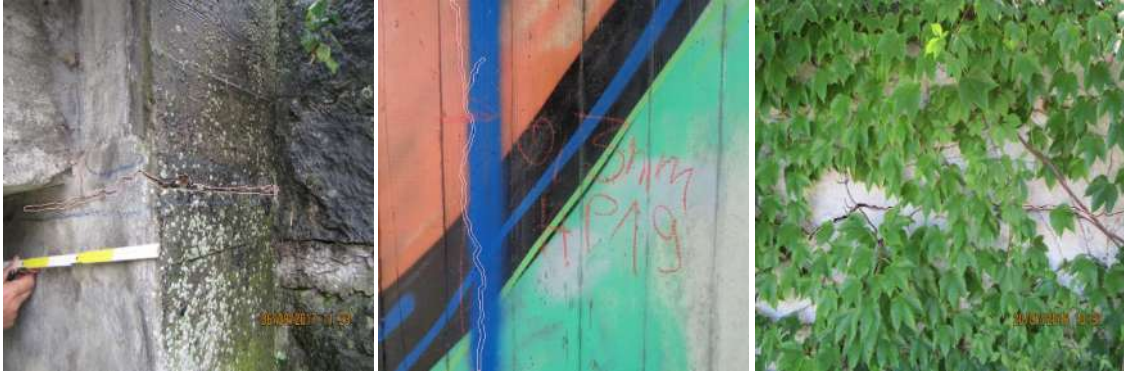
(a) Challenging samples showing a *Crack*: in combination with strong *Weathering*, in combination with *Graffiti* and partially overlapped by vegetation (*Weathering*).

Figure 4. Challenging defects. All subcaptions describe the images from left to right.

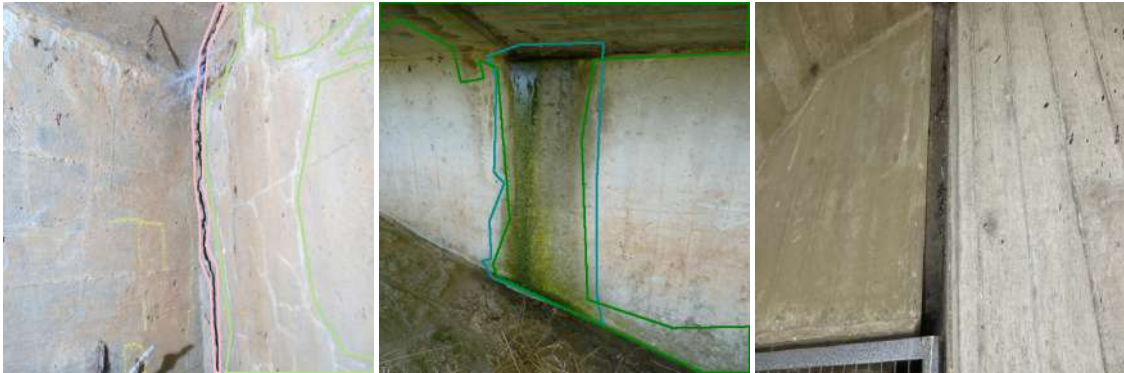
(b) *Crack* vs. *Alligator Crack*, *Weathering* vs. *Wet spot*, *Restformwork* covered with concrete slurry (no ground-truth annotation for better visibility).

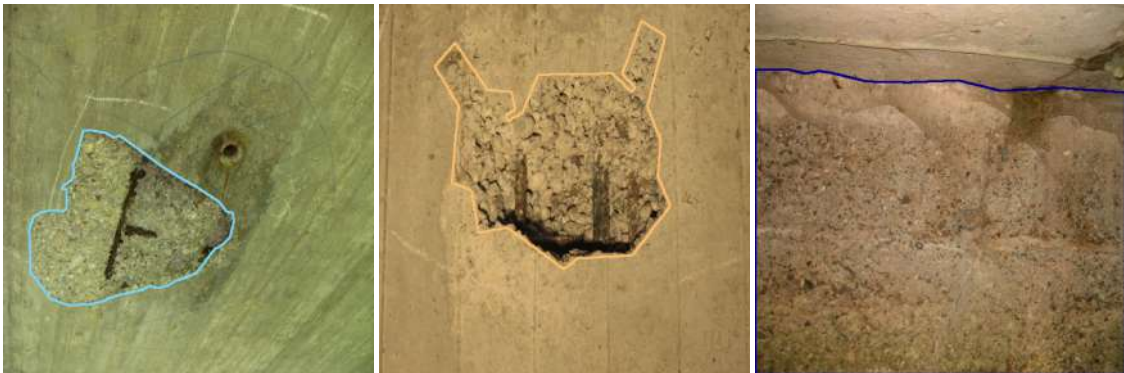
(c) *Spalling*, *Rockpocket*, *Washouts/Concrete corrosion*.

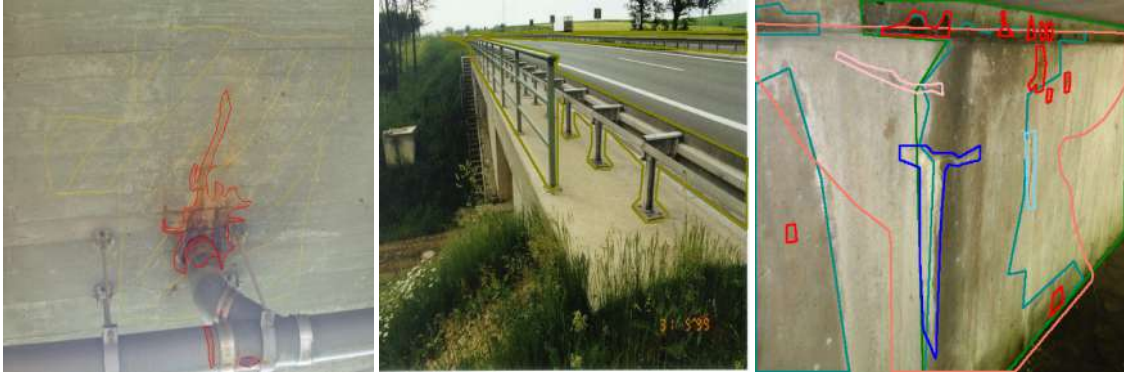
(a) No clear border of the defect (*Rust*), the class (*Protective Equipment*) is stretched from fore- to background. Many overlapping classes with partially low contrast like the border and hatching of the *Hollowarea* (pale red), and the *Efflorescence* (dark blue) next to the bright, dry and healthy concrete surface.

Figure 5. General problems across the dataset. All subcaptions describe the images from left to right.

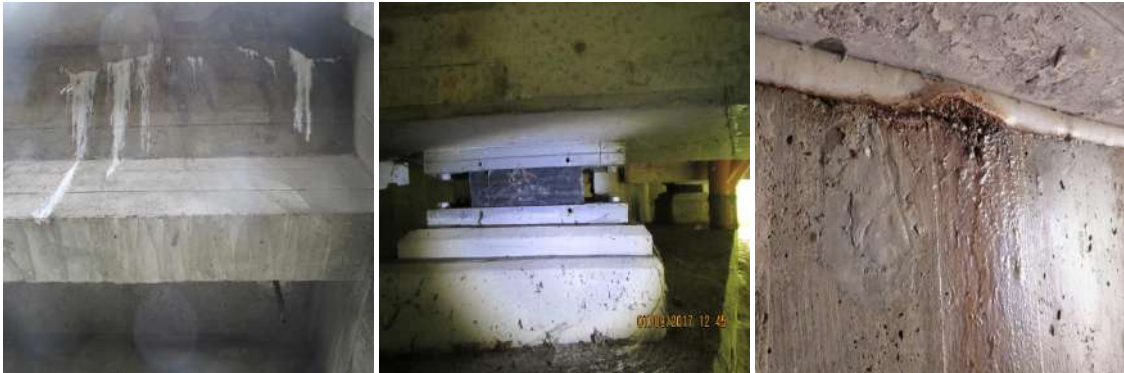
(b) Image quality problems: lens flares, partial overexposures due to flashlight, and sunlight.

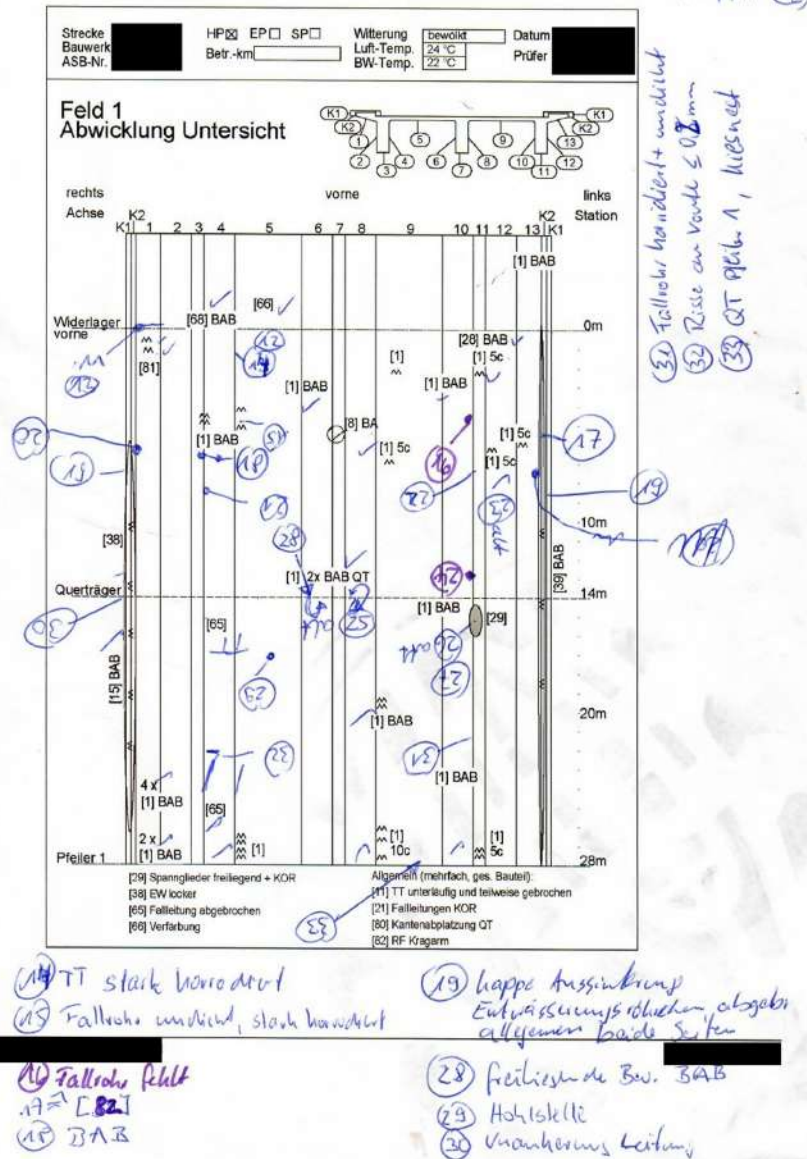
Figure 6. Damage sketch from a real bridge inspection with three T-beams. The sketch represents the bridge flipped-open along its longitudinal axis. Thus, the “vertical lines” represent the edges of the bridge cross-section. The defects are numbered in chronological order. Exemplary damage-information separated by comma (damage-number, damage-class, longitudinal, and cross-section dependent localization): #28, *Spalling* (“BAB”) with *Exposed Rebars* (“freiliegende Bewehrung”), at the cross girder (“Querträger”), on the left side of the web (6); #29, *Hollowarea* (“Hohlstelle”), approximately 3m from the cross girder (“Querträger”), on the flange (5); #31, *Drainage* (“Fallrohr”) with *Rust* (“korrodiert”) which is leaking (“undicht”), approximately 7m from the cross girder (“Querträger”), on the bottom of the web (11).
