Abstract

Keywords : cesium contamination, concrete carbonation, aggregate

1. Introduction

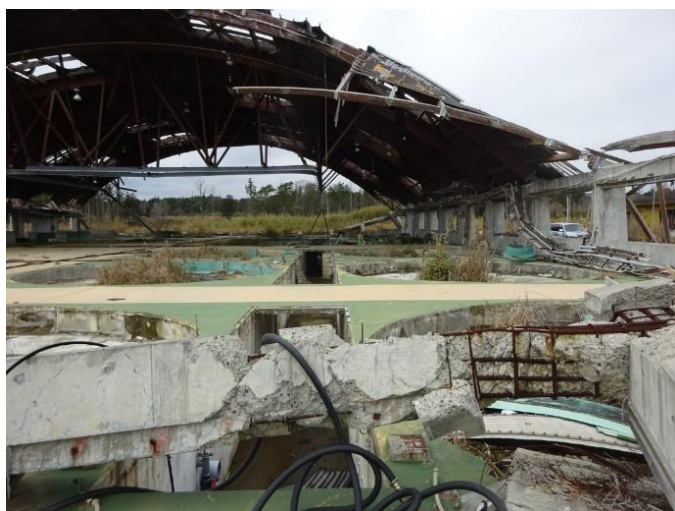
Fig. 2 Collapse of the dome-shaped building during the tsunami.

The facility surveyed in the second through fourth stages is described in more detail here, and the sampling locations are indicated in the next section. The facility is a dome-shaped building, which featured a circular pool for flatfish farming. The building endured severe damage during the March 11, 2011 tsunami, half of the building on the seaward side having collapsed (Fig. 2). Additionally, a neighboring one-story reinforced concrete building suffered partial destruction, including the collapse of a wall (Fig. 3).

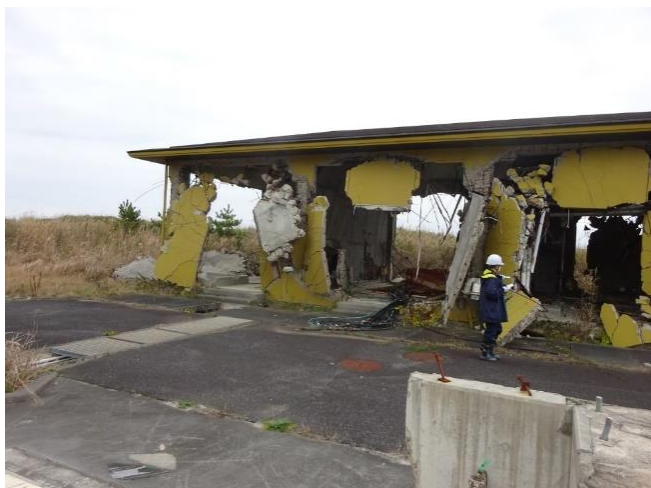
Fig. 3 One-story building with collapsed walls and rubble.

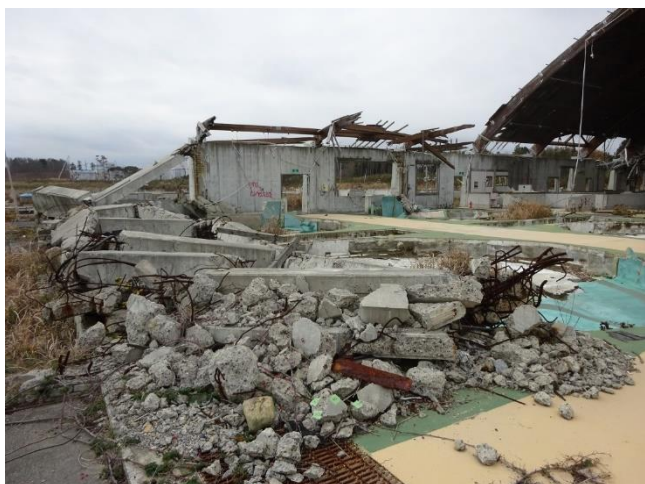
Fig. 4 Example of rubble.

Samples were collected from rubble and debris of collapsed concrete buildings (Fig. 4) and from intact concrete structures. The intact structures included a column that was cracked by the tsunami but was standing upright (Fig. 5a), a collapsed column (Fig. 5b), a collapsed column with a spalled concrete cover (Fig. 5c), the floor of the facility (Fig. 5d), and the bottom of the aqua-farming pond (Fig. 5e).

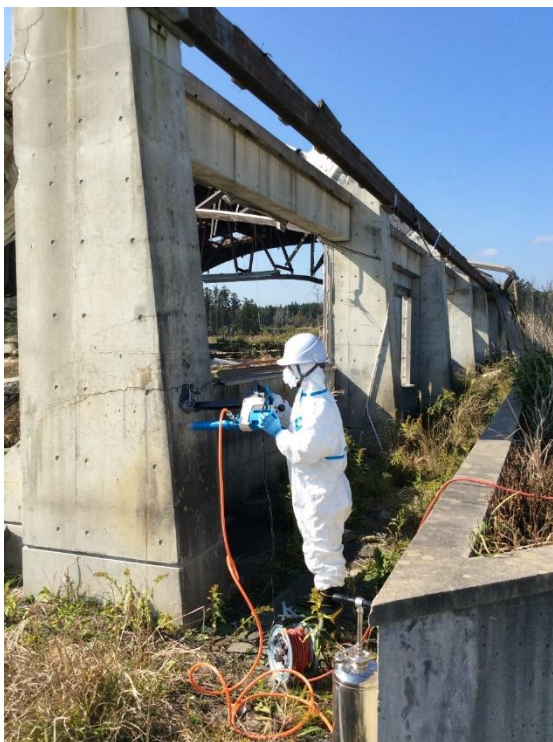
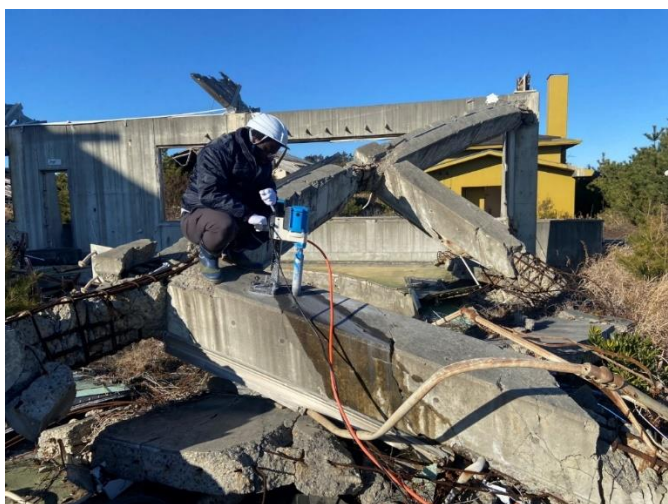
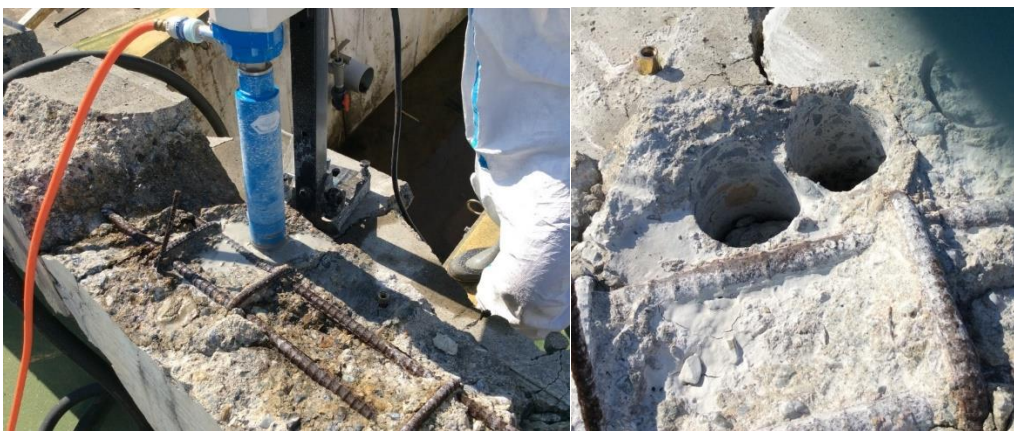
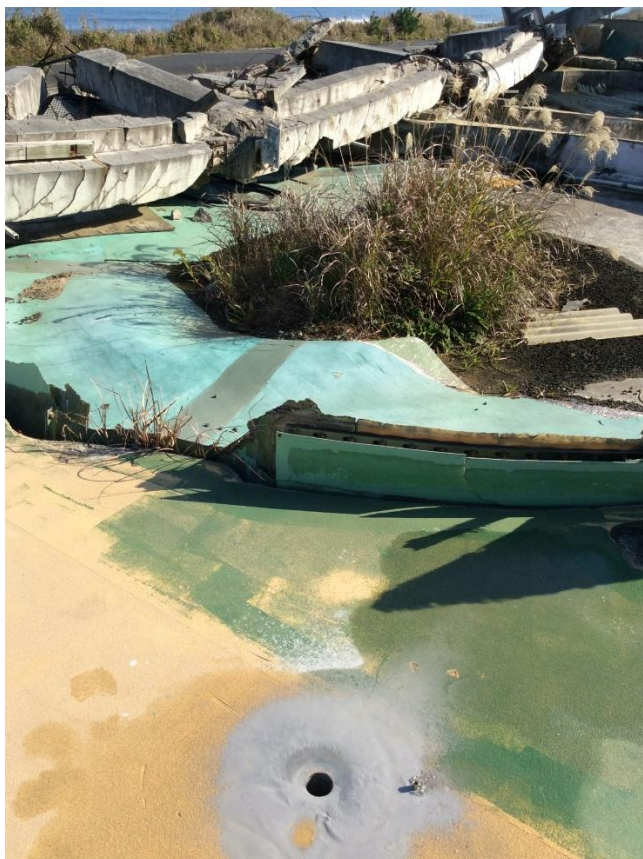
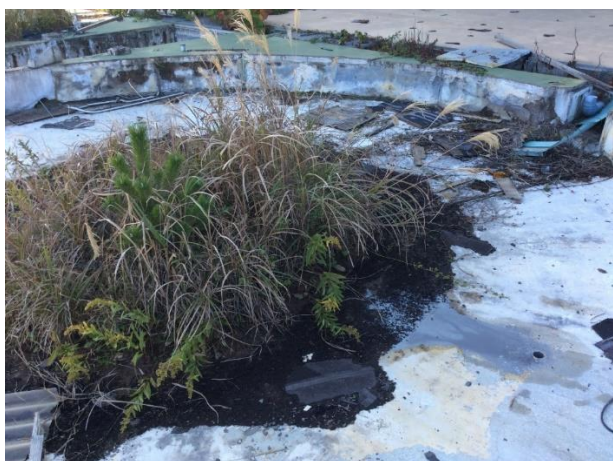
Fig. 5 Core sampling locations.

(a) Upright columns that survived the collapse of the building

(b) Building columns that collapsed during the tsunami

(c) Columns that had collapsed and whose cover concrete was spalled

(d) Floor of the building containing the flatfish farming pond

(e) Bottom of aqua-farming pond

considerably higher than that of deeper layers or when Cs penetration is inhomogeneous. Therefore, cores with diameters of 47 mm and 50 mm were collected in the second and third surveys and the fourth survey, respectively, through core drilling using water-lubricated core bits. Given the outdoor exposure of the samples to rainfall over several years, the impact of water usage during drilling was considered negligible. The sampling process is shown in Figs. 5a-c.

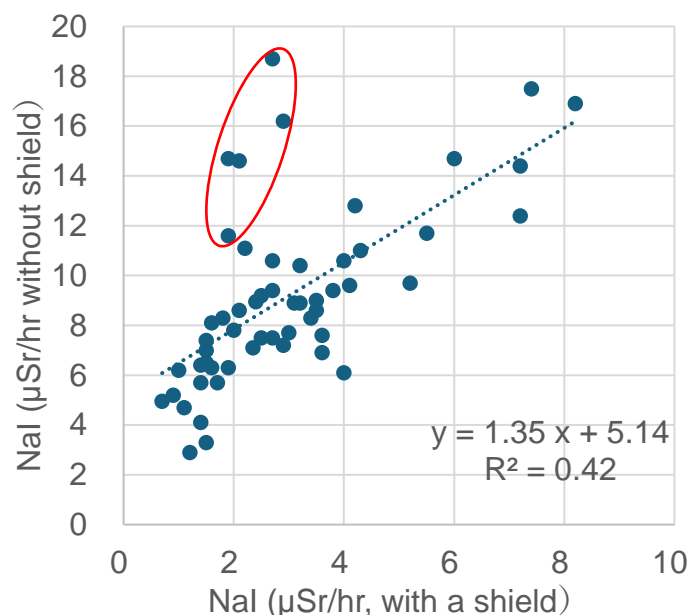
Fig. 6 γ -ray dose rate measurement by NaI scintillator in the field.

The surface dose rate measurements of structural concrete and rubble obtained during the first survey are depicted in Figs. 6 and 7, respectively. Ideally, a 1:1 linear relationship is expected for each measurement method, irrespective of shielding presence, in the absence of external environmental influences. However, as shown in Fig. 6, a comparison of the two methods, particularly with NaI, revealed poor correlation because of significant variation, with unshielded measurements yielding higher values in some cases. In addition, the effectiveness of shielding exhibited substantial variability across measurement locations because of difference air dose rates. As shown in Fig. 7, the measurements using the unshielded GM tube yielded larger values but with relatively good linearity for shielded measurements.

Fig. 6 illustrates an overall linear relationship between respective dose rates when data are grouped based on shielding presence, although γ -rays cannot be entirely shielded, leading to variation. However, certain measurement locations, delineated by red circles, indicated considerably elevated values in the absence of shielding, attributable to increased air dose rates. One contributing factor could be the presence of soil. As experienced in decontamination works in off-site, at the place where rainwater directly drained from gutters to the ground exhibited locally quite higher dose rates even during off-site decontamination efforts [13]. This phenomenon arises from the adsorption of radioactive Cs by soil, with rainwater containing radioactive Cs increasing its concentration upon continuous supply. Although the surveyed facility predominantly comprises concrete-covered areas, grass growth from the soil was observed in some regions; the points encircled in red indicate areas influenced by soil radiation. Excluding these data points, the correlation coefficient R^2 between values with and without shielding increased from 0.42 to 0.75. Additionally, shielding resulted in a reduction of counts by 5 $\mu\text{Sv/h}$ (y-intercept of the regression line), equivalent to 36% of the maximum value of 18 $\mu\text{Sv/h}$.

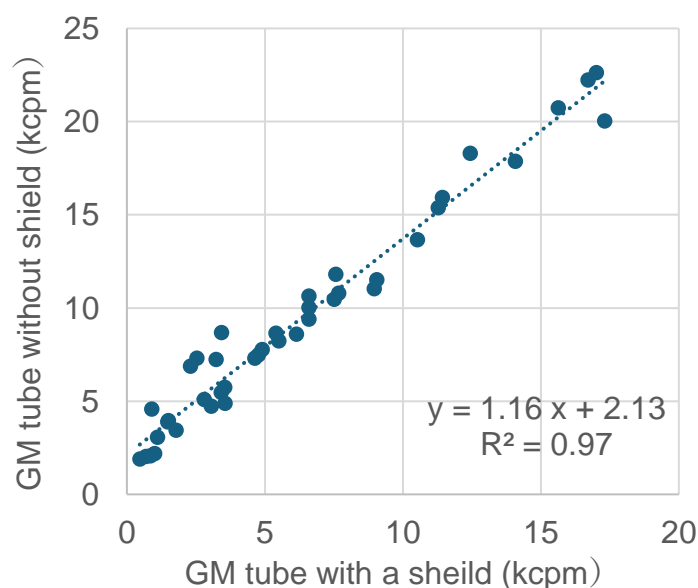
Fig. 7 β -ray dose rate measurement by GM tube in the field.

Fig. 7 shows the relationship between GM tube readings with and without shielding. The correlation coefficient R^2 of 0.97 indicates strong linearity, with shielding reducing readings by an average of 2 kcpm. This reduction, accounting for 10% of the maximum value of 23 kcpm, represents a fraction of the effect observed with NaI. Essentially, β -ray measurements exhibit relatively low sensitivity to variations in air dose rates at measurement sites. Among fission products, Cs-134 and Cs-137

emitting β and γ rays and Sr-90 emitting β rays, primarily influence dose rates. Typically, GM tubes detect β -rays from these nuclides. However, in scenarios where contamination is primarily attributed to radioactive Cs, as observed at the 1F off-site locality [10], GM tube assessments offer a more appropriate gauge of contamination levels due to their lower sensitivity to air dose rate when shielding is applied.

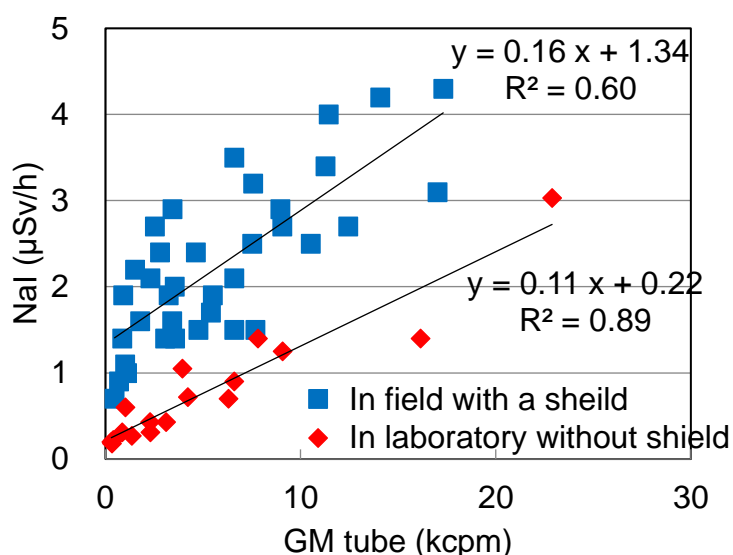
Fig. 8 Correlation of GM tube and NaI measurements in field with a shield and in laboratory environments without shield

The rubble samples (from the aqua-farming facility) obtained during the third survey were transported to the laboratory at the National Institute for Environmental Studies in Tsukuba City for surface dose rate measurements. In the sample storage room, the air dose rate was $0.07 \mu\text{Sv/h}$ for NaI and 72 cpm for GM tube. The correlation between NaI and GM tube measurements was plotted for field conditions (with shielding) and laboratory conditions (without shielding), respectively. The correlation coefficient R^2 was 0.60 for the field measurements and 0.89 for the laboratory measurements. The better correlation observed for the laboratory data suggests that field measurements were influenced by radiation from the surrounding area. The linearity between the NaI and GM tube readings indicated that, for the evaluated samples, most radioactive Cs was concentrated near the sample surface, where β -rays remain unattenuated and penetration into the interior of the sample is limited.

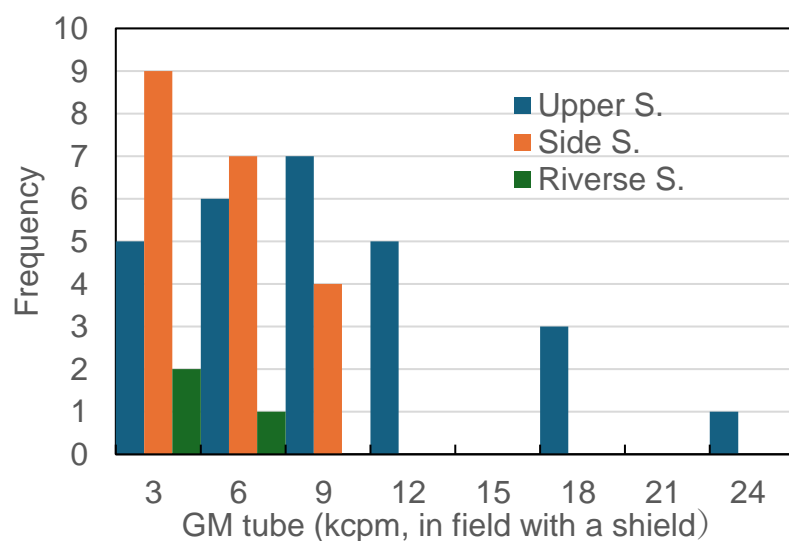
Fig. 9 Difference of dose rate frequency depending on the direction of concrete rubble.

Because of the polyhedral structure of the rubble, rainfall-induced contamination may vary across the top, side, and back surfaces. Therefore, several blocks of rubble (10 cm to 30 cm in length) were tested at each side while employing on-site shielding. The results are summarized as a histogram in Fig. 9. The mode and maximum values were 9 kcpm and 24 kcpm for the top surface, 3 kcpm and 9 kcpm for the sides, and 3 kcpm and 6 kcpm for the back surface, respectively. Contamination levels were notably higher on the top surface compared with the sides, with the back surface exhibiting even lower contamination levels. However, the determination of differences in contamination between the sides and the back is challenging because of the limited number of measurements on the back side.

Fig. 11b depicts results for an upright column on the north face, facing to the 1F site. Compared with the collapsed column, the measured values were approximately half. This aligns with the trend observed for rubble in Fig. 9, where the top surface exposed to rainwater remained highly contaminated. Over time, the contamination levels decreased substantially, which is particularly evident in cracked parts where the dose rate was halved. On the other hand, while the dose rate decreased in areas without cracks, the reduction was not as substantial as in the cracked parts. The surface dose rate also decreased with age in both collapsed and upright columns.

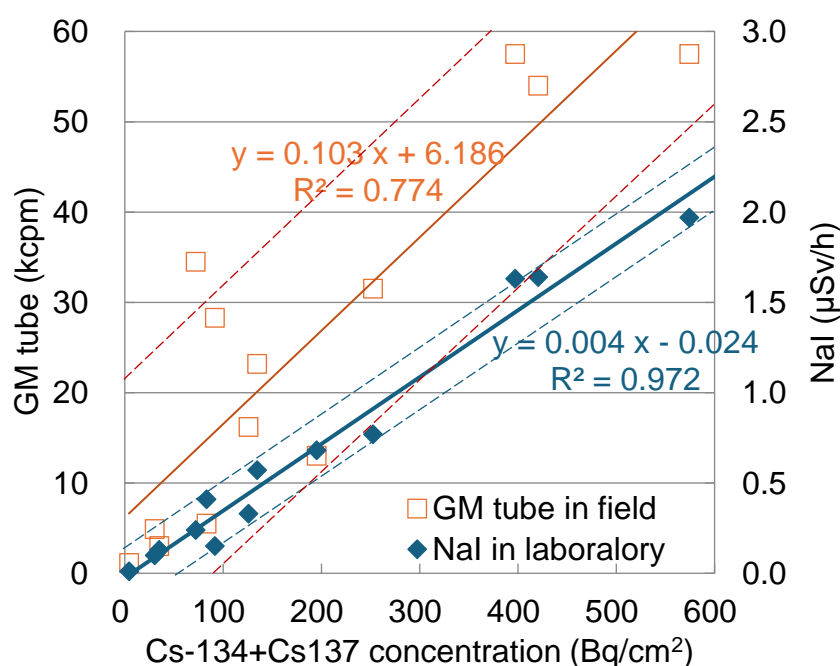
Fig. 10 Correlations between GM tube measurements in the field with a shield or NaI measurements in the laboratory versus radioactive Cs surface concentration.

Fig. 10 shows the relationship between surface radioactivity concentration and measured values using GM tube with a shield in the field or NaI, which were deemed suitable for measuring total γ -ray radioactivity in a low background environment. A robust linear relationship between surface radioactivity concentration and laboratory NaI counts was observed, with a correlation coefficient R^2 of 0.97. While a positive correlation was observed between measured values and radioactivity level with GM tubes, the variation was substantial, as indicated by a y-intercept of 6 kcpm and R^2 of 0.77. Fig. 8 shows a high correlation between NaI and GM tube measurements in a low background environment, indicating that GM tube measurements in the field may be moderately influenced by the air dose rate at the measurement site.

Using the regression equation, GM tube counts were converted into estimates of surface radioactivity concentration (Fig. 10), revealing an average difference of 76 Bq/cm² from the measured values. This value is considered as an estimation error in this study. The error in determining radioactivity density from NaI in the laboratory was 24 Bq/cm². The dotted line in Fig. 10 represents twice the error, indicating the range of estimation from survey meter readings. Because of the relatively large error associated with estimating radioactivity density from field measurements using GM tubes, for more accurate estimation, the radioactivity concentration of core samples is recommended to be assessed in the laboratory using NaI. Note that radioactive Sr was not evaluated in this analysis.

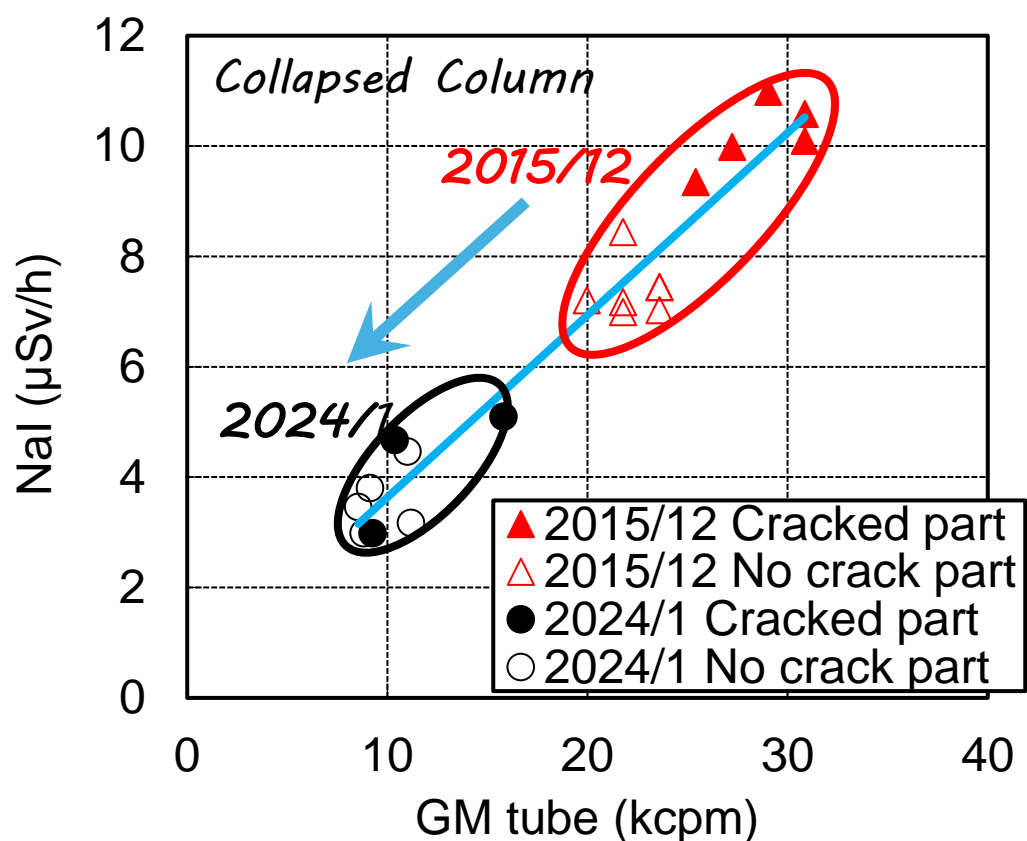
(a) Collapsed column with cracks.

(b) Upright column with cracks caused by the tsunami.

Fig. 11 Changes in radiation dose rate of columns from December 2015 to January 2024. Dose rates were calibrated for the values on March 11, 2011.

Field measurements of aqua-farming facility columns were conducted twice, once in the second and again in the fourth surveys. Fig. 11 shows two examples of columns measured at the same location. The values were adjusted to reflect the conditions on March 11, 2011, accounting for attenuation effects. In Fig. 6, only a low correlation between NaI and GM tube data was observed. However, in Fig. 11, a high correlation between NaI and GM tube data was observed for both collapsed and upright columns, indicating consistent air dose rates at the same location.

Examining results for the collapsed column in Fig. 11a, both GM tube and NaI readings were reduced by half in January 2024, approximately 8 years later, compared with measurements conducted in December 2015. This reduction could signify the leaching of radioactive Cs into the environment due to rain. Measurements above cracked surfaces were greater than those

in the crack-free areas in December 2015, but no clear difference was observed in the January 2024 measurements. The reason for this is not well understood.

Third, rainfall may facilitate Cs leaching from carbonated cement paste, while leaching from aggregates may be limited, as depicted in Fig. 11. Therefore, Cs adsorption on carbonated cement paste and Cs-adsorbing aggregate must be examined.
