## RADIATION ROSE

## CONCLUSION

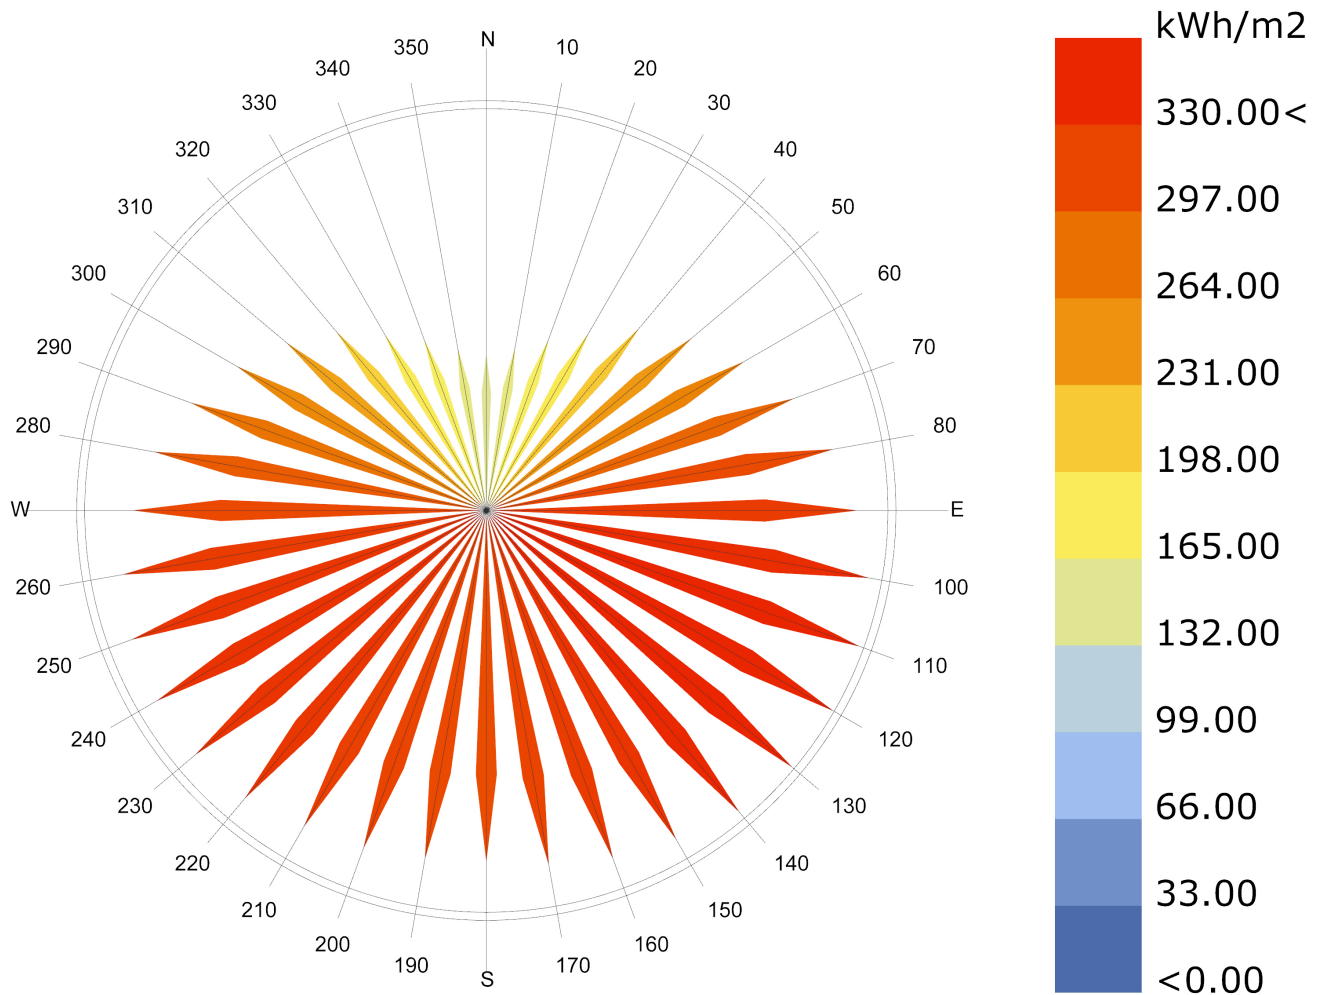
Total Radiation(kWh/m<sup>2</sup>)  
 Philadelphia\_International\_Ap\_PA\_USA  
 1 JUN 1:00 - 30 SEP 24:00

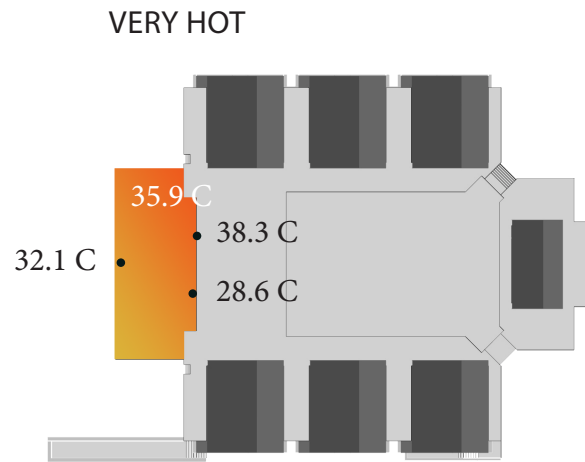
REPORTED	MEASURED
Temp.: 26	Temp.: 24.6
Humidity: 69%	Humidity: 41.2%
Wind: 0.8 m/s	Wind: 1.4 m/s

Surface Temperature: about 5-8 degree difference between the local weather report and the on site temperature.  
 Dry Bulb Temperature: about 3-5 degree difference among three measurements.

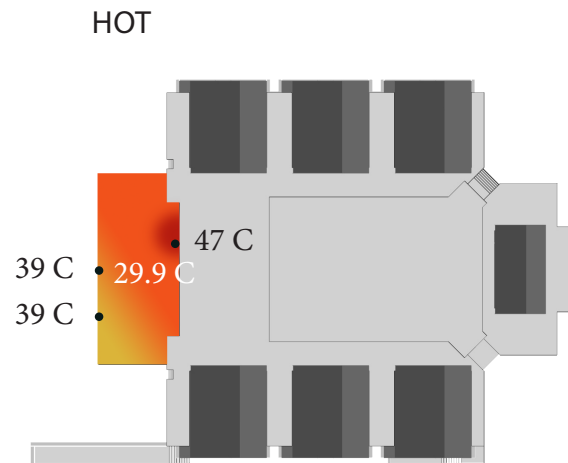
REPORTED	MEASURED
Temp.: 28	Temp.: 26.6
Humidity: 50%	Humidity: 50.5%
Wind: 2 m/s	Wind: 1.3 m/s

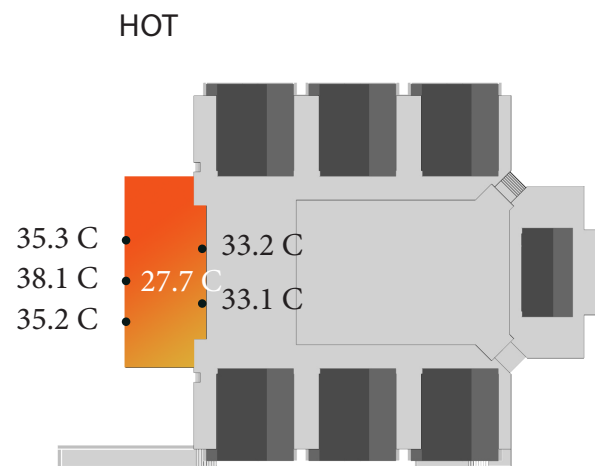
REPORTED	MEASURED
Temp.: 31	Temp.: 22.3
Humidity: 46%	Humidity: 60.5%
Wind: 2 m/s	Wind: 1 m/s

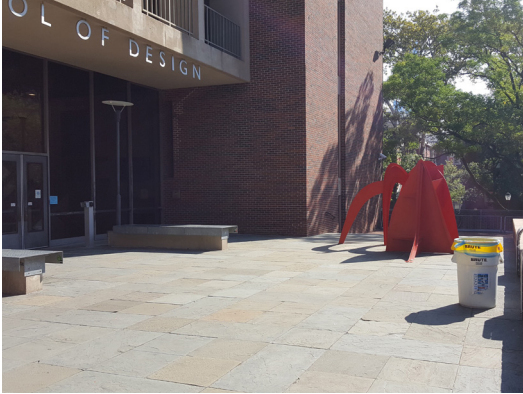
10:30

The area is under a lot of sunlight, while there is no shading provided by clouds, resulting in the area being really hot.

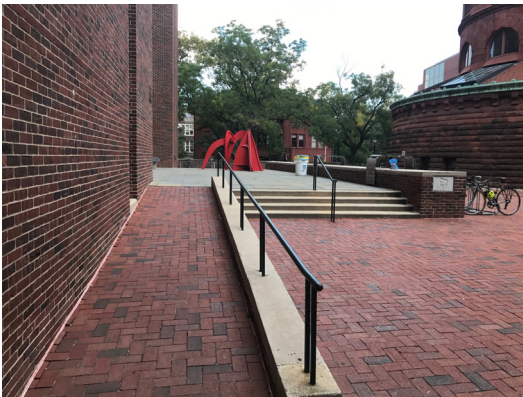
13:30

There is shading provided by the clouds, therefore the temperature is lower compared to morning. However, the surface temperature of the benches is hotter due to longer exposure to the sunlight.

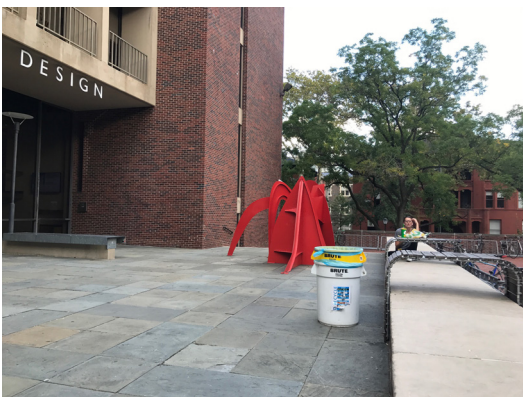
16:30

The weather turned from sunny to cloudy. The temperature is the lowest amongst the three measurements. It's about to rain, so the humidity level increases.
