EXPERIMENTAL STUDY ON ADOBE WALLS WITH LONG TERM WATER EXPOSURE DUE TO FLOODS

Conference Paper · June 2013

A. San Bartolomé¹, D. Quiun¹, D. Cabrera², W. Huaynate², I. Romero², J. Pereyra²

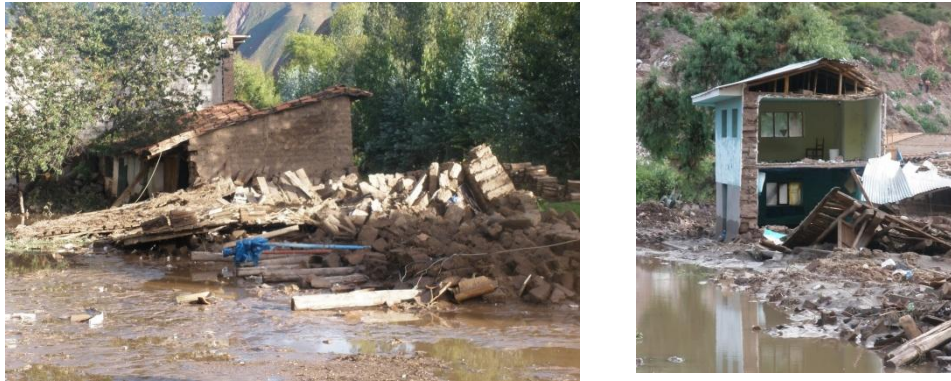
Figure1: Collapse of adobe houses under floods, Cusco Perú - 2010.

As result of our climatic diversity, Peru rural areas are affected periodically by intense rains that generate floods and the overflow of rivers. On the other hand, traditional adobe has a high vulnerability under prolonged contact with water product of of these floods, which can cause the collapse of the structures (Figure 1). In this paper, two sets of experiments are reported, in which the water action of flooding was simulated on four adobe walls in each set. Of the eight walls that were tested, two were traditional and the other six had some treatment or protection under water action. The traditional adobe walls collapsed after 20 and 73 minutes, while the other six remained stable without danger of collapse. The solutions to protect the base of the adobe walls were all simple and economic. It is necessary to indicate that these solutions do not protect the adobes structures against the action of avalanches that drag big stones or rocks.

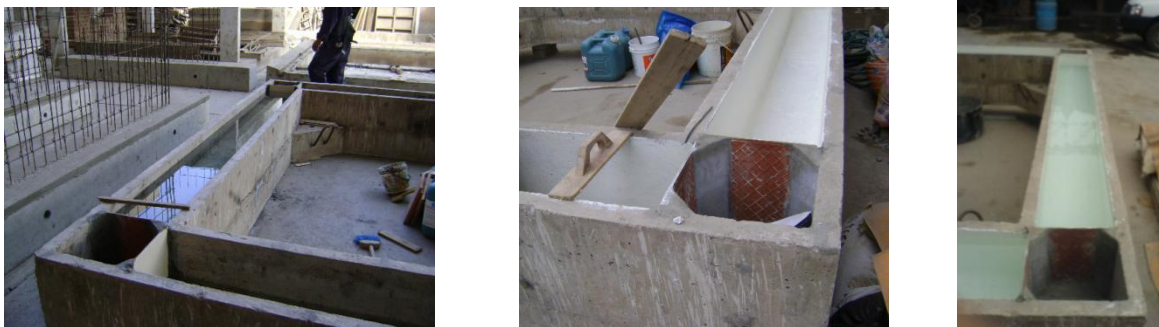
A reinforced concrete channel with “U” section was used for the floods simulations, with 280 mm of internal width. The channel fulfilled the requirements of impermeability and water tightness. It was divided into four sections of equal dimensions with independent channels as shown in Figure 2. By this way, the analyses of the variables of absorption, capillarity and performance along time of each wall were independent.

Figure 2: Channel used in the test of flooding. Test of water tightness.

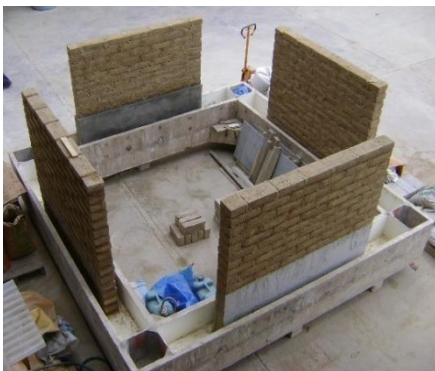
The first set of four walls had a Traditional Wall (TW1) and three improved walls with different treatments against water action. The first treatment, Concrete Plinth Wall (CPW), used a plinth of plain concrete, instead of the traditional foundation of adobe walls made of stones. The second treatment, Stabilized Wall (SW), consisted in the use of stabilized adobe units with 5% of cement, in the bottom six layers exposed to flooding. In the third treatment, Plastered Wall (PW1), the units under water action were protected with a cement-sand (1:5 volume proportion) mortar cover applied over a henhouse mesh made of galvanized wires, connected to the wall. The main characteristics of the walls inside the channel are shown in Figure 3. With exception of the wall PW1 whose thickness increased due to the mortar plaster, all the walls had the same dimensions: 1.50m high, 1.65m length and 0.13m thickness. All the walls were constructed by the same masons. The vertical and horizontal joints of the walls had 15 mm thickness and the mortar was done by the same material used in the adobes.

Figure 3: View of the four walls of the first set

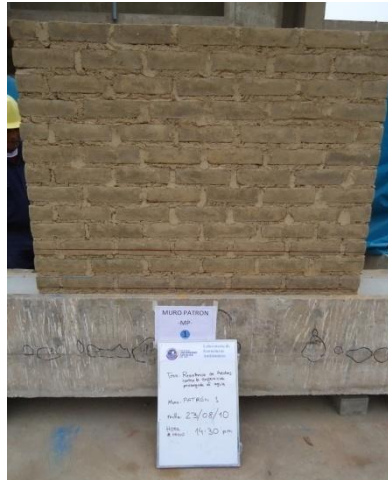
The traditional wall (TW1) in Figure 4 does not have any improvement and the mortar was of the same material of which the adobe units were made. For the construction of the Concrete Plinth Wall CW1 shown in Figure 5, the plinth of plain concrete had $f'_c = 21$ MPa. This foundation had 300 mm height over the water level and had the same thickness as the wall. The same traditional units and mortar were used (similar to TW1).

Figure 4: Traditional Wall set 1– TW1

For the first set of walls, the traditional wall TW1 resisted only 20 minutes of flood (less than the short period of flooding). The adobe units at the base were disintegrated and immediately the wall overturned as can be seen in Figure 9. The other three walls of set 1, CW1, SW and PW1 resisted 16 days of flooding and they are shown in Figure 10.

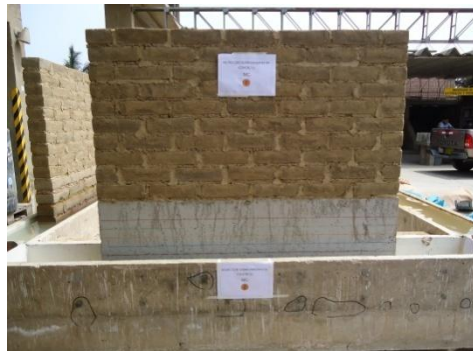
Figure 5: Concrete Plinth Wall – CW1

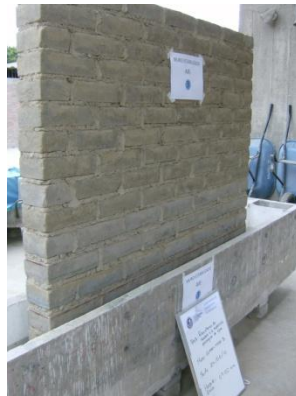
In the stabilized wall SW (Figure 6), from the base of the channel up to a height of 300 mm over the water level, six layers of stabilized adobes with 5% of cement (in weight), were used. The mud mortar was stabilized with the same proportion of cement, whereas the following layers had traditional adobe units and traditional mortar, similar to TW1. The plastered wall PW1 (Figure 7) was constructed totally with traditional adobes and mortar mud (similar to TW1). Later, it was plastered with a cement-sand mortar mix of 15 mm thickness, from the base up to a height of 300mm above the water level, over a henhouse wire mesh.

Figure 6: Stabilized Wall - SW

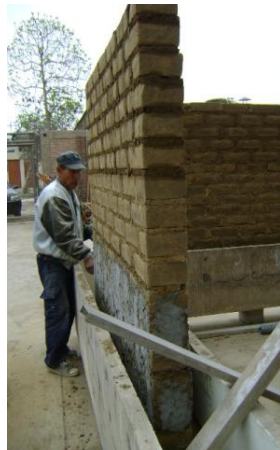
Figure 7: Plastered Wall set1 – PW1

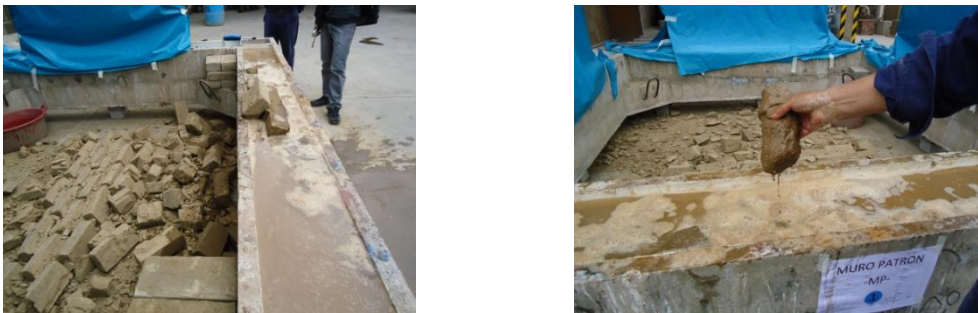
Figure 9: Overturned wall TW1 and condition of the adobes in the base.

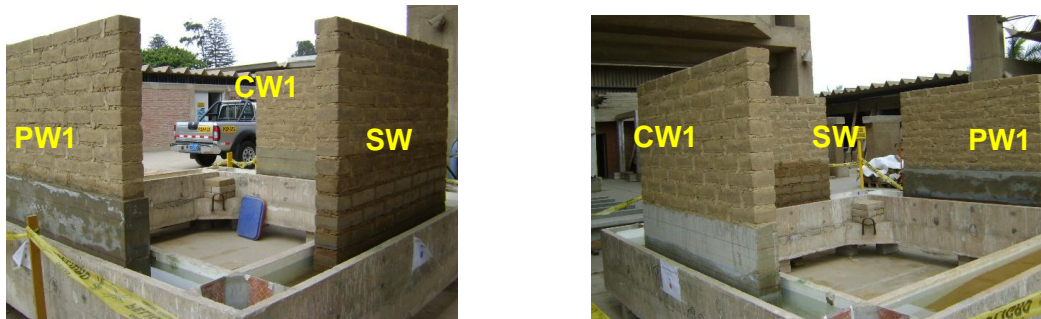
Figure 10: Three walls of set 1 that resisted the flooding simulation test

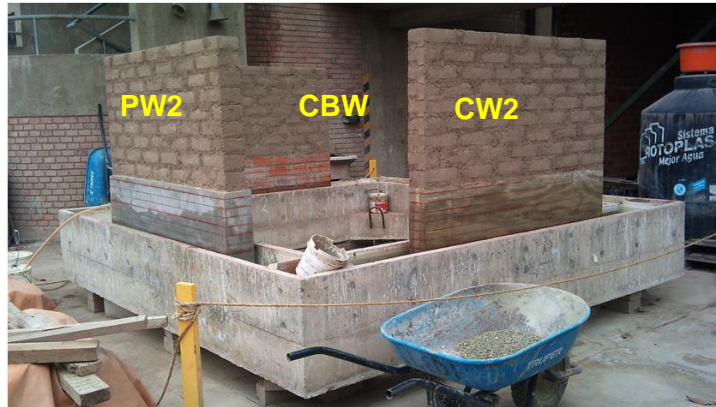
For the second set of walls, the traditional wall TW2 resisted 73 minutes of flood; also, less than the short period of flooding. The other three walls of set 2, CW2, CBW and PW2 resisted all the

24 days of flooding before being demolished, they are shown in Figure 11. Figure 12 shows the condition of adobe units of walls PW1 and SW of set 1, and the brick units of CBW of set 2.

Figure 11: Three walls of set 2 that resisted the flooding simulation test

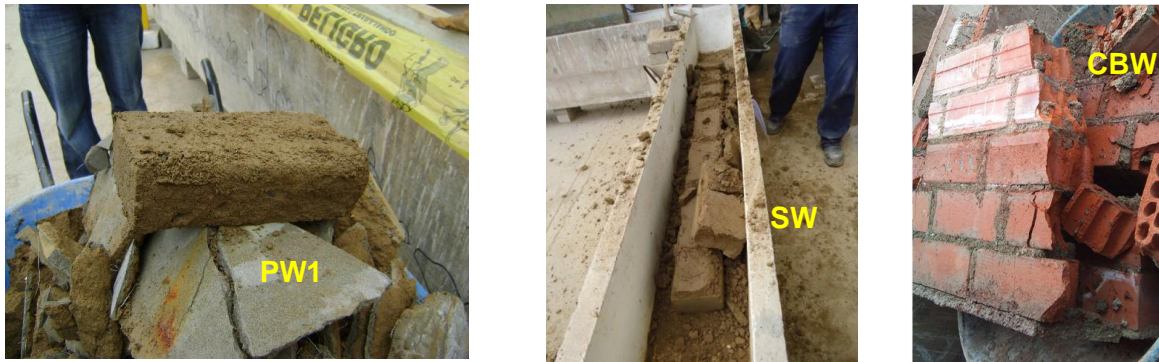
Figure 12: Inspection of masonry units in the base after demolition of the walls.

After finishing the tests, the walls had all their 15 layers carefully dismantled. For set 1 of walls, the first 8 layers of SW and the first 6 layers of PW1 were humid, whereas all the units of CW1 were dry. Therefore, the humidity ratio can be set as 4:3:0 for the walls SW, PW1 and CW1, respectively. For set 2 of walls, the first 3 layers of CBW and the first 4 layers of PW2 were saturated, while the first 350mm, equivalent to 3 and a half layers, of CW2 were saturated. Therefore, the humidity ratio is 3:4:3.5 for the walls CBW, PW2 and CW2, respectively.

The consistency of the units was defined as the touch sensation. By this way, the adobe units at the base for walls SW and PW1 had partial instability, whereas CW1's adobes were dry. Therefore the proportion can be set as 1:1:0 for the set 1 walls SW, PW1 and CW1, respectively. Similarly, for set 2 walls, the units of CBW and PW2 were unstable and the units of CW2 were dry. Therefore the proportion can be set as 0:1:0 for the walls CBW, PW2 and CW2, respectively.
