# The salt architecture in Siwa oasis – Egypt (XII–XX centuries)

Article in *Construction and Building Materials* · July 2009

DOI: 10.1016/j.conbuildmat.2009.02.003

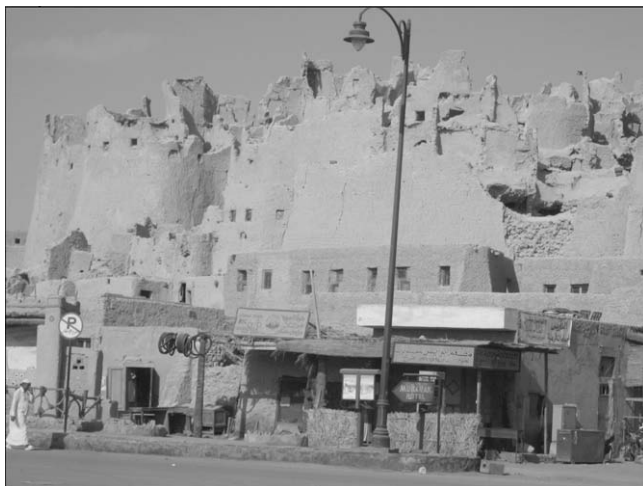
Fig. 2. Ancient fortress of Shali.

Ammon dating back to Amasis, Pharaoh of the XXVI dynasty and the ancient fortress of Shali (Fig. 2) built in the XII century on the highest hill of the oasis in order to better defend from the attacks of the Arab tribes from the desert [4].

actions like rain water and rock falls along the slopes of the hill [7,8]. Such accidents seem to be hindered by thin walls, often damaged, all of them realised with a masonry based on salt blocks “karshif”, bounded a salty mud.

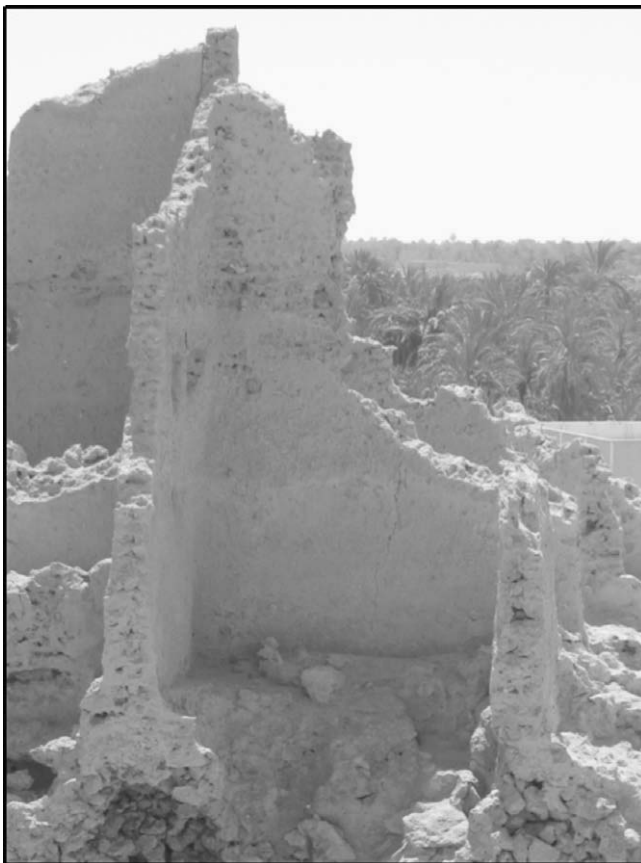
Fig. 5. Wall with small thickness.

- Those characterised by a prevalent partition role. Their width is smaller (between 30 and 60 cm); they are made by quite homogeneous size karshif pieces, cemented with abundant salty mud mortar. In such walls the constructive technique is simplified; we cannot find devices employed in order to obtain a real transversal joint, neither special attempt to realise privileged layers are recognisable. (Figs. 4 and 5).

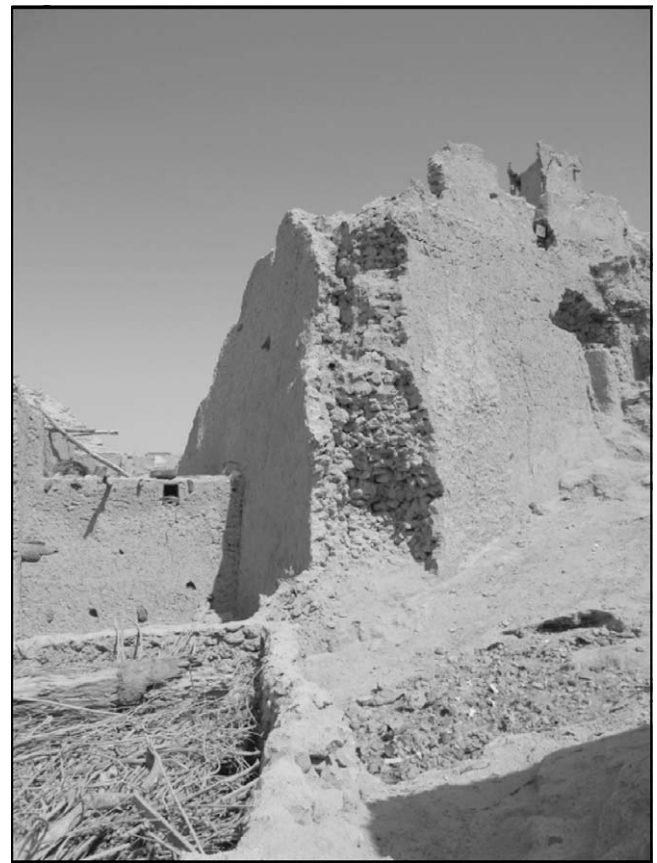
Fig. 6. Collapse in the corners–edges.

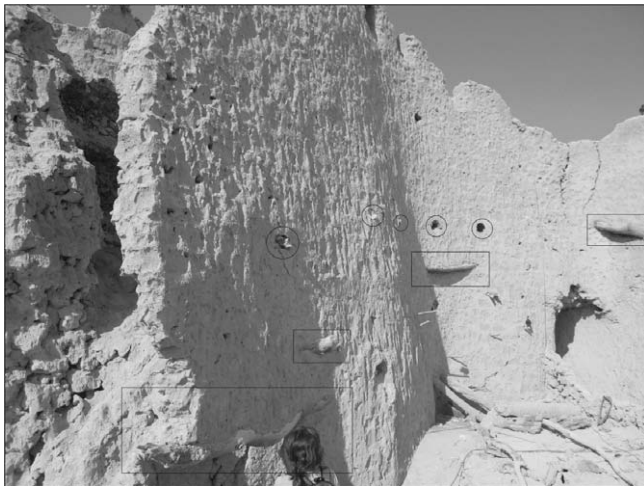
Fig. 9. Wood elements in the wall: utilised to change the orientation of the walls from convexity to concavity (square contour); utilised to improve the jointing between the external and the internal parts of the walls (circular contour).

Both typologies of wood inserts can be observed in the undulated wall located near the North Door of the fortress (Figs. 8 and 9). In particular the second typology is defined by the tools and tracks of wooden pieces or trunks left in the internal part of the wall (partially collapsed). Some of these tracks, semicircular in shape, are typical of palm trees cut in the middle. A careful observation of the external surface of the wall made it possible to eval-

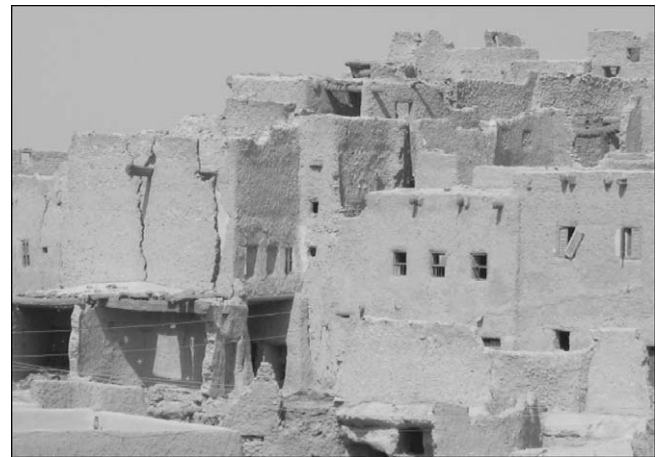
Fig. 11. Fractures under the palm beams in the walls.

Two starting points, easy to read, concerns the use of wooden beams, their efficiency and their relation with the masonry walls. The wood more employed in building is palm. It is well known that palm wood is a very deformable material and it exhibits great vertical displacements even in presence of small loads. In the common use (with the entire cross section) its deformability is impressive (we have to bear in mind that palm is a monocotyledon made of bundles of parallel fibers without the annular structure that characterises the trunks of trees). Therefore frequently palm is used with its trunk separated longitudinally into two halves, in order to employ the halves turned out in respect to the original symmetry axis (Fig. 10). This kind of setting makes it easy the laying of the upper plank floor. Nevertheless the elastic movements might be heavy in this case too, as pointed out by the constant presence of fractures under the point of support in the wall. As a matter of fact the use of a device able to distribute the burden on the whole section of the wall under the wooden beam has never been observed; nevertheless the small entity of loads involved does not justify such deep cracks pattern unless the consequence of a cyclic action, acted over the wall by the extremity of the beam during its continuous bending, is considered (Fig. 11).

3. the cracks under the palm beam or near a concentration of load. These fractures are a consequence of the loss of specific loads distribution devices.

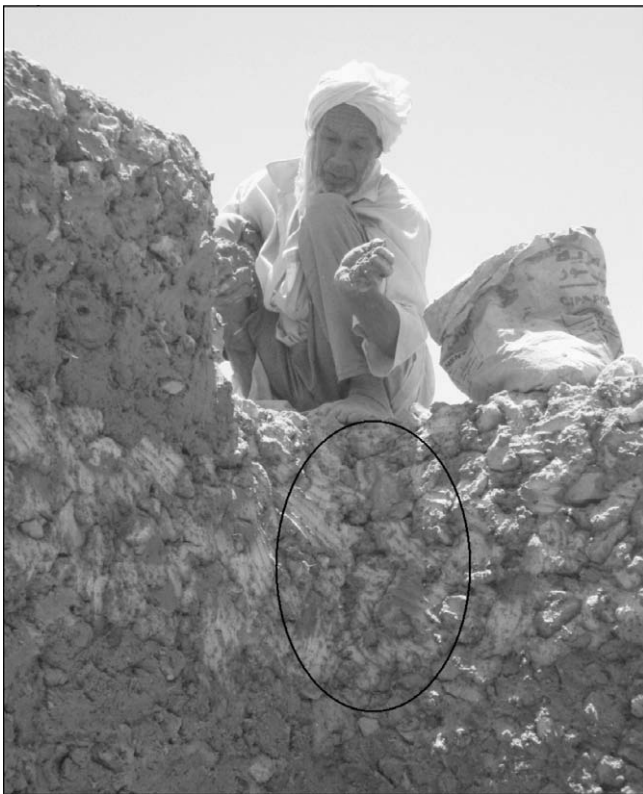
Fig. 13. Old expert mason (*maalem*) at work (look at the crack in the corner).

and, consequently, to the setting time of the salty mud: this mortar quickly hardens and crystallises, at most the setting can be delayed wetting the masonry (Fig. 13). Therefore no doubt that the discontinuities are a problem; in fact, whenever there is a stop in the construction site (due to the different phases of the building process), an interruption shall occur, probably, in the masonry body.

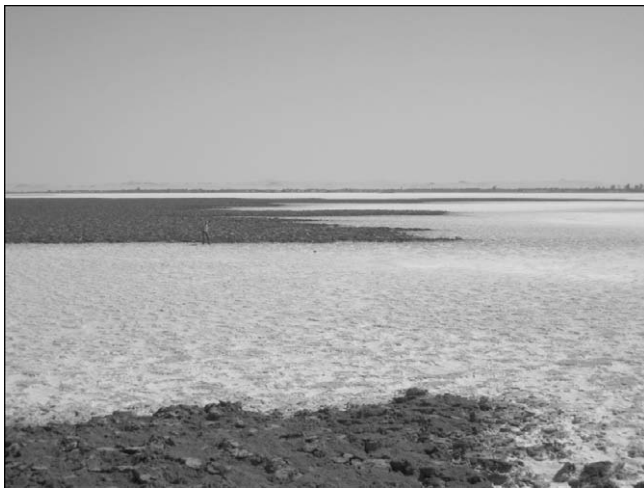
Fig. 15. Salty lake.

The salt blocks, called karshif, are made of NaCl crystals with a little amount of clay and sand and are taken from the shore around the salty lakes (Fig. 15). They are evaporitic deposits which form through precipitation of NaCl and other secondary salts like KCl during evaporation of water from the salty lakes. During this process, in occasion of sandstorms, minerals like quartz, feldspar calcite and clay minerals can be included as impurities in the salt.

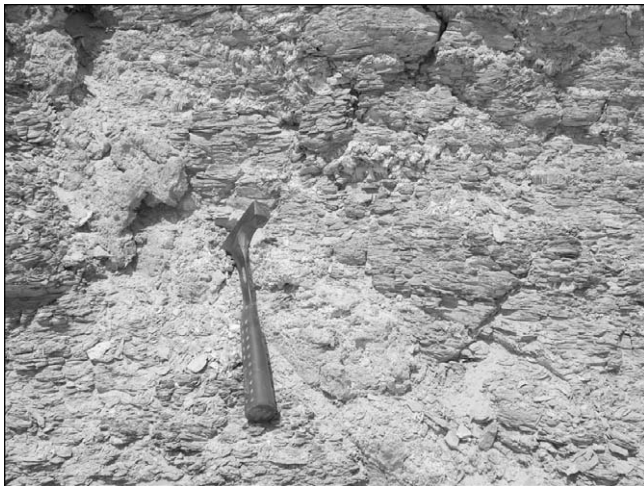
Fig. 16. The argillite, characterised by a brown greenish colour and by the presence of levels and fissures filled by gypsum crystals.

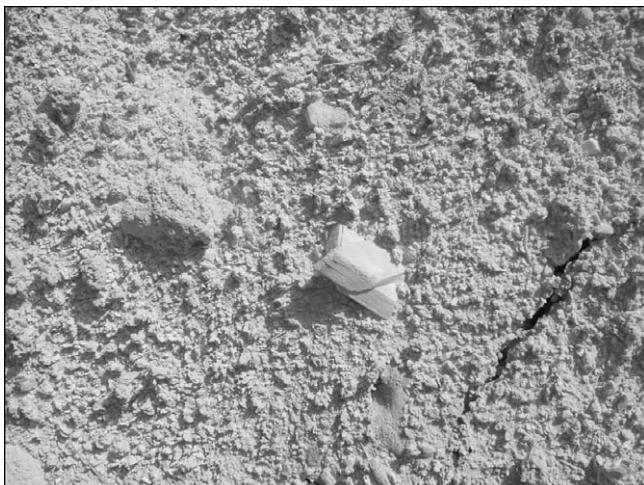
Fig. 17. Mortar with gypsum crystals in an old masonry.

tified by the aspect of the old masonries (Fig. 17): the argillite was disaggregated in salty water for about 10 days (oral tradition) in

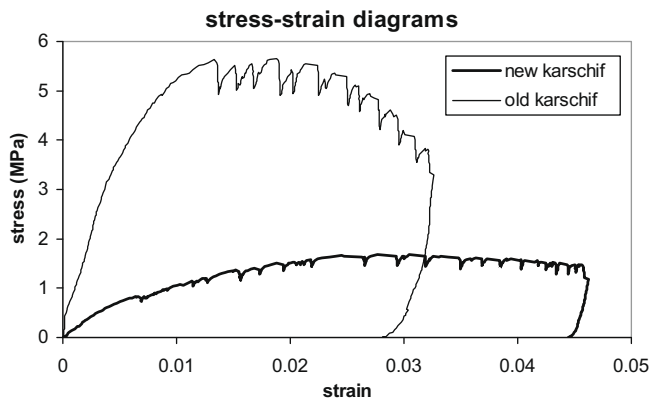
**Fig. 18.** Stress–strain diagrams recorded during the monoaxial compression tests of an old masonry karshif sample and of a new masonry karshif sample.

In Fig. 18 the stress–strain diagrams, recorded during the monoaxial compression tests of an old karshif specimen and new karshif specimen, are reported. The apparatus utilised for the monotone monoaxial compression test (Fig. 19) consists of an hydraulic press with 50,000 N loading cell, four displacement transducers placed on the upper surface of the loading plate and by a recorder of data (TDS). The tests have been performed at controlled displacement in order to record the diagram loading–displacement also in the post peak phase. From the karshif blocks, cubic and parallelepiped shape samples have been cut in order to perform the uniaxial compression test. The heterogeneity of karshif blocks, rich in cavities and crystals of different dimensions, made it difficult to realise samples with regular surfaces. Moreover, given the little amount of blocks and trying to realise the highest number of samples (in order to have statistically significant data) samples with slightly different dimensions have been realised. Nevertheless we tried to assure that the minimal dimension of the samples would be seven times higher than the dimension of the bigger heterogeneity (referring to the norms relative to the compression tests on concrete) in order to avoid scale effects. In order to compare the equilibrium paths of specimens with different dimensions, stress–strain diagrams have been derived from load–displacements diagrams.

The following characteristic points can be identified in each stress–strain diagram:  $li$ , start of linear segment;  $l$ , end of linear segment;  $m$  stress peak;  $l'$ , intersection between the linear branch and the ordinate corresponding to the stress peak  $m$ . The values of the following mechanical parameters were calculated by using the values of the characteristic points recorded during the tests: compressive strength  $\sigma c = (ym)$ , apparent elastic modulus (tangent stiffness)  $E = (yl - yli)/(xl - xli)$ , and kinematic ductility  $\mu c = (xm/xl')$ . The values of the mechanical parameters described are summarised in Table 4 together with the statistical parameters.

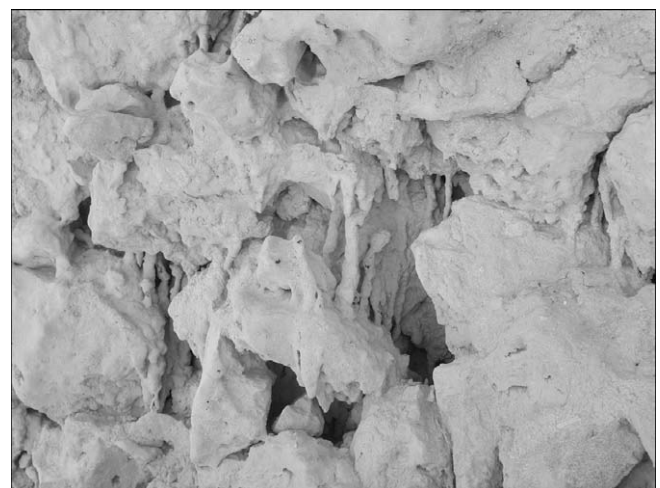
**Fig. 22.** Process of dissolution and precipitation of NaCl.

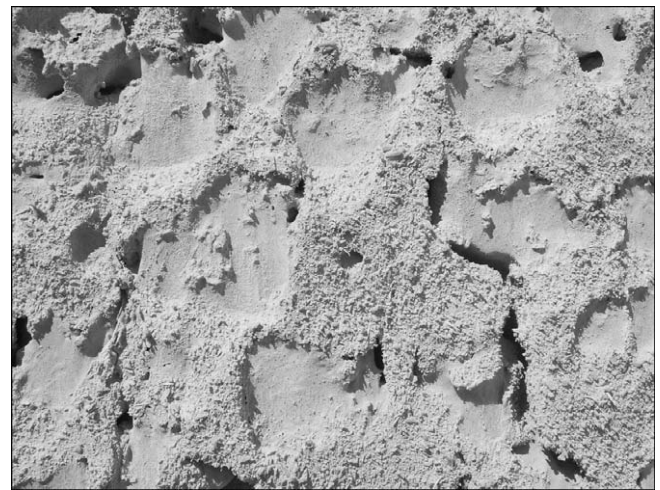
Fig. 26. Dissolution of the karshif blocks due to the greater solubility of the block than the mortar.

- dissolution of the karshif blocks (Fig. 26);
- loss of cohesion of the mortar due to dissolution of the salty component of the binder (NaCl) and washing away of the clay minerals;
- mortar disgregation caused by mechanical tensions developed through swelling and shrinkage phenomena of the smectitic component of the clay, mineral strongly affected by humidity variations.
