1. Report No. <b>FHWA/TX-08/5-4385-01-1</b>		2. Government Accession No.		3. Recipient's Catalog No.	
4. Title and Subtitle <b>PILOT IMPLEMENTATION OF BUMP DETECTION PROFILER</b>				5. Report Date <b>Published: December 2007</b>

# **PILOT IMPLEMENTATION OF BUMP DETECTION PROFILER**

Project Title: Pilot Implementation of Bump Detection Profilers for CRCP Construction

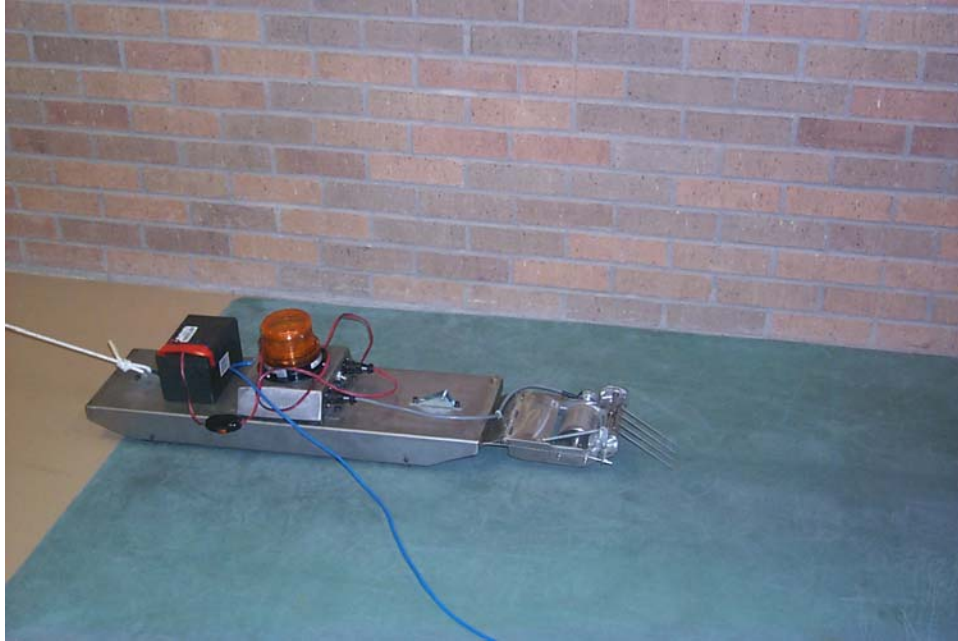
During the fall of 2005, the first version of the production unit was completed and tested in a sandbox constructed for the test at the Texas A&M Riverside Campus. The parts needed for the instrumentation were also obtained, wired and mounted within the sliding profiler unit. The system was then brought to UTA where the bump algorithm was tested by pulling the device down the hall outside the UTA Transportation Instrumentation Lab. Figure 1 illustrates the device being tested at UTA.

**Figure 1 Testing Unit at UTA Lab**

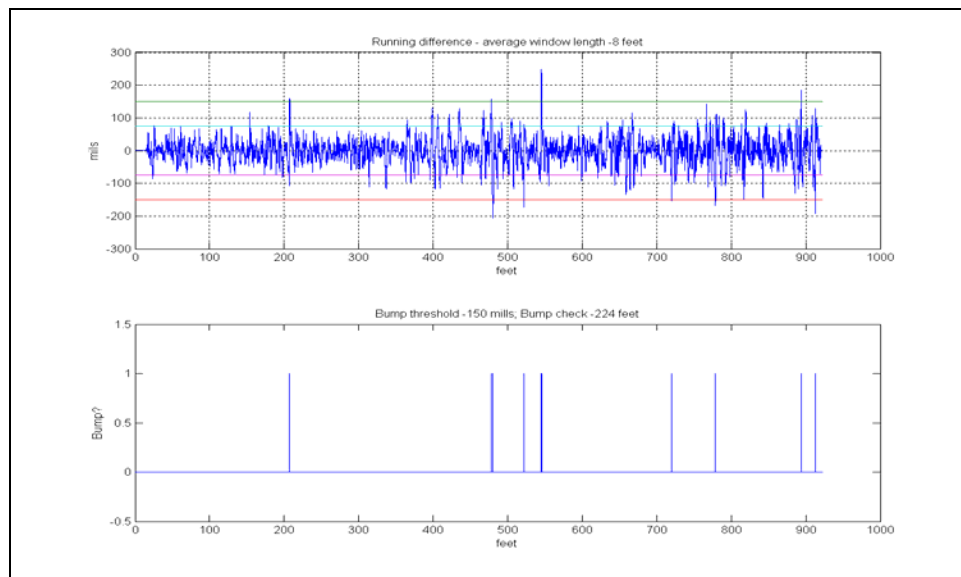
The data were recorded and then later processed with the bump threshold set to 150 mils as specified in the ride quality procedure. Figure 3 illustrates the bumps found for the 150 mils setting and the differences between points and the eight foot running average used in the sliding profiler's bump detection procedure.

**Figure 3 El Paso Points Differences between Running Average  
(Bump Detection set to 150 mils)**

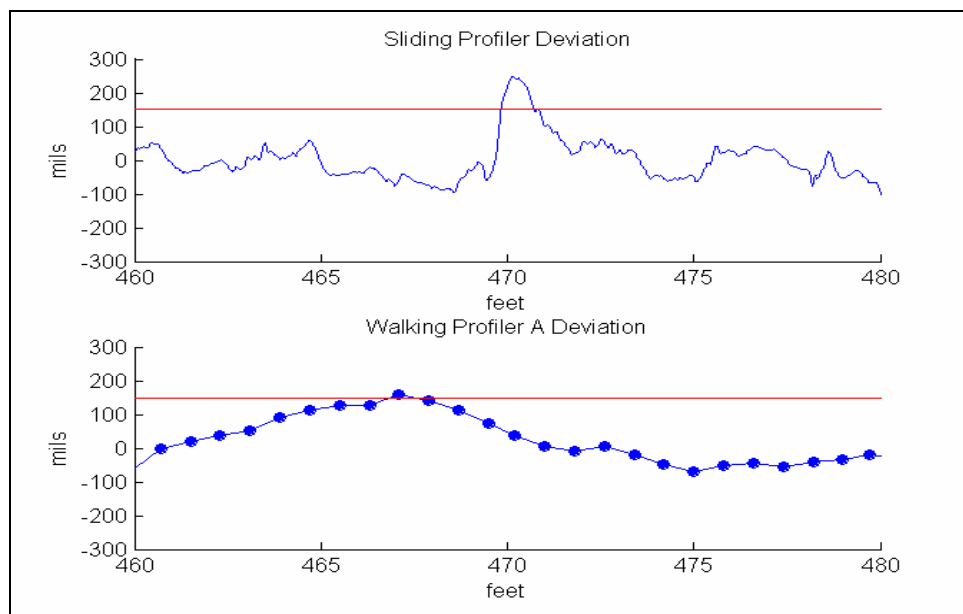
A comparison between the two detection methods is shown in the next figure. Because of the bump detection method used, the Sliding Profiler bump detection readings are always offset by about four feet. Note that the Walking Profiler detected a bump at 467 feet, and the Sliding Profiler detected a significant bump at 469 feet as illustrated in Figure 4.

**Figure 4 Comparison of El Paso 2 Bump Location and El Paso 1 Deviation at Same Point**

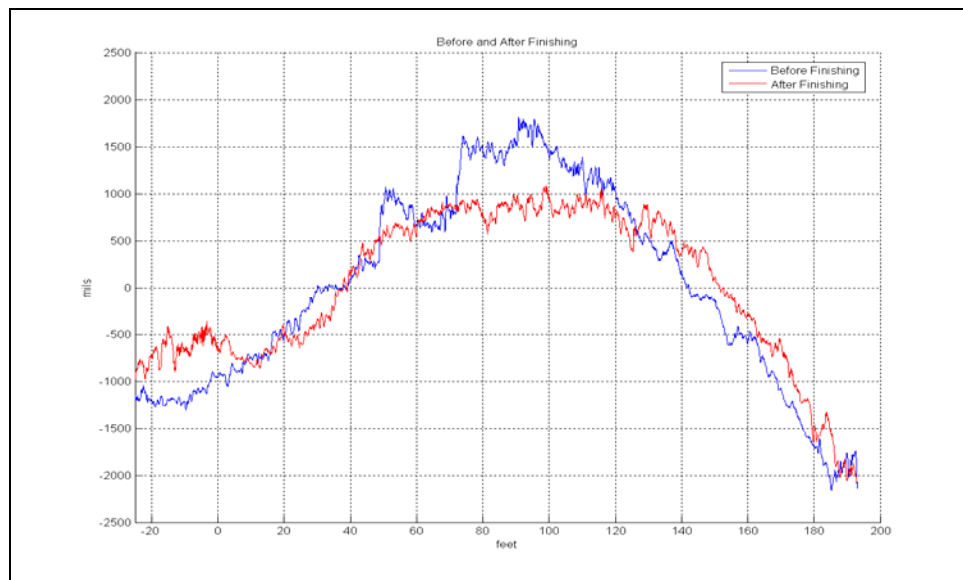
pavement, which had now been worked by the finishers, and the profiler was run over the section a second time. In both cases, a large number of bumps were noted. It was unknown if this was due to actual bumps, the bump settings or because of jerking caused by pushing the work bridge. Two workers, one on either side of the bridge would push the bridge. Additionally, if one end started before the other, the work bridge would not only jerk, but also result in pulling the profiler unit slightly to the right or left. A bump would typically be noted soon (six to eight feet) after the bridge would start up again. The data from the two runs were later plotted for comparison. The approximately same starting location was obtained by using a combination of the GPS coordinates and the distance count. Once the same beginning and end were established, the linear trend was removed and plotted in Figure 5 below.

**Figure 5 Decatur Section Before and After Finishing**

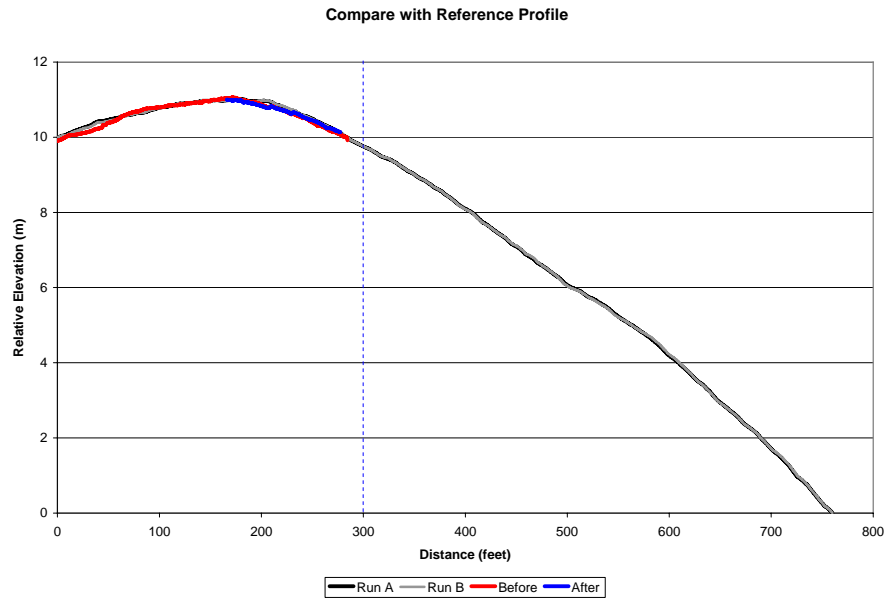
Later during the month, after the concrete had dried, the walking profiler was brought to the site and a reference profile was taken over the entire section. Figure 7 illustrates an overlay of the reference profile and data collected by the sliding profiler. The blue plot illustrates the 100 foot section where the pavement was rerun after the bump was detected.

**Figure 7 Comparison of Sliding Profiler with Reference Profile**

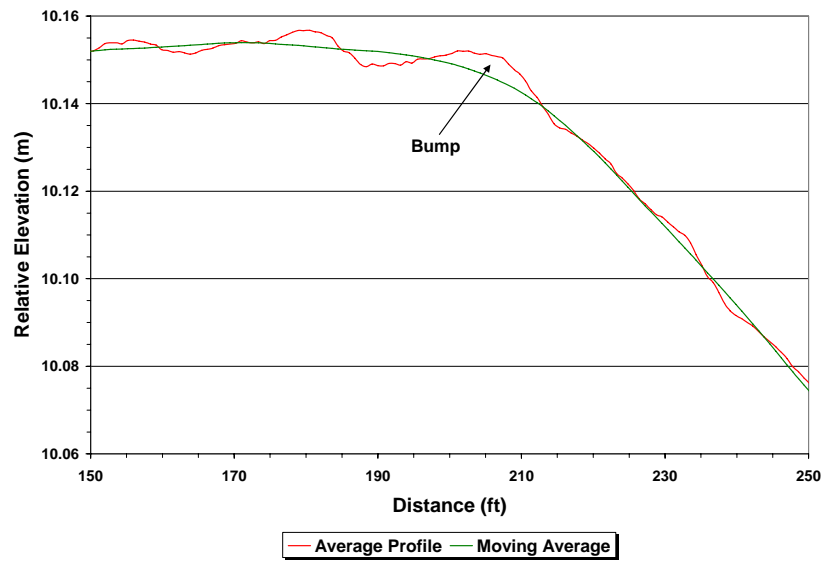
Figure 8 illustrates a bump found in the reference profile at approximately the same location as the bump noted by the sliding profiler during operations. Figure 9 illustrates a plot of the profile from the sliding profiler after reworking the bump area but still showing a bump in approximately the same area as found in the reference profile and during measurements.

**Figure 8 Bump Illustrated on Pavement**

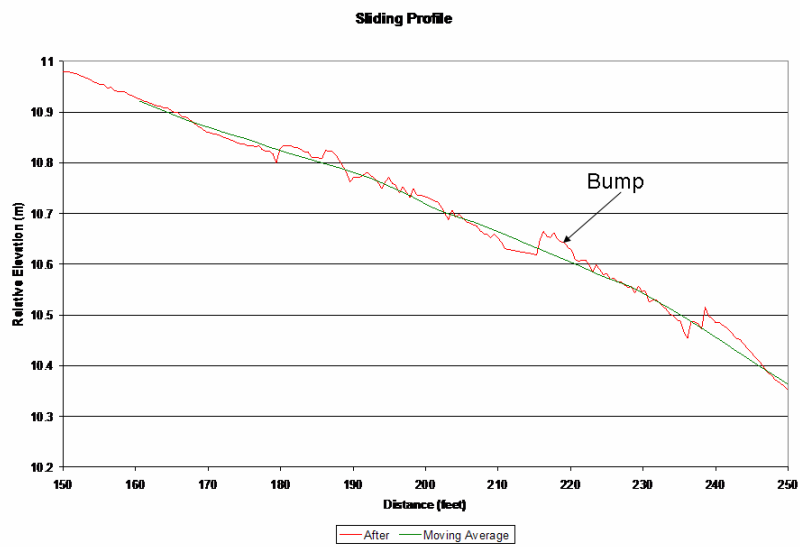
**Figure 9 Bump Found in Sliding Profiler Data**

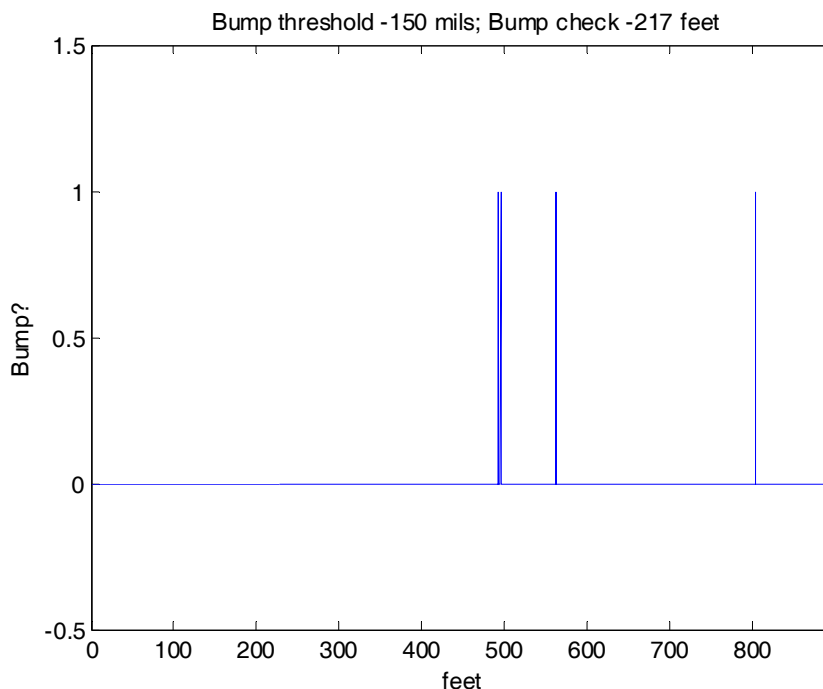
In a project wrap-up meeting on December 20, 2006, with David Head and other interested TxDOT personnel, the problems of introducing false bumps because of jerks when using the work bridge was discussed. UTA researchers developed a simple jerk removal procedure that was applied to the El Paso data. This procedure eliminated some of the false bump readings. Figure 14 shows that the number of bumps detected during the El Paso data runs changed from eight to three for the 150-mils bump setting (See Figure 3). In Figure 10, the first bump is the same one found in the reference profile taken by the Walking Profiler. The second bump indicated is at approximately the location where the work bridge was moved behind the finishers. Differences between the Walking Profiler and Sliding Profiler results may be due to changes in the concrete surface brought about by tining and curing. Note that the test with the Sliding Profiler was done on wet concrete while the test with the Walking Profiler was done after the concrete has hardened.

**Figure 10 Bump Detected Using Jerk Procedure**

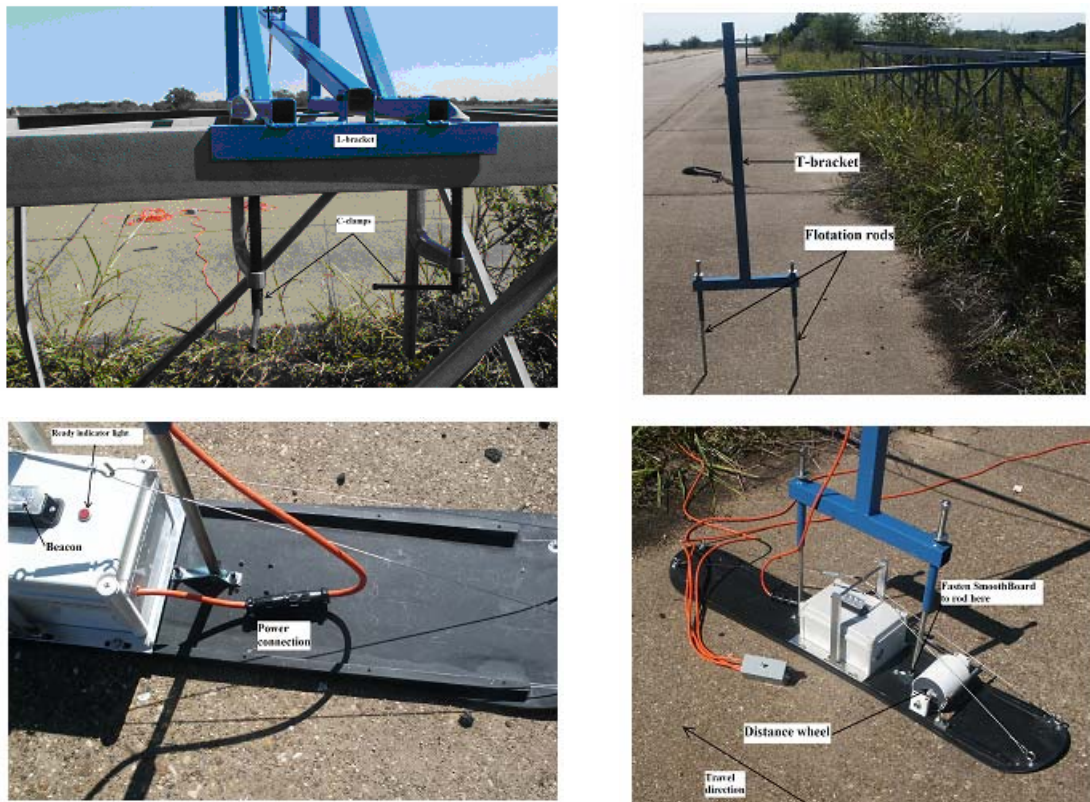
Three sliding profiler devices including hardware for attachments and an instruction manual were delivered to TxDOT. Figure 11 illustrates the sliding profiler delivered to TxDOT along with hardware used for attachment of the sliding profiler to an autofloat, work bridge or paver.

**Figure 11 Sliding Profiler and Connection Hardware**
