Bilston Glen No.1 DC Shaft Survey

Summary

A downhole CCTV survey was carried out of Bilston Glen No.1 DC (downcast) Shaft (Site Ref 432.1) on 10 July 2019. In addition, a geophysical survey using an electrical conductivity (EC) and temperature probe was run, as well as the collection of discrete water 'grab' samples for laboratory analysis.

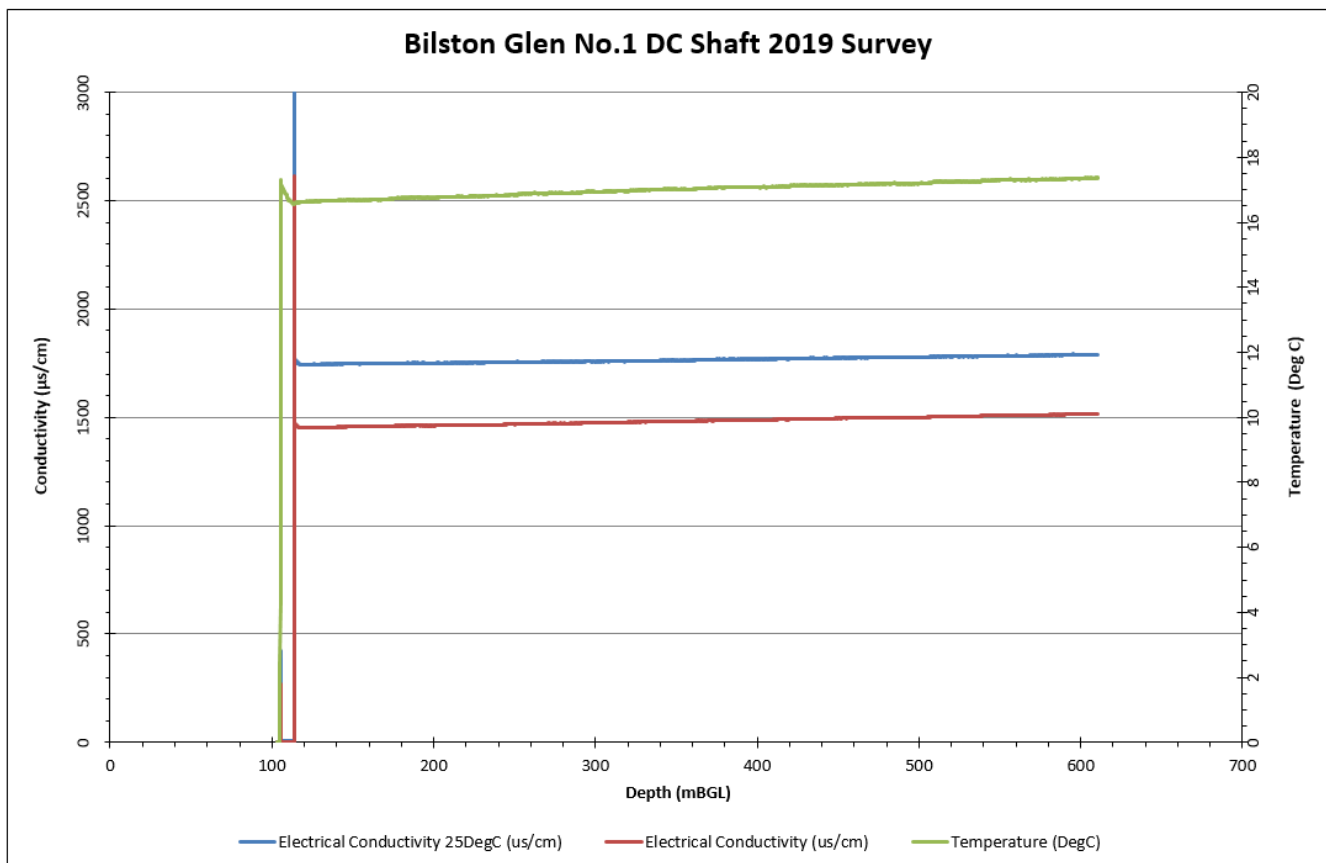
Figure 1: 2019 shaft survey showing electrical conductivity at 25°C, electrical conductivity, natural gamma and temperature vs depth

Standing water level at the time of survey was 113.6 mBGL. Samples were collected from the depths listed above. The full downhole geophysical survey results are presented in **Figure 1** with the shaft survey log included as **Appendix A**.

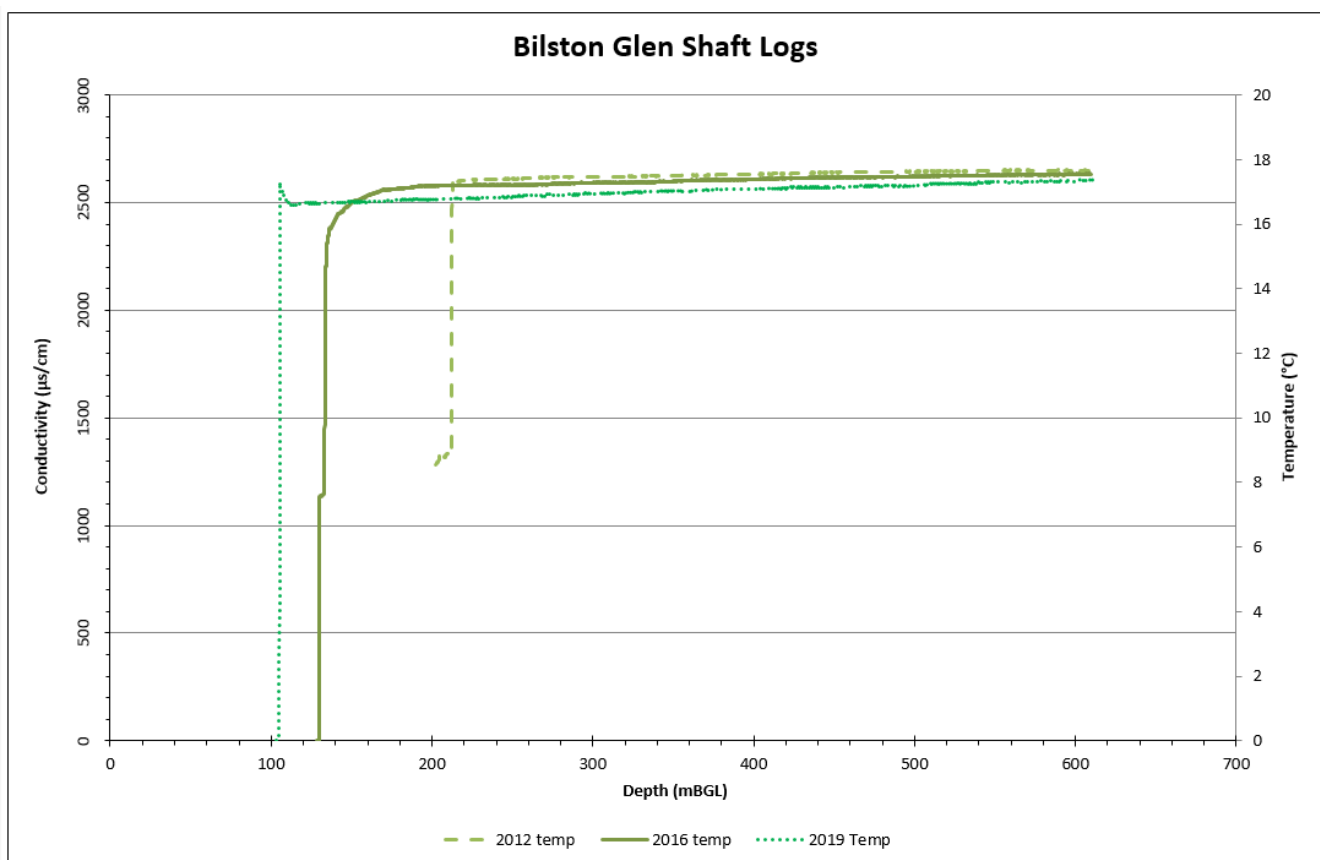
Figure 2: Comparison of 2012, 2016 and 2019 Bilston Glen shaft surveys, showing temperature

- The shaft temperature profile showed the water temperature to be in the range 16.5 to 17.4°C. The temperature profile is presented in **Figure 2** together with the in shaft temperature profiles from previous surveys in 2012 and 2016;

Previous shaft surveys were carried out in 2012 and 2016. The temperature and EC results from all three surveys are presented for comparison in **Figure 2** and **Figure 3**.

Overall, the 2019 assessment shows no substantial change in either in-shaft conditions or water quality from the previous surveys. The EC and the temperature profiles from each survey show the similar traces, representing consistent conditions throughout the shaft with no step changes detected, indicating a lack of stratification.

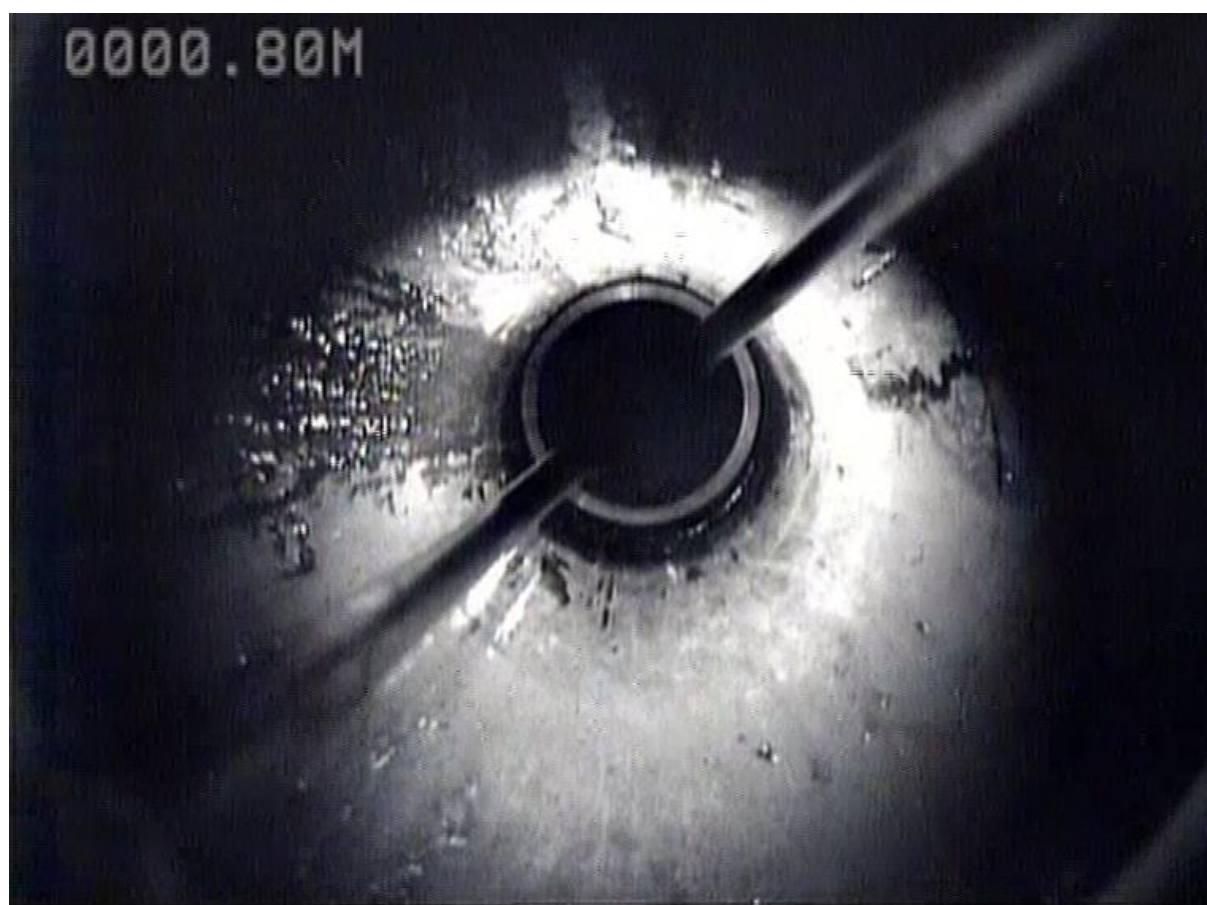
- The shaft is capped with a manhole access, the cap is penetrated by a 150mm casing;
- Below the cap (depth 24 m) the shaft is large diameter (7.3 m from shaft files);

Plate 1: Cased (~100mm) penetration through shaft cap (0 - 24mBGL)

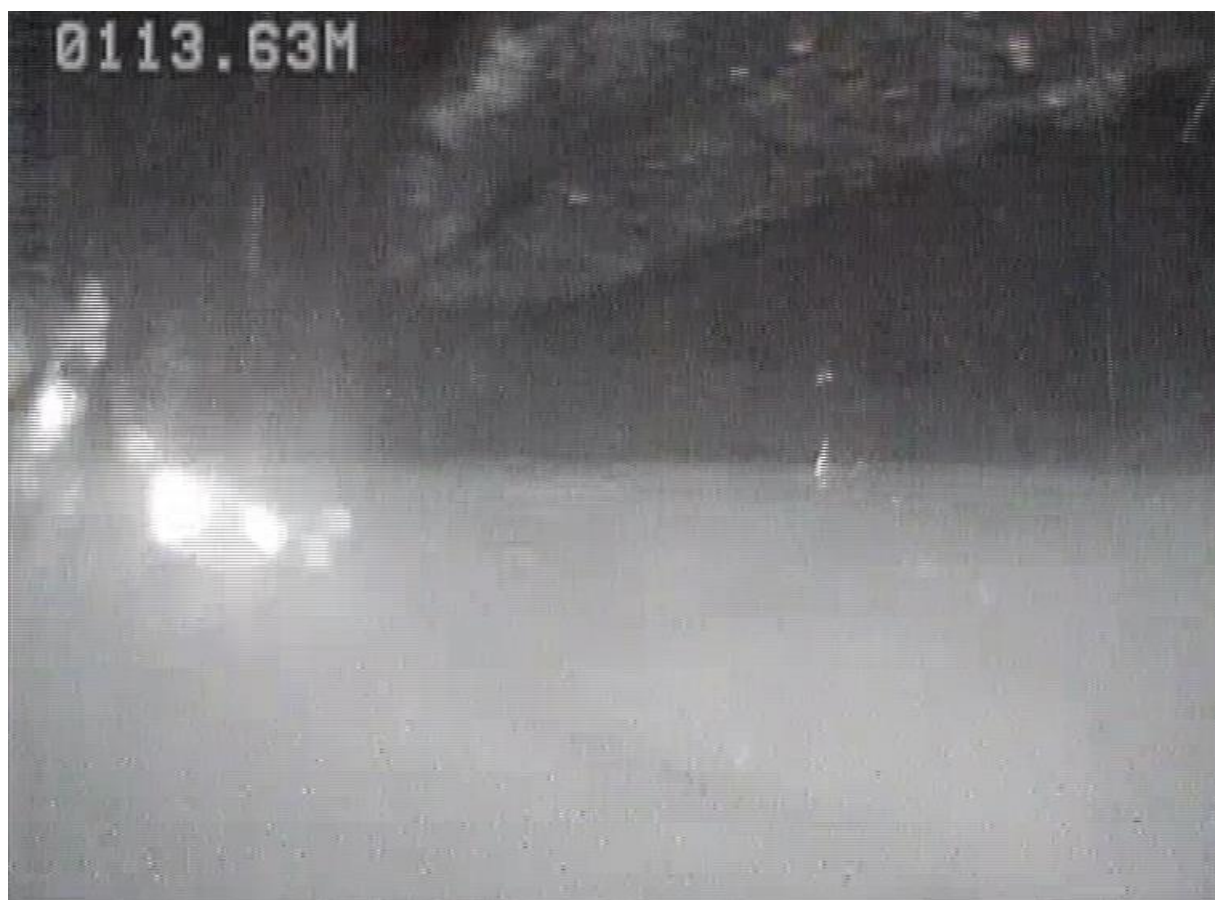
Immediately prior to the survey, water level was dipped at 113.6 mBGL. This was confirmed by the CCTV and downhole geophysical survey.

Plate 3: Water level at 113.6 mBGL

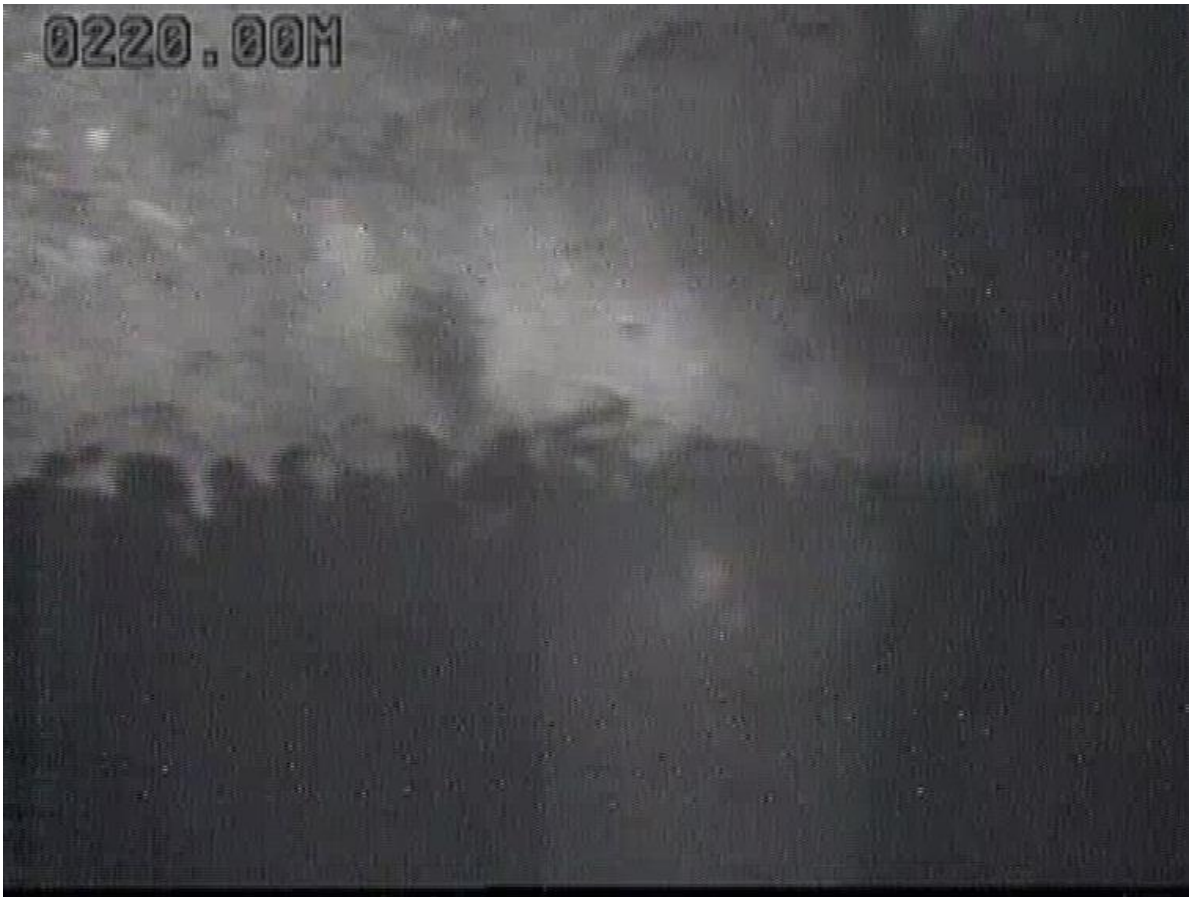
Plate 4: First sampling point at 220 mBGL

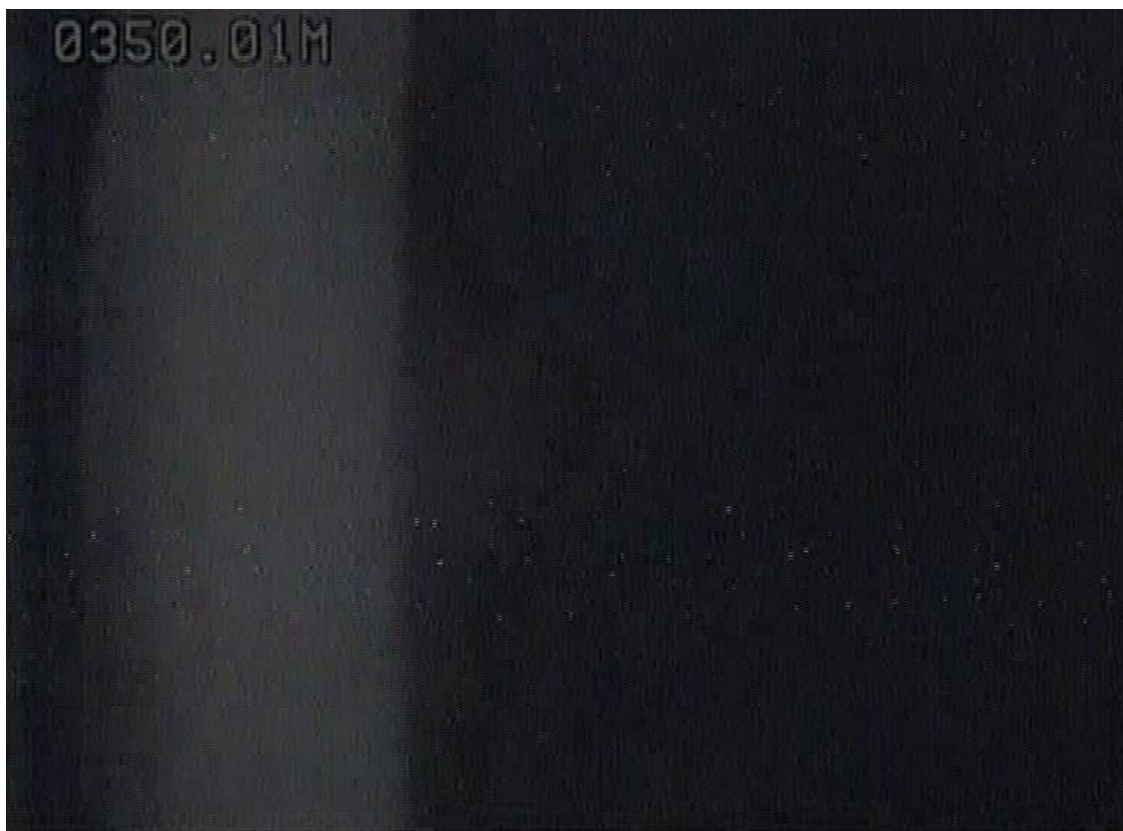
Plate 5: Photo 5: Second sampling point at 350 mBGL

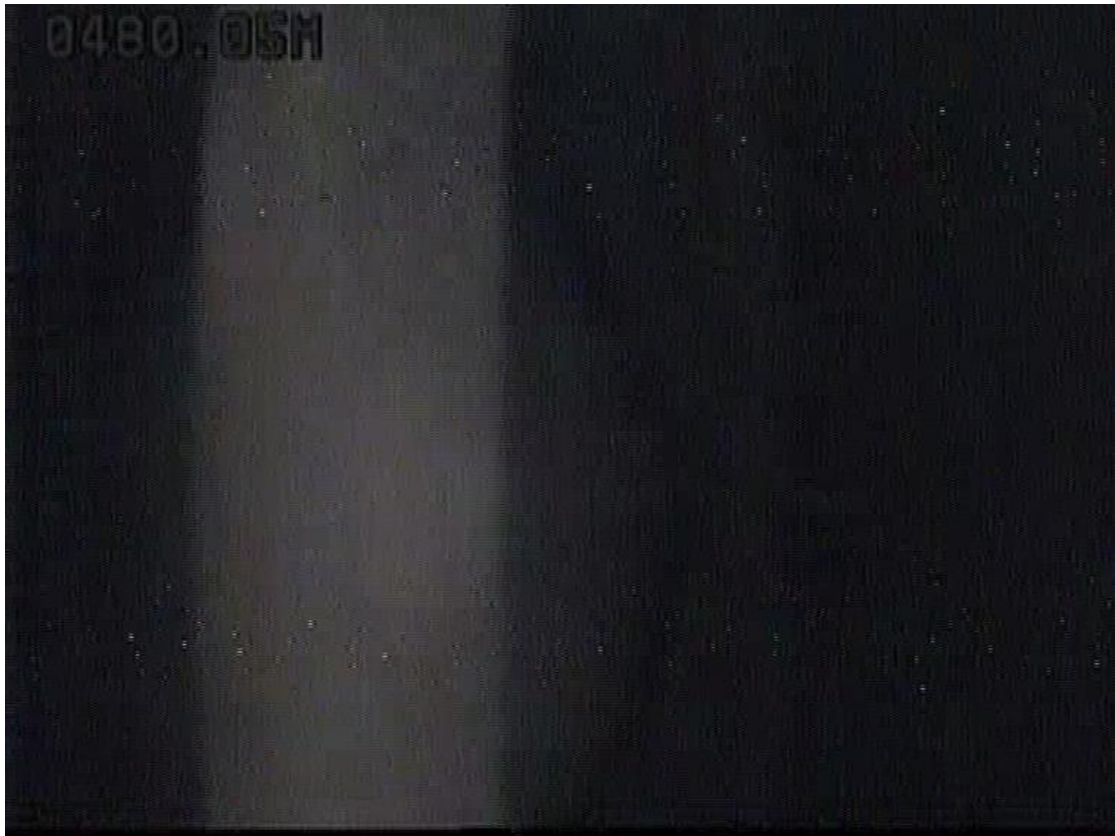
Plate 6: Third sampling point at 480 mBGL

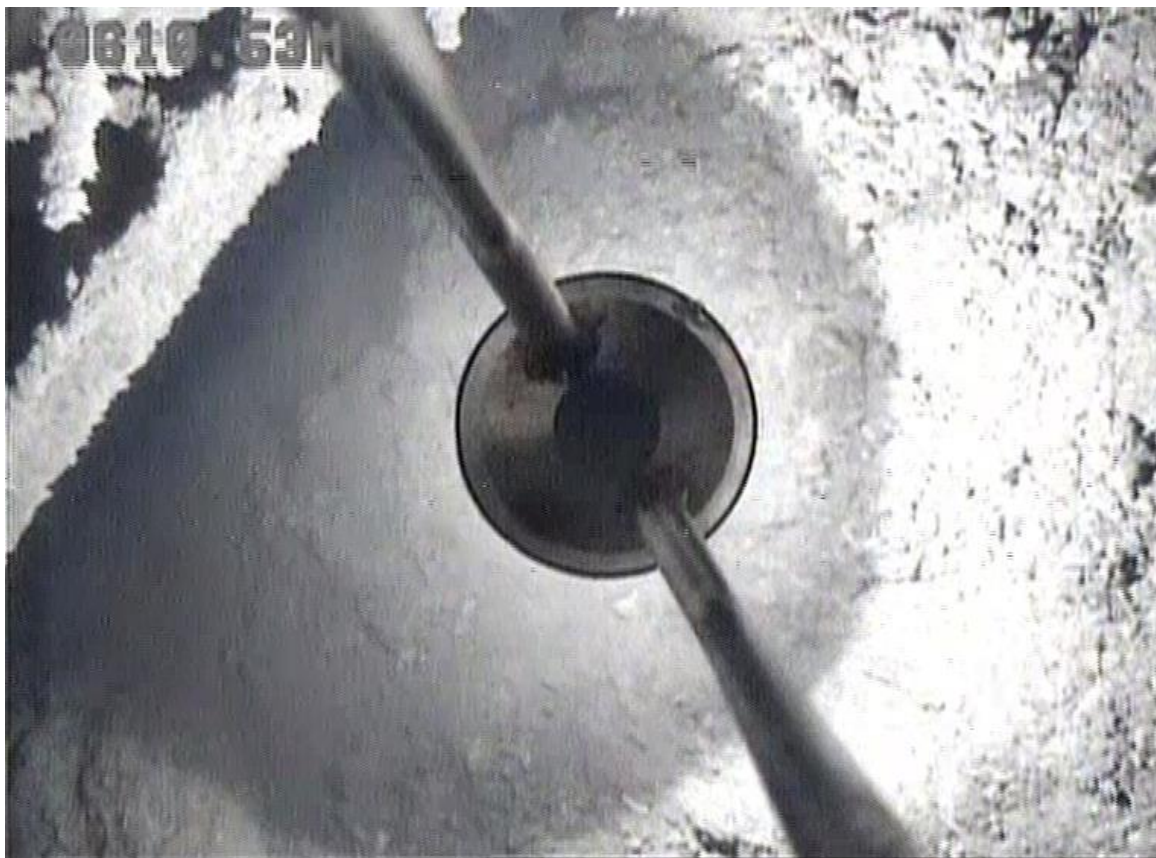
Plate 7: Final sampling point at 610 mBGL

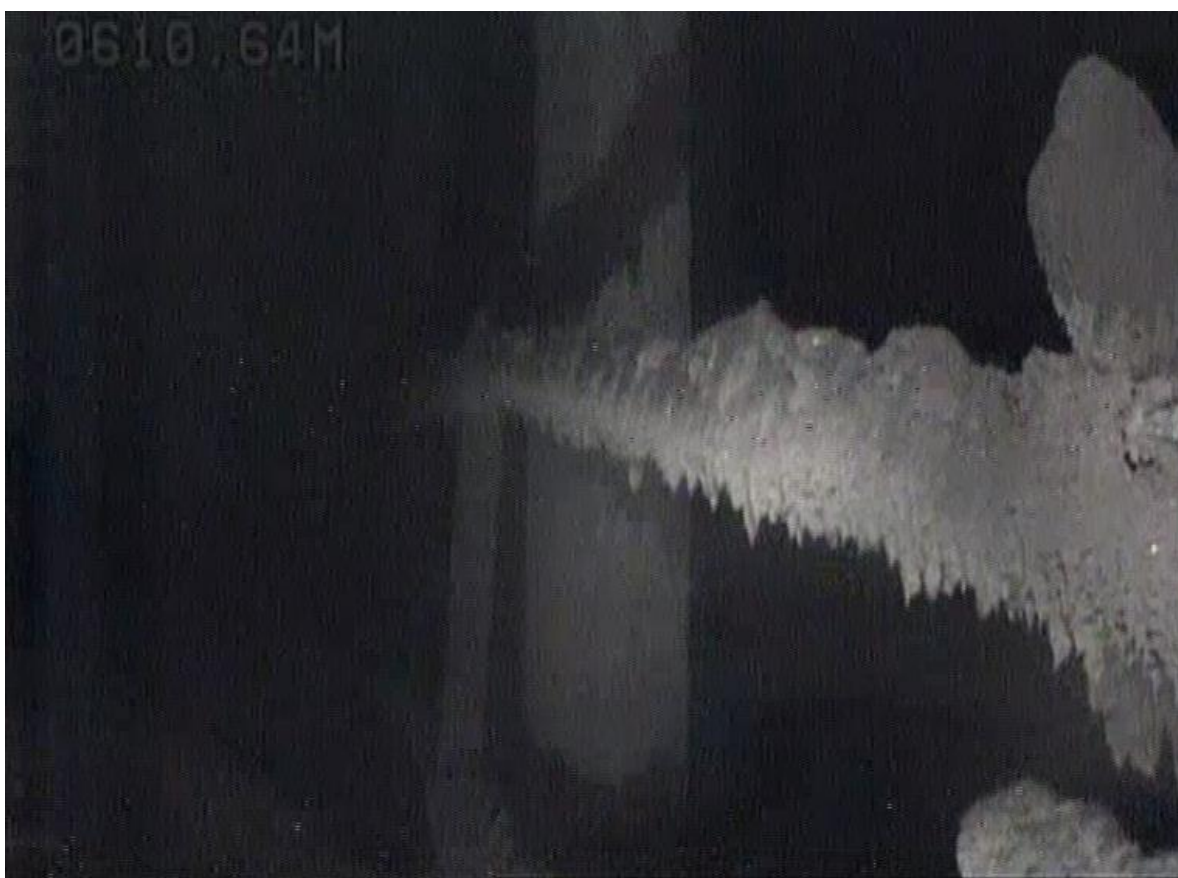
- Above water within the shaft various structures including risers and possibly cage guides and beams can be seen;
- Below water the visibility was good with clear water though some light coloured suspended sediment was visible. Due to the shaft diameter and the limits of light penetration the shaft sides were not clearly visible;
- Regular steel beams were visible at approximately 3 m intervals, these appeared to be in stable condition. Accumulations of light coloured sediment were present on top of all beams; and
- The base of shaft was visible with good water clarity, various structures including a suspected handrail were visible with accumulations of light coloured sediment.

Plate 8: Handrail at the base of the shaft 610 mBGL, probably associated with the 2010' Inset Level

Plate 9: Handrail at the base of the shaft 610 mBGL, probably associated with the 2010' Inset Level
