# Easthouses Great Seam Borehole Survey

## Summary

A CCTV survey was carried out on the Easthouses Great Seam Borehole (site ref 787.1) on the 11 July 2019. In addition to conductivity and temperature profiling, a calliper survey (which incorporates natural gamma) and sampling of water in the borehole was undertaken.

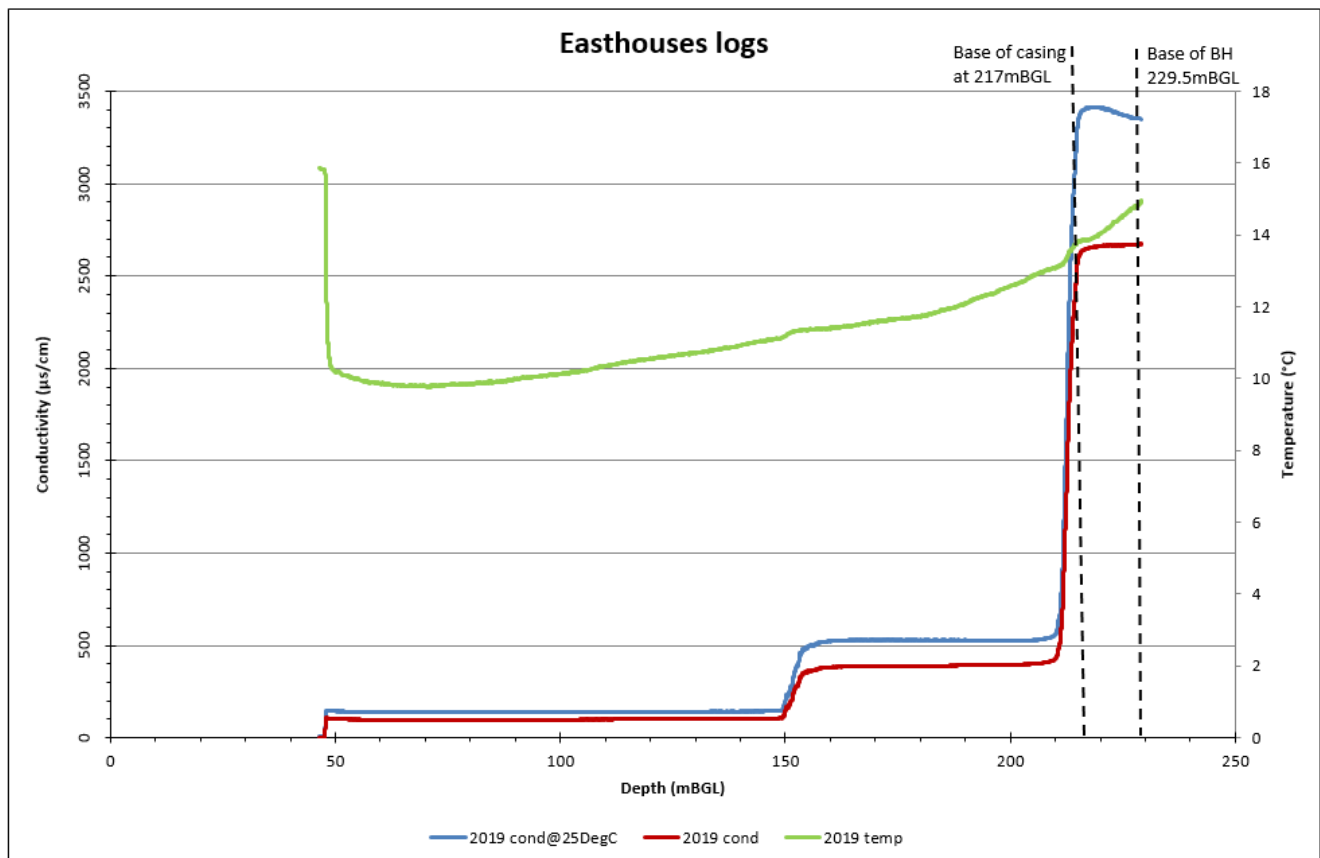
The conductivity data shows two step changes in the borehole at approximately 150 mBGL and 210 mBGL (shown in **Figure 1** and **Figure 4**).

The temperature increases by approximately 5°C throughout the hole, with further increases at the two step changes.

Figure 1: Graph showing all data for the 2019 survey. Including; conductivity, temperature and natural gamma

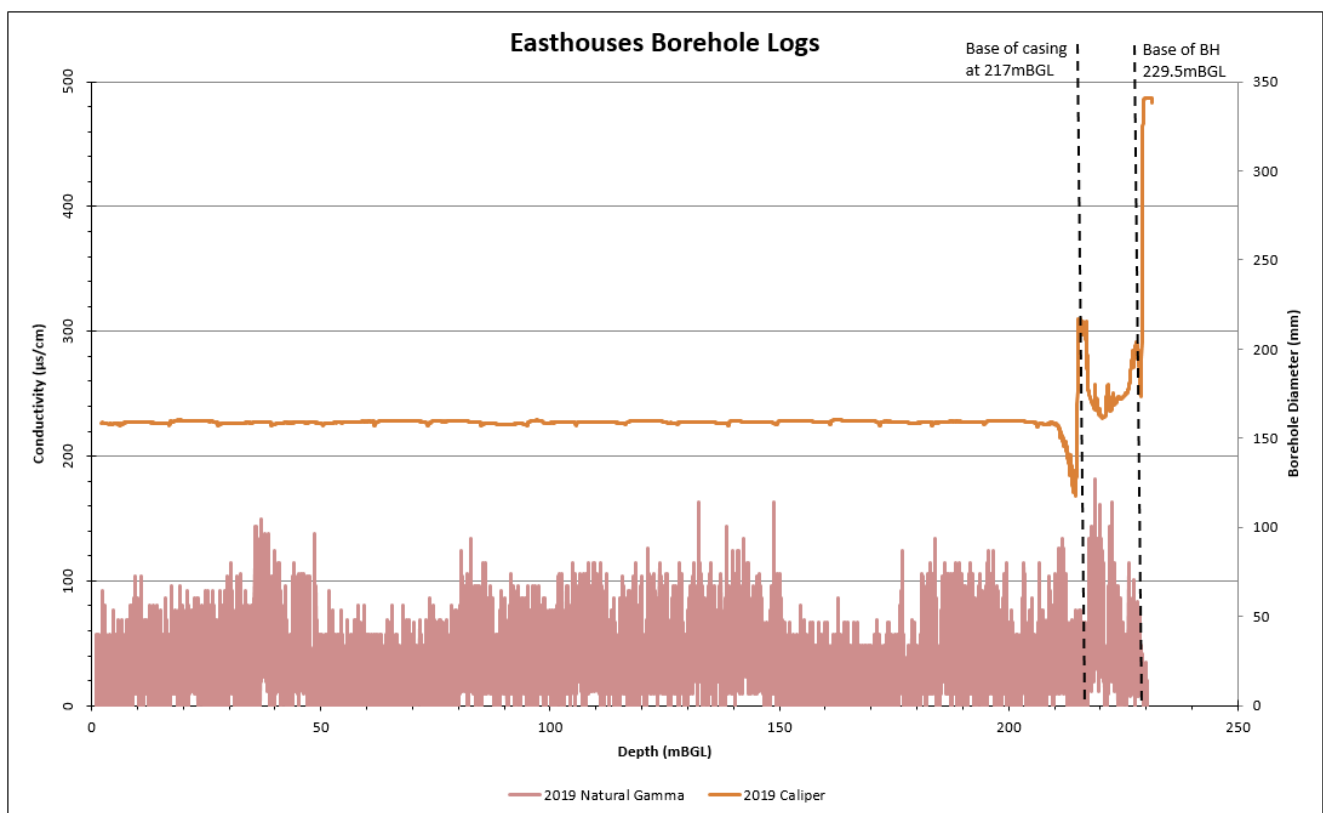
The calliper survey confirmed an average casing internal diameter of 160.8 mm. The survey showed no significant damage to the casing with a consistent diameter until approximately 210 mBGL, where the diameter appears to decrease in the last section of the casing. The open hole section showed a variable diameter, reaching a maximum of 338 mm at the bottom.

The average casing internal diameter of the 2019 survey was 160.8 mm, the average of the 2016 survey was 162.4 mm. The calliper survey results were broadly similar to the 2016 results, both of the surveys showed a relatively consistent diameter throughout (**Figure 2**).

Figure 2: Natural gamma results against the calliper data for the 2019 survey

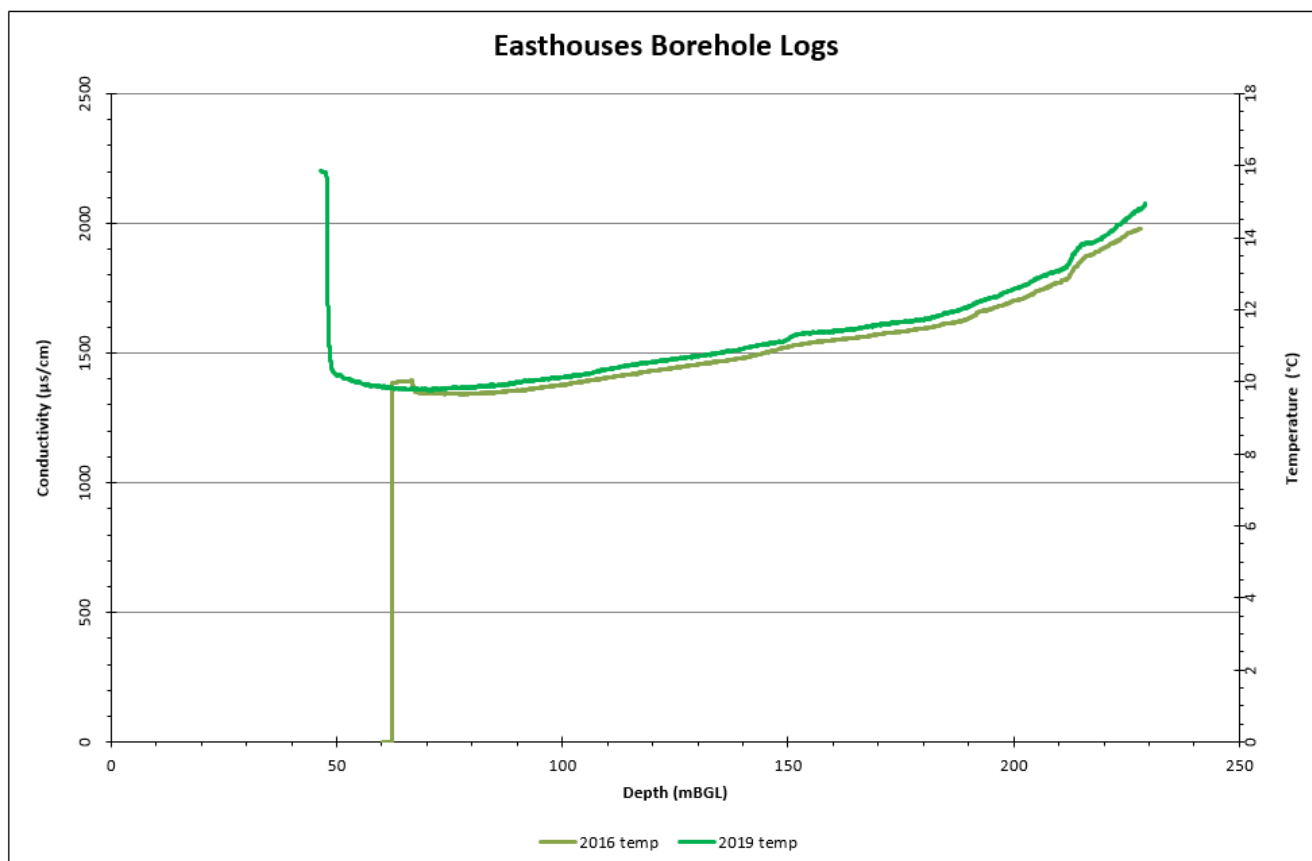
The temperature results from the 2019 survey show a ~1°C increase when compared to the 2016 survey (Figure 2). Overall, throughout the borehole the temperature profile remains the same as that of the 2016 survey, showing a gradual increase of approximately 4°C with borehole depth (**Figure 2**).

Figure 3: Graph showing the temperature data for the 2016 and 2019 surveys

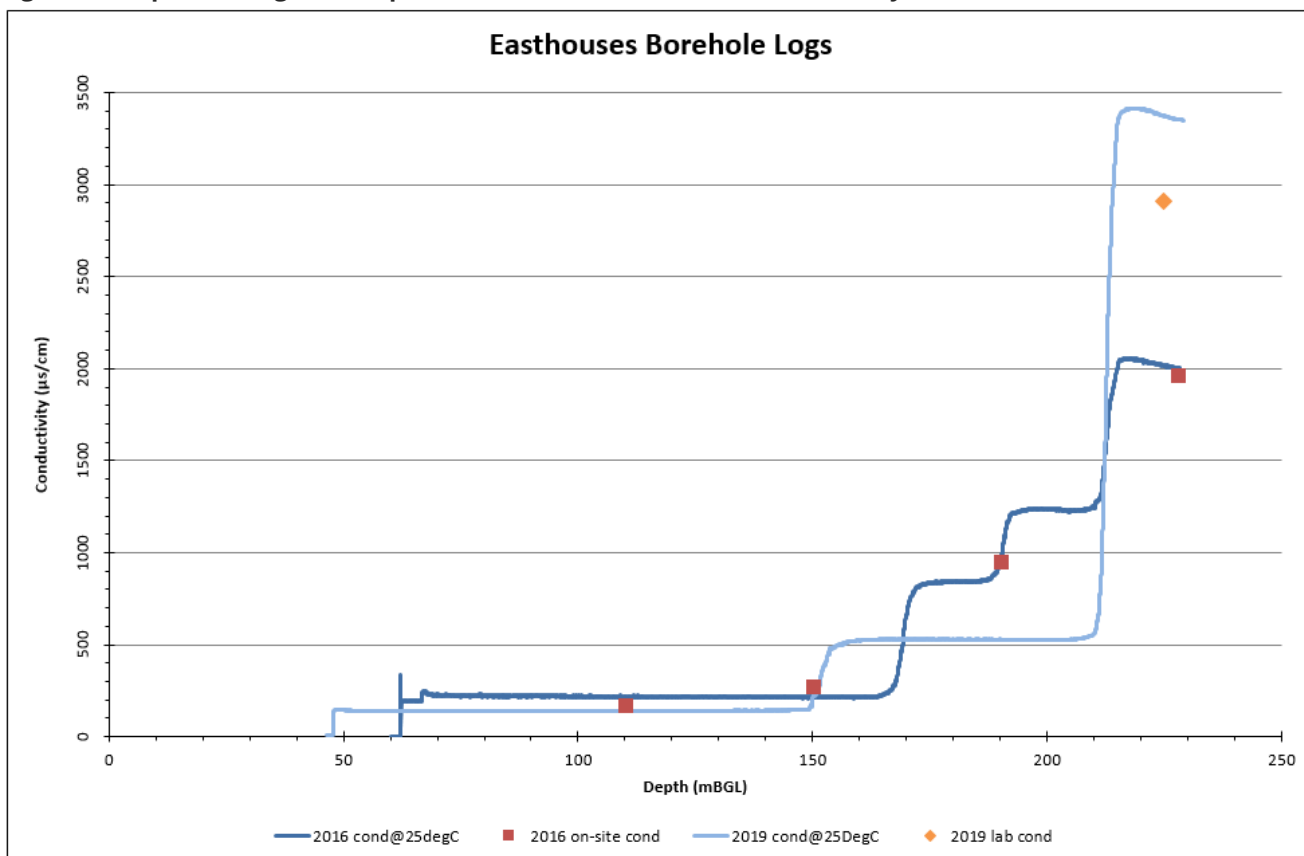
The conductivity results from the 2019 survey show two main step changes throughout the borehole, at 150 mBGL and 210 mBGL. This differs from the 2016 survey, which shows three main step changes at 170 mBGL, 190 mBGL and 210 mBGL (**Figure 3**).

Figure 4: Graph showing the conductivity for the 2016 and 2019 surveys

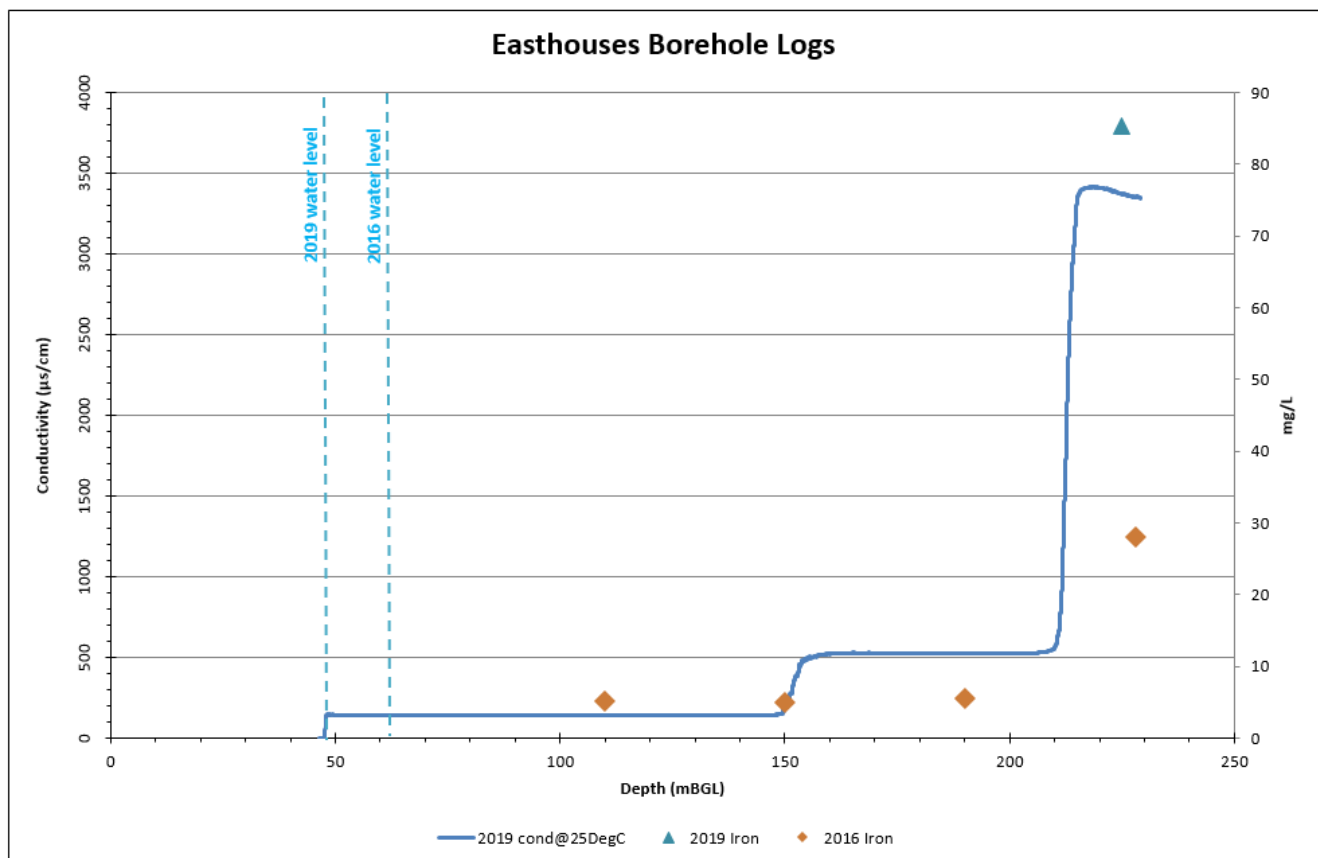
- The iron concentrations have increased by ~57 mg/L since the 2016 survey;
- The sulphate concentrations have decreased by ~500 mg/L since the 2016 survey;
- The chloride concentrations have increased by ~20 mg/L since the 2016 survey;

Figure 5: Graph showing the iron data from the 2016 and 2019 surveys

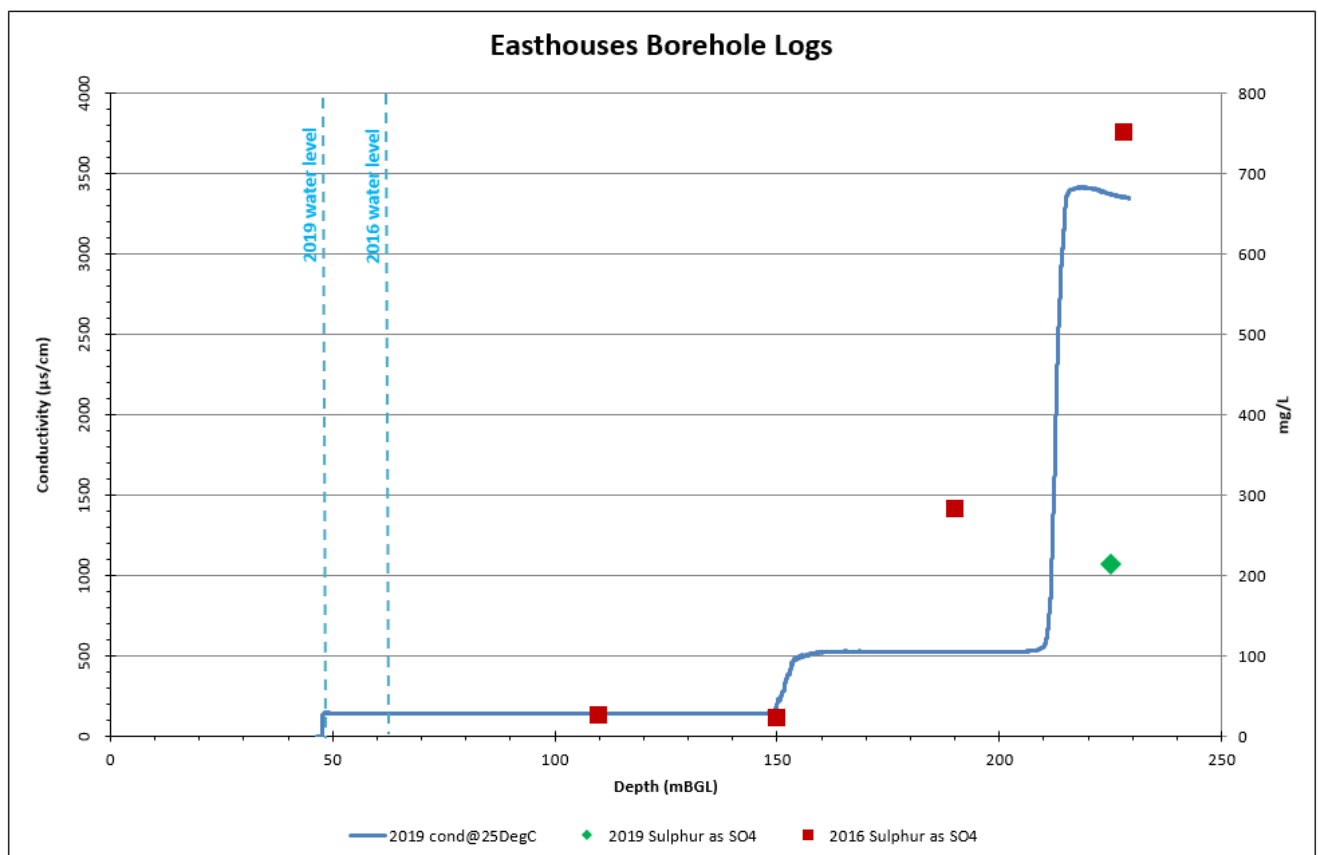
Figure 6: Graph showing the sulphur data from the 2016 and 2019 surveys

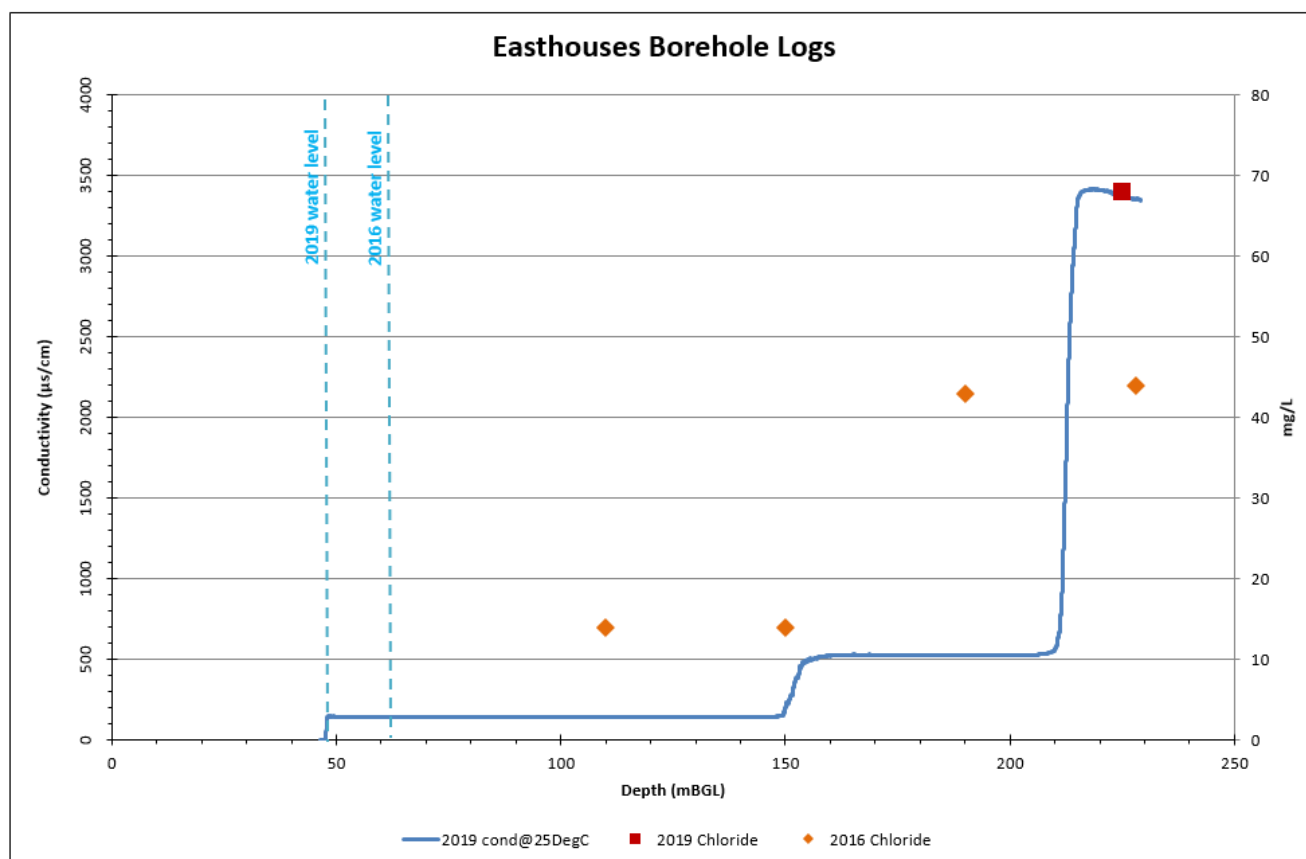
Figure 7: Graph showing the chloride data from the 2016 and 2019 surveys

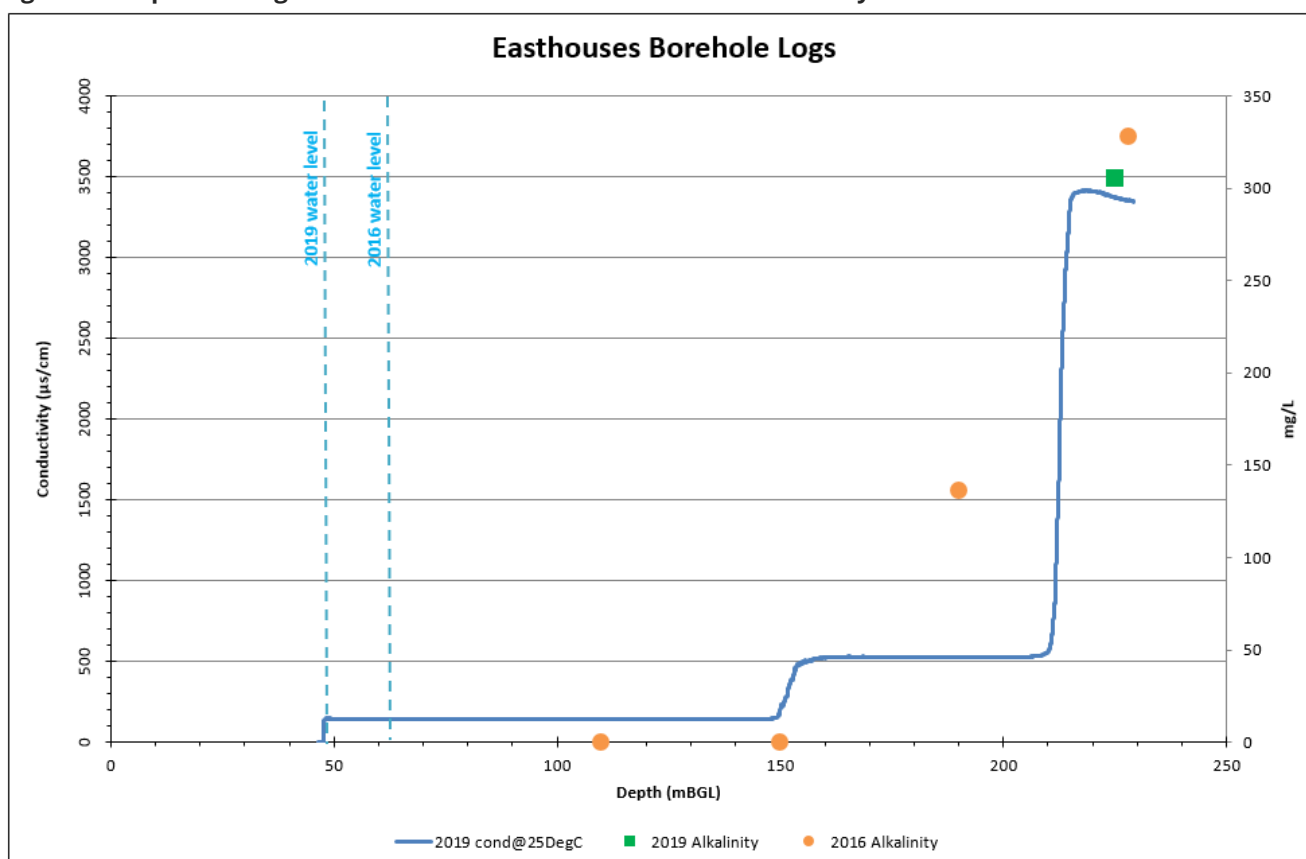
- The alkalinity results are within ~20 mg/L difference between the two surveys.

Figure 8: Graph showing the alkalinity data from 2016 and 2019

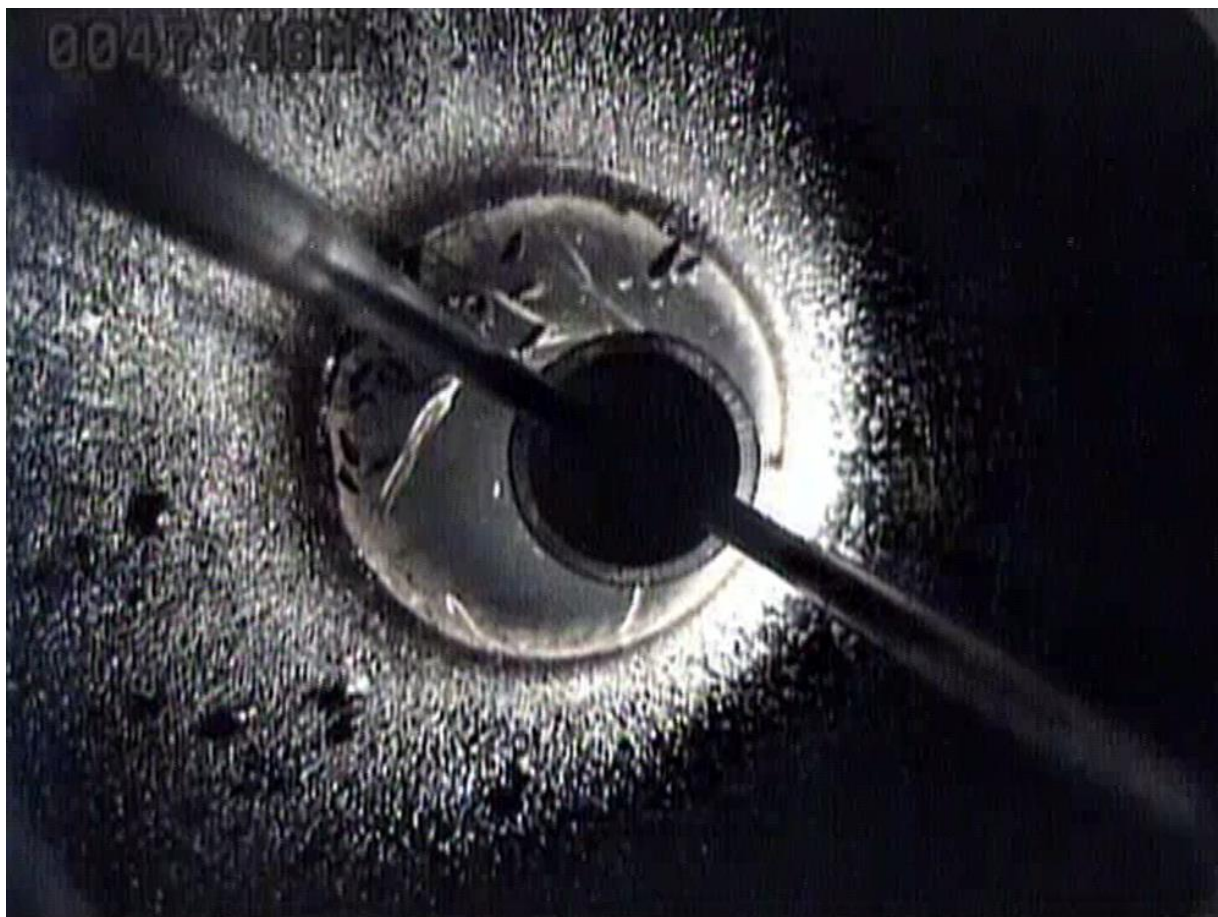
Immediately prior to the survey, water level was manually dipped at 47.84mBGL. This matched the water level observed by the CCTV survey at 47.8mBGL. The conductivity and temperature logs further confirm the water level.

Plate 1: Water level at 47.6 mBGL.

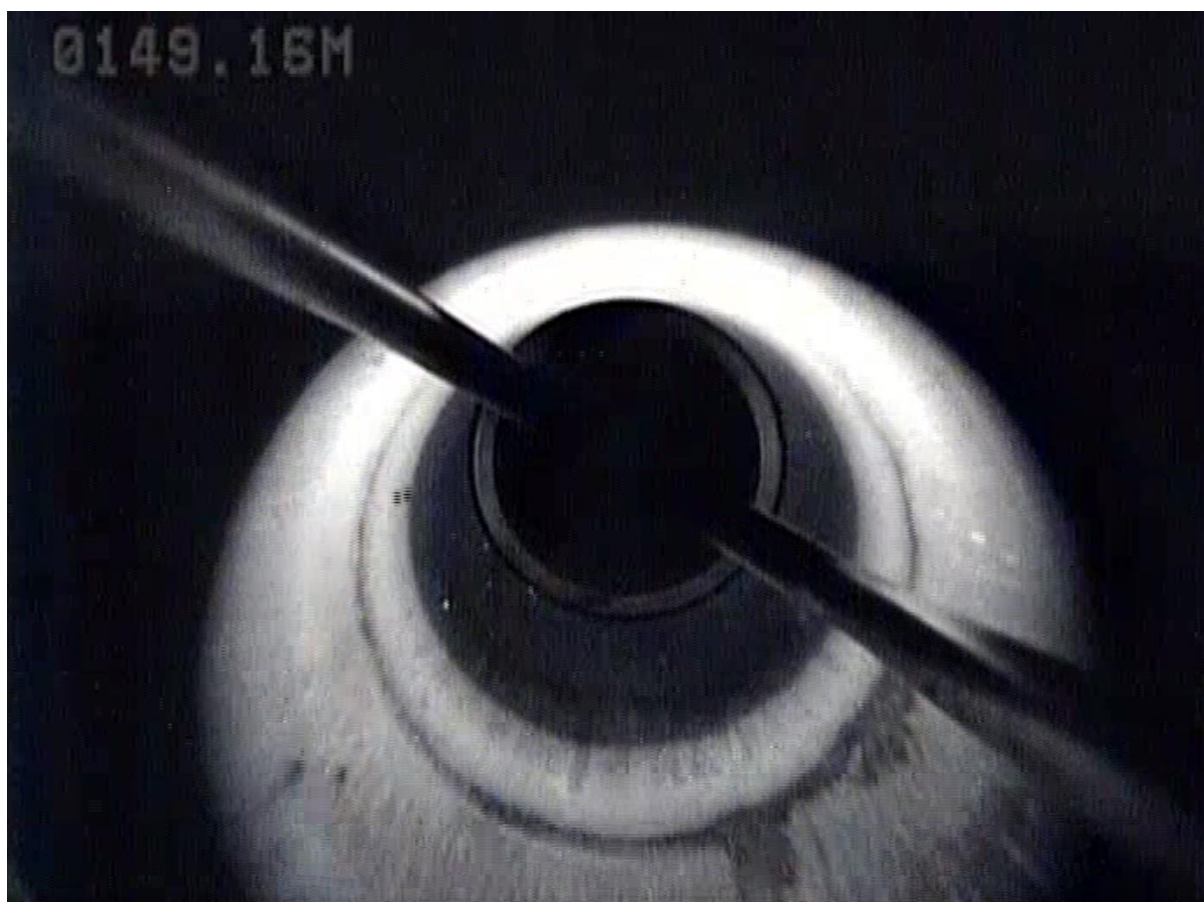
- No visible water quality differences at both step changes (150 and 210 mBGL);
- Minor debris/suspended solids visible from 150 mBGL, the amount of debris increases gradually with depth;

Plate 2: Level of the first step change in the borehole with a casing joint at 149mBGL

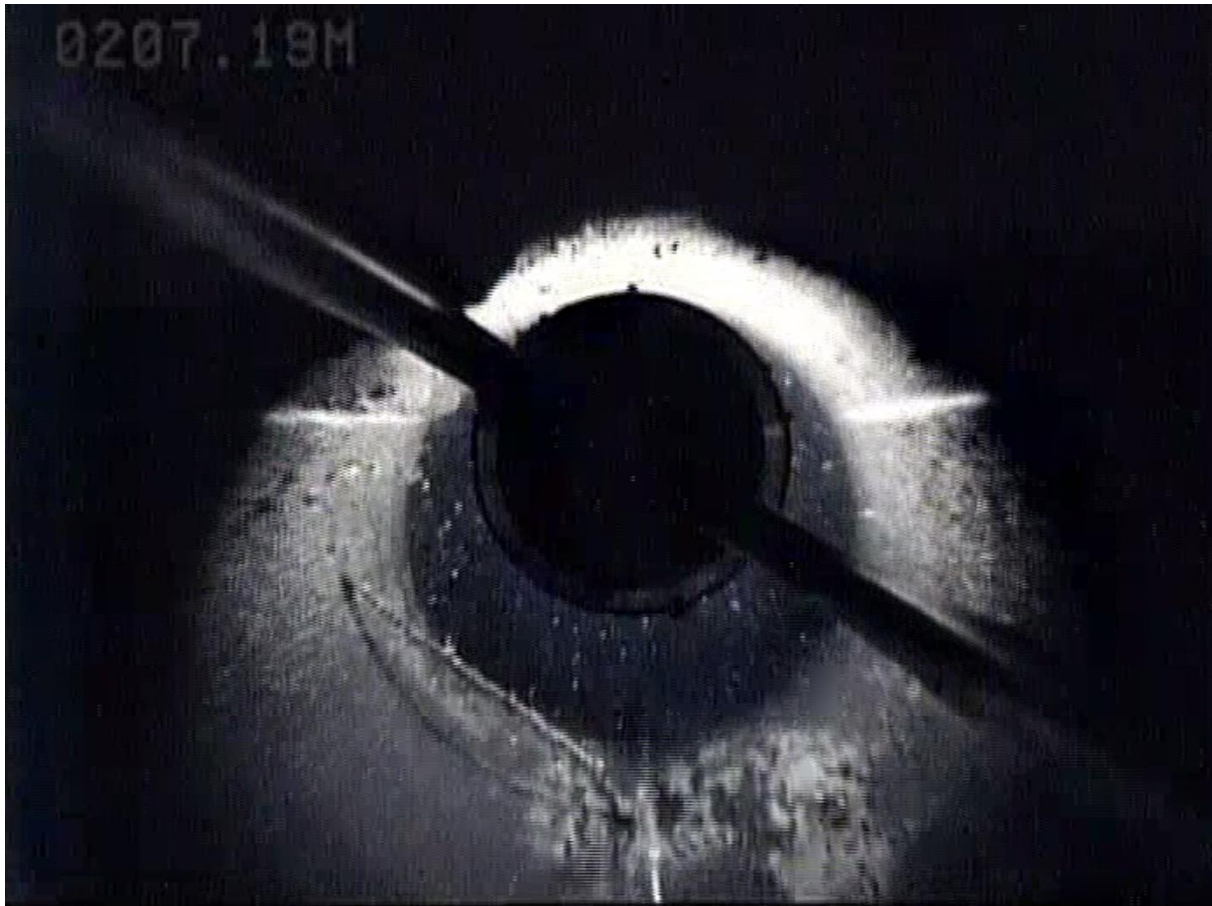
**Plate 3: Scratches from a previous calliper survey and debris at 207mBGL**

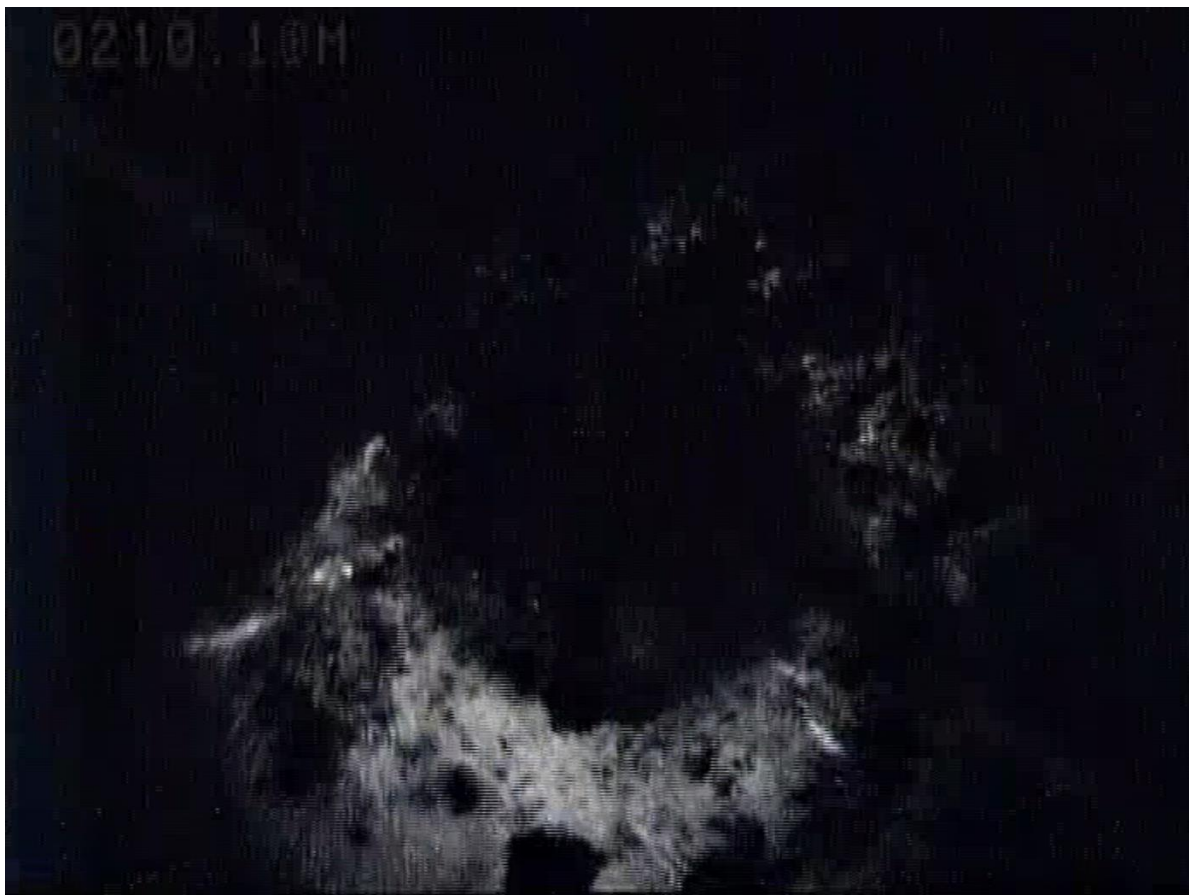
- There is a clear reduction in clarity from 209 mBGL, visibility gradually deteriorates before being completely lost below 213 mBGL: and
- Debris accumulation appears to have caused a reduction of the borehole diameter and possibly an obstruction at 211 mBGL.

**Plate 4: Level of the second step change and increase in debris in the borehole at 210mBGL**

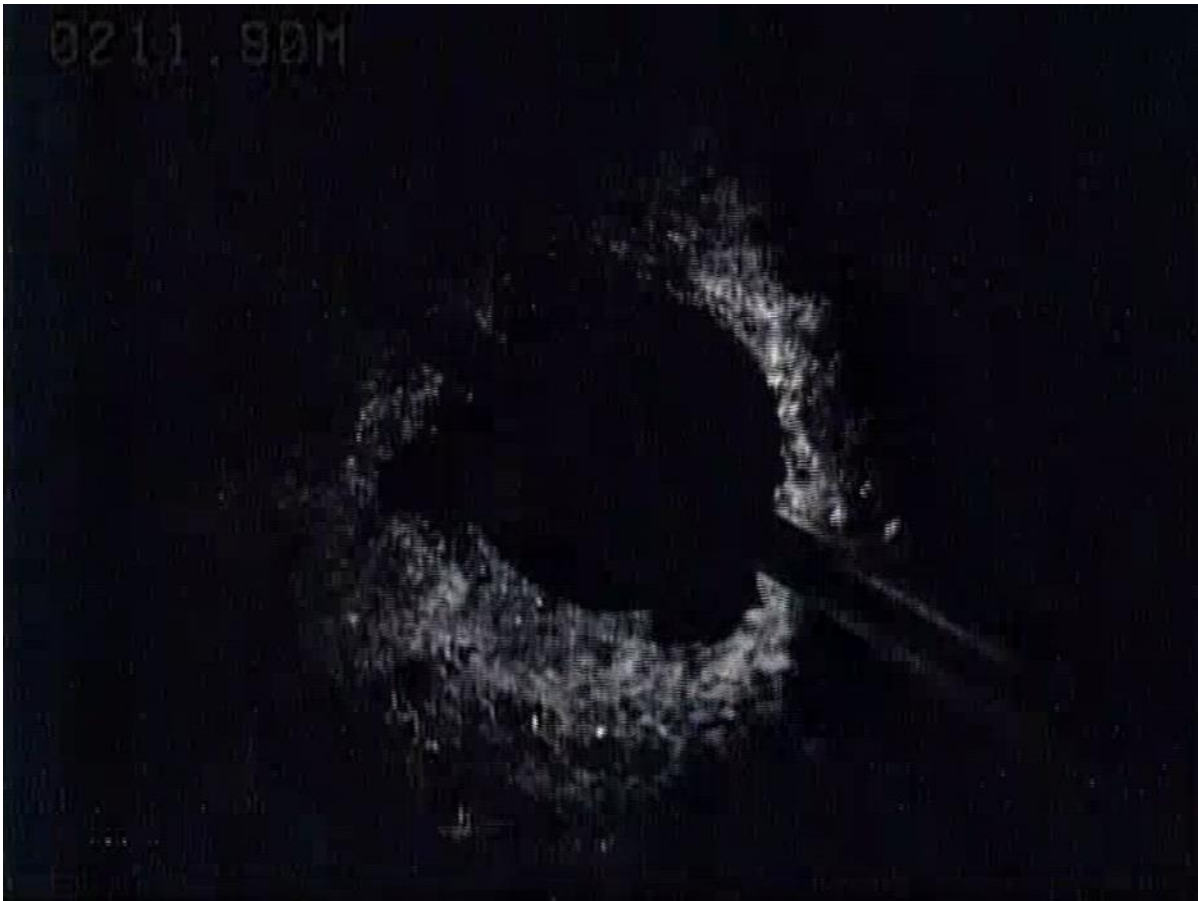
**Plate 5: Build-up of debris in borehole at 212mBGL. CCTV survey ended at 214.27mBGL due to poor image**
