KENYA SPACE AGENCY
Possibilities beyond our skies

N-3.5 Launch report

15th July 2024

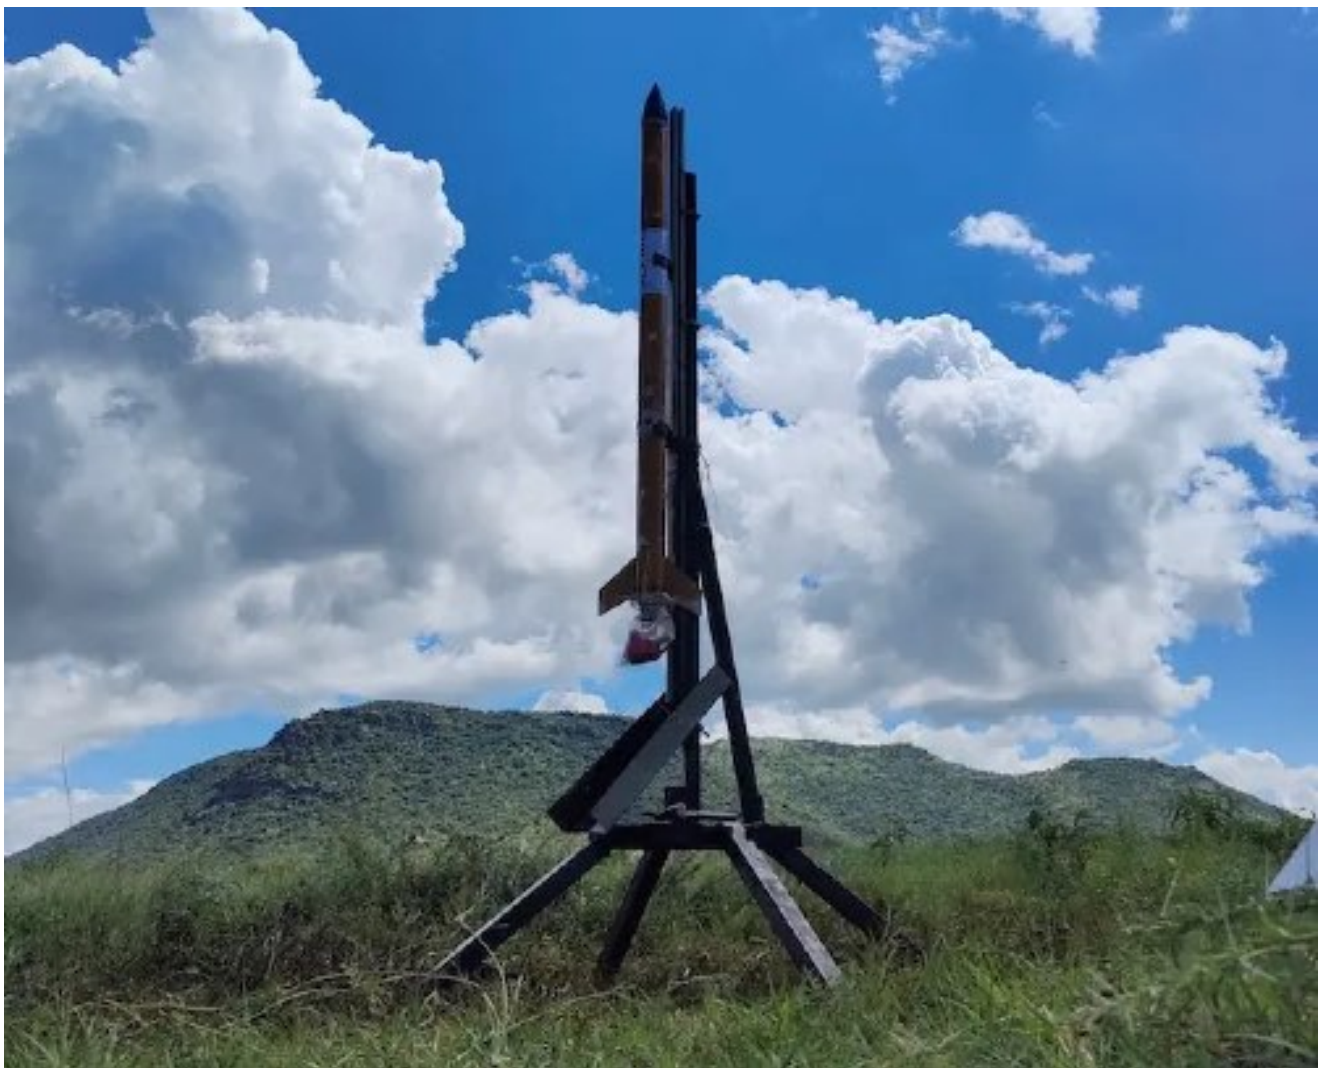
Figure 1. N-3.5 rocket installed at the launch pad

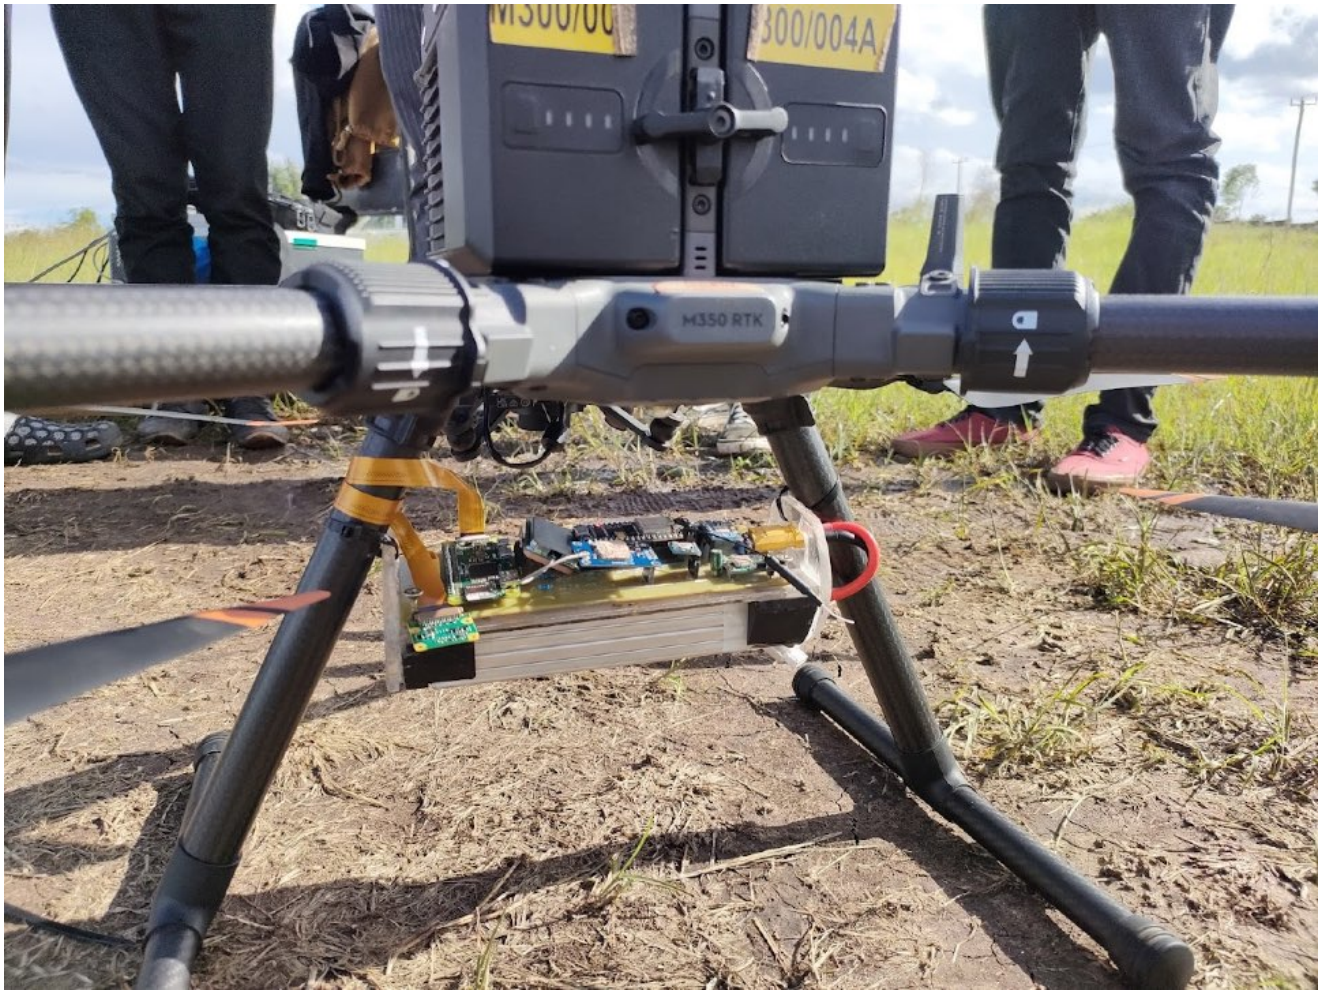
A state machine is implemented on the flight computer software to detect the apogee and trigger the parachute ejection. The transition of the state machine was confirmed through flight testing using a DJI Matrice M300/M350 drone.

Figure 4. Flight computer testing using Drone

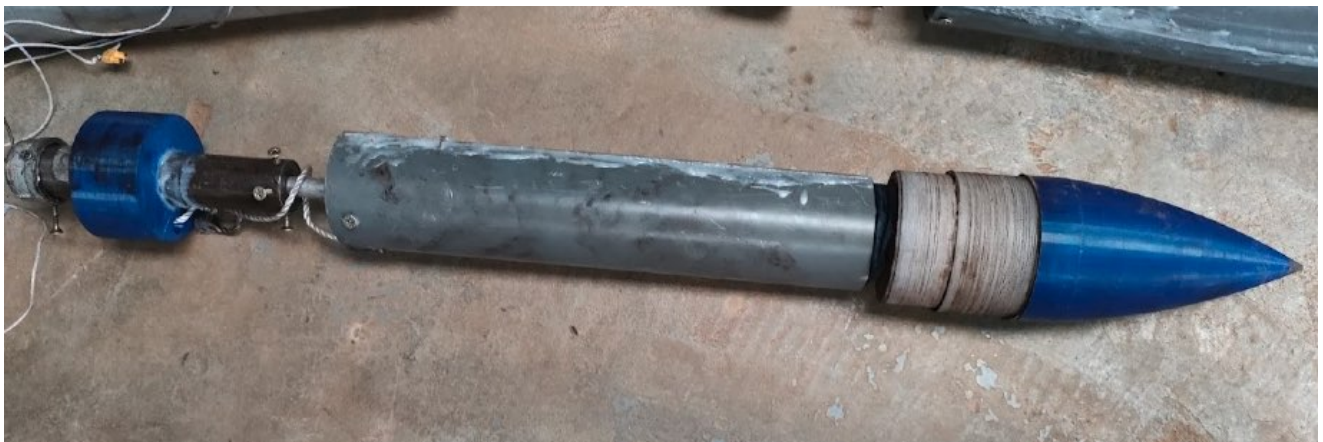
The N-3.5 rocket uses the pyrotechnic parachute ejection mechanism as the N-3 rocket. The PVC cylinder has a crimson powder ignited to generate high-pressure gas that pushes the piston forward.

Figure 6. Parachute ejection mechanism

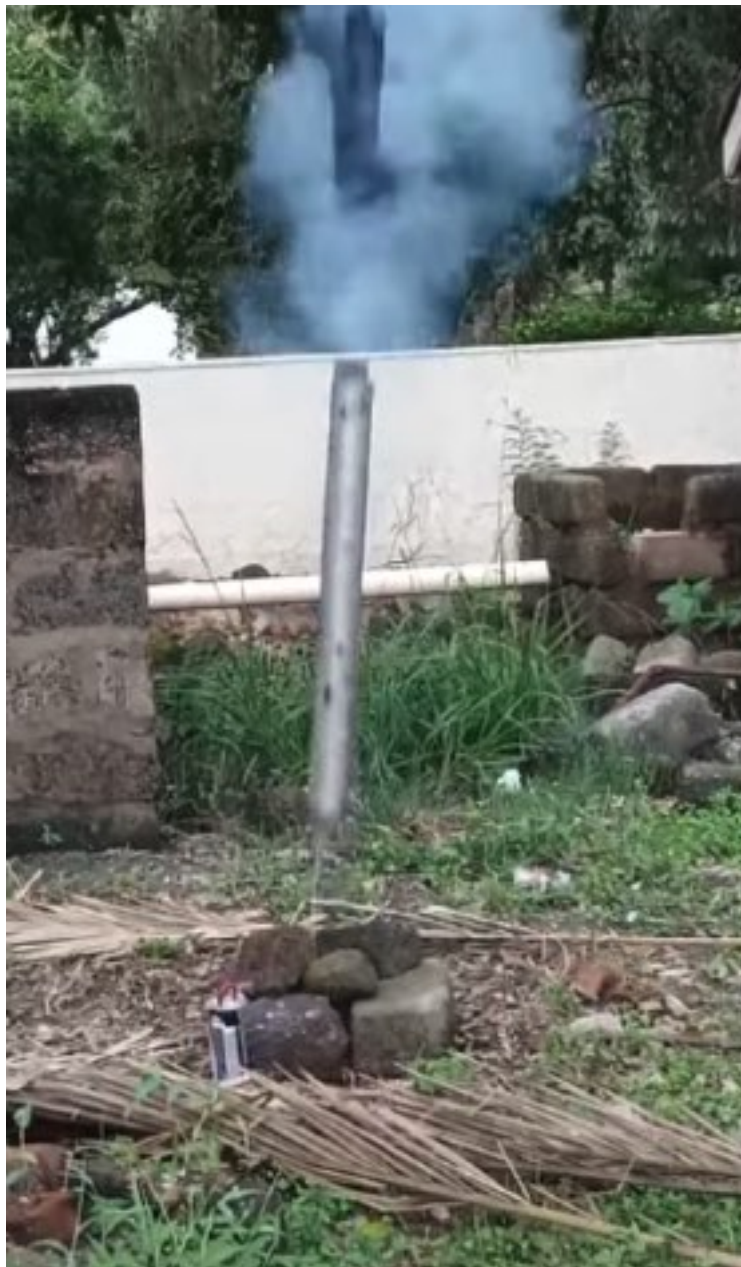
The parachute ejection mechanism was tested through the pop test. The amount of the crimson powder necessary to push the piston was identified as 17 grams.

Figure 7. Pop test

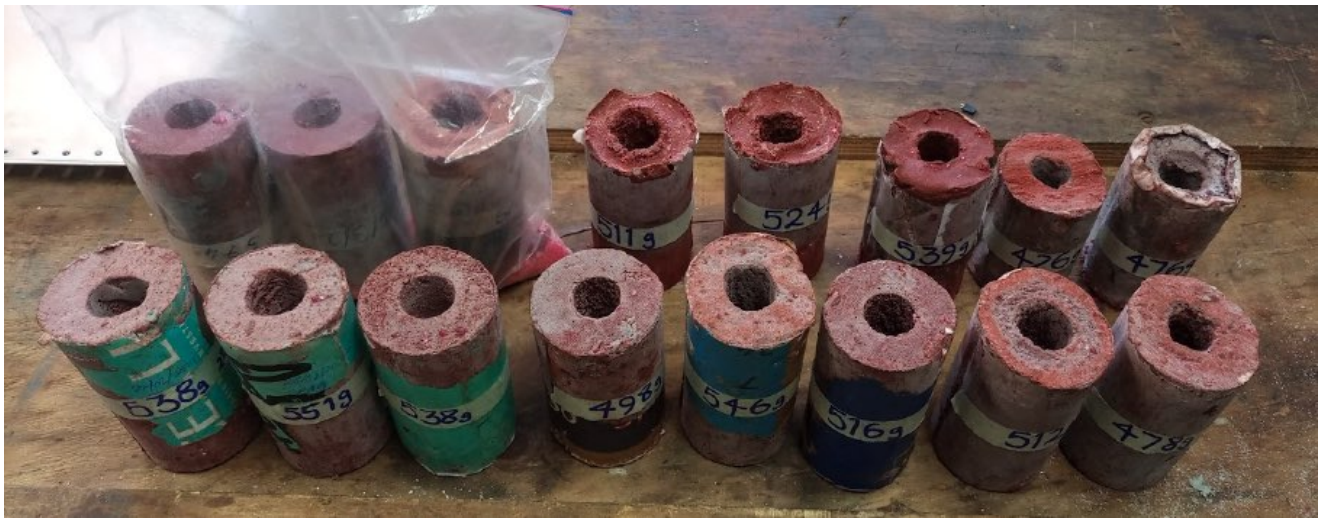
The solid rocket motor is a KNSB propellant, which uses sorbitol and potassium nitrate as fuel and oxidizer, respectively. The casted grains are shown in Figure 8. Four grains are installed in a single rocket motor casing.

Figure 8. KNSB grains

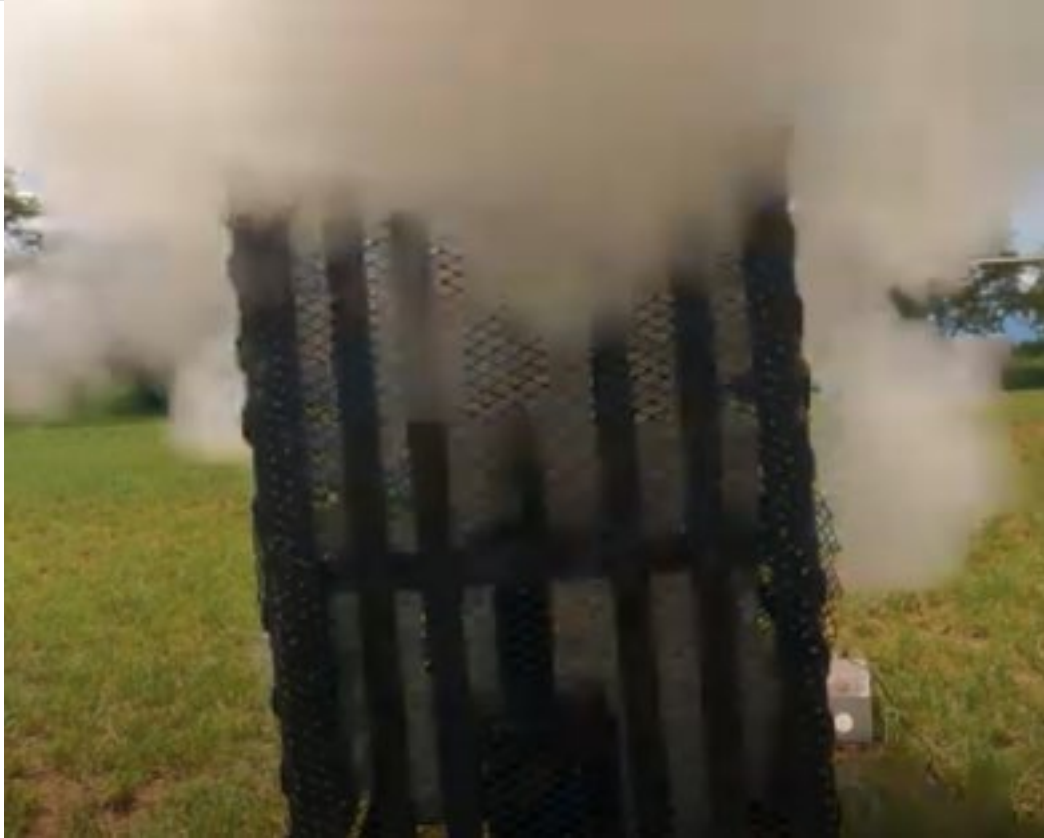
Figure 10. Static test on 25th April 2024

No.	Date	Remark	Video
5	12/04/2024	83% of theoretical total impulse. Airframe also withstood.	https://youtu.be/5G2vEjkUCaA
6	25/04/2024	Outsourced casing had to have 2.5mm thickness, but the thinnest thickness turned to be 1.7mm. It worked without burst.	https://youtu.be/if4z0yCCtAo

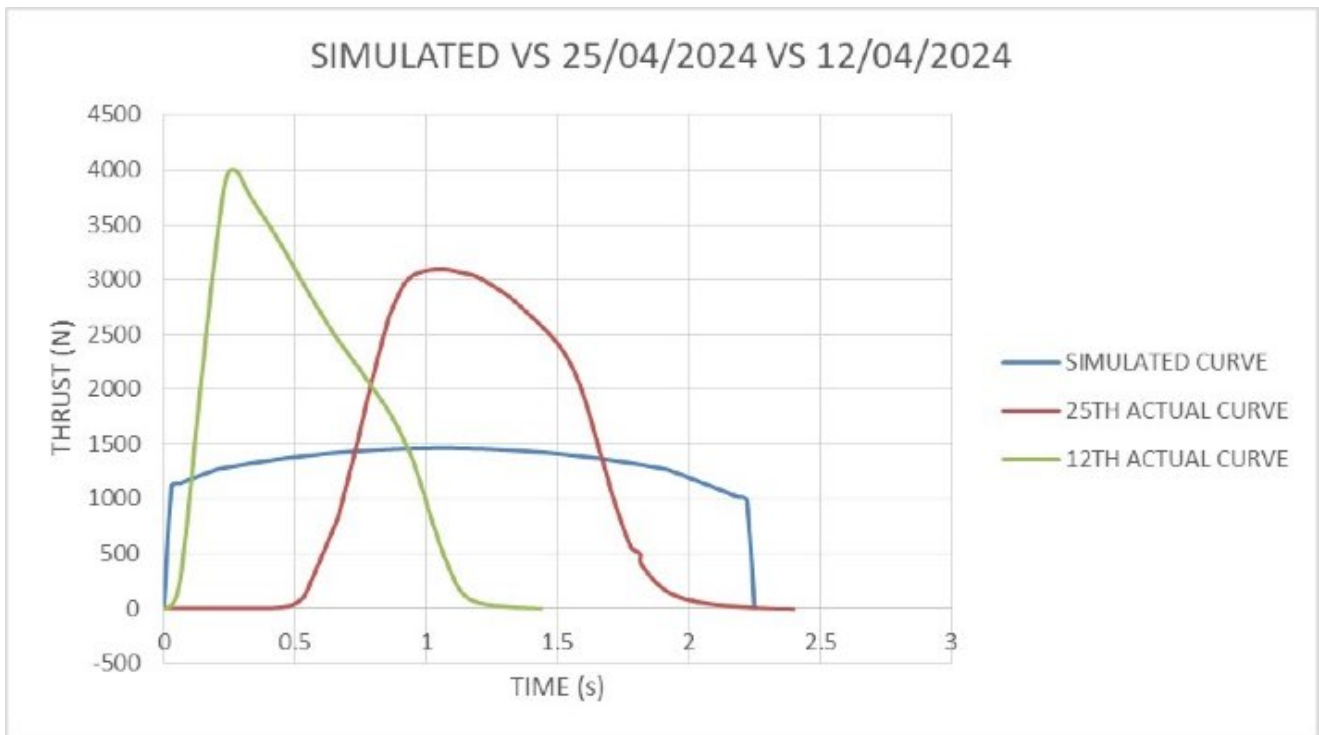
Figure 11 plots the two successful static tests carried out on April 12th and 25th, 2024. The static test on April 25th confirmed a total impulse of 2,773 N•s, which is 93% of the designed performance.

Figure 11. Thrust curve obtained from the static test

Motor type	Total impulse [N•s]	Peak thrust [N]
Designed value from simulation	2,977	1,450
Static test on 12th April 2024	2,482	4,000
Static test on 25th April 2024	2,773	3,092

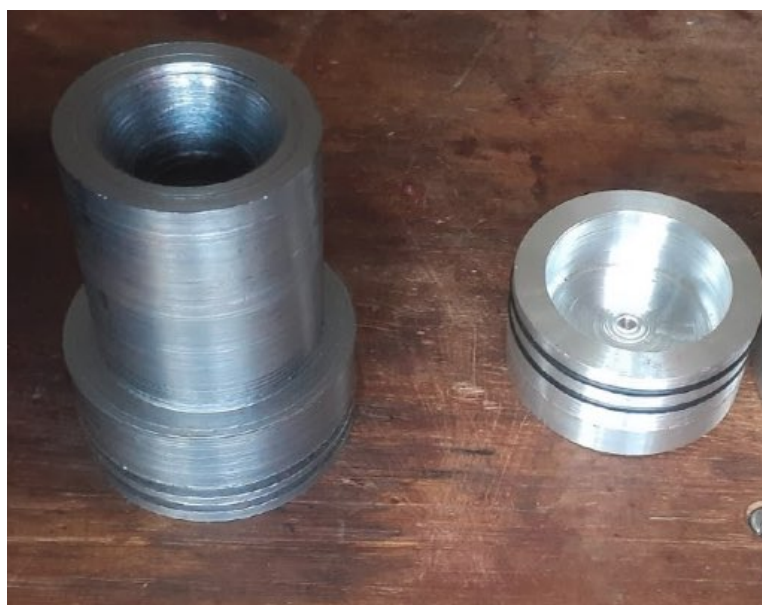
Figures 12 and 13 show images of the solid rocket motor's casing, nozzle, and bulkhead.

Figure 12. Nozzle and bulkhead

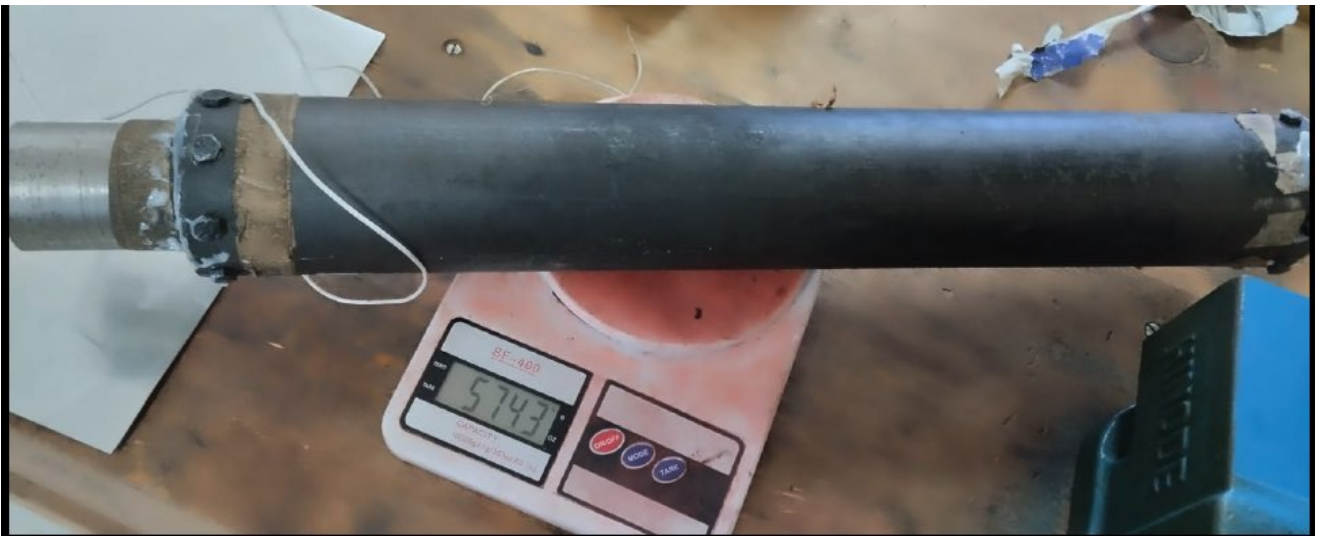
Figure 13. Solid rocket motor assembly

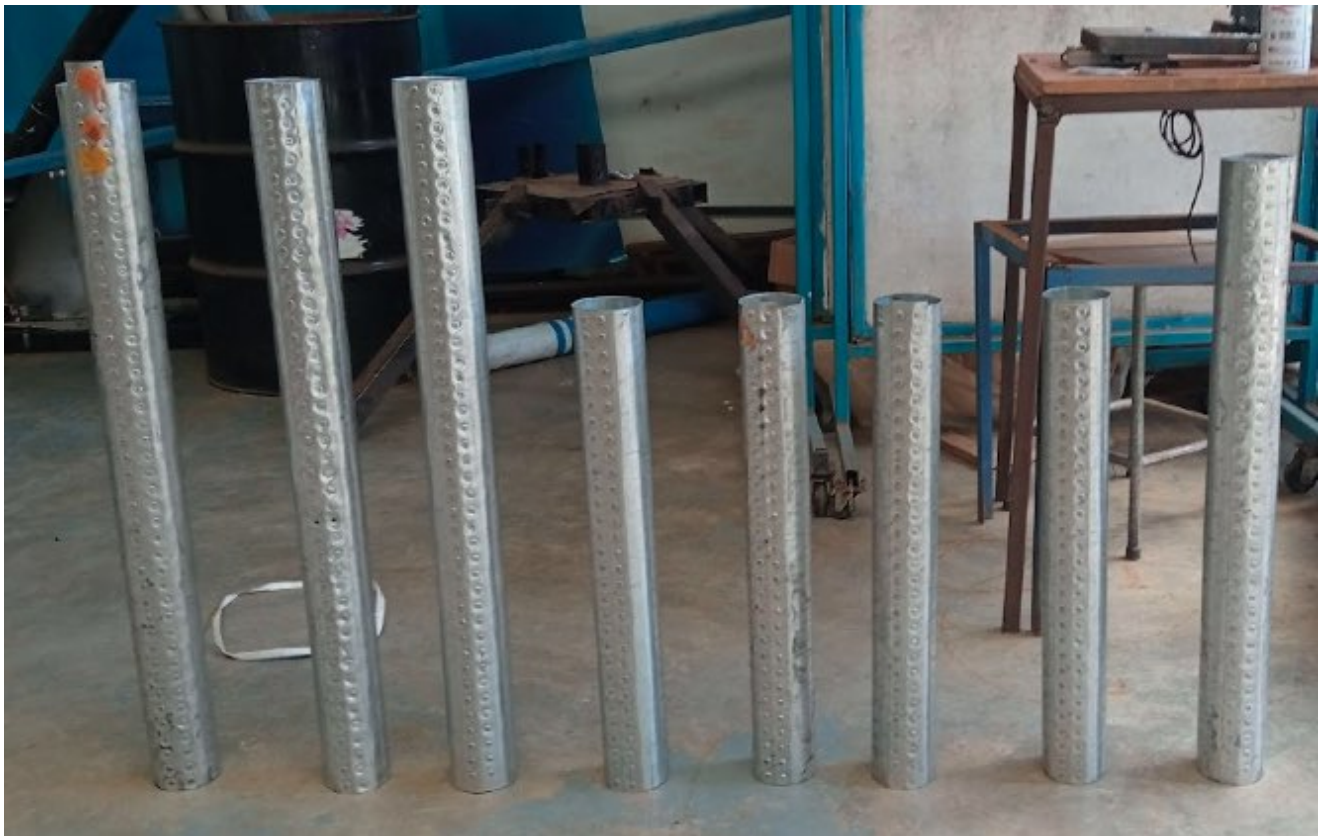
The body tubes were made from rolled and riveted aluminum sheets, as shown in Figure 14.

Figure 14. Body tubes

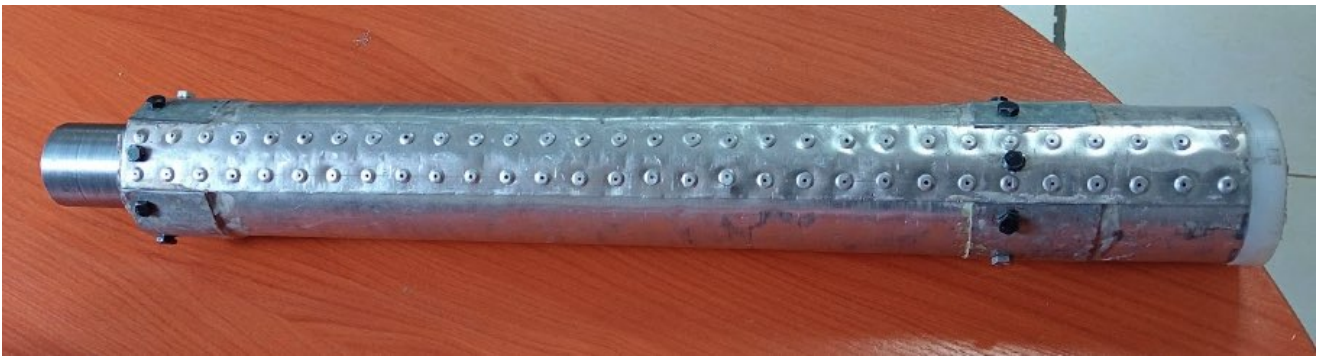
The solid rocket motor is fastened to the airframe using the bolts, as shown in Figure 15.

Figure 15. Assembly of airframe and solid rocket motor

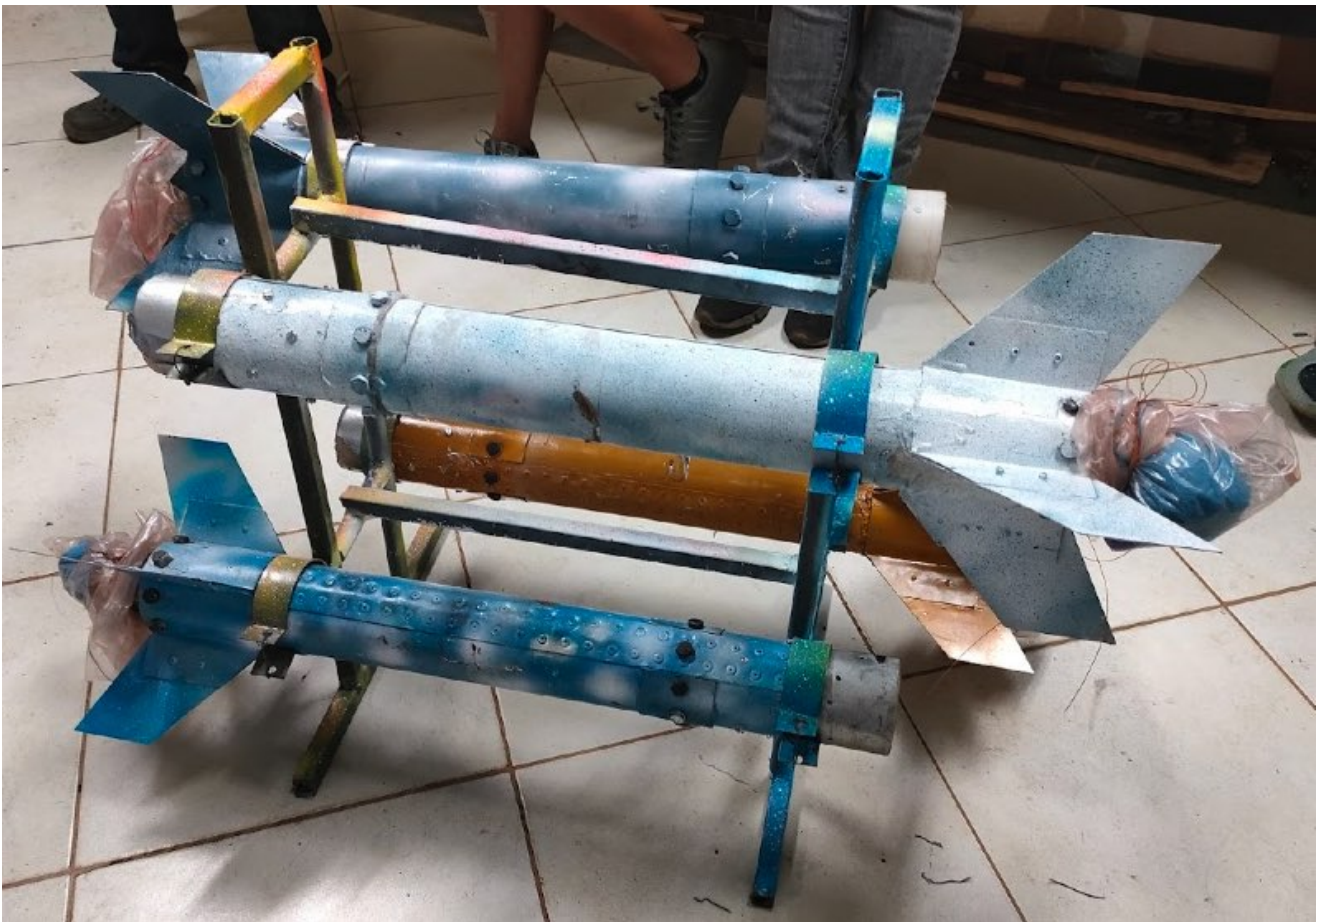
The fins have tapered swept shapes and are made from aluminum sheets, as shown in Figure 16. The four fins are attached to each rocket.

Figure 16. Lower part of the airframe with fins attached

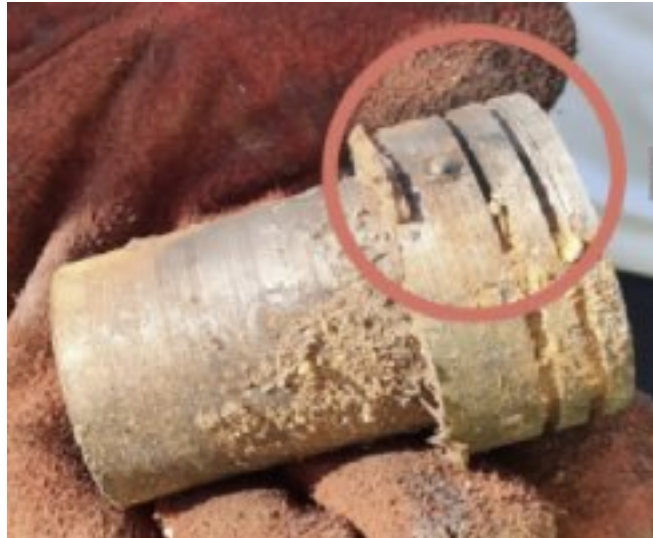
During the launch of the N-3 rocket, the shear force cut all eight bolts, fastening the solid rocket motor with the airframe. This was due to the abrupt replacement of the steel bolt with the silicon bronze bolt, which has way lower strength, especially in a high-temperature environment. The bolts were replaced with the proper steel bolts, and the function was confirmed through the static tests.

Figure 17. Silicon bronze bolts that were cut by shear force (from previous N-3 launch)

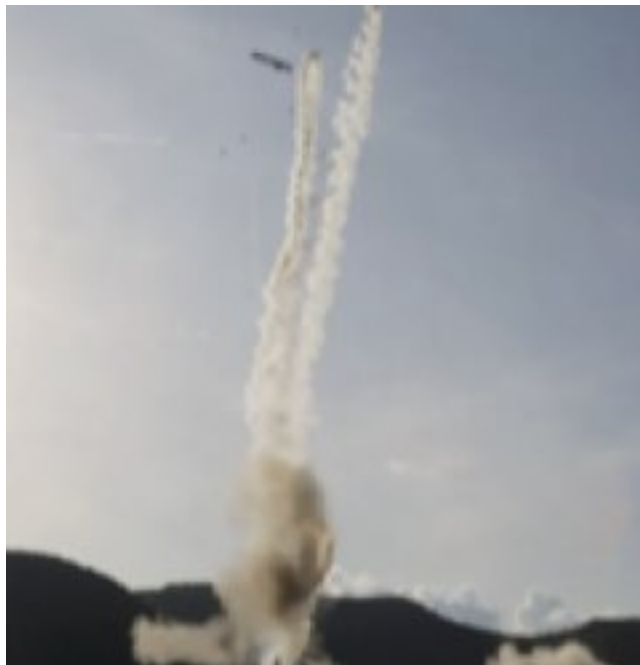
Figure 18. Catastrophic failure caused by the bolts (from previous N-3 launch)

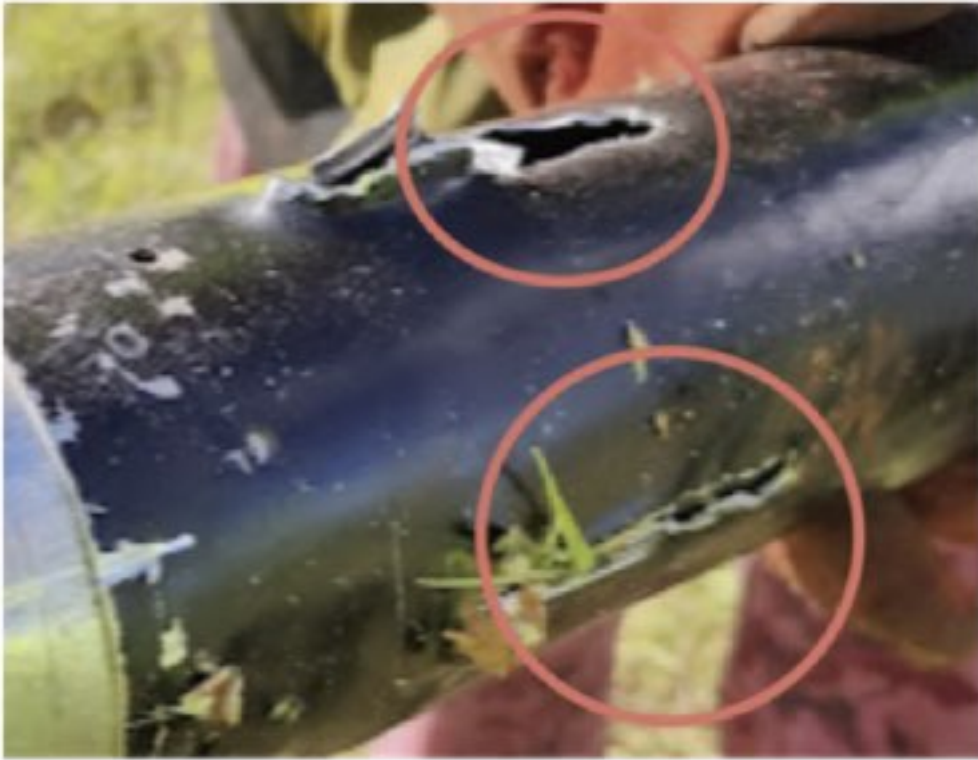
The airframe of the N-3 rocket did not have sufficient strength as it was torn by the thrust generated by the solid rocket motor. The team conducted material testing and ensured the strength where the solid rocket motor was joined with the airframe.

Figure 19. N-3 rocket airframe torn by the thrust (from previous N-3 launch)

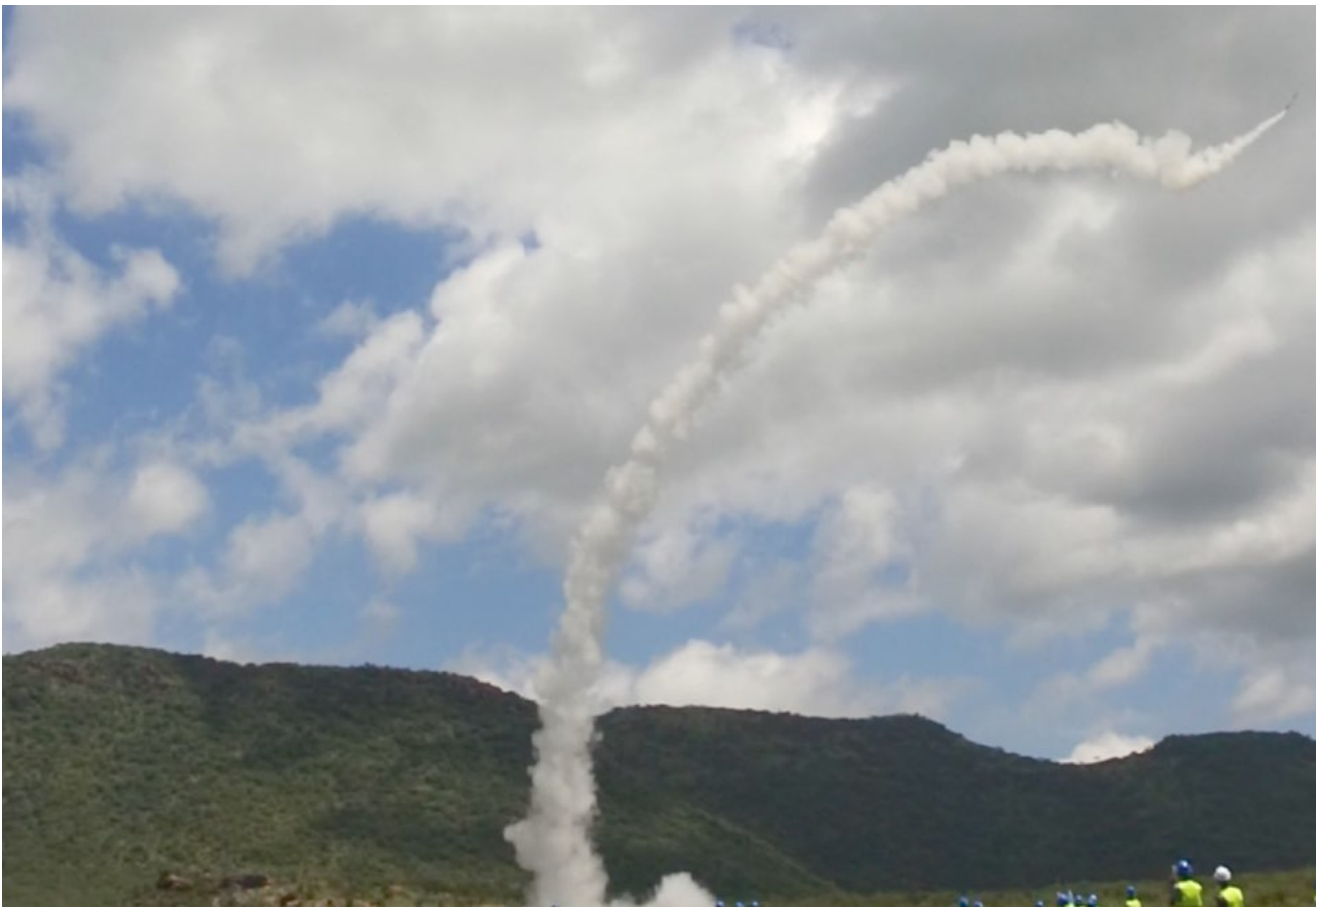
Among the three rockets (Beta, Delta, and Charlie), the Delta rocket was the only one that could fly vertically straight. The Beta and Charlie rockets were diverted horizontally due to weathercocking.

Figure 22. Flight path of Beta rocket

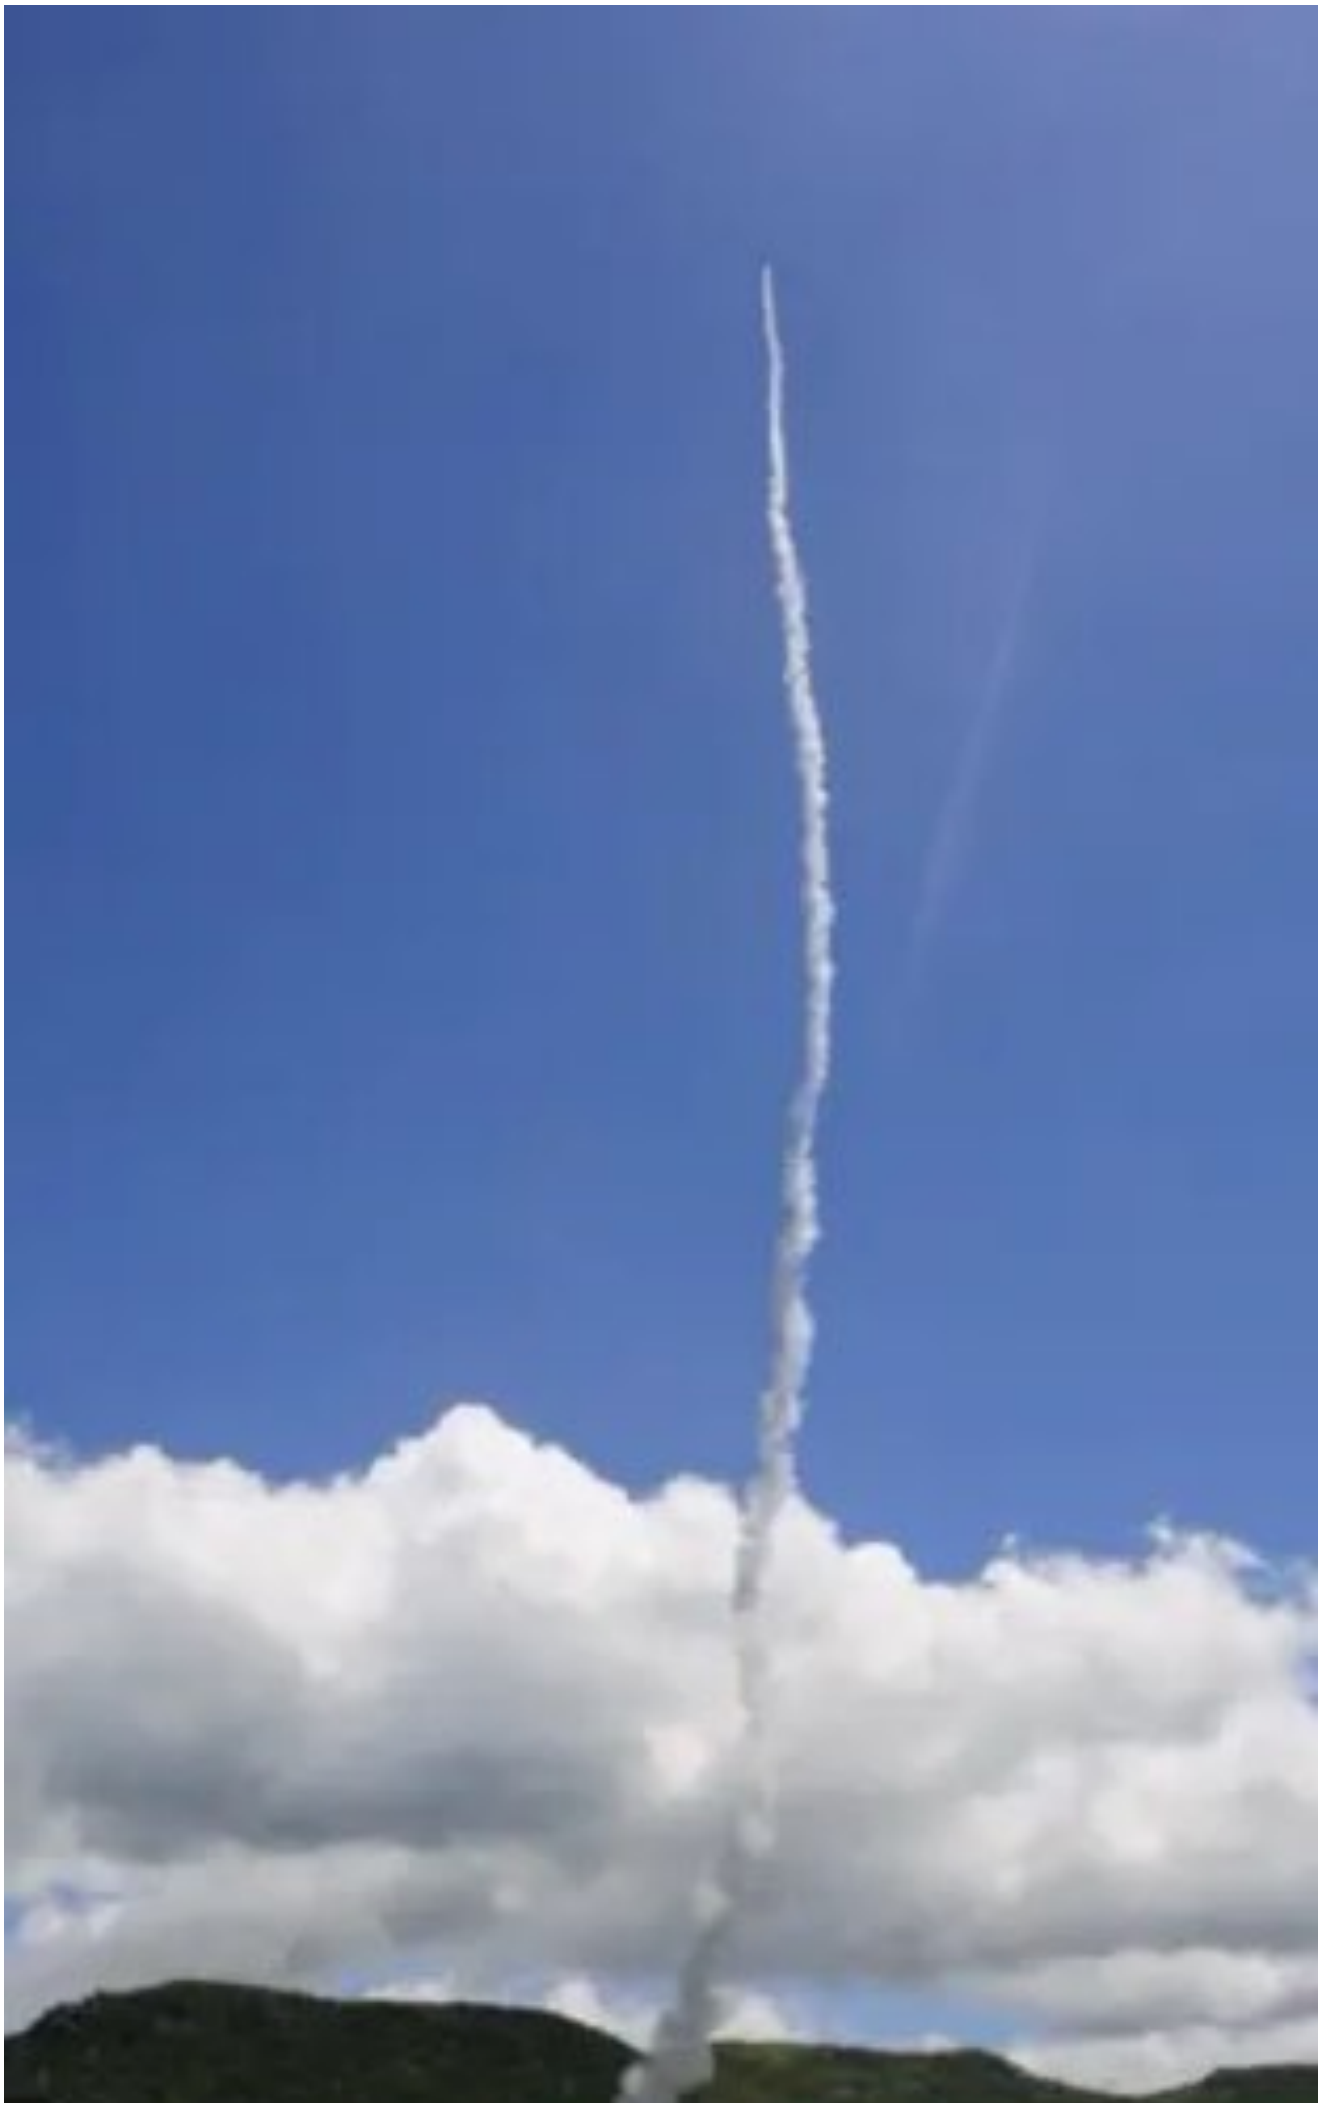
Figure 23. Flight path of Delta rocket

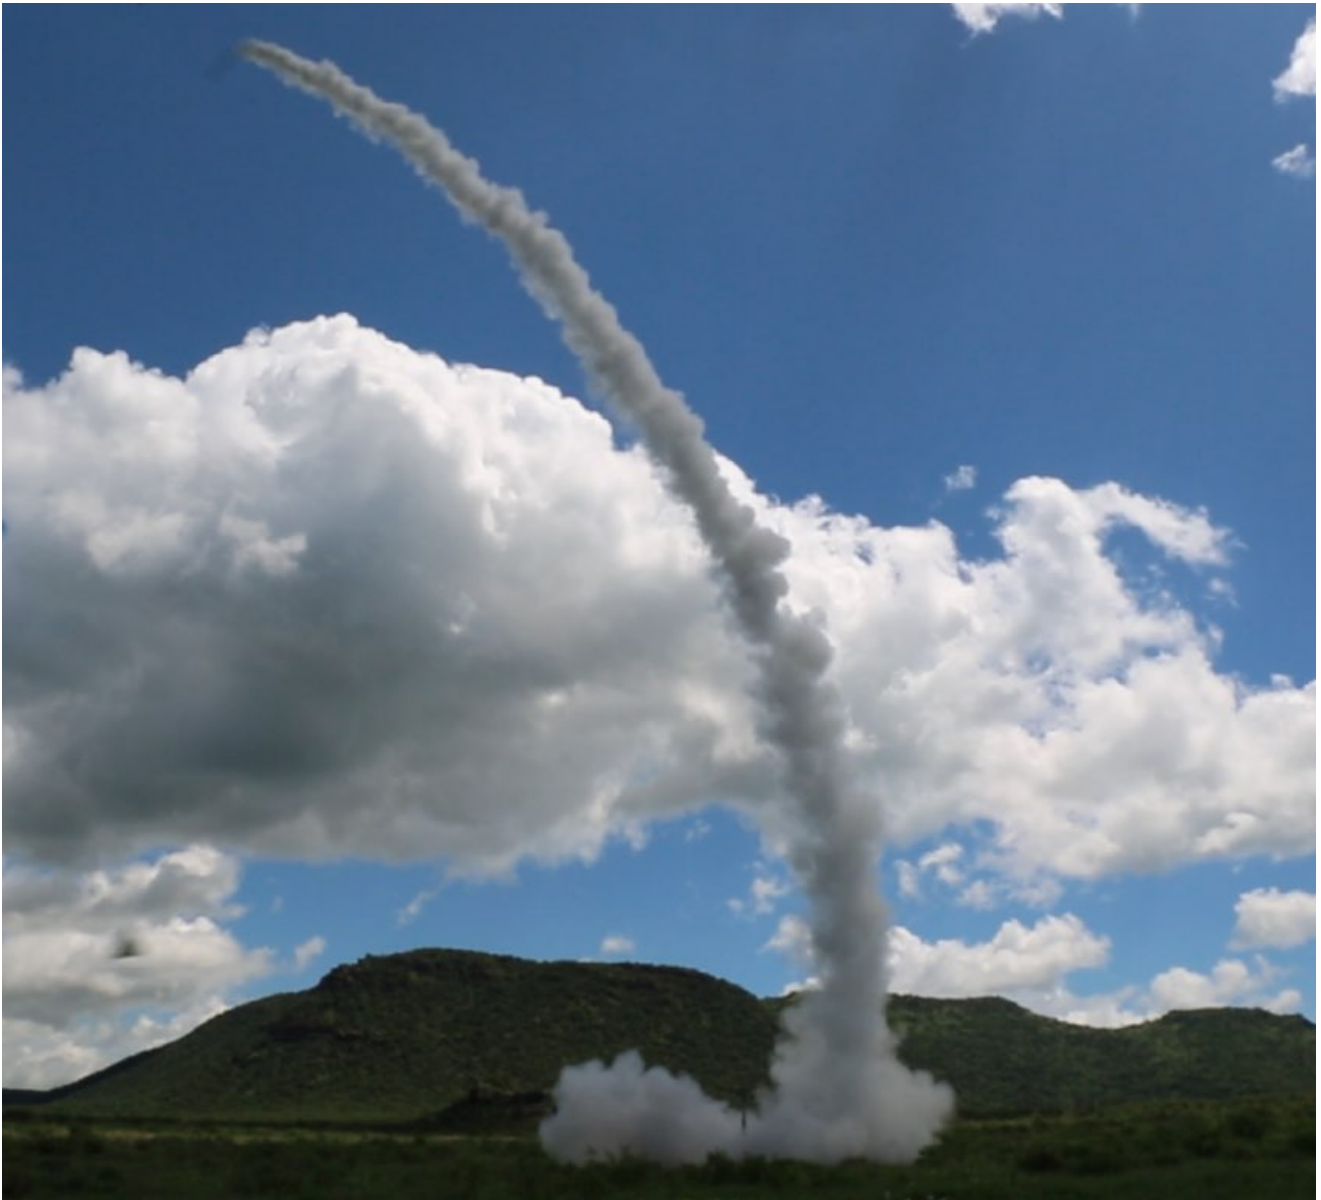
Figure 24. Flight path of Charlie rocket

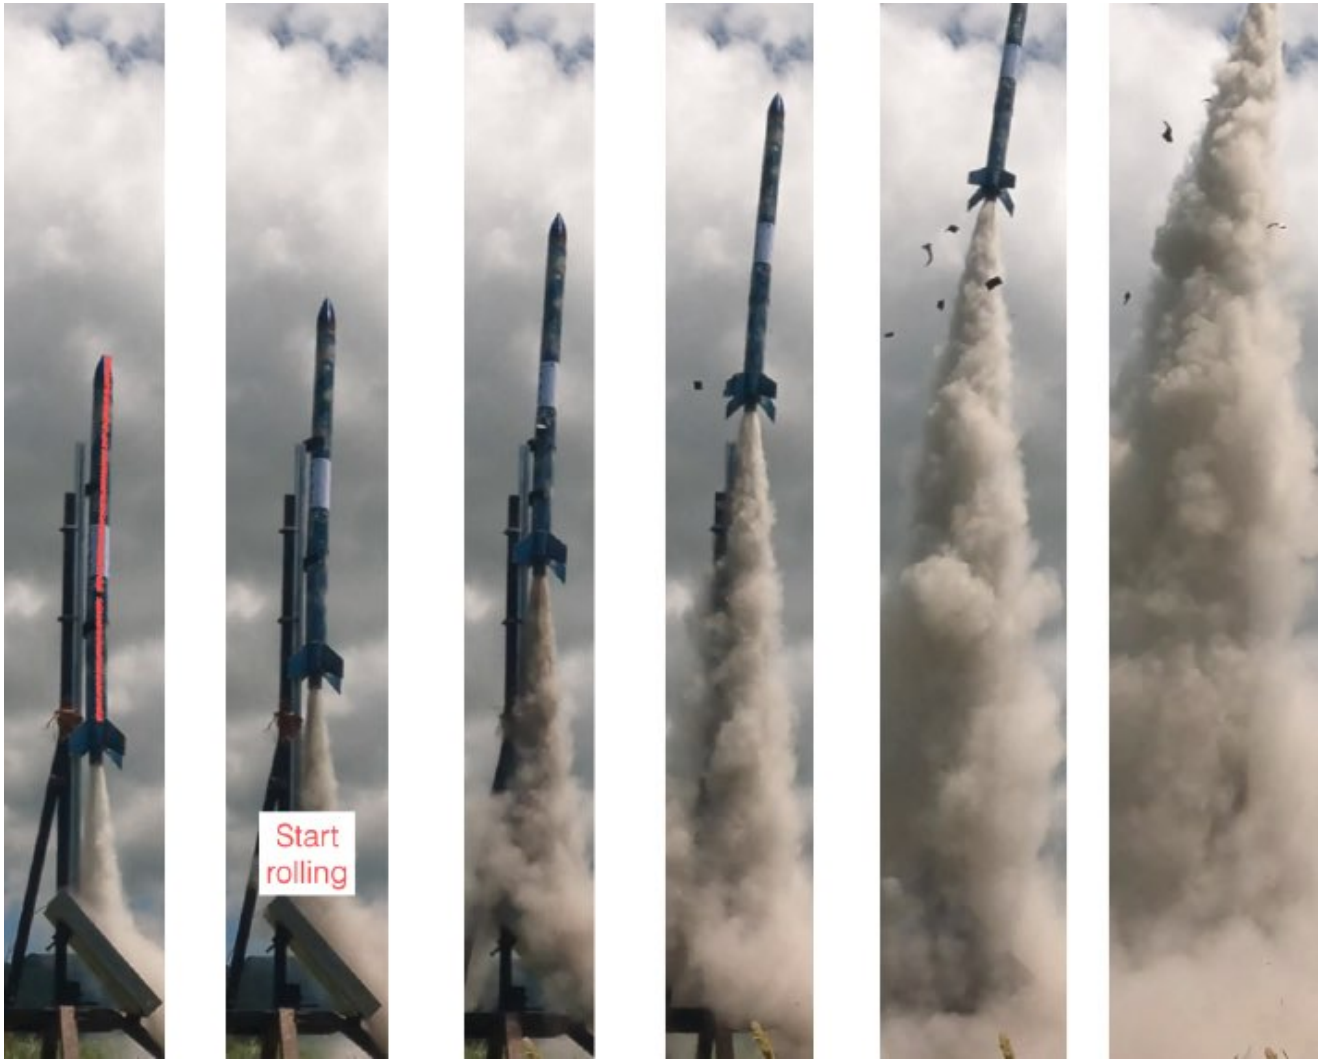
Below are close-ups of the initial orientations. The images show that the weathercocking starts immediately after the launch.

Figure 25. Orientation of Beta rocket after launch

The reasons for the weathercocking may be multilateral. In general, too much stability and strong wind would have caused weathercocking. From the mass measurement, the successful Delta rocket was found to be the lightest, whereas the rest had much higher mass. This means the three rockets had different positions in the Center of Gravity. Some team members also reported that the failed Beta and Charlie rockets had **misalignment between the upper and lower parts of the rocket airframe.**

To avoid weathercocking, the **measurement of the Center of Gravity and Center of Pressure** must be conducted to check the final value of the static stability. In addition, the

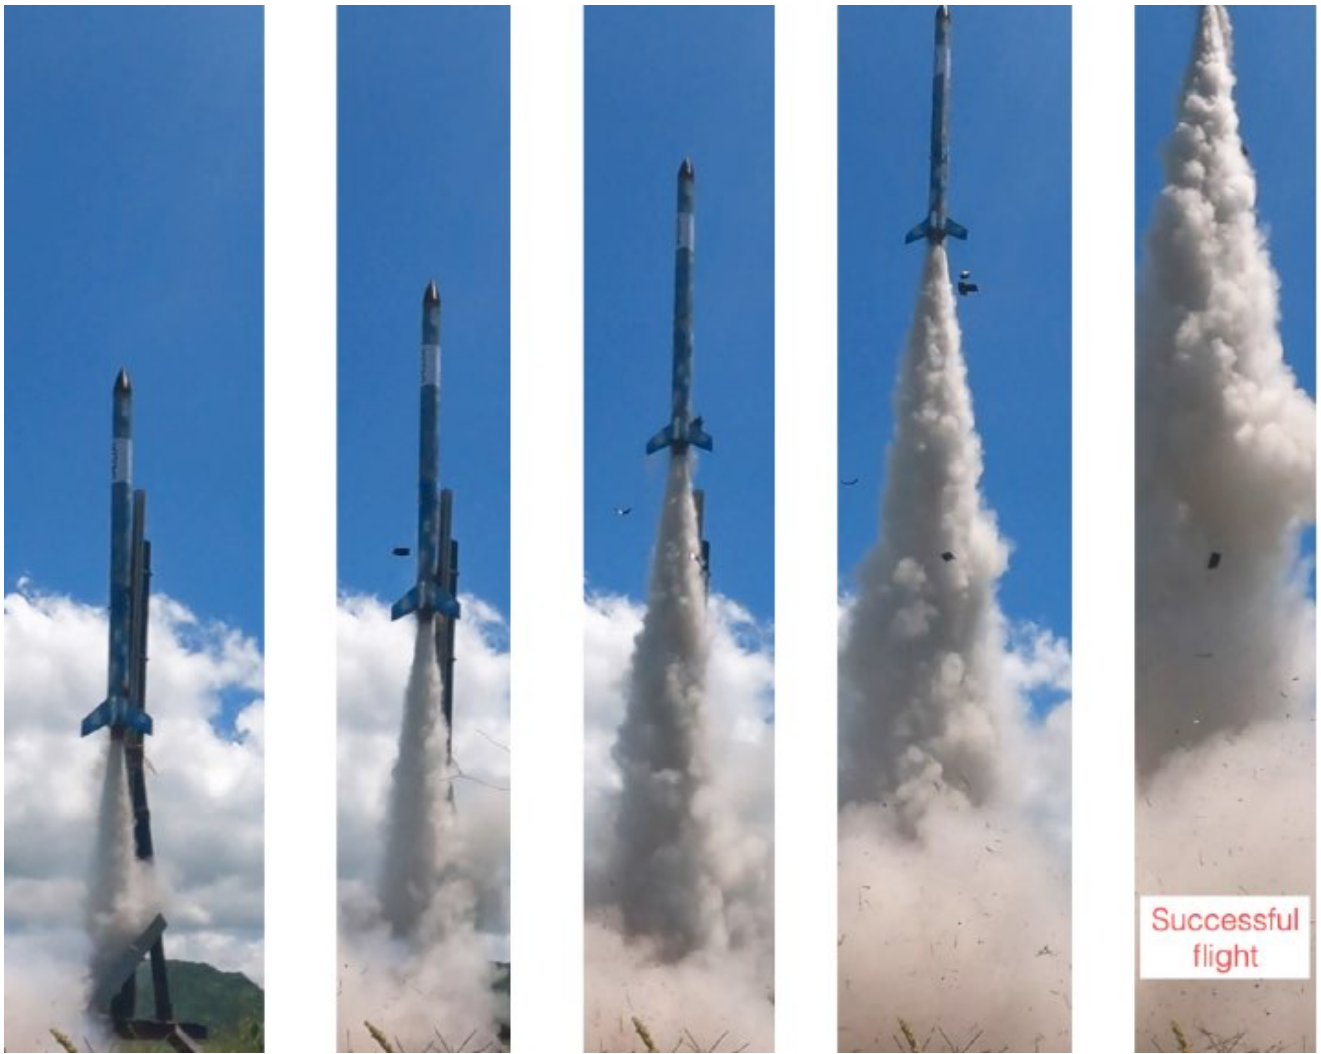
Figure 26. Orientation of Delta rocket after the launch

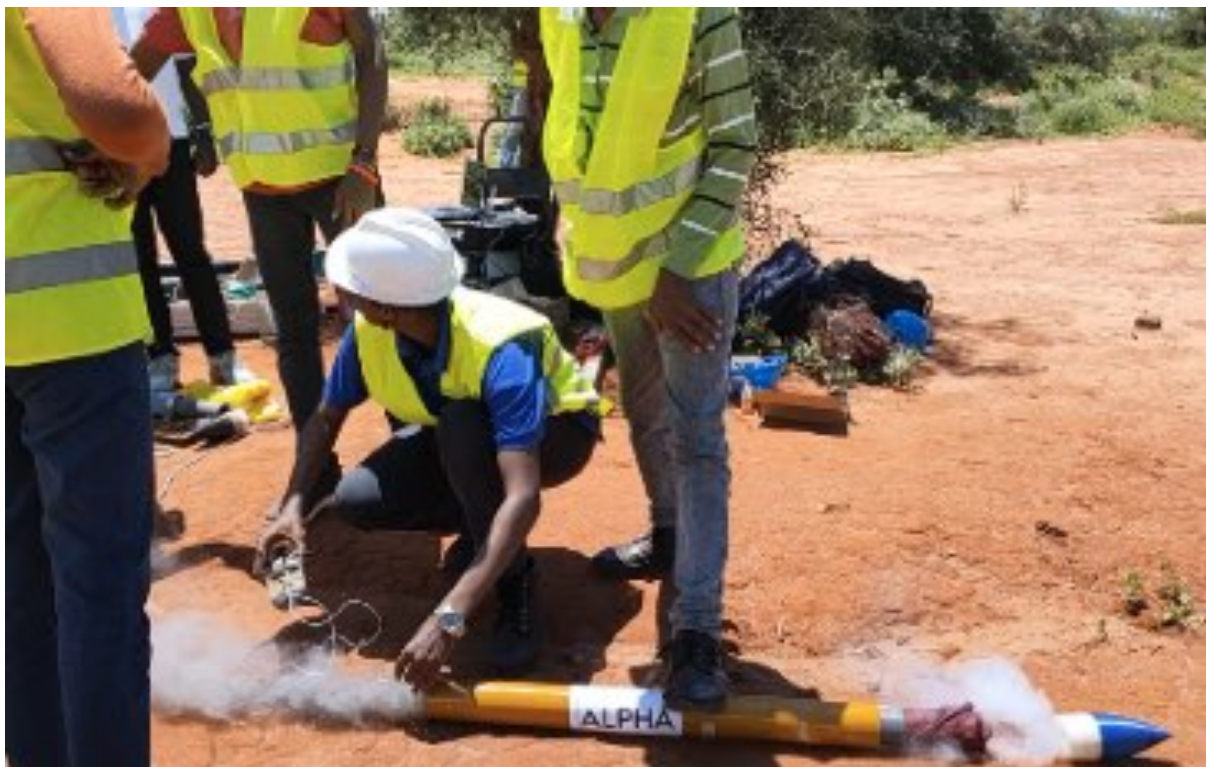
Accidental firing occurred three times while preparing the pyrotechnic used for the parachute ejection. In the beginning, the short circuit of the flight computer PCB was suspected. However, the main culprit was concluded to be the interference between the first flight computer, which had already launched and landed, and the second flight computer, which was being prepared on the ground. The first flight computer was continuously sending its own state to the base station, which mistakenly updated the state of the second flight computer.

Figure 28. Accidental firing of ejection pyrotechnic

To address the issue, each flight computer PCB must have a unique identifier, and the base station must recognize each board as a different board.
