NAKUJA PROJECT INTERNSHIP

WEEK 8 PROGRESS REPORT

PROPULSION

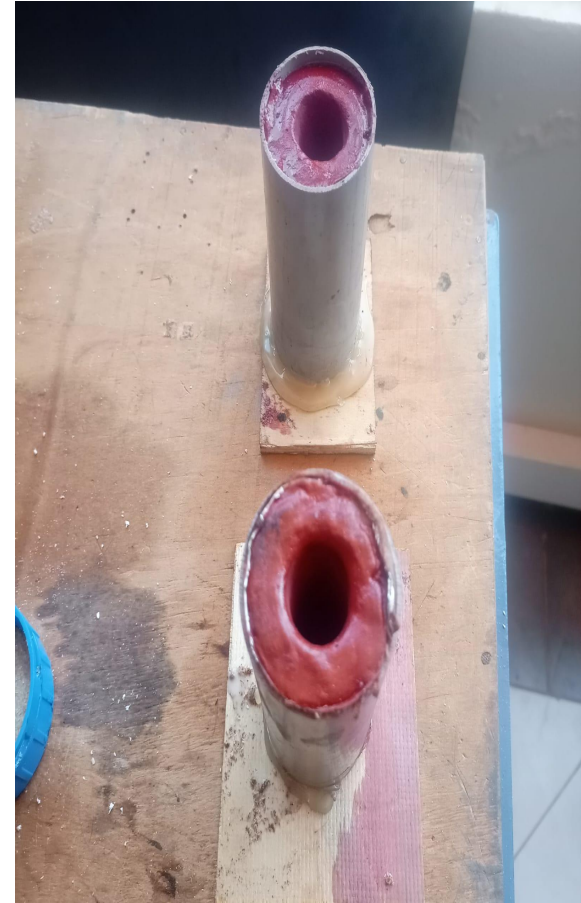
We prepared two grains of fuel separately.

Both were prepared under similar conditions;

67:33 ratio of potassium nitrate to sorbitol, 5g of iron oxide.

The two grains were then fitted to the same casing.

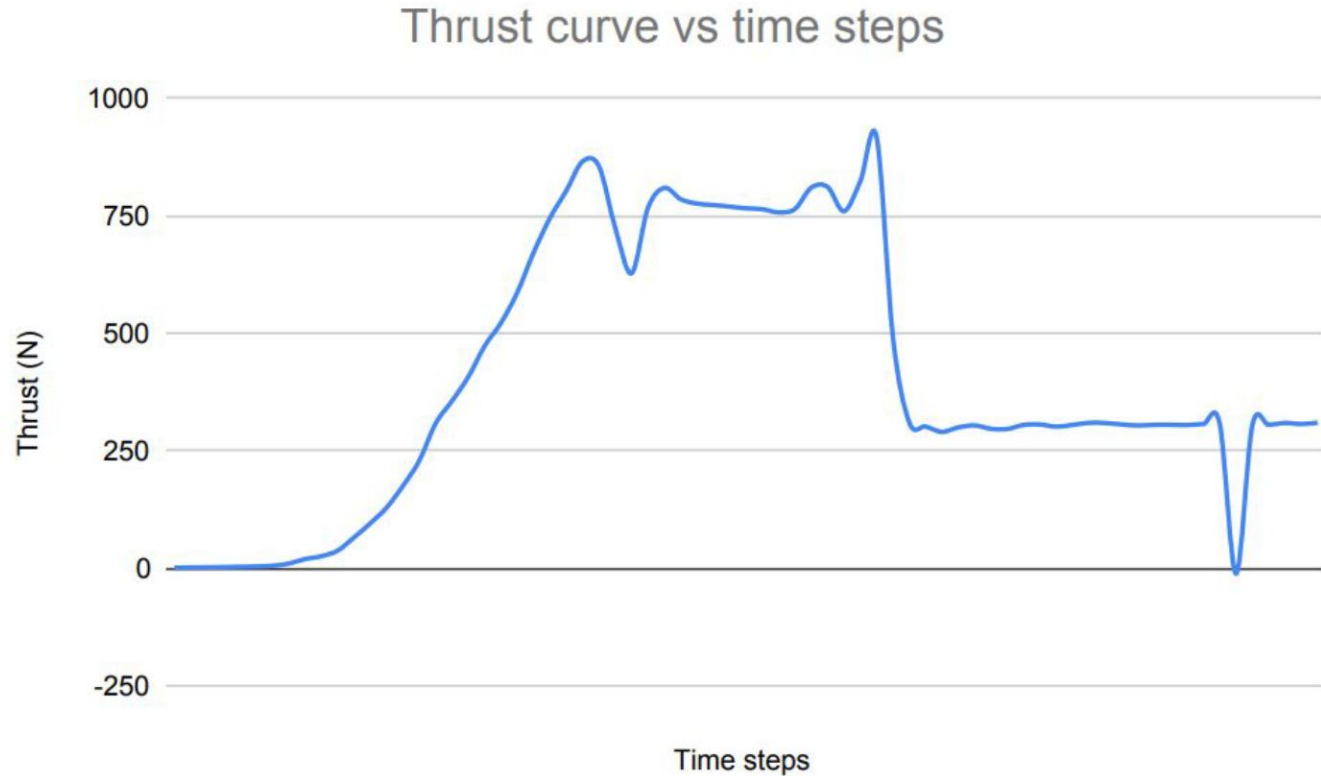
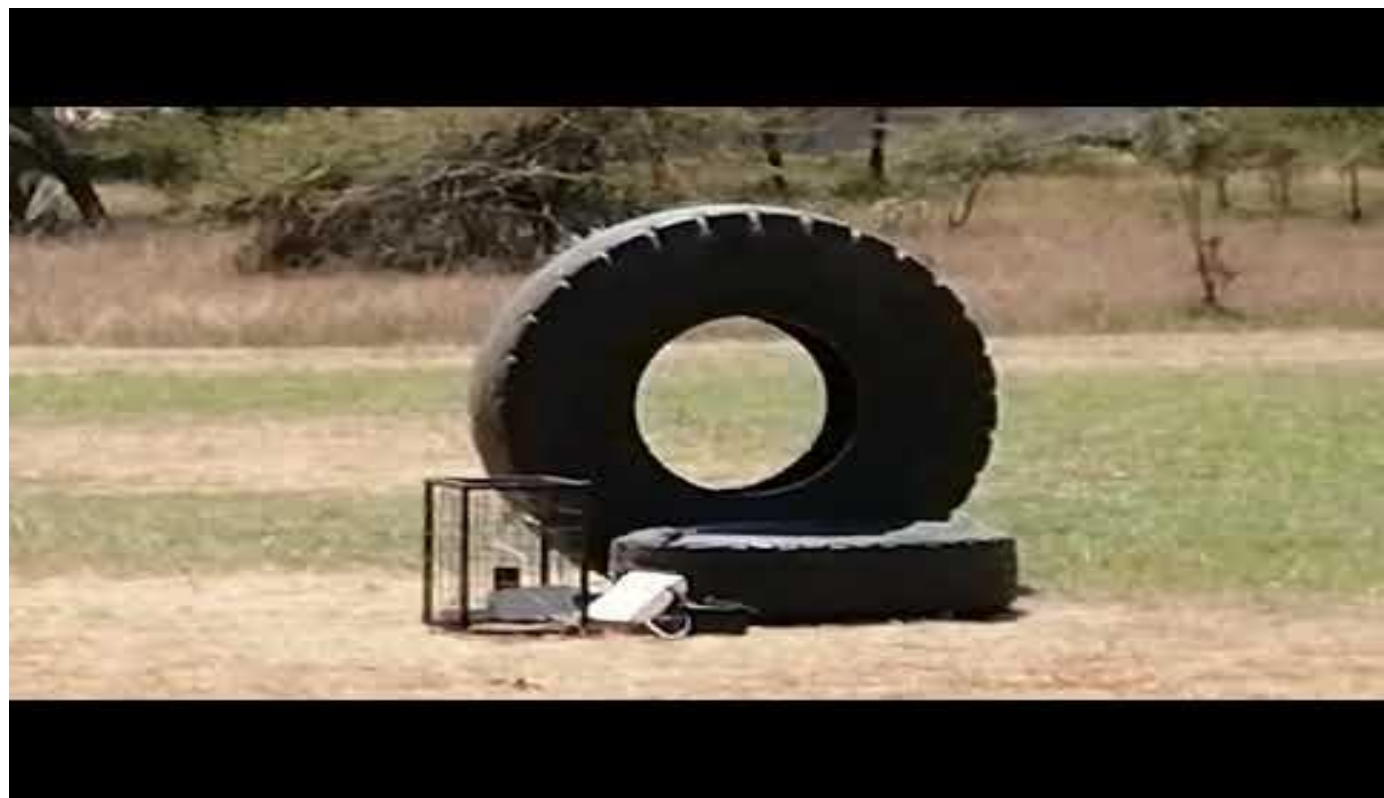
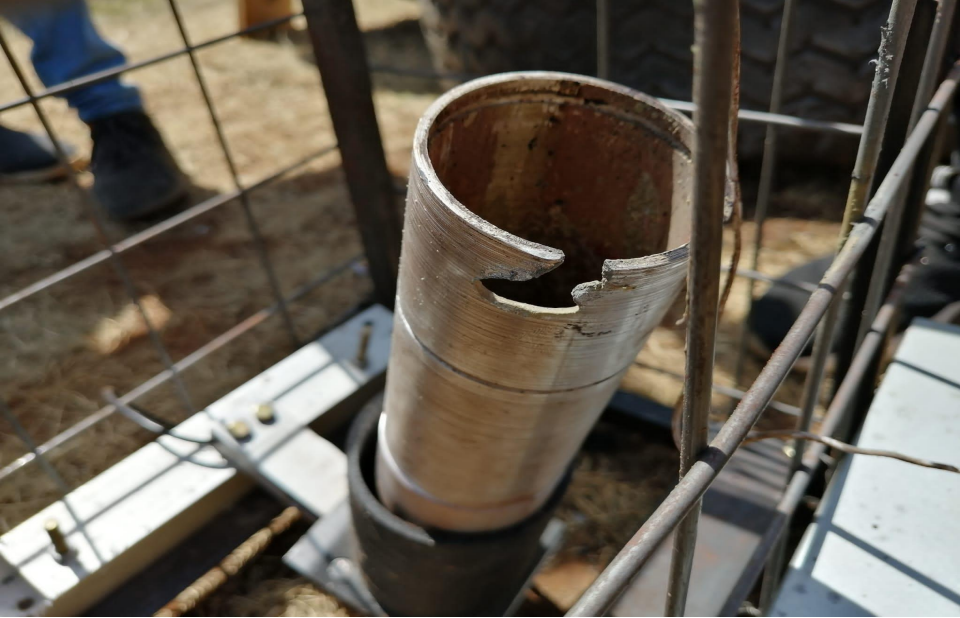
THRUST TIME CURVE

1. A section of the casing melted away. The temperatures were too high for the material to withstand.

Thrust maxed out t
around 950 N.

Load cell limit is 500N

Load cell was
damaged

Solution; We are going to incorporate thermal insulation inside the casing walls. Going to research on the most suitable heat-resistant material which will protect the casing from the excess heat.

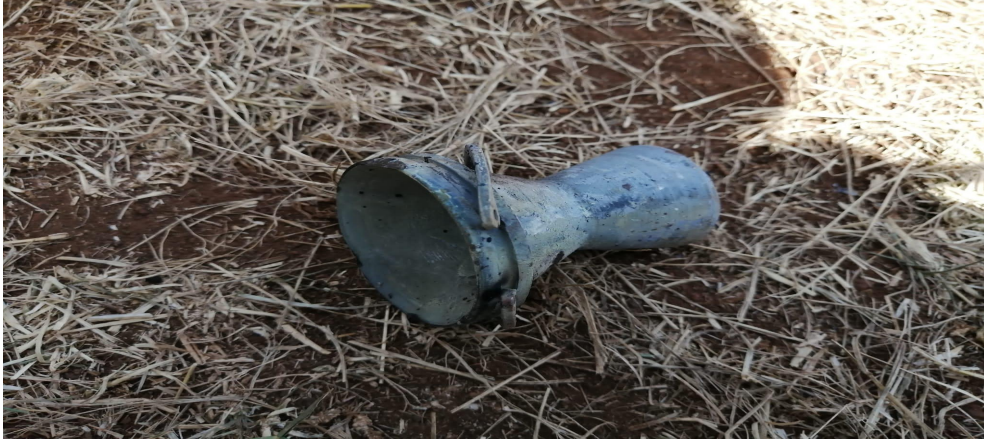
2. The nozzle was ejected from the casing but did fall close to the casing.

Other than that, the steel nozzle was able to withstand the temperature and pressure.

Solution; Redesigning of the nozzle and adjusting a few changes by reducing the material.

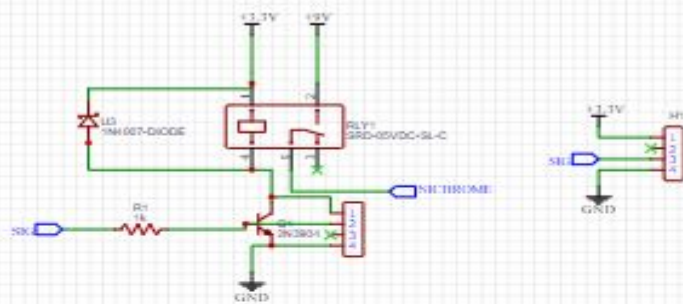
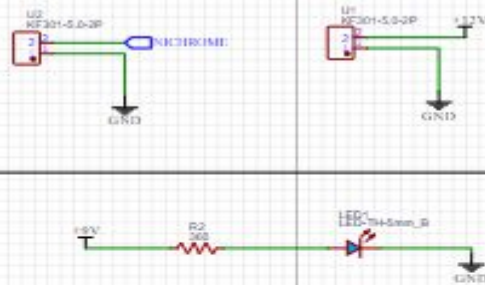
[#24] Test stand PCB Design

The last PCB failed during the firing test. The relay was blown up due to the excess current passing through.

In the new PCB design, issues of over current and over voltage are being solved by the use of a fuse(10A) and zener diode(9V) respectively.

The items are being purchased and the new PCB will be used for the next static firing test.
