Smart Call Center Phone Fix

imageRUNNER ADVANCE 8000 Series > Accessory > Professional Puncher-C1

E503-0003

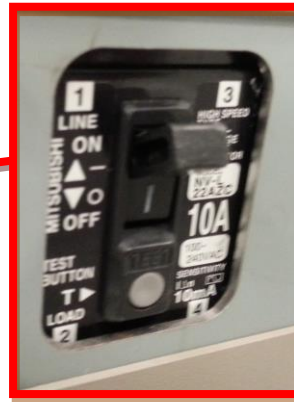
7. Check to make sure the circuit breaker to the right of the power plug is in the “ON” position (up) as shown.

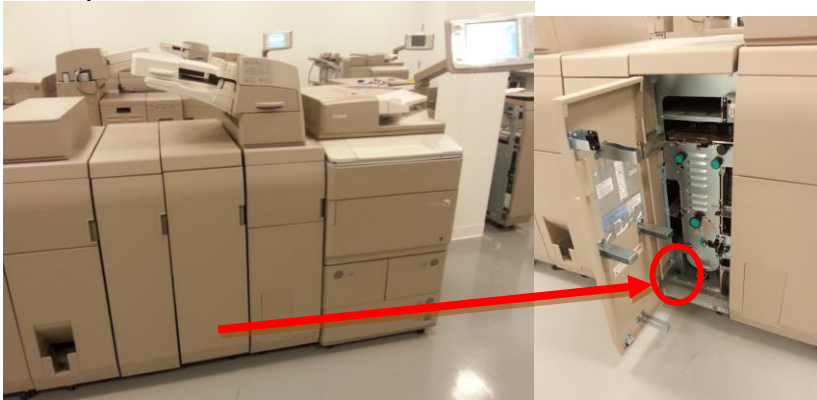
8. From the front inside cover of the Professional Puncher-C1 perform the following action:
-Open the Front Cover.

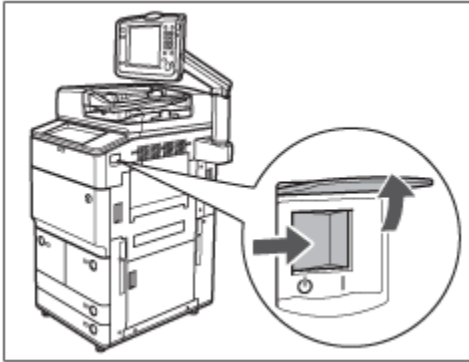
9. After connecting any cables in the rear of the machine that have may have been disconnected and checking the switches in the rear and front, turn on the Main Power switch.
