# PROVISION OF CORROSION MONITORING SERVICES AT OFFSHORE AND MESAIEED

Document: PROVISION OF CORROSION MONITORING SERVICE REPORT  
AT OFFSHORE LOCATION PS-3 1ST CAMPAIGN

LOCATION DETAILS:	Location	PS-3A Platform - Lower deck		
	Line Description	4" Gas injection manifold		
	Line Identification	4-GP-532019-9151	Process Pressure	150

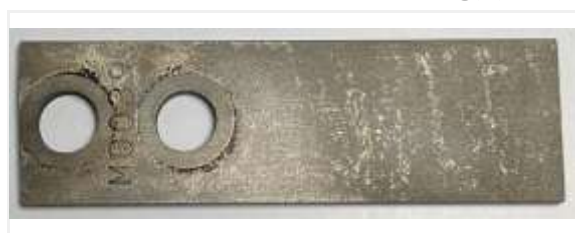
Front After Cleaning (C)

COUPON DETAILS:	Report No.		Coupon Install Date	7/23/2023
	A/F Tag No	53-XCC-1413	Coupon Initial Weight (gm)	36.5112
	Access fitting orientation	Top Mounted 12 O' clock	Pre-Cleaning Weight (g)	36.428
	Holder Length	6200-4.75"	Final Weight (g)	36.3
	Coupon Type	3" Strip	Duration	722
	Coupon Position	BTM	Weight Loss (g)	0.211
	Coupon Material	C 1018	Corrosion Rate (mpy)	0.1518
	Coupon Serial No	MQ039	Calculated PittingRate (mpy)	0.35849
			Deepest measured pit (mils)	2.8
	Coupon Obeseration During retrieval	Coupon are in blackish colour with oily layer

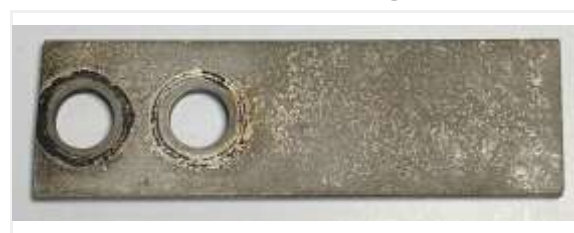
Back After Cleaning (D)

Low Corrosive

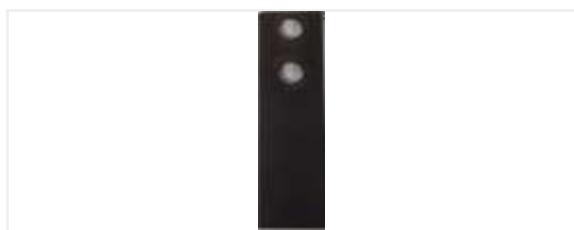
Front Before Cleaning (A)

COUPON DETAILS:	Report No.		Coupon Install Date	7/23/2023
	A/F Tag No	53-XCC-1413	Coupon Initial Weight (gm)	36.8093
	Access fitting orientation	Top Mounted 12 O' clock	Pre-Cleaning Weight (g)	36.727
	Holder Length	6200-4.75"	Final Weight (g)	36.584
	Coupon Type	3" Strip	Duration	722
	Coupon Position	BTM	Weight Loss (g)	0.225
	Coupon Material	C 1018	Corrosion Rate (mpy)	0.1625
	Coupon Serial No	MQ040	Calculated PittingRate (mpy)	0.39874
	Coupon Obeseration During retrieval	Coupon are in blackish colour with oily layer		
			Deepest mesured pit (mils)	2.5

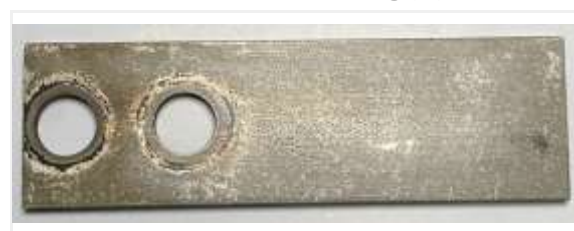
Back After Cleaning (D)

Low Corrosive

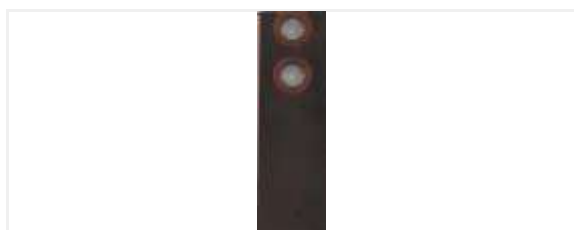
Front Before Cleaning (A)

COUPON DETAILS:	Report No.		Coupon Install Date	7/24/2023
	A/F Tag No	53-XCC-949	Coupon Initial Weight (gm)	36.8855
	Access fitting orientation	TopMounted 12 O' clock	Pre-Cleaning Weight (g)	36.66
	Holder Length	6202-8.75"	Final Weight (g)	36.553
	Coupon Type	3" Strip	Duration	717
	Coupon Position	BTM	Weight Loss (g)	0.333
	Coupon Material	C 1018	Corrosion Rate (mpy)	0.2451
	Coupon Serial No	MQ005	Calculated PittingRate (mpy)	0.98562
	Coupon Obeseration During retrieval	Coupon are in blackish colour with oily layer		
			Deepest mesured pit (mils)	3.7\

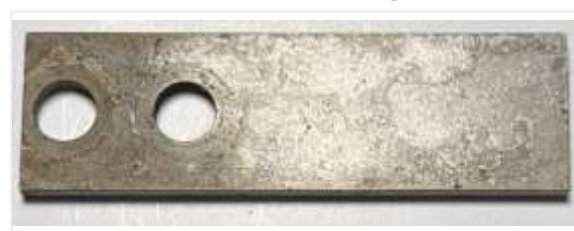
Back After Cleaning (D)

Low Corrosive

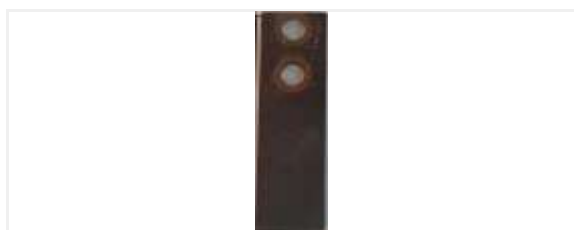
Front Before Cleaning (A)

COUPON DETAILS:	Report No.		Coupon Install Date	7/24/2023
	A/F Tag No	53-XCC-949	Coupon Initial Weight (gm)	36.8841
	Access fitting orientation	TopMounted 12 O' clock	Pre-Cleaning Weight (g)	36.727
	Holder Length	6202-8.75"	Final Weight (g)	36.593
	Coupon Type	3" Strip	Duration	717
	Coupon Position	BTM	Weight Loss (g)	0.291
	Coupon Material	C 1018	Corrosion Rate (mpy)	0.2136
	Coupon Serial No	MQ006	Calculated PittingRate (mpy)	1.325836
	Coupon Obeseration During retrieval	Coupon are in blackish colour with oily layer		
			Deepest mesured pit (mils)	6.4

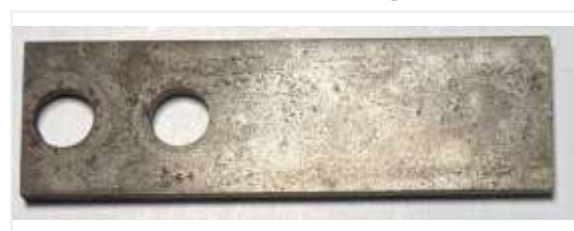
Back After Cleaning (D)

Low Corrosive

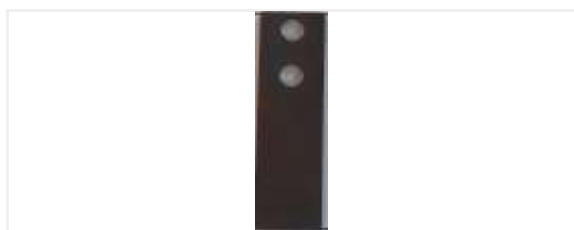
Front Before Cleaning (A)

COUPON DETAILS:	Report No.		Coupon Install Date	7/24/2023
	A/F Tag No	53-XCC-951	Coupon Initial Weight (gm)	36.8444
	Access fitting orientation	Top Mounted 12 O' clock	Pre-Cleaning Weight (g)	36.848
	Holder Length	6200-12.25"	Final Weight (g)	36.808
	Coupon Type	3" Strip	Duration	715
	Coupon Position	BTM	Weight Loss (g)	0.036
	Coupon Material	C1018	Corrosion Rate (mpy)	0.0201
	Coupon Serial No	MQ003	Calculated PittingRate (mpy)	0.125874
	Coupon Obeseration During retrieval	Coupon are in blackish colour with oily layer		
			Deepest mesured pit (mils)	1.2

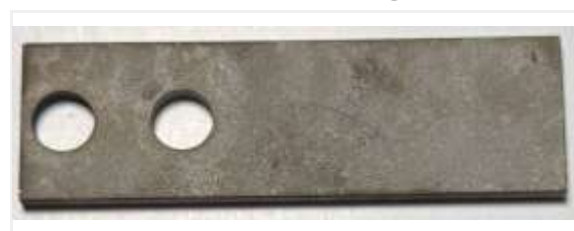
Back After Cleaning (D)

Low Corrosive

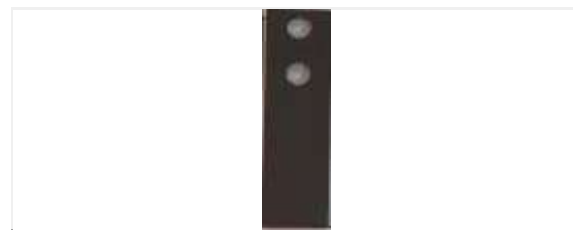
Back Before Cleaning (B)

COUPON DETAILS:	Report No.		Coupon Install Date	7/24/2023
	A/F Tag No	53-XCC-951	Coupon Initial Weight (gm)	36.9441
	Access fitting orientation	Top Mounted 12 O' clock	Pre-Cleaning Weight (g)	36.949
	Holder Length	6200-12.25"	Final Weight (g)	36.924
	Coupon Type	3" Strip	Duration	715
	Coupon Position	BTM	Weight Loss (g)	0.020
	Coupon Material	C1018	Corrosion Rate (mpy)	0.0077
	Coupon Serial No	MQ004	Calculated PittingRate (mpy)	0.32584
	Coupon Observation During retrieval	Coupon are in blackish colour with oily layer		
			Deepest measured pit (mils)	2.5

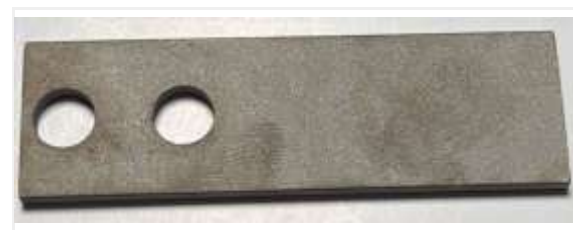
Back After Cleaning (D)

Low Corrosive

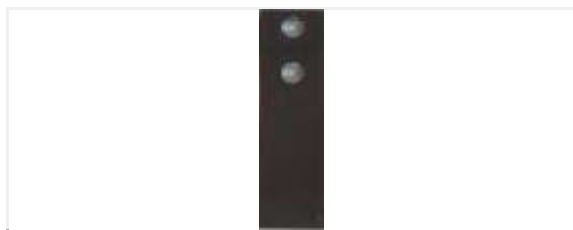
Front Before Cleaning (A)

COUPON DETAILS:	Report No.		Coupon Install Date	7/23/2023
	A/F Tag No	53-XCC-953	Coupon Initial Weight (gm)	36.9255
	Access fitting orientation	Top Mounted 12 O' clock	Pre-Cleaning Weight (g)	36.937
	Holder Length	6200-12.50"	Final Weight (g)	36.897
	Coupon Type	3" Strip	Duration	716
	Coupon Position	BTM	Weight Loss (g)	0.029
	Coupon Material	C1018	Corrosion Rate (mpy)	0.0141
	Coupon Serial No	MQ001	Calculated PittingRate (mpy)	0.185475
	Coupon Obeseration During retrieval	Coupon are in blackish colour with oily layer		
			Deepest mesured pit (mils)	1.3

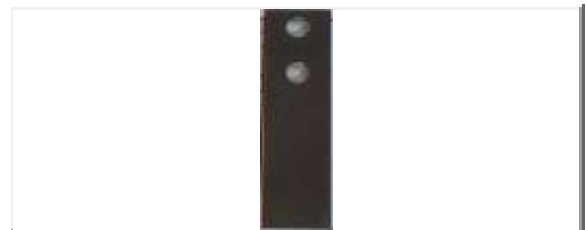
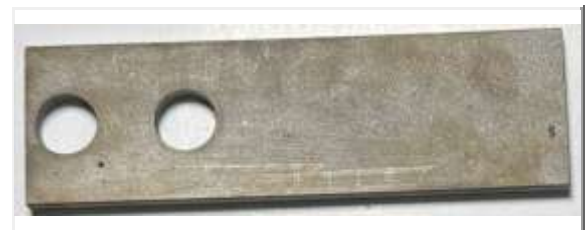
Back After Cleaning (D)

Low Corrosive

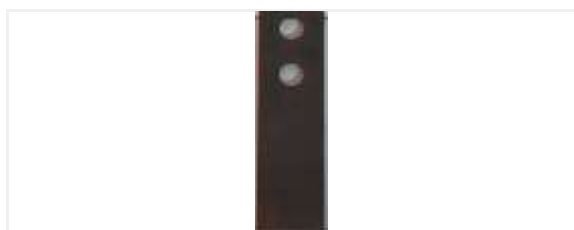
Front Before Cleaning (A)

COUPON DETAILS:	Report No.		Coupon Install Date	7/23/2023
	A/F Tag No	53-XCC-953	Coupon Initial Weight (gm)	36.927
	Access fitting orientation	Top Mounted 12 O' clock	Pre-Cleaning Weight (g)	36.91
	Holder Length	6200-12.50"	Final Weight (g)	36.865
	Coupon Type	3" Strip	Duration	716
	Coupon Position	BTM	Weight Loss (g)	0.062
	Coupon Material	C1018	Corrosion Rate (mpy)	0.0396
	Coupon Serial No	MQ002	Calculated PittingRate (mpy)	0.36587
	Coupon Obeseration During retrieval	Coupon are in blackish colour with oily layer		
			Deepest measured pit (mils)	2

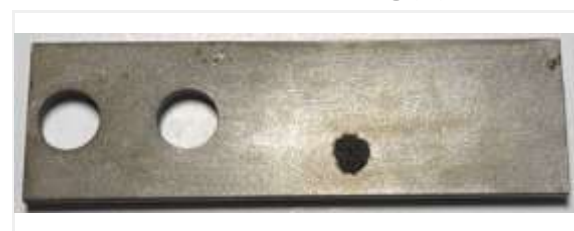
Back After Cleaning (D)

Low Corrosive

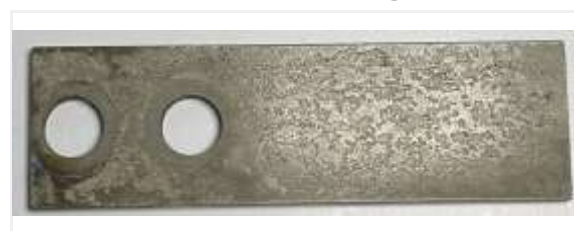
Back After Cleaning (D)

COUPON DETAILS:	Report No.		Coupon Install Date	7/22/2023
	A/F Tag No	53-XCC-1430	Coupon Initial Weight (gm)	37.09
	Access fitting orientation	Top Mounted 12 O' clock	Pre-Cleaning Weight (g)	36.885
	Holder Length	6200-12.25"	Final Weight (g)	36.597
	Coupon Type	3" Strip	Duration	726
	Coupon Position	BTM	Weight Loss (g)	0.493
	Coupon Material	C 1018	Corrosion Rate (mpy)	0.3625
	Coupon Serial No	MQ033	Calculated PittingRate (mpy)	3.3547
	Coupon Observation During retrieval	Coupon are in blackish colour with oily layer		
			Deepest measured pit (mils)	8.6

Low Corrosive

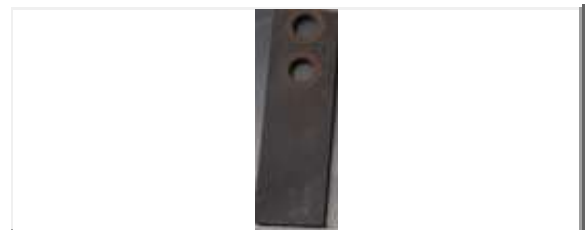
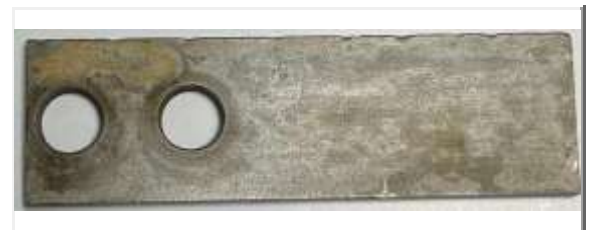
Back After Cleaning (D)

COUPON DETAILS:	Report No.		Coupon Install Date	7/23/2023
	A/F Tag No	53-XCC-1430	Coupon Initial Weight (gm)	37.0153
	Access fitting orientation	Top Mounted 12 O' clock	Pre-Cleaning Weight (g)	36.638
	Holder Length	6200-12.25"	Final Weight (g)	36.541
	Coupon Type	3" Strip	Duration	725
	Coupon Position	BTM	Weight Loss (g)	0.474
	Coupon Material	C 1018	Corrosion Rate (mpy)	0.3489
	Coupon Serial No	MQ034	Calculated PittingRate (mpy)	0.8563214
	Coupon Serial No	MQ034	Deepest measured pit (mils)	2.9
	Coupon Obeseration During retrieval	Coupon are in blackish colour with oily layer

Low Corrosive

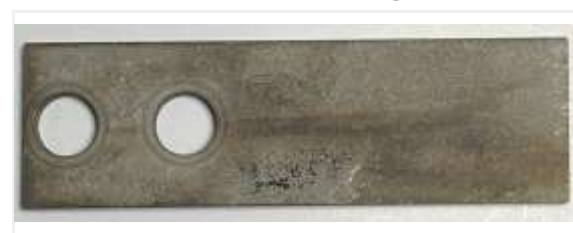
Back After Cleaning (D)

COUPON DETAILS:	Report No.		Coupon Install Date	7/21/2023
	A/F Tag No	53-XCC-971	Coupon Initial Weight (gm)	36.8528
	Access fitting orientation	Side Mounted 3/9 O' clock	Pre-Cleaning Weight (g)	36.795
	Holder Length	6200-8.75"	Final Weight (g)	36.682
	Coupon Type	3" Strip	Duration	726
	Coupon Position	BTM	Weight Loss (g)	0.171
	Coupon Material	C1018	Corrosion Rate (mpy)	0.1207
	Coupon Serial No	MQ049	Calculated PittingRate (mpy)	2.36587
	Coupon Observation During retrieval	Coupon are in blackish colour with oily layer		
			Deepest measured pit (mils)	7.4

Low Corrosive

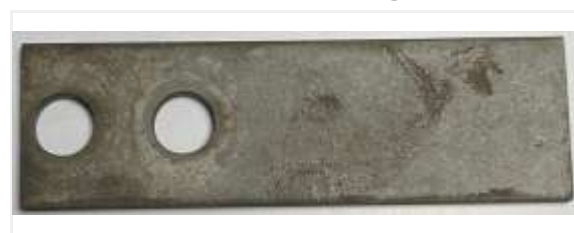
Back After Cleaning (D)

COUPON DETAILS:	Report No.		Coupon Install Date	7/21/2023
	A/F Tag No	53-XCC-971	Coupon Initial Weight (gm)	36.8239
	Access fitting orientation	Side Mounted 3/9 O' clock	Pre-Cleaning Weight (g)	36.72
	Holder Length	6200-8.75"	Final Weight (g)	36.652
	Coupon Type	3" Strip	Duration	726
	Coupon Position	BTM	Weight Loss (g)	0.172
	Coupon Material	C1018	Corrosion Rate (mpy)	0.1215
	Coupon Serial No	MQ050	Calculated PittingRate (mpy)	0.365874
	Coupon Obeseration During retrieval	Coupon are in blackish colour with oily layer		
			Deepest mesured pit (mils)	2.3

Low Corrosive

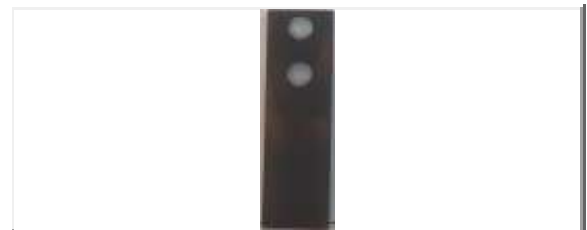
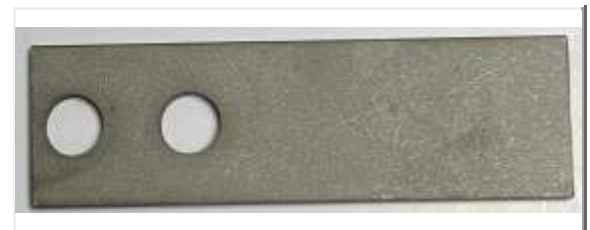
Back After Cleaning (D)

COUPON DETAILS:	Report No.		Coupon Install Date	7/22/2023
	A/F Tag No	53-XCC-1001	Coupon Initial Weight (gm)	36.6161
	Access fitting orientation	Top Mounted 12 O' clock	Pre-Cleaning Weight (g)	36.633
	Holder Length	6200-14.75	Final Weight (g)	36.605
	Coupon Type	3" Scale Coupn	Duration	726
	Coupon Position	BTM	Weight Loss (g)	0.011
	Coupon Material	C1018	Corrosion Rate (mpy)	0.0008
	Coupon Serial No	MQ037	Calculated PittingRate (mpy)	0.2147587
	Coupon Obeseration During retrieval	Coupon are in blackish colour with oily layer		
			Deepest mesured pit (mils)	1..7

Low Corrosive

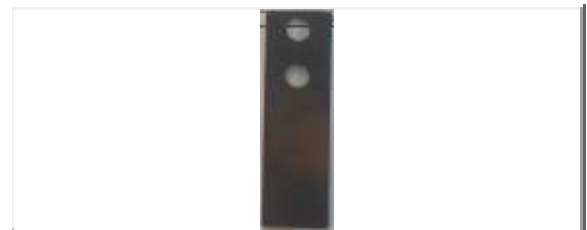
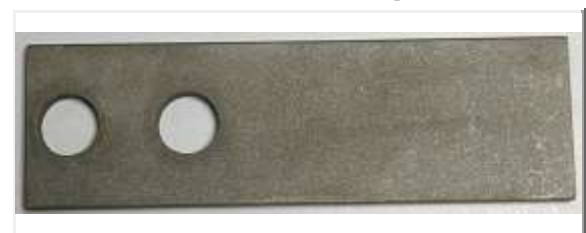
Back After Cleaning (D)

COUPON DETAILS:	Report No.		Coupon Install Date	7/22/2023
	A/F Tag No	53-XCC-1001	Coupon Initial Weight (gm)	36.9023
	Access fitting orientation	Top Mounted 12 O' clock	Pre-Cleaning Weight (g)	36.92
	Holder Length	6200-14.75	Final Weight (g)	36.895
	Coupon Type	3" Scale Coupn	Duration	726
	Coupon Position	BTM	Weight Loss (g)	0.007
	Coupon Material	C1018	Corrosion Rate (mpy)	-0.0020
	Coupon Serial No	MQ038	Calculated PittingRate (mpy)	0.14785
	Coupon Obeseration During retrieval	Coupon are in blackish colour with oily layer		
			Deepest mesured pit (mils)	0.9

Low Corrosive

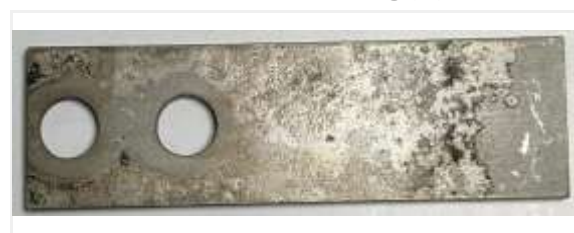
Back After Cleaning (D)

COUPON DETAILS:	Report No.		Coupon Install Date	7/21/2023
	A/F Tag No	53-XCC-945	Coupon Initial Weight (gm)	36.8085
	Access fitting orientation	Top Mounted 12 O' clock	Pre-Cleaning Weight (g)	36.613
	Holder Length	6200-12.25"	Final Weight (g)	36.504
	Coupon Type	3" Strip	Duration	727
	Coupon Position	BTM	Weight Loss (g)	0.305
	Coupon Material	C 1018	Corrosion Rate (mpy)	0.2207
	Coupon Serial No	MQ047	Calculated PittingRate (mpy)	0.6587425
	Coupon Serial No	MQ047	Deepest measured pit (mils)	3.7
	Coupon Observation During retrieval	Coupon are in blackish colour with oily layer

Low Corrosive

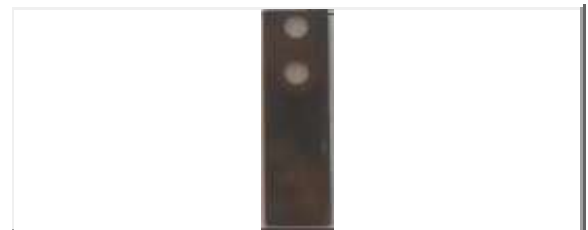
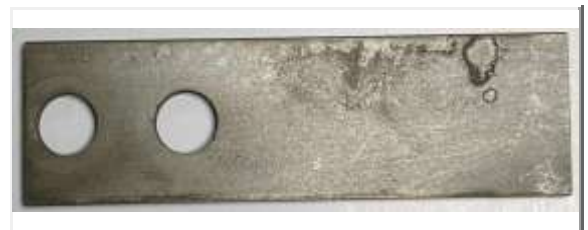
Back After Cleaning (D)

COUPON DETAILS:	Report No.		Coupon Install Date	7/21/2023
	A/F Tag No	53-XCC-945	Coupon Initial Weight (gm)	36.734
	Access fitting orientation	Top Mounted 12 O' clock	Pre-Cleaning Weight (g)	36.623
	Holder Length	6200-12.25"	Final Weight (g)	36.527
	Coupon Type	3" Strip	Duration	727
	Coupon Position	BTM	Weight Loss (g)	0.207
	Coupon Material	C 1018	Corrosion Rate (mpy)	0.1476
	Coupon Serial No	MQ048	Calculated PittingRate (mpy)	1.32547
	Coupon Obeseration During retrieval	Coupon are in blackish colour with oily layer		
			Deepest measured pit (mils)	5.8

Low Corrosive

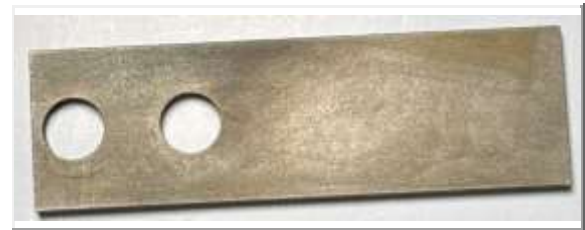
Back After Cleaning (D)

COUPON DETAILS:	Report No.		Coupon Install Date	7/17/2023
	A/F Tag No	53-XCC-1143	Coupon Initial Weight (gm)	36.8805
	Access fitting orientation	Bottom Mounted 6 O' Clock	Pre-Cleaning Weight (g)	36.897
	Holder Length	6200-3.00"	Final Weight (g)	36.863
	Coupon Type	3" Strip	Duration	727
	Coupon Position	BTM	Weight Loss (g)	0.017
	Coupon Material	C 1018	Corrosion Rate (mpy)	0.0056
	Coupon Serial No	MQ000	Calculated PittingRate (mpy)	0.02325
	Coupon Observation During retrieval	Coupon are in blackish colour with oily layer		
			Deepest measured pit (mils)	1.2

Low Corrosive

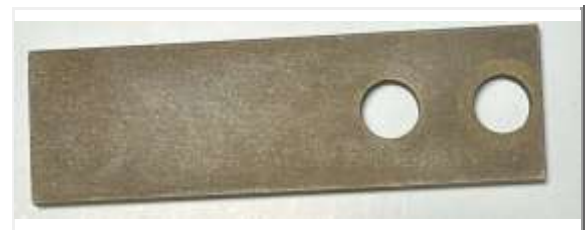
Back After Cleaning (D)

COUPON DETAILS:	Report No.		Coupon Install Date	7/17/2023
	A/F Tag No	53-XCC-1143	Coupon Initial Weight (gm)	36.779
	Access fitting orientation	Bottom Mounted 6 O' Clock	Pre-Cleaning Weight (g)	36.798
	Holder Length	6200-3.00"	Final Weight (g)	36.767
	Coupon Type	3" Strip	Duration	727
	Coupon Position	BTM	Weight Loss (g)	0.012
	Coupon Material	C 1018	Corrosion Rate (mpy)	0.0015
	Coupon Serial No	MP999	Calculated Pitting Rate (mpy)	0.02148
	Coupon Observation During retrieval	Coupon are in blackish colour with oily layer		
			Deepest measured pit (mils)	2.4

Low Corrosive

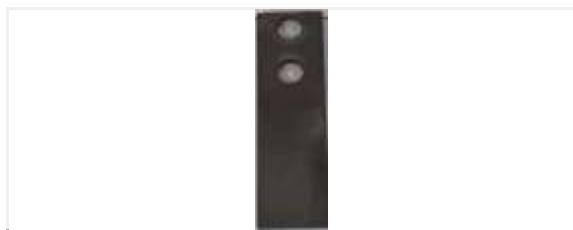
Front Before Cleaning (A)

COUPON DETAILS:	Report No.		Coupon Install Date	7/18/2023
	A/F Tag No	53-XCC-0002	Coupon Initial Weight (gm)	37.0398
	Access fitting orientation	Top Mounted 12 O' clock	Pre-Cleaning Weight (g)	36.966
	Holder Length	6200-4.75"	Final Weight (g)	36.813
	Coupon Type	3" Strip	Duration	725
	Coupon Position	BTM	Weight Loss (g)	0.227
	Coupon Material	C 1018	Corrosion Rate (mpy)	0.1629
	Coupon Serial No	MQ023	Calculated PittingRate (mpy)	1.365871
	Coupon Observation During retrieval	Coupon are in blackish colour with oily layer		
			Deepest measured pit (mils)	4.7

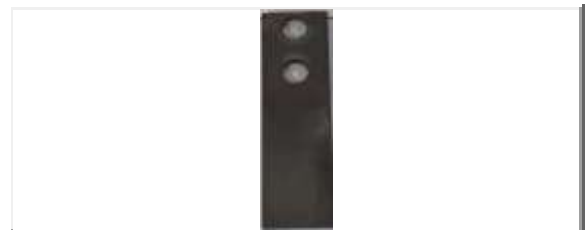
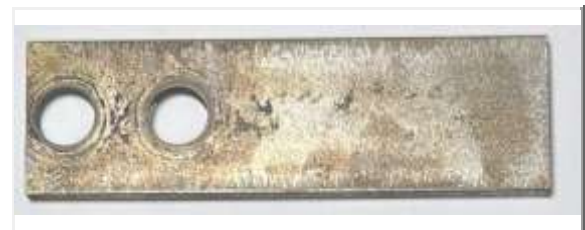
Back After Cleaning (D)

Low Corrosive

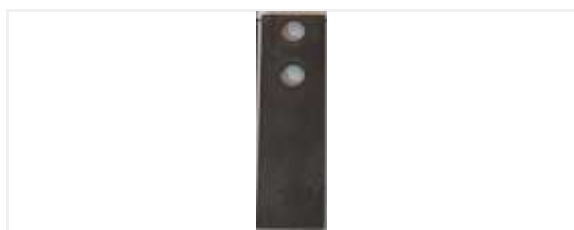
Front Before Cleaning (A)

COUPON DETAILS:	Report No.		Coupon Install Date	7/18/2023
	A/F Tag No	53-XCC-0002	Coupon Initial Weight (gm)	36.952
	Access fitting orientation	Top Mounted 12 O' clock	Pre-Cleaning Weight (g)	36.924
	Holder Length	6200-4.75"	Final Weight (g)	36.786
	Coupon Type	3" Strip	Duration	725
	Coupon Position	BTM	Weight Loss (g)	0.166
	Coupon Material	C 1018	Corrosion Rate (mpy)	0.1172
	Coupon Serial No	MQ024	Calculated PittingRate (mpy)	0.6985471
	Coupon Obeseration During retrieval	Coupon are in blackish colour with oily layer		
			Deepest mesured pit (mils)	1.2

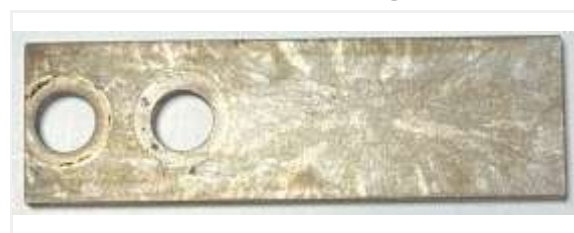
Back After Cleaning (D)

Low Corrosive

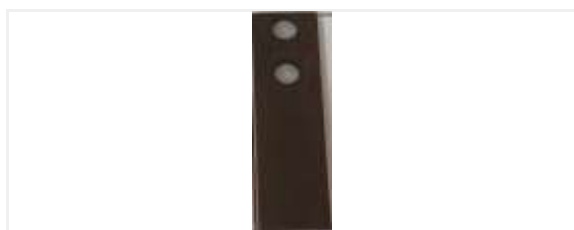
Front Before Cleaning (A)

COUPON DETAILS:	Report No.		Coupon Install Date	7/18/2023
	A/F Tag No	53-XCC-1210	Coupon Initial Weight (gm)	36.6347
	Access fitting orientation	Side Mounted 3/9 O' clock	Pre-Cleaning Weight (g)	36.686
	Holder Length	6200-9.50"	Final Weight (g)	36.629
	Coupon Type	3" Strip	Duration	725
	Coupon Position	BTM	Weight Loss (g)	0.006
	Coupon Material	C 1018	Corrosion Rate (mpy)	-0.0032
	Coupon Serial No	MQ027	Calculated PittingRate (mpy)	0.002148
	Coupon Obeseration During retrieval	Coupon are in blackish colour with oily layer		
			Deepest mesured pit (mils)	0.2

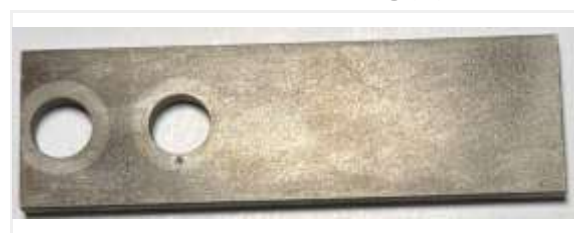
Back After Cleaning (D)

Low Corrosive

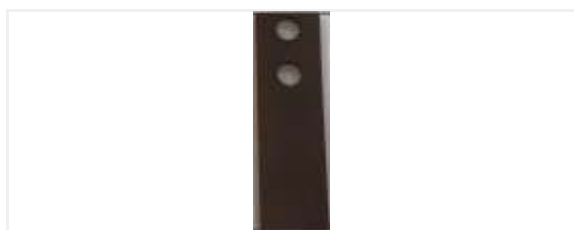
Front Before Cleaning (A)

COUPON DETAILS:	Report No.		Coupon Install Date	7/18/2023
	A/F Tag No	53-XCC-1210	Coupon Initial Weight (gm)	37.0164
	Access fitting orientation	Side Mounted 3/9 O' clock	Pre-Cleaning Weight (g)	37.063
	Holder Length	6200-9.50"	Final Weight (g)	37.005
	Coupon Type	3" Strip	Duration	725
	Coupon Position	BTM	Weight Loss (g)	0.011
	Coupon Material	C 1018	Corrosion Rate (mpy)	0.0011
	Coupon Serial No	MQ028	Calculated PittingRate (mpy)	0.0145287
	Coupon Obeseration During retrieval	Coupon are in blackish colour with oily layer		
			Deepest mesured pit (mils)	0.3

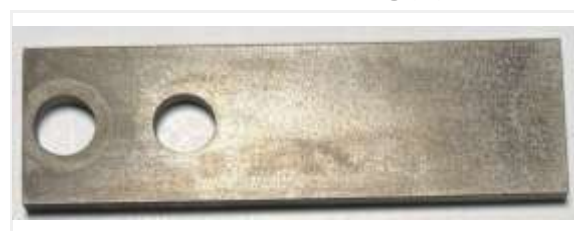
Back After Cleaning (D)

Low Corrosive

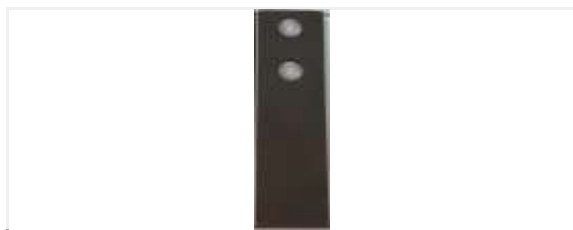
Front Before Cleaning (A)

COUPON DETAILS:	Report No.		Coupon Install Date	7/18/2023
	A/F Tag No	53-XCC-1211	Coupon Initial Weight (gm)	36.689
	Access fitting orientation	Side Mounted 3/9 O' clock	Pre-Cleaning Weight (g)	36.712
	Holder Length	6200-7.00"	Final Weight (g)	36.674
	Coupon Type	3" Strip	Duration	725
	Coupon Position	BTM	Weight Loss (g)	0.015
	Coupon Material	C 1018	Corrosion Rate (mpy)	0.0038
	Coupon Serial No	MQ029	Calculated PittingRate (mpy)	0.0214785
	Coupon Obeseration During retrieval	Coupon are in blackish colour with oily layer		
			Deepest measured pit (mils)	0.8

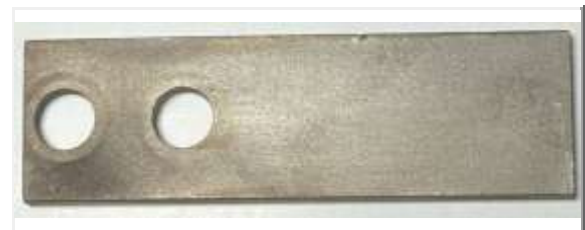
Back After Cleaning (D)

Low Corrosive

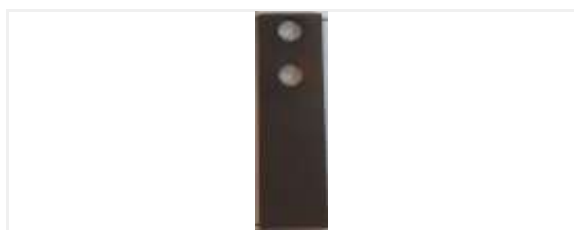
Front Before Cleaning (A)

COUPON DETAILS:	Report No.		Coupon Install Date	7/18/2023
	A/F Tag No	53-XCC-1211	Coupon Initial Weight (gm)	37.0734
	Access fitting orientation	Side Mounted 3/9 O' clock	Pre-Cleaning Weight (g)	37.085
	Holder Length	6200-7.00"	Final Weight (g)	37.052
	Coupon Type	3" Strip	Duration	725
	Coupon Position	BTM	Weight Loss (g)	0.021
	Coupon Material	C 1018	Corrosion Rate (mpy)	0.0086
	Coupon Serial No	MQ030	Calculated PittingRate (mpy)	0.01254875
	Coupon Obeseration During retrieval	Coupon are in blackish colour with oily layer		
			Deepest measured pit (mils)	0.5

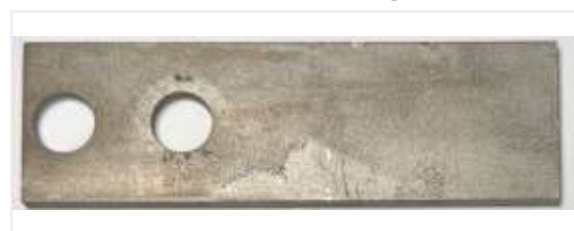
Back After Cleaning (D)

Low Corrosive

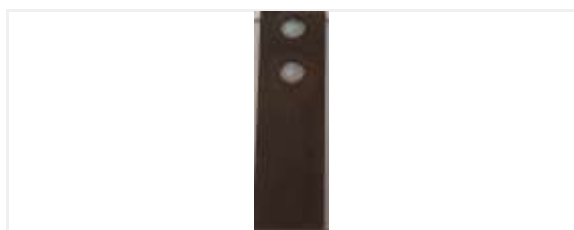
Front Before Cleaning (A)

COUPON DETAILS:	Report No.		Coupon Install Date	7/19/2023
	A/F Tag No	53-XCC-1140	Coupon Initial Weight (gm)	36.9164
	Access fitting orientation	Side Mounted 3/9 O' clock	Pre-Cleaning Weight (g)	36.89
	Holder Length	6200-7.75"	Final Weight (g)	36.764
	Coupon Type	3" Strip	Duration	724
	Coupon Position	BTM	Weight Loss (g)	0.152
	Coupon Material	C 1018	Corrosion Rate (mpy)	0.1072
	Coupon Serial No	MQ015	Calculated PittingRate (mpy)	1.23548
	Coupon Obeseration During retrieval	Coupon are in blackish colour with oily layer		
			Deepest measured pit (mils)	3.6

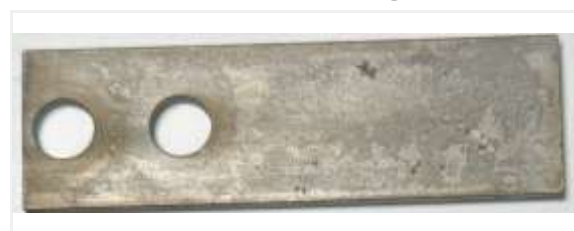
Back After Cleaning (D)

Low Corrosive

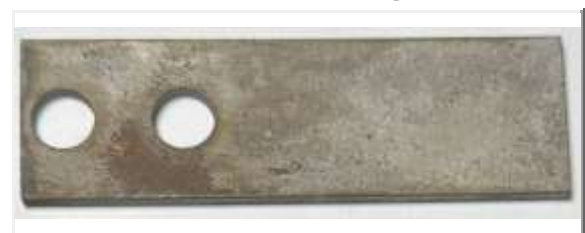
Back After Cleaning (D)

COUPON DETAILS:	Report No.		Coupon Install Date	7/19/2023
	A/F Tag No	53-XCC-1140	Coupon Initial Weight (gm)	36.7853
	Access fitting orientation	Side Mounted 3/9 O' clock	Pre-Cleaning Weight (g)	36.758
	Holder Length	6200-7.75"	Final Weight (g)	36.619
	Coupon Type	3" Strip	Duration	724
	Coupon Position	BTM	Weight Loss (g)	0.166
	Coupon Material	C 1018	Corrosion Rate (mpy)	0.1176
	Coupon Serial No	MQ016	Calculated PittingRate (mpy)	3.258471
	Coupon Obeseration During retrieval	Coupon are in blackish colour with oily layer		
			Deepest measured pit (mils)	8.9

Low Corrosive

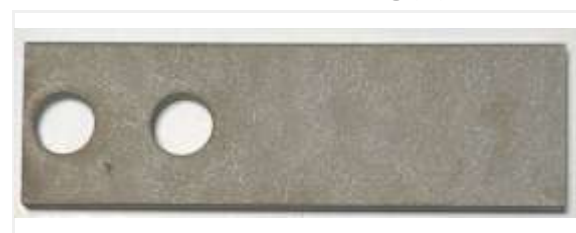
Back After Cleaning (D)

COUPON DETAILS:	Report No.		Coupon Install Date	7/19/2023
	A/F Tag No	53-XCC-1139	Coupon Initial Weight (gm)	36.9
	Access fitting orientation	Top Mounted 12 O' clock	Pre-Cleaning Weight (g)	36.918
	Holder Length	6200-4.75"	Final Weight (g)	36.885
	Coupon Type	3" Strip	Duration	723
	Coupon Position	BTM	Weight Loss (g)	0.015
	Coupon Material	C 1018	Corrosion Rate (mpy)	0.0038
	Coupon Serial No	MQ017	Calculated PittingRate (mpy)	0.0215478
	Coupon Obeseration During retrieval	Coupon are in blackish colour with oily layer		
			Deepest mesured pit (mils)	0.2

Low Corrosive

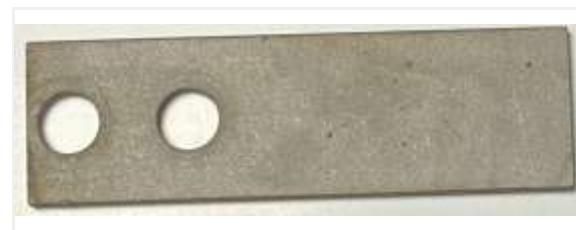
Back After Cleaning (D)

COUPON DETAILS:	Report No.		Coupon Install Date	7/19/2023
	A/F Tag No	53-XCC-1139	Coupon Initial Weight (gm)	36.7313
	Access fitting orientation	Top Mounted 12 O' clock	Pre-Cleaning Weight (g)	36.742
	Holder Length	6200-4.75"	Final Weight (g)	36.714
	Coupon Type	3" Strip	Duration	723
	Coupon Position	BTM	Weight Loss (g)	0.017
	Coupon Material	C 1018	Corrosion Rate (mpy)	0.0055
	Coupon Serial No	MQ018	Calculated PittingRate (mpy)	0.325684
	Coupon Obeseration During retrieval	Coupon are in blackish colour with oily layer		
			Deepest mesured pit (mils)	2.3

Low Corrosive

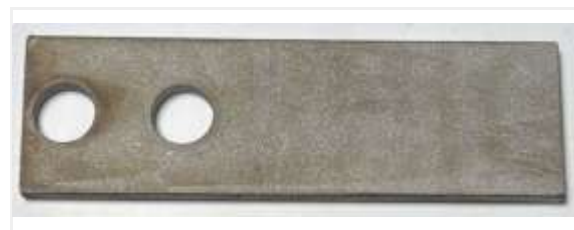
Back After Cleaning (D)

Low Corrosive

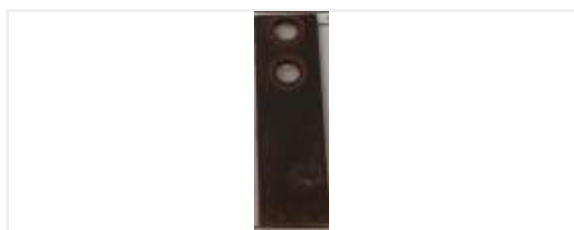
Front Before Cleaning (A)

COUPON DETAILS:	Report No.		Coupon Install Date	7/21/2023
	A/F Tag No	53-XCC-1426	Coupon Initial Weight (gm)	37.0341
	Access fitting orientation	Top Mounted 11 O' clock	Pre-Cleaning Weight (g)	37.2
	Holder Length	6200-10.75"	Final Weight (g)	36.759
	Coupon Type	3" Strip	Duration	725
	Coupon Position	BTM	Weight Loss (g)	0.275
	Coupon Material	C 1018	Corrosion Rate (mpy)	0.1992
	Coupon Serial No	MQ045	Calculated PittingRate (mpy)	1.325414
	Coupon Obeseration During retrieval	Coupon are in blackish colour with oily layer		
			Deepest mesured pit (mils)	3.7

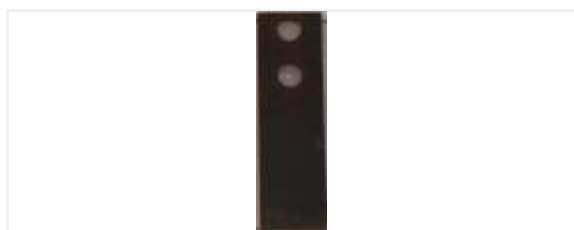
Front Before Cleaning (A)

COUPON DETAILS:	Report No.		Coupon Install Date	7/21/2023
	A/F Tag No	53-XCC-1426	Coupon Initial Weight (gm)	36.9712
	Access fitting orientation	Top Mounted 11 O' clock	Pre-Cleaning Weight (g)	36.933
	Holder Length	6200-10.75"	Final Weight (g)	36.715
	Coupon Type	3" Strip	Duration	725
	Coupon Position	BTM	Weight Loss (g)	0.256
	Coupon Material	C 1018	Corrosion Rate (mpy)	0.1850
	Coupon Serial No	MQ046	Calculated PittingRate (mpy)	0.985241
	Coupon Obeseration During retrieval	Coupon are in blackish colour with oily layer		
			Deepest measured pit (mils)	2.1

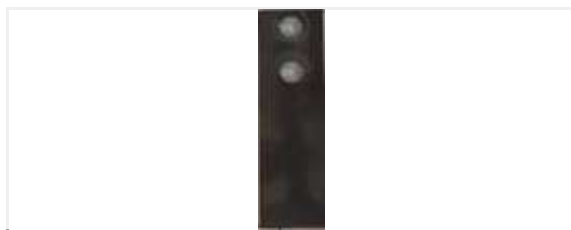
Front Before Cleaning (A)

COUPON DETAILS:	Report No.		Coupon Install Date	7/20/2023
	A/F Tag No	53-XCC-1002	Coupon Initial Weight (gm)	36.798
	Access fitting orientation	TopMounted 12 O' clock	Pre-Cleaning Weight (g)	36.423
	Holder Length	620005-X56-1	Final Weight (g)	36.264
	Coupon Type	3" Strip	Duration	722
	Coupon Position	BTM	Weight Loss (g)	0.534
	Coupon Material	C 1018	Corrosion Rate (mpy)	0.3954
	Coupon Serial No	MQ019	Calculated PittingRate (mpy)	3.214875
	Coupon Obeseration During retrieval	Coupon are in blackish colour with oily layer		
			Deepest mesured pit (mils)	8.7

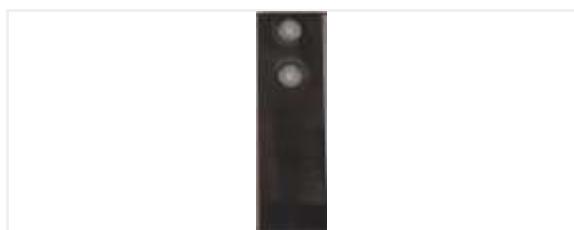
Front Before Cleaning (A)

COUPON DETAILS:	Report No.		Coupon Install Date	7/20/2023
	A/F Tag No	53-XCC-1002	Coupon Initial Weight (gm)	36.9074
	Access fitting orientation	TopMounted 12 O' clock	Pre-Cleaning Weight (g)	36.604
	Holder Length	620005-X56-1	Final Weight (g)	36.449
	Coupon Type	3" Strip	Duration	722
	Coupon Position	BTM	Weight Loss (g)	0.458
	Coupon Material	C 1018	Corrosion Rate (mpy)	0.3384
	Coupon Serial No	MQ020	Calculated PittingRate (mpy)	0.8563214
	Coupon Observation During retrieval	Coupon are in blackish colour with oily layer		
			Deepest measured pit (mils)

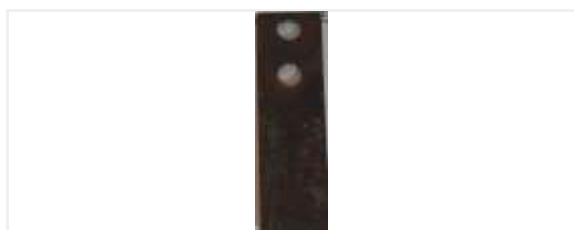
Front Before Cleaning (A)

COUPON DETAILS:	Report No.		Coupon Install Date	7/20/2023
	A/F Tag No	53-XCC-1003	Coupon Initial Weight (gm)	36.8938
	Access fitting orientation	Top Mounted 12 O' clock	Pre-Cleaning Weight (g)	36.629
	Holder Length	620005-X59-1	Final Weight (g)	36.502
	Coupon Type	3" Strip	Duration	731
	Coupon Position	BTM	Weight Loss (g)	0.392
	Coupon Material	C 1018	Corrosion Rate (mpy)	0.2846
	Coupon Serial No	MQ043	Calculated PittingRate (mpy)	1.325874
	Coupon Serial No	MQ043	Deepest measured pit (mils)	3.5
	Coupon Observation During retrieval	Coupon are in blackish colour with oily layer

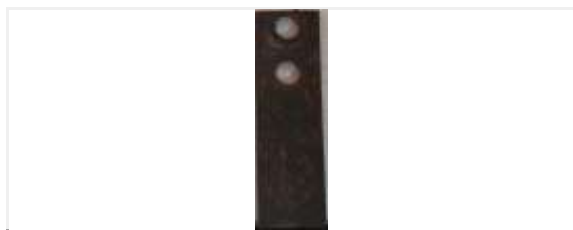
Front Before Cleaning (A)

COUPON DETAILS:	Report No.		Coupon Install Date	7/20/2023
	A/F Tag No	53-XCC-1003	Coupon Initial Weight (gm)	36.8939
	Access fitting orientation	Top Mounted 12 O' clock	Pre-Cleaning Weight (g)	36.622
	Holder Length	620005-X59-1	Final Weight (g)	36.423
	Coupon Type	3" Strip	Duration	731
	Coupon Position	BTM	Weight Loss (g)	0.471
	Coupon Material	C 1018	Corrosion Rate (mpy)	0.3435
	Coupon Serial No	MQ044	Calculated PittingRate (mpy)	0.985214
	Coupon Obeseration During retrieval	Coupon are in blackish colour with oily layer		
			Deepest mesured pit (mils)	1.2

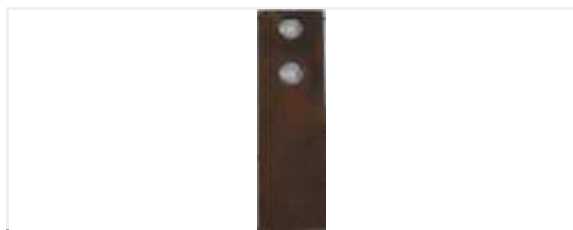
Front Before Cleaning (A)

COUPON DETAILS:	Report No.		Coupon Install Date	7/20/2023
	A/F Tag No	53-XCC-1004	Coupon Initial Weight (gm)	36.7993
	Access fitting orientation	Top Mounted 12 O' clock	Pre-Cleaning Weight (g)	36.862
	Holder Length	620005-X63-0	Final Weight (g)	36.721
	Coupon Type	3" Strip	Duration	721
	Coupon Position	BTM	Weight Loss (g)	0.078
	Coupon Material	C 1018	Corrosion Rate (mpy)	0.0516
	Coupon Serial No	MQ041	Calculated PittingRate (mpy)	0.21547
	Coupon Obeseration During retrieval	Coupon are in blackish colour with oily layer		
			Deepest mesured pit (mils)	0

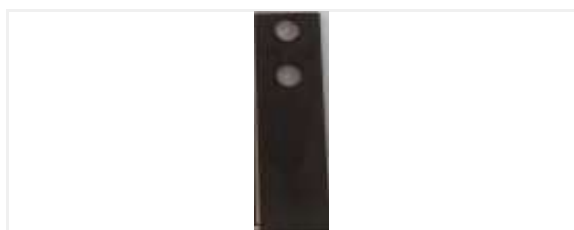
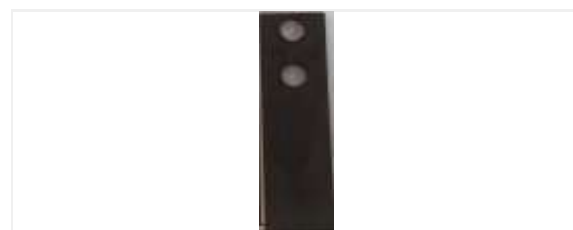
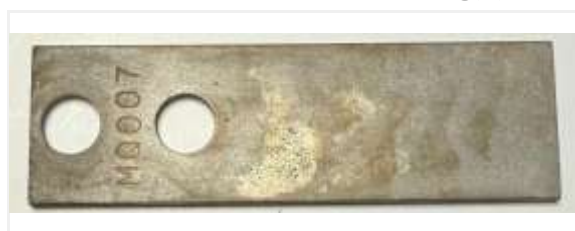
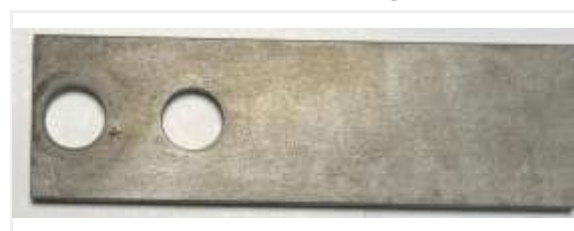
COUPON DETAILS:	Report No.		Coupon Install Date	7/24/2023
	A/F Tag No	43-XCC-176	Coupon Initial Weight (gm)	37.0342
	Access fitting orientation	Top Mounted 12 O' clock	Pre-Cleaning Weight (g)	37.021
	Holder Length	6200-7.00"	Final Weight (g)	36.99
	Coupon Type	3" Strip	Duration	725
	Coupon Position	BTM	Weight Loss (g)	0.044
	Coupon Material	C 1018	Corrosion Rate (mpy)	0.0257
	Coupon Serial No	MQ007	Calculated PittingRate (mpy)	1.254714
	Coupon Obeseration During retrieval	Coupon are in blackish colour with oily layer		
			Deepest mesured pit (mils)	2.8

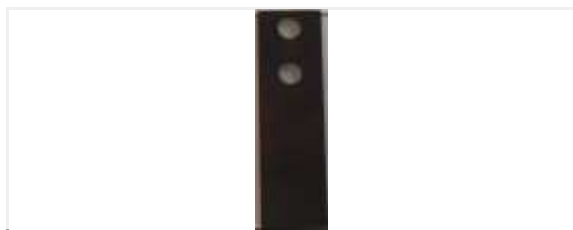
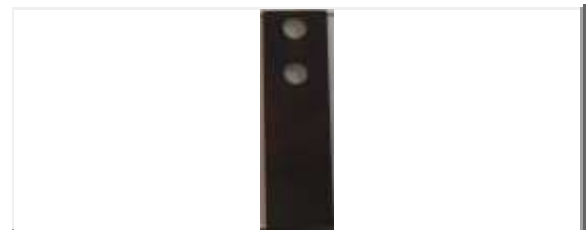
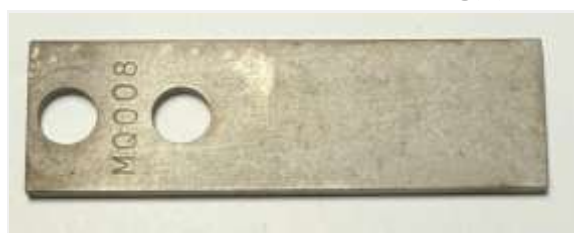
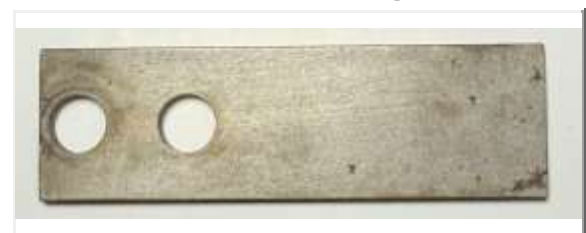
COUPON DETAILS:	Report No.		Coupon Install Date	7/24/2023
	A/F Tag No	43-XCC-176	Coupon Initial Weight (gm)	37.021
	Access fitting orientation	Top Mounted 12 O' clock	Pre-Cleaning Weight (g)	37.025
	Holder Length	6200-7.00"	Final Weight (g)	36.989
	Coupon Type	3" Strip	Duration	725
	Coupon Position	BTM	Weight Loss (g)	0.032
	Coupon Material	C 1018	Corrosion Rate (mpy)	0.0165
	Coupon Serial No	MQ008	Calculated PittingRate (mpy)	0.9856321
	Coupon Obeseration During retrieval	Coupon are in blackish colour with oily layer		
			Deepest mesured pit (mils)	1.3

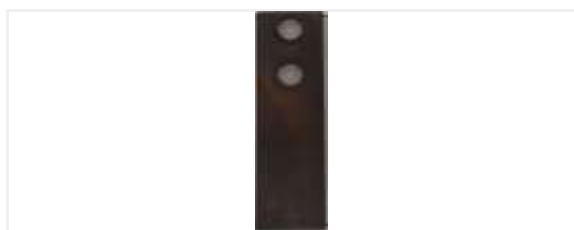
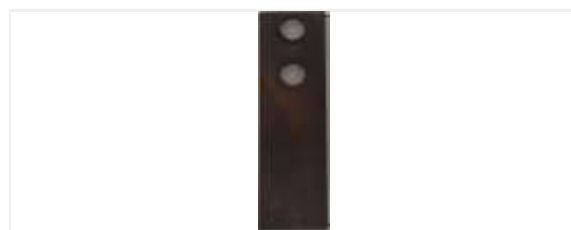
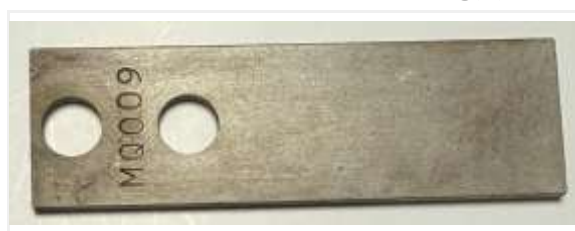
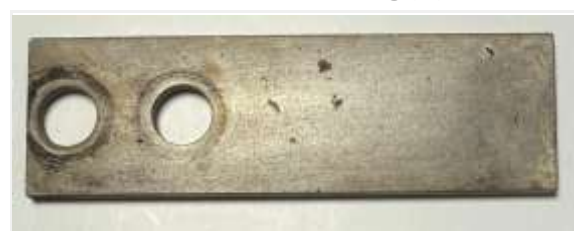
COUPON DETAILS:	Report No.		Coupon Install Date	7/24/2023
	A/F Tag No	43-XCC-300	Coupon Initial Weight (gm)	36.7816
	Access fitting orientation	Top Mounted 11 O' clock	Pre-Cleaning Weight (g)	36.784
	Holder Length	6200-3.00"	Final Weight (g)	36.737
	Coupon Type	3" Strip	Duration	725
	Coupon Position	TOP	Weight Loss (g)	0.045
	Coupon Material	C 1018	Corrosion Rate (mpy)	0.0260
	Coupon Serial No	MQ009	Calculated PittingRate (mpy)	0.6325417
	Coupon Obeseration During retrieval	Coupon are in blackish colour with oily layer		
			Deepest measured pit (mils)	1.1

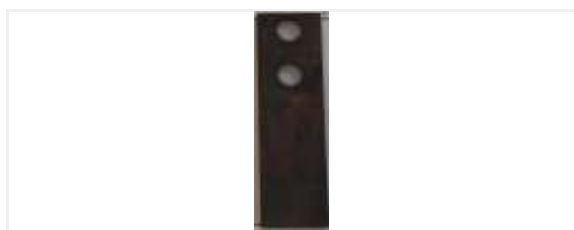
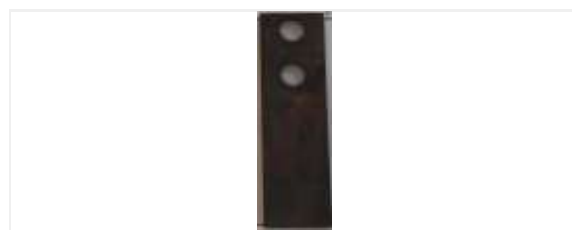
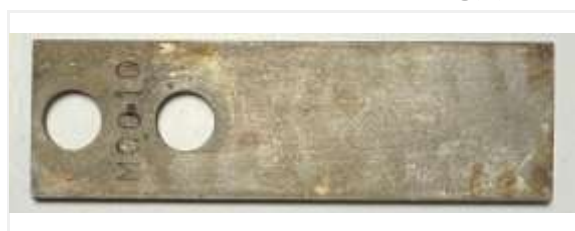
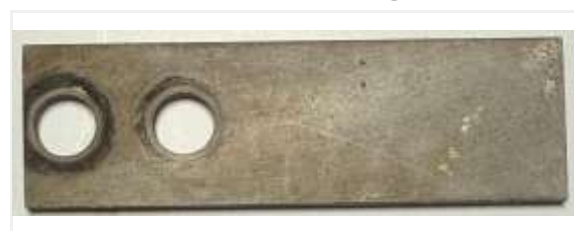
COUPON DETAILS:	Report No.		Coupon Install Date	7/24/2023
	A/F Tag No	43-XCC-300	Coupon Initial Weight (gm)	36.9431
	Access fitting orientation	Top Mounted 11 O' clock	Pre-Cleaning Weight (g)	36.987
	Holder Length	6200-3.00"	Final Weight (g)	36.935
	Coupon Type	3" Strip	Duration	725
	Coupon Position	TOP	Weight Loss (g)	0.008
	Coupon Material	C 1018	Corrosion Rate (mpy)	-0.0014
	Coupon Serial No	MQ010	Calculated PittingRate (mpy)	0.0125425
	Coupon Obeseration During retrieval	Coupon are in blackish colour with oily layer		
			Deepest mesured pit (mils)	0.5

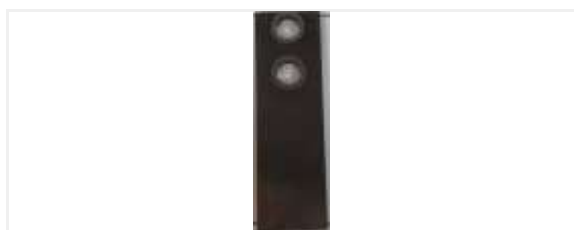
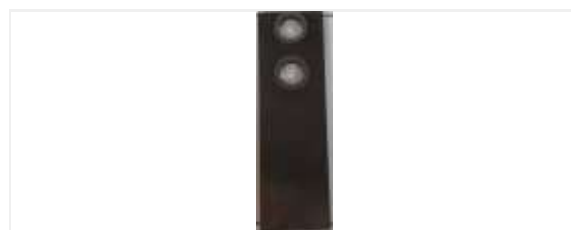
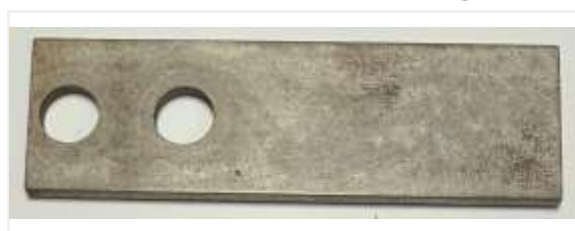
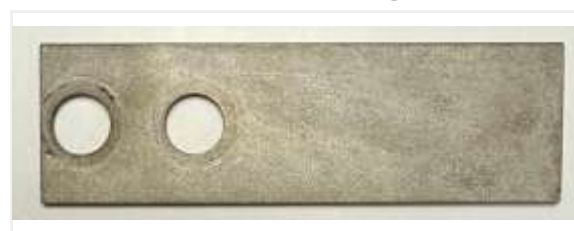
COUPON DETAILS:	Report No.		Coupon Install Date	7/25/2023
	A/F Tag No	43-XCC-169	Coupon Initial Weight (gm)	36.8939
	Access fitting orientation	Top Mounted 2 O' clock	Pre-Cleaning Weight (g)	36.686
	Holder Length	6200-9.50"	Final Weight (g)	36.622
	Coupon Type	3" Strip	Duration	724
	Coupon Position	BTM	Weight Loss (g)	0.272
	Coupon Material	C 1018	Corrosion Rate (mpy)	0.1971
	Coupon Serial No	MP981	Calculated PittingRate (mpy)	1.3652147
	Coupon Obeseration During retrieval	Coupon are in blackish colour with oily layer		
			Deepest mesured pit (mils)

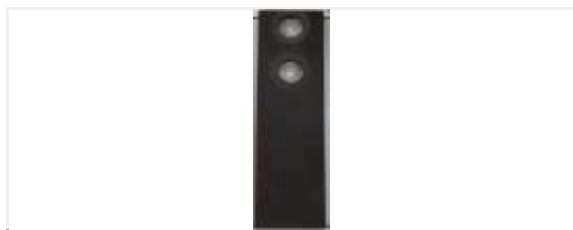
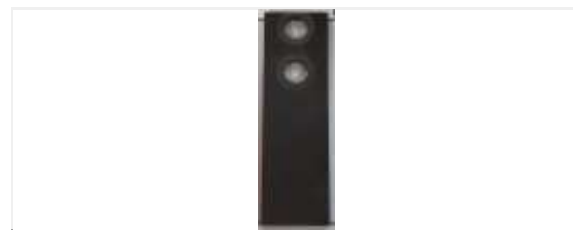
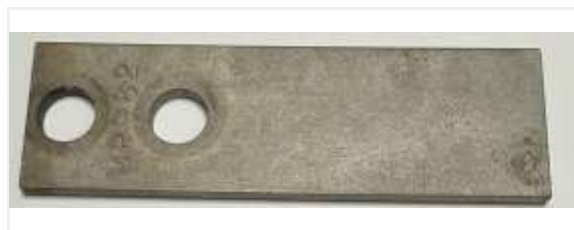
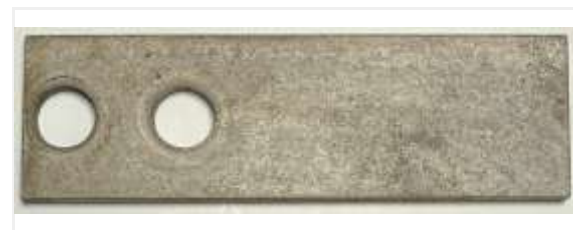
COUPON DETAILS:	Report No.		Coupon Install Date	7/25/2023
	A/F Tag No	43-XCC-169	Coupon Initial Weight (gm)	36.8939
	Access fitting orientation	Top Mounted 2 O' clock	Pre-Cleaning Weight (g)	36.864
	Holder Length	6200-9.50"	Final Weight (g)	36.812
	Coupon Type	3" Strip	Duration	724
	Coupon Position	BTM	Weight Loss (g)	0.082
	Coupon Material	C 1018	Corrosion Rate (mpy)	0.0541
	Coupon Serial No	MP982	Calculated PittingRate (mpy)	0.02154782
	Coupon Observation During retrieval	Coupon are in blackish colour with oily layer		
			Deepest measured pit (mils)

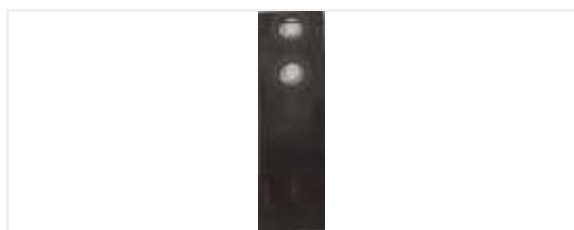
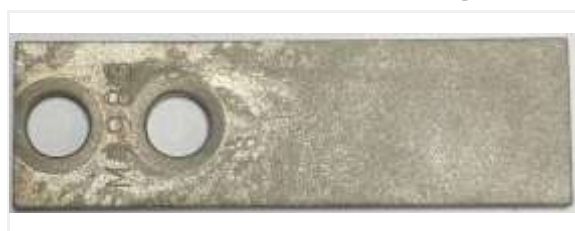
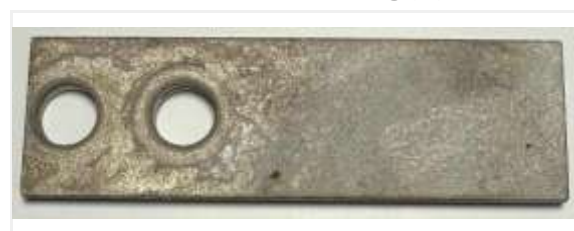
COUPON DETAILS:	Report No.		Coupon Install Date	7/25/2023
	A/F Tag No	43-XCC-171	Coupon Initial Weight (gm)	36.6903
	Access fitting orientation	Top Mounted 2 O' clock	Pre-Cleaning Weight (g)	36.662
	Holder Length	6200-3.50"	Final Weight (g)	36.512
	Coupon Type	3" Strip	Duration	724
	Coupon Position	TOP	Weight Loss (g)	0.178
	Coupon Material	C 1018	Corrosion Rate (mpy)	0.1267
	Coupon Serial No	MP983	Calculated PittingRate (mpy)	1.36521478
	Coupon Obeseration During retrieval	Coupon are in blackish colour with oily layer		
			Deepest mesured pit (mils)	2.7

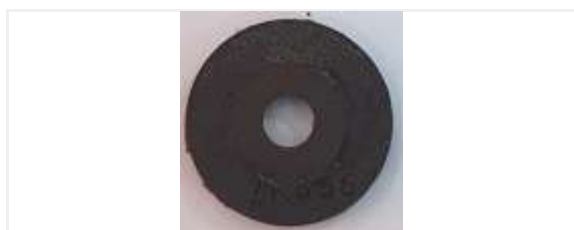
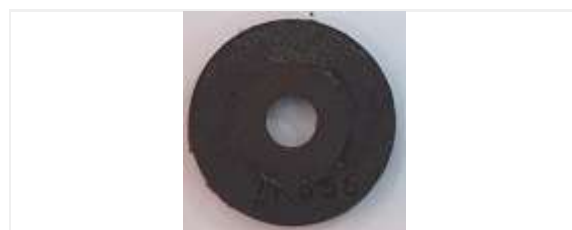
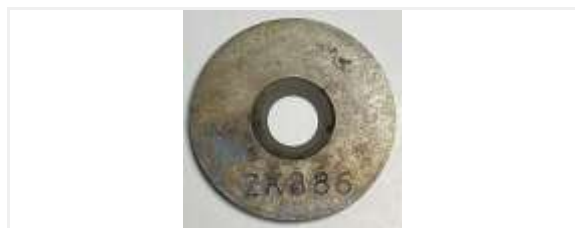
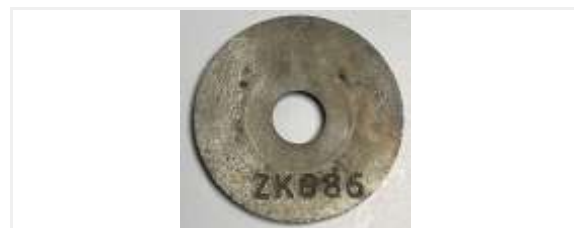
Front Before Cleaning (A)

Back Before Cleaning (B)

Front After Cleaning (C)

Back After Cleaning (D)

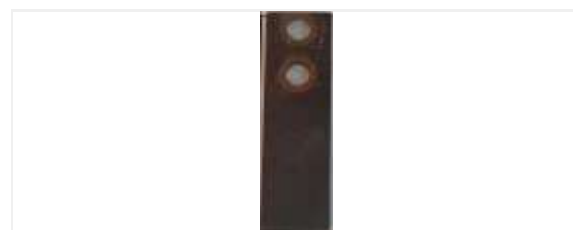
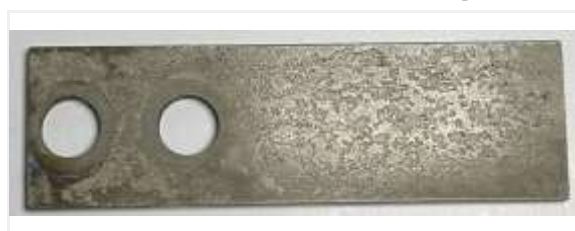
COUPON DETAILS:	Report No.		Coupon Install Date	7/22/2023
	A/F Tag No	53-XCC-909	Coupon Initial Weight (gm)	36.9129
	Access fitting orientation	Top Mounted 12 O' clock	Pre-Cleaning Weight (g)	36.946
	Holder Length	6202-21.25	Final Weight (g)	36.8
	Coupon Type	3" Scale coupo	Duration	763
	Coupon Position	BTM	Weight Loss (g)	0.113
	Coupon Material	C 1018	Corrosion Rate (mpy)	0.1528
	Coupon Serial No	MQ031	Calculated PittingRate (mpy)	
	Coupon Obeseration During retrieval	Coupon are in blackish colour with oily layer		
			Deepest mesured pit (mils)

Back Before Cleaning (B)

Front After Cleaning (C)

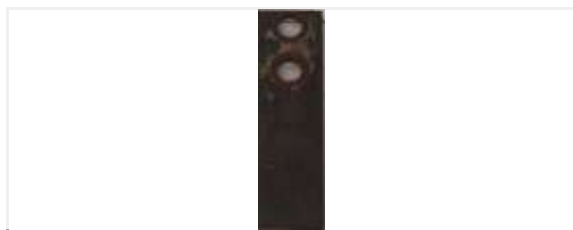
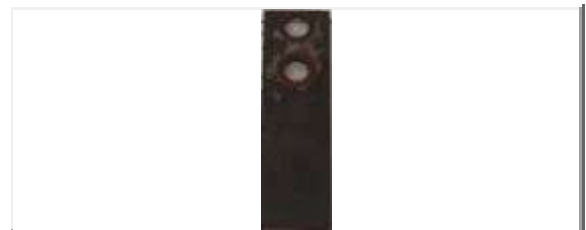
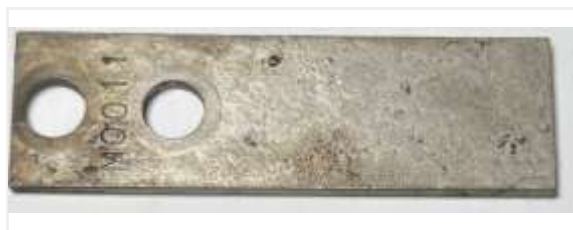
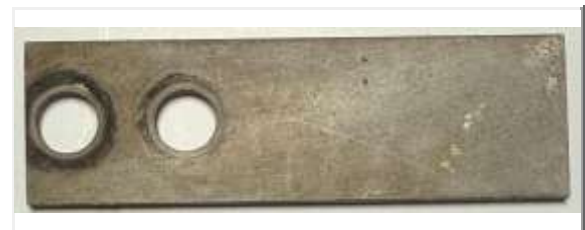
COUPON DETAILS:	Report No.		Coupon Install Date	7/22/2023
	A/F Tag No	53-XCC-909	Coupon Initial Weight (gm)	37.0324
	Access fitting orientation	Top Mounted 12 O' clock	Pre-Cleaning Weight (g)	37.056
	Holder Length	6202-21.25	Final Weight (g)	36.926
	Coupon Type	3" Scale coupo	Duration	763
	Coupon Position	BTM	Weight Loss (g)	0.106
	Coupon Material	C 1018	Corrosion Rate (mpy)	0.1432
	Coupon Serial No	MQ032	Calculated PittingRate (mpy)	
	Coupon Obeseration During retrieval	Coupon are in blackish colour with oily layer		
			Deepest mesured pit (mils)

Front Before Cleaning (A)

Back Before Cleaning (B)

Front After Cleaning (C)

Back After Cleaning (D)

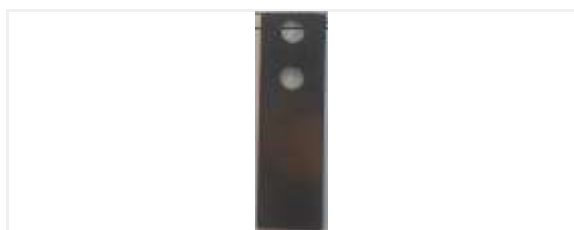
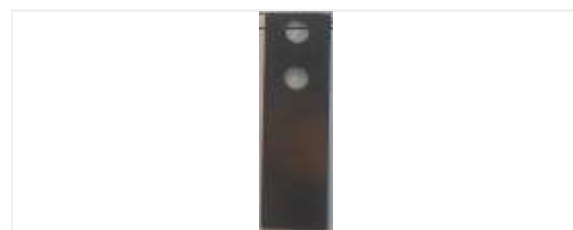
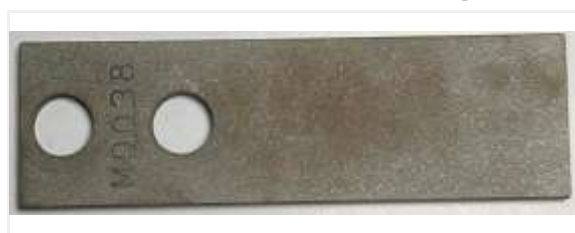
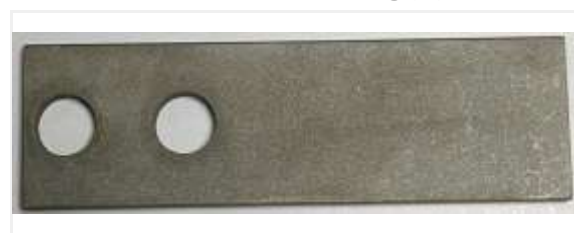
COUPON DETAILS:	Report No.		Coupon Install Date	7/22/2023
	A/F Tag No	53-XCC-1428	Coupon Initial Weight (gm)	36.7602
	Access fitting orientation	Top Mounted 12 O' clock	Pre-Cleaning Weight (g)	36.389
	Holder Length	6202-21.25	Final Weight (g)	35.92
	Coupon Type	3" Strip	Duration	765
	Coupon Position	BTM	Weight Loss (g)	0.840
	Coupon Material	C 1018	Corrosion Rate (mpy)	0.5913
	Coupon Serial No	MQ035	Calculated PittingRate (mpy)	
	Coupon Obeseration During retrieval	Coupon are in blackish colour with oily layer		
			Deepest measured pit (mils)

Front Before Cleaning (A)

Back Before Cleaning (B)

Front After Cleaning (C)

Back After Cleaning (D)

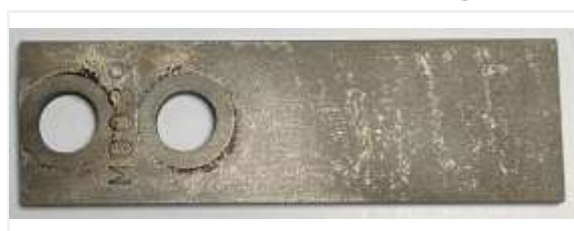
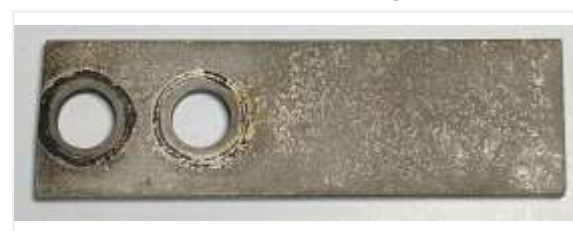
COUPON DETAILS:	Report No.		Coupon Install Date	7/22/2023
	A/F Tag No	53-XCC-1428	Coupon Initial Weight (gm)	37.0007
	Access fitting orientation	Top Mounted 12 O' clock	Pre-Cleaning Weight (g)	36.67
	Holder Length	6202-21.25	Final Weight (g)	36.174
	Coupon Type	3" Strip	Duration	765
	Coupon Position	BTM	Weight Loss (g)	0.830
	Coupon Material	C 1018	Corrosion Rate (mpy)	0.5817
	Coupon Serial No	MQ036	Calculated PittingRate (mpy)	
	Coupon Observation During retrieval	Coupon are in blackish colour with oily layer		
			Deepest measured pit (mils)

Front After Cleaning (C)

Back After Cleaning (D)

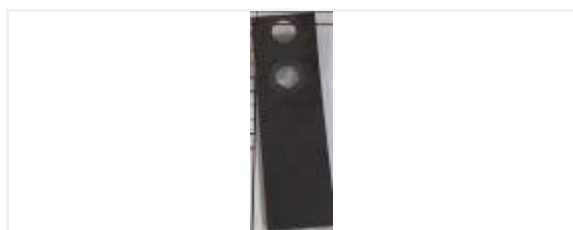
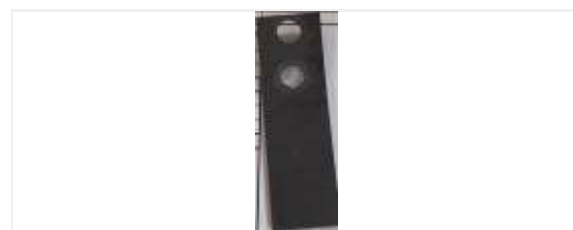
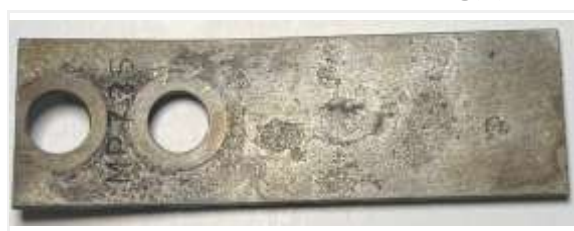
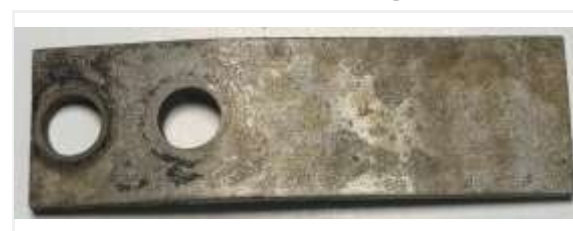
COUPON DETAILS:	Report No.		Coupon Install Date	7/22/2023
	A/F Tag No	43-XCC-178	Coupon Initial Weight (gm)	37.0007
	Access fitting orientation	SideMounted 3/9 O' clock	Pre-Cleaning Weight (g)	36.542
	Holder Length	6202-21.25	Final Weight (g)	36.297
	Coupon Type	3" Strip	Duration	765
	Coupon Position	BTM	Weight Loss (g)	0.245
	Coupon Material	C 1018	Corrosion Rate (mpy)	0.1674
	Coupon Serial No	MQ735	Calculated PittingRate (mpy)	
	Coupon Obeseration During retrieval	Dark in colour Scoring marks from internal obstruction Coupon Bent		
			Deepest mesured pit (mils)

Front Before Cleaning (A)

Back Before Cleaning (B)

Front After Cleaning (C)

Back After Cleaning (D)
