# PROVISION OF CORROSION MONITORING SERVICES AT OFFSHORE AND MESAIEED

Document: PROVISION OF CORROSION MONITORING SERVICE REPORT  
AT OFFSHORE LOCATION PS-3 1ST CAMPAIGN

LOCATION DETAILS:	Location	PS-3A Platform - Lower deck		
	Line Description	4" Gas injection manifold		
	Line Identification	4-GP-532019-9151	Process Pressure	150

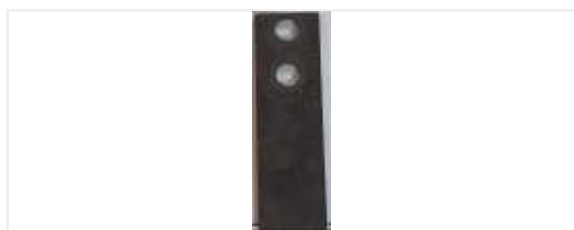
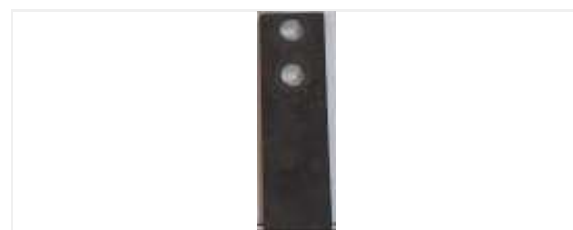
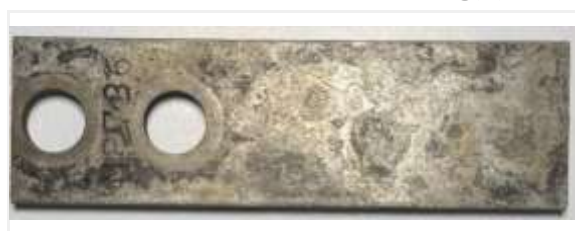
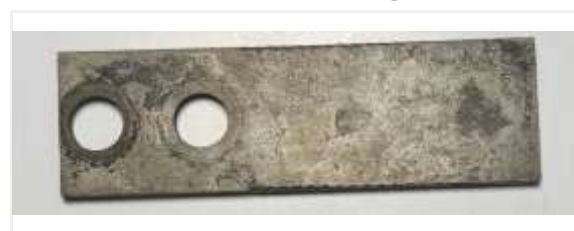
COUPON DETAILS:	Report No.		Coupon Install Date	7/22/2023
	A/F Tag No	43-XCC-178	Coupon Initial Weight (gm)	37.0007
	Access fitting orientation	SideMounted 3/9 O' clock	Pre-Cleaning Weight (g)	36.312
	Holder Length	6202-21.25	Final Weight (g)	35.997
	Coupon Type	3" Strip	Duration	765
	Coupon Position	BTM	Weight Loss (g)	0.315
	Coupon Material	C 1018	Corrosion Rate (mpy)	0.2172
	Coupon Serial No	MQ736	Calculated PittingRate (mpy)	
	Coupon Obeseration During retrieval	Dark in colour Scoring marks from internal obstruction Coupon Bent		
			Deepest mesured pit (mils)

Front Before Cleaning (A)

Back Before Cleaning (B)

Front After Cleaning (C)

Back After Cleaning (D)
