Inspect the Condenser Assembly for Gasket Degradation

After four or more years of use, the gasket inside a 1710 Condenser Assembly may degrade. This is one of many possible root causes for symptoms such as early make-up cartridge write downs. The steps here allow you to verify the state of the gasket, however if you are just starting troubleshooting of early cartridge write downs, you should first troubleshoot as instructed in [Make up Not adding, Cartridge Write Down to Zero \(1710\)](#).

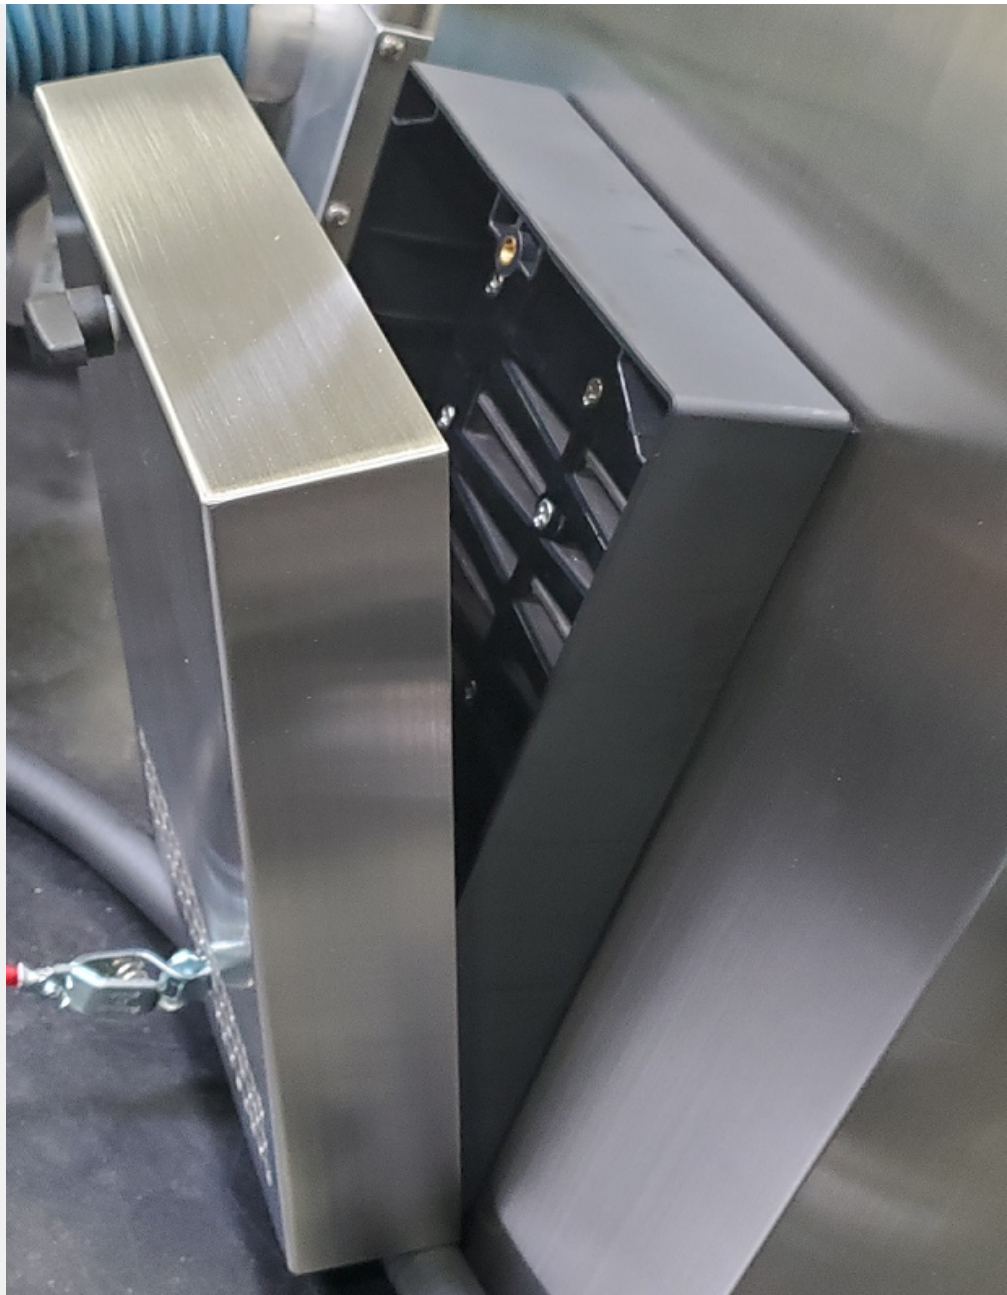
1. Remove the fan filter cover.
