AUDIT REPORT

Security Audit of Computing Resources – University of Greenwich King William Building

Date: 27th March 2025

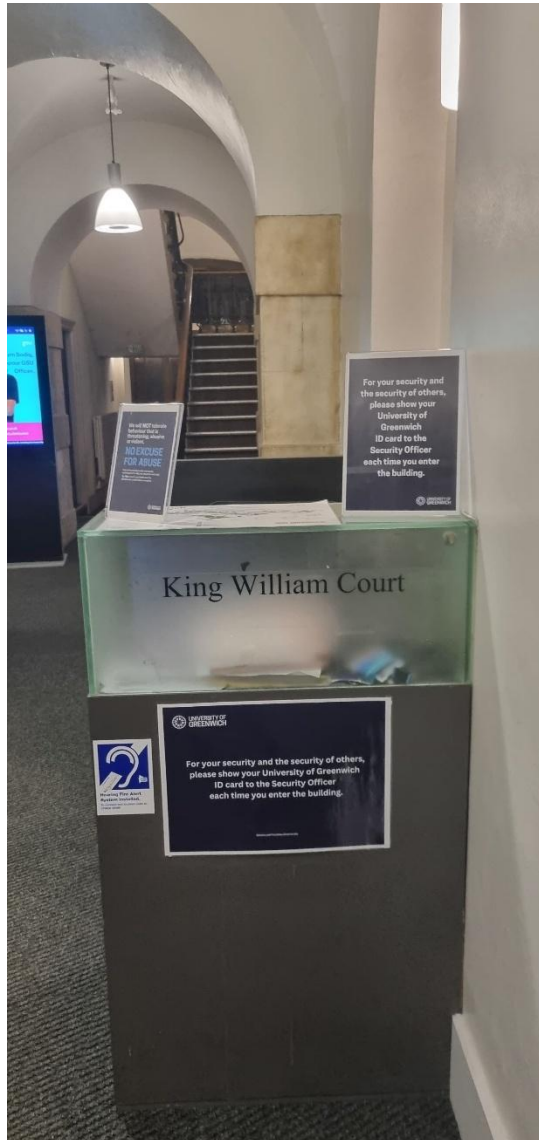
The main entrance to the King William Building is access-controlled, requiring an access ID card for entry, as shown in Figure 1 (refer to the Appendix). This prevents unauthorized individuals from freely accessing the facility. However, once inside, no further authentication is required to enter the computing laboratories or access computing resources. In some cases, individuals can enter the labs without displaying an ID card, as there are no additional access controls, such as biometric authentication or PIN-based systems, for extra verification. This lack of extra checks means a lost or stolen ID card could be used by someone else. Another issue is tailgating, where an unauthorized person can follow someone with an ID card into restricted areas. Since there are no turnstiles, man-trap doors, or other barriers, it's easy for someone to enter the computing laboratories without proper checks. Improving internal access controls would help make the building more secure.

Figure 1 King William Building entrance security check

To improve security and prevent unauthorized access to critical areas, it is recommended to implement a tap-in mechanism at the entrances to sensitive zones like computer labs. This system would require individuals to tap their ID card against a reader for additional verification before gaining access. This added layer of authentication reduces the risk of unauthorized entry, as it ensures that only authorized individuals with valid ID cards are granted access. Implementing turnstiles or mantraps at key access points would further ensure that only one person enters at a time, preventing tailgating and further securing restricted areas. The benefits of this system include enhanced security, improved monitoring of access to sensitive areas, and the reduction of security breaches and unauthorized access. Additionally, this solution is cost-effective, leveraging existing ID infrastructure and providing a simple yet powerful enhancement to building security.

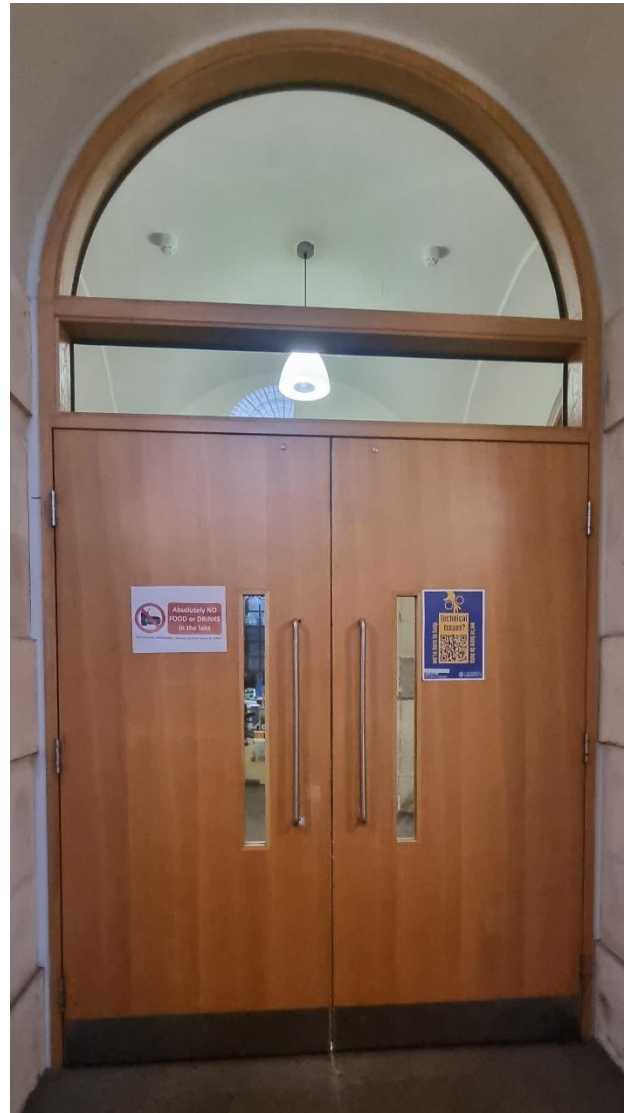
Figure 2 Lab Entrance Door

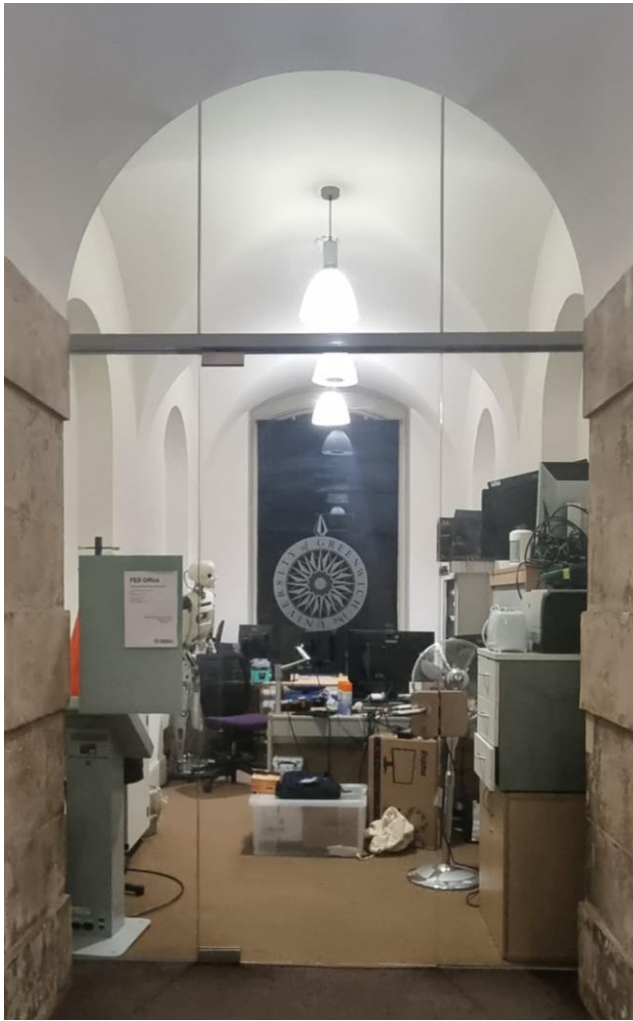
Physical barriers, such as walls, secure doors, windows, and lighting, are the first line of defence against unauthorized access to the building. The organization has implemented solid physical security measures, including locked doors and windows, which provide basic protection against intrusions. The presence of well-lit walkways and entrances enhances visibility, reducing security risks during low-light conditions. However, certain vulnerabilities were identified. Some doors lack reinforced locking mechanisms, making them susceptible to forced entry. Additionally, the laboratory IT support office doors are made of glass, which increases visibility into restricted areas and makes them more vulnerable to break-ins or unauthorized access.

Figure 3 Vulnerable Glass Door in Computing Lab

Doors with glass panels should be fitted with shatter-resistant film or replaced with more secure materials, making it significantly more difficult to break, thereby delaying or deterring forced entry attempts. Replacing glass doors with solid-core or reinforced materials eliminates visibility into secure areas, preventing unauthorized individuals from observing sensitive activities or targeting valuable IT assets, thereby enhancing overall security.

- Fit shatter-resistant film on all glass doors within 1 month; plan replacement with solid-core doors in the next quarter.
- Reinforce door locks where needed; phase out weaker locking mechanisms.
- Perform a physical security risk assessment after installation of films and new locks.
- Update maintenance and inspection routines to include checks of door integrity and security film condition.

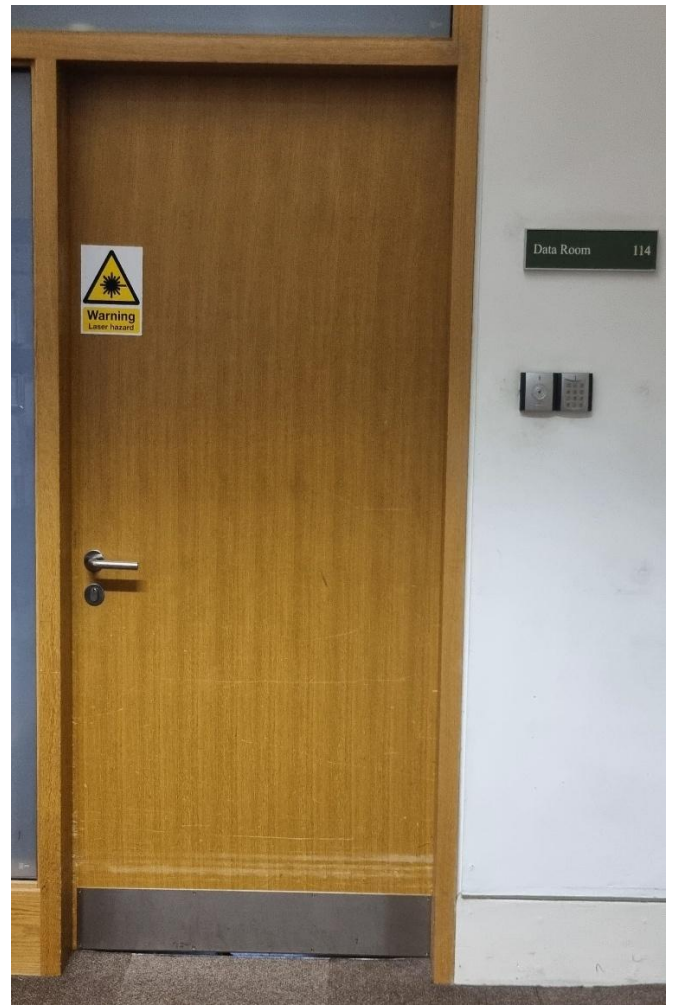
During the audit, it was observed that certain restricted areas, such as the data rooms and the electrical riser cupboard, were properly secured and consistently remained locked, as seen in Figure 4 and 5 (refer to the Appendix). This ensures that only authorized personnel can access these areas, providing an essential control to protect sensitive data and equipment. However, it was noted that some restricted areas, particularly the data rooms, lack visible signage indicating restricted access, as seen in Figure 4 (refer to the Appendix). The absence of clear signage means there is no immediate indication that entry is limited to authorized personnel only. This could lead to confusion or accidental entry by unauthorized individuals, posing a potential security risk. While the emergency exits were well-marked and free from obstructions, ensuring safe evacuation in case of an emergency, the computing laboratories lacked clear

Figure 4 Data room secured access via pin/card entry

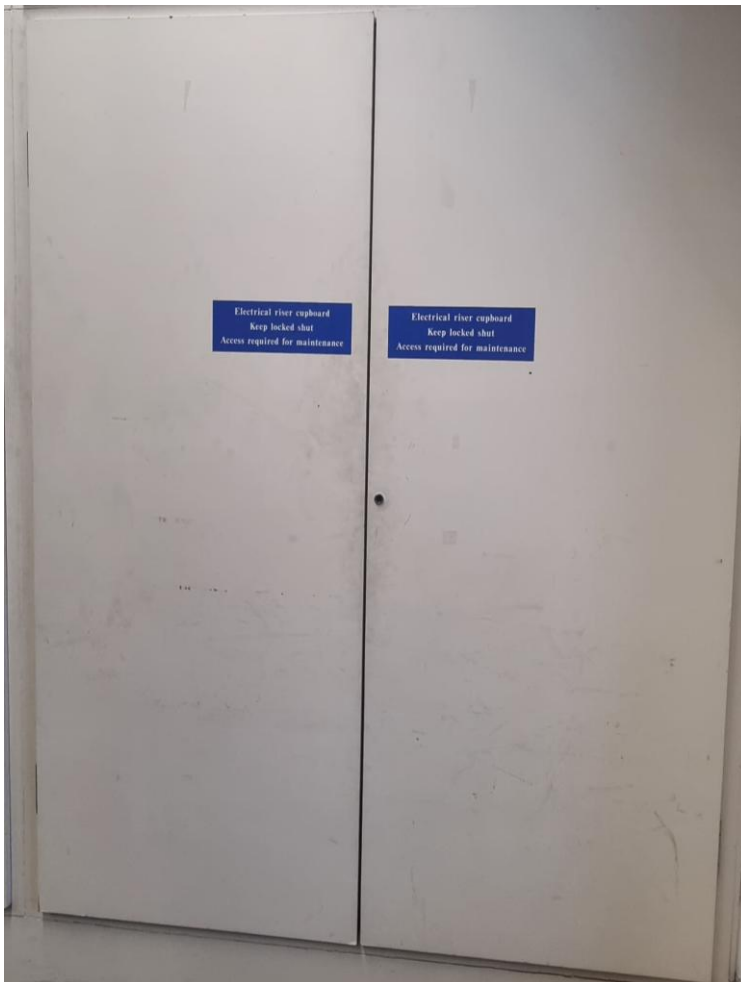
Figure 5 Electrical Riser area Secured and locked

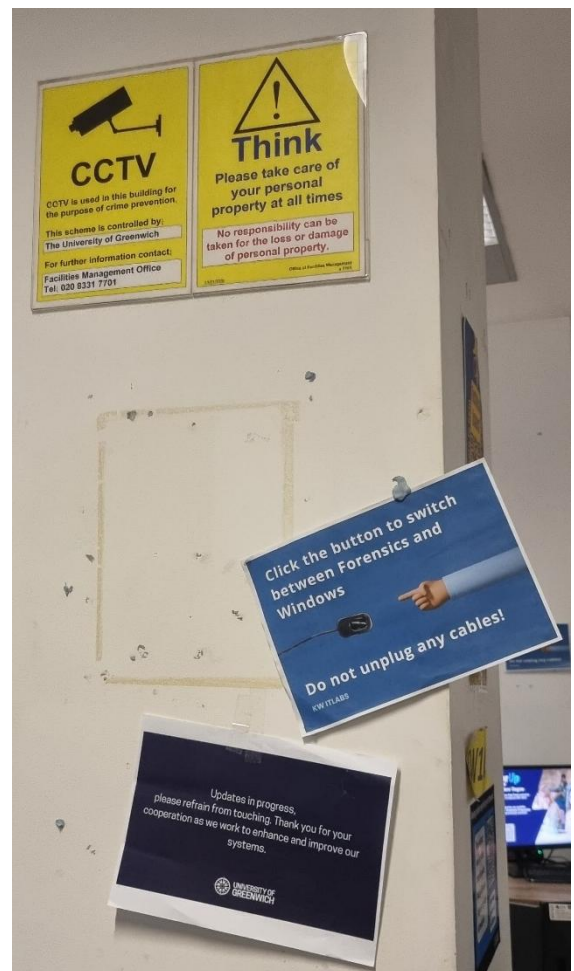
During the audit, several security awareness posters were observed throughout the entire King William Building, including the computing laboratories. These posters helped to promote security, as seen in Figure 6, 7 (refer to the Appendix). In addition, a fire action plan was visibly posted in key areas, ensuring that emergency procedures were easily accessible to staff and students, as seen in Figure 8 (refer to the Appendix). Both students and staff were generally adhering to the security guidelines posted in the labs, with screens consistently locked when students left their workstations, demonstrating good security practices. No sensitive data was left exposed, and students appeared cautious with their personal information. These observations suggest that both students and staff are aware of the security guidelines, and the presence of the posters, is having a positive impact in promoting good security practices throughout the building.

Figure 6 Security awareness Posters

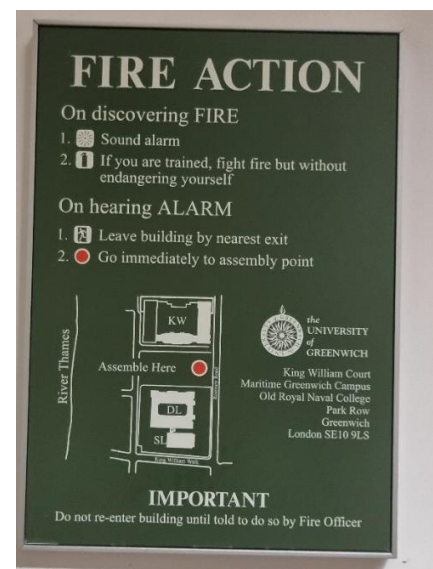
Figure 8 Fire action plan

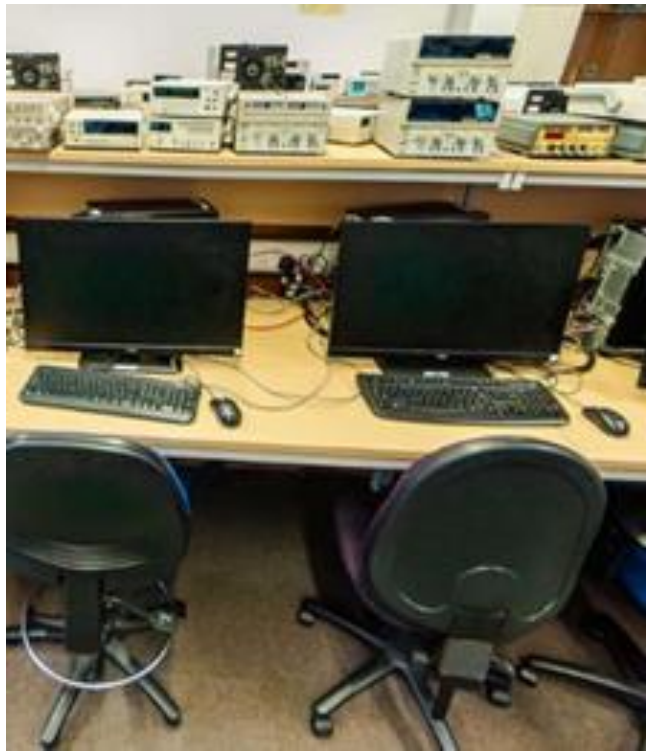
The computing resources were found in open-access labs, with no clear separation or distinction from adjacent areas, potentially exposing them to unauthorized access or theft. In some labs on the upper floor, systems such as CPUs and desktops were securely embedded into the desks and locked, effectively preventing theft as seen in Figure 9 (refer to the Appendix). However, in other labs on the lower floor, the systems, including CPUs and monitors, were unsecured to the desks, which posed a risk of theft as seen in Figure 10 (refer to the Appendix). Also, the systems were placed too close to each other, which increased the risk of shoulder surfing. This setup allowed unauthorized individuals to easily view sensitive information on nearby screens, as seen in Figure 11 (refer to the Appendix). Additionally, a portable air conditioner was observed in the open area of the lab with an "Out of Order" sign attached, indicating it was not functional as seen in Figure 12 (refer to the Appendix). Non-operational equipment, such as this, should not remain in active work areas. These items should be promptly removed and stored in designated, separate areas to prevent confusion, minimize potential hazards, and avoid obstruction of walkways or disruption to the workspace environment. Fire safety measures were robustly in place, with fire extinguishers and alarms strategically located and in good working condition. These safety devices were easily accessible, and a fire action plan was prominently displayed in visible areas, clearly outlining evacuation procedures and safety protocols to follow in the event of an emergency.

The audit revealed several concerns related to IT equipment security and cabling management, both of which could expose the organization to physical and security risks. In the labs, IT equipment such as CPUs and desktops were found in open-access areas without adequate physical security, making them vulnerable to theft or unauthorized tampering. Systems were also placed too closely together, increasing the risk of shoulder surfing, where unauthorized individuals can easily view sensitive information on screens.

Figure 10 Systems unmounted from desk

- Install mounting brackets and privacy screens.
- Remove all loose cables and secure any exposed equipment to prevent theft or damage. Put in place clear policies for keeping IT equipment safe and organized.
- Provide training for IT and facilities staff on how to maintain equipment security and proper cable management. Make sure procedures are updated and easy to follow.

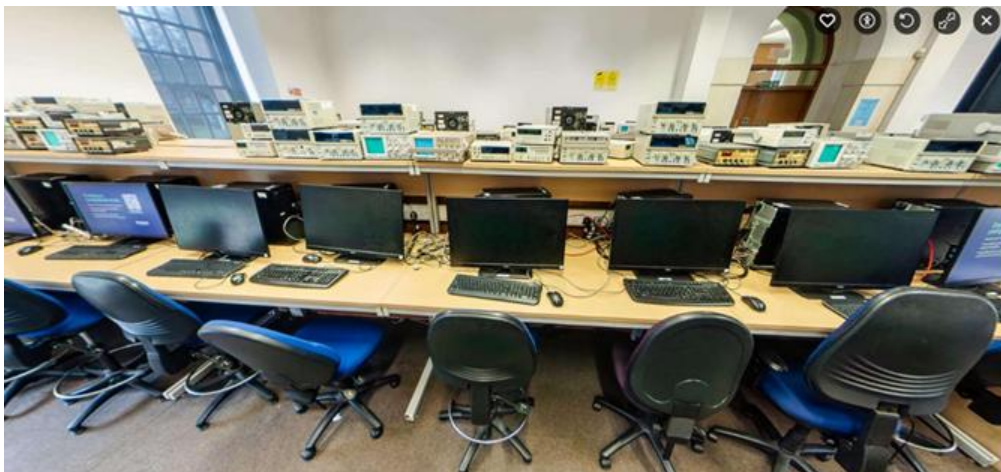
Figure 11 Systems Placed Too Close, Leading to Shoulder Surfing

- **Reduce Shoulder Surfing Risk:** Reconfiguring system placement to create adequate space between workstations or using privacy screens on monitors will help protect sensitive data from unauthorized viewing, minimizing the risk of data breaches and information leaks due to shoulder surfing.

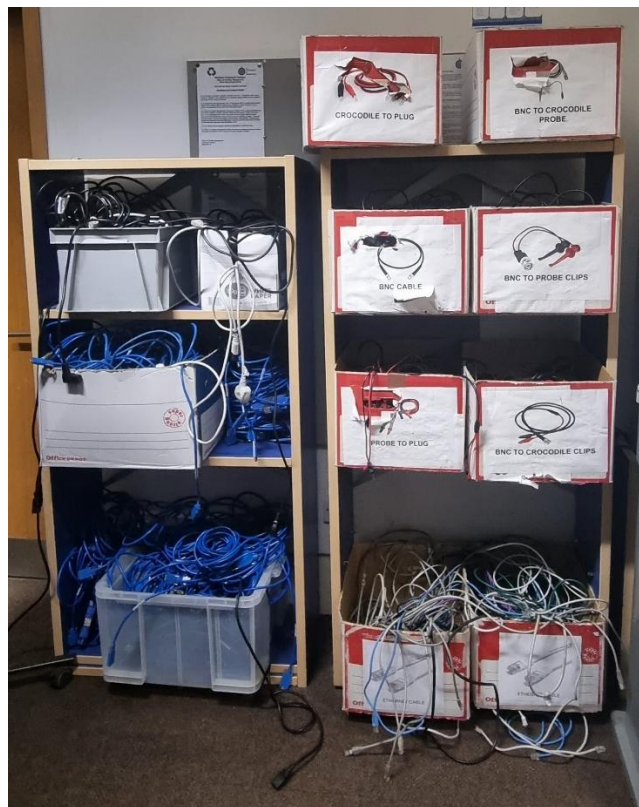
Additionally, cabling practices in certain areas were inadequate. Cables were loosely placed across desks, some were entangled, and unused cables were stored openly in cupboards. These practices increase the risk of physical damage, disconnections, tripping hazards, and unauthorized access to potentially sensitive infrastructure. While some areas adhered to best practices with structured cabling systems, others still posed significant safety and security concerns.

Figure 13 Unused IT Cables Loosely Stored

- **Address Cable Safety:** Secure loose cables and prevent entanglement by routing them through cable trays or protective conduits. Store unused cables in locked cabinets or designated spaces to eliminate tripping hazards, accidental disconnections, physical damage, and unauthorized access, reducing the risk of theft or tampering.

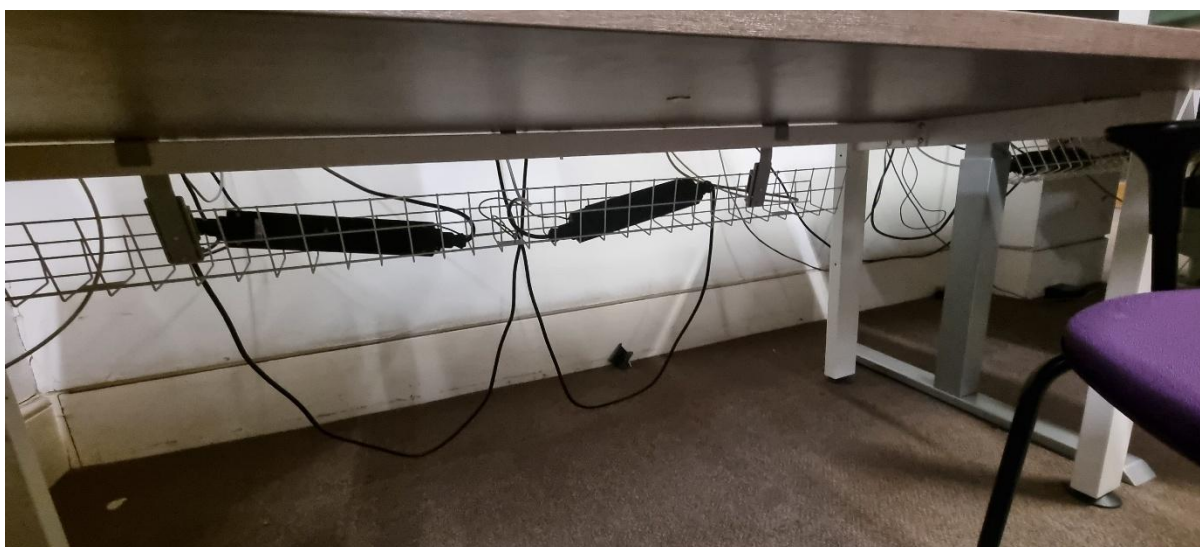
Figure 14 Extension boards and cable trays

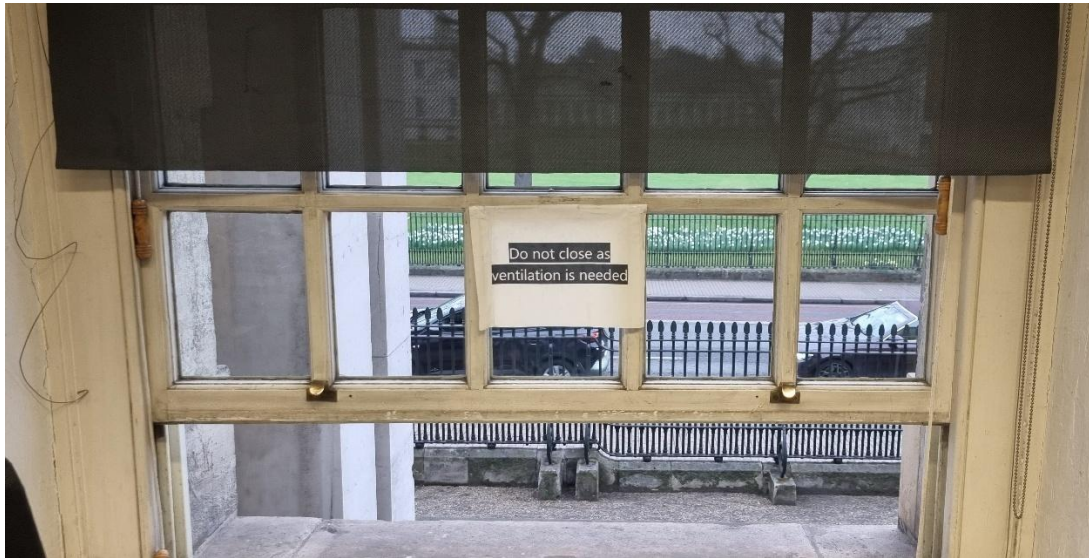
Check for adequate environmental controls (e.g., cooling systems, proper ventilation) in computing areas.	Ceiling ventilation systems, poster on windows to keep windows open and windows blinds were present.
Cabling Security	Inspect cabling for physical protection against damage or tampering.	All cables were in good condition, with no visible damage.
	Ensure critical infrastructure cabling is secured.	The electrical riser cupboard, which contains critical cabling and electrical infrastructure, was securely locked,
	Check that network and power cables are organized and protected from damage.	In some areas, cables were entangled, creating obstructions and increasing wear and tear risks and in other areas, network and power cables were properly routed through structured cabling systems
	Check that unused IT cables are stored securely	Unused cables were stored in an open cupboard near the lab entrance, which could be a security risk.

Figure 15 Ventilation Poster and Blinds on Window
