# Homework 1

Due 27 August 2021

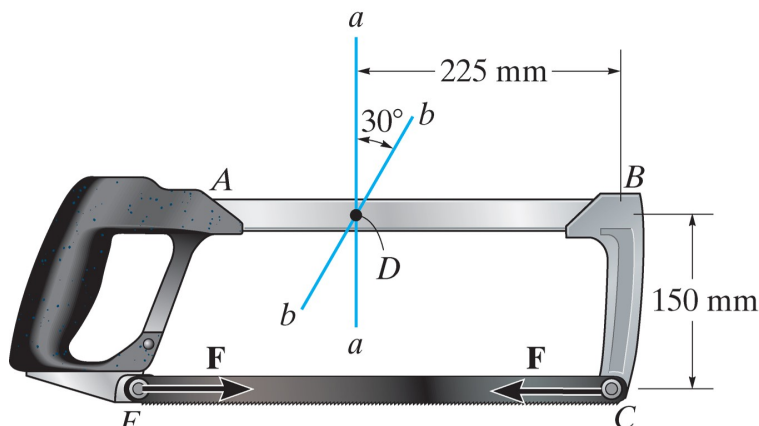
- A hacksaw (and many other styles of thin-bladed saws) are held stiff via a pretensioning as shown. For a pre-load force of 120 N, find the internal loading acting on section  $b - b$  through point D.

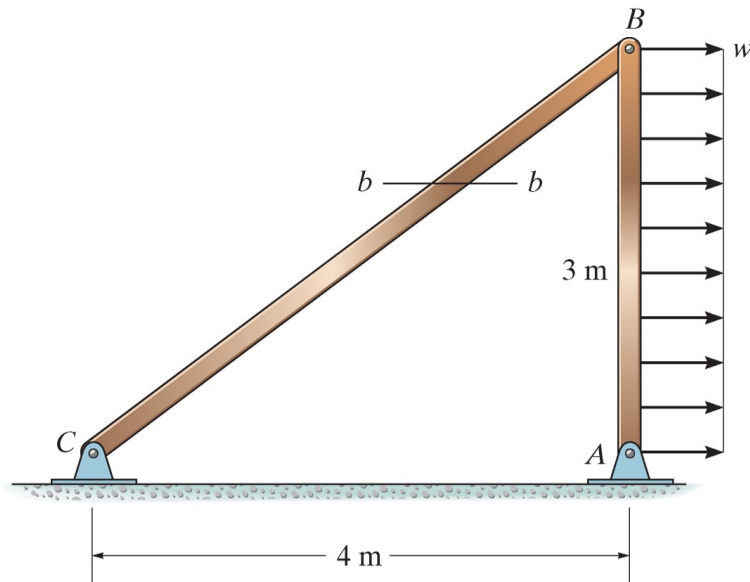
4. Determine the largest uniform load,  $w$ , that can be applied to the frame shown without exceeding an average tensile stress of  $\sigma = 15 \text{ MPa}$  or an average shear stress of  $\tau = 16 \text{ MPa}$  along section  $b - b$ . The bars shown are square tubes 45 mm on the outside and 35 mm on the inside.

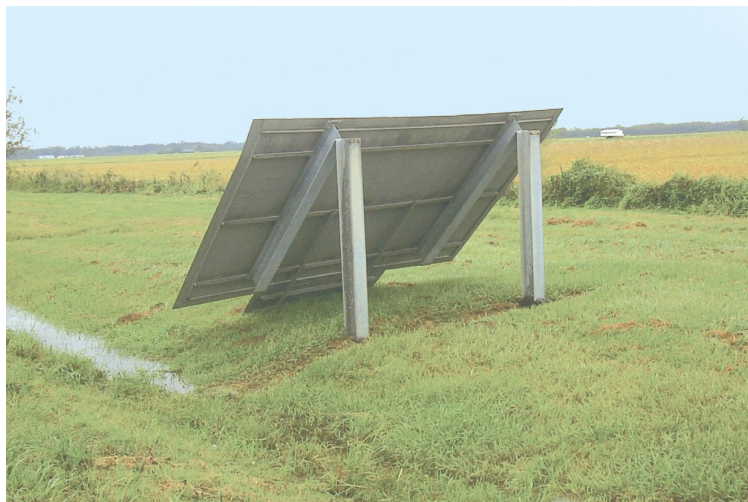
8. Extreme high winds can cause failure of highway signs, as shown here. Assuming a uniform wind pressure of 4 kPa, estimate reasonable sign dimensions and determine the resultant shear where the failure occurred. Compare your answer with the material properties listed on the back cover of your textbook (or an online database), does this seem like a reasonable failure or do you suspect some bad assumptions?

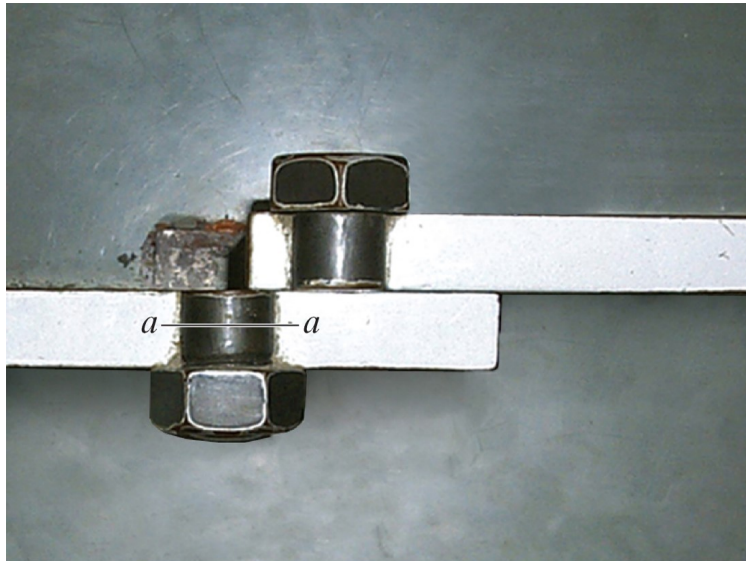
9. The bolt shown has failed due to single shear. Use free body diagrams to show why the bolt failed at this point and not somewhere else.
