# Homework 1

Due 25 Aug 2020

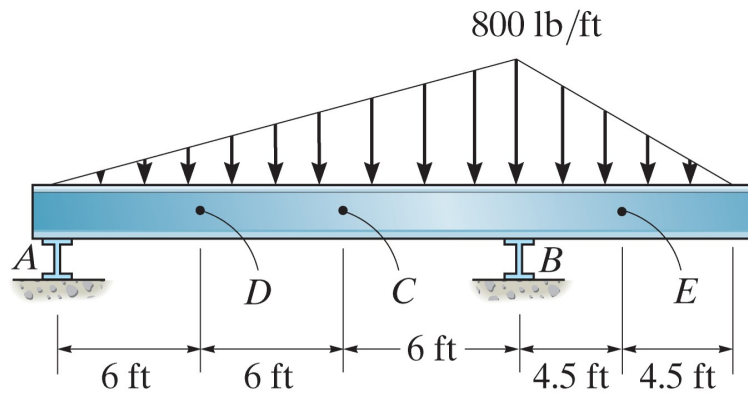
1. Find the internal load at points D and E.

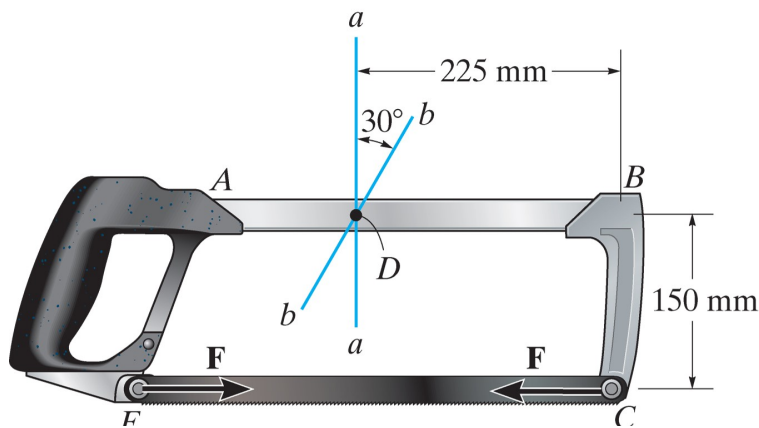
2. A hacksaw (and many other styles of thin-bladed saws) are held stiff via a pretensioning as shown. For a pre-load force of 120 N, find the internal loading acting on section  $b - b$  through point D.

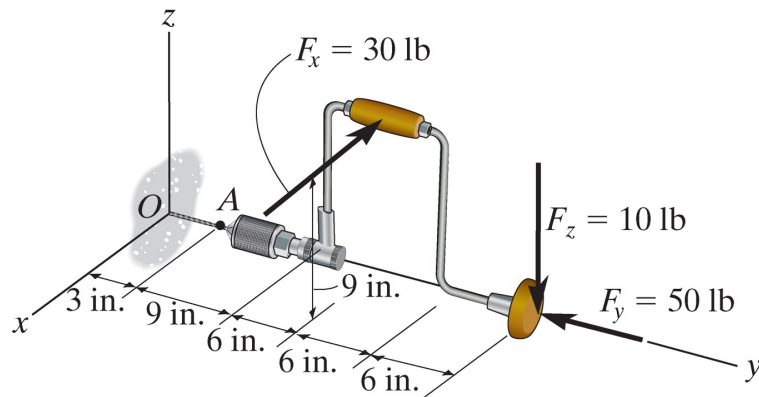
3. A bit brace is a type of hand drill. If the brace shown jams and is subjected to the force shown, find the resultant internal loading on the shank of the drill bit (point A).

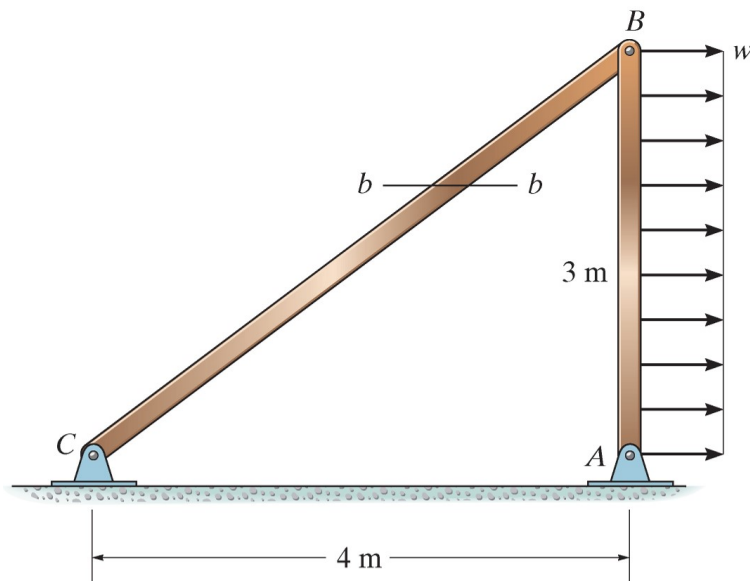
4. Determine the largest uniform load,  $w$ , that can be applied to the frame shown without exceeding an average tensile stress of  $\sigma = 15 \text{ MPa}$  or an average shear stress of  $\tau = 16 \text{ MPa}$  along section  $b - b$ . The bars shown are square tubes 40 mm on the outside and 30 mm on the inside.

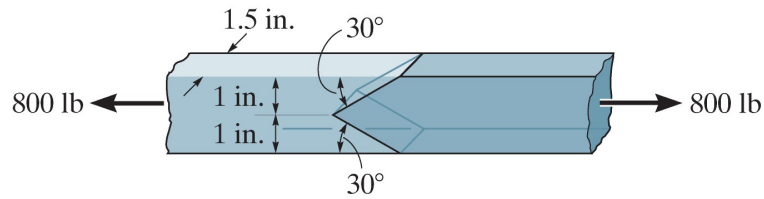
5. Two members for an airframe are welded together using a  $30^\circ$  fish-mouth weld. Find the average shear stress on the plane of each weld for the case shown.

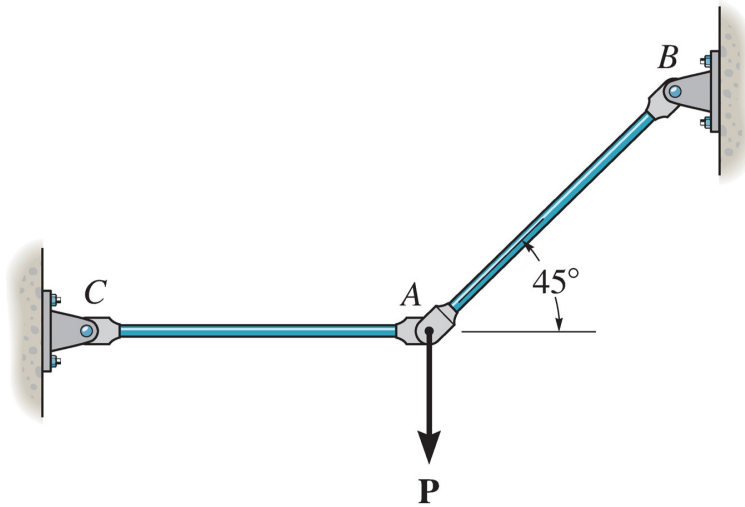
6. Two aluminum rods support a vertical force of  $P = 20$  kN. Find the diameter of the rods (they are solid and have the same diameter) for a failure stress of  $\sigma = 120$  MPa and a safety factor of 1.5.

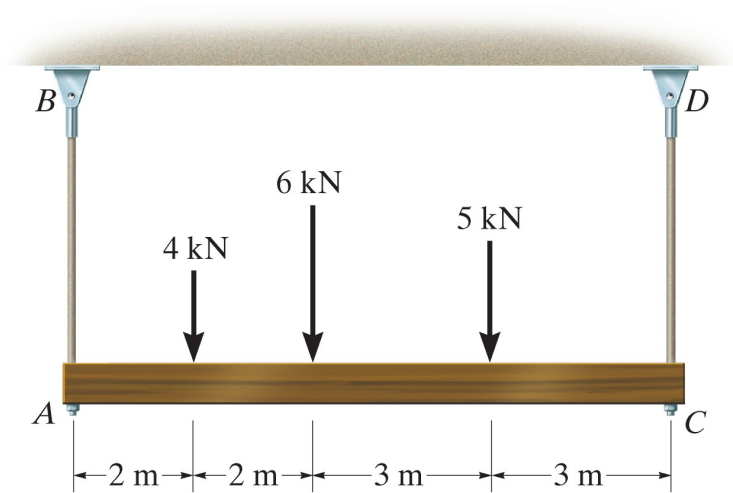
7. The two rods ( $AB$  and  $CD$ ) supporting beam  $AC$  are made of steel. Determine the smallest rod diameter to support the dead loads shown along with an additional live load of 5 kN. The resistance factor for steel in tension is  $\phi = 0.9$ , use a dead load factor of  $\gamma_D = 1.4$  and a live load factor of  $\gamma_L = 1.9$ . The failure stress for this steel alloy is  $\sigma_{fail} = 360$  MPa.

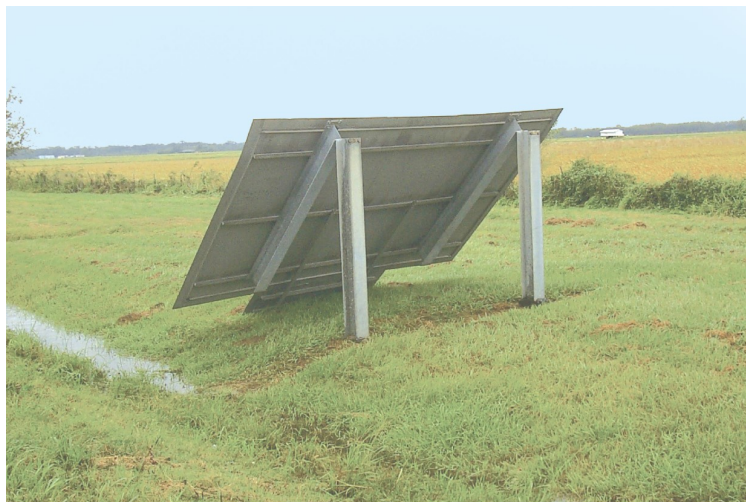
8. Extreme high winds can cause failure of highway signs, as shown here. Assuming a uniform wind pressure of 3 kPa, estimate reasonable sign dimensions and determine the resultant shear where the failure occurred. Compare your answer with the material properties listed on the back cover of your textbook (or an online database), does this seem like a reasonable failure or do you suspect some bad assumptions?

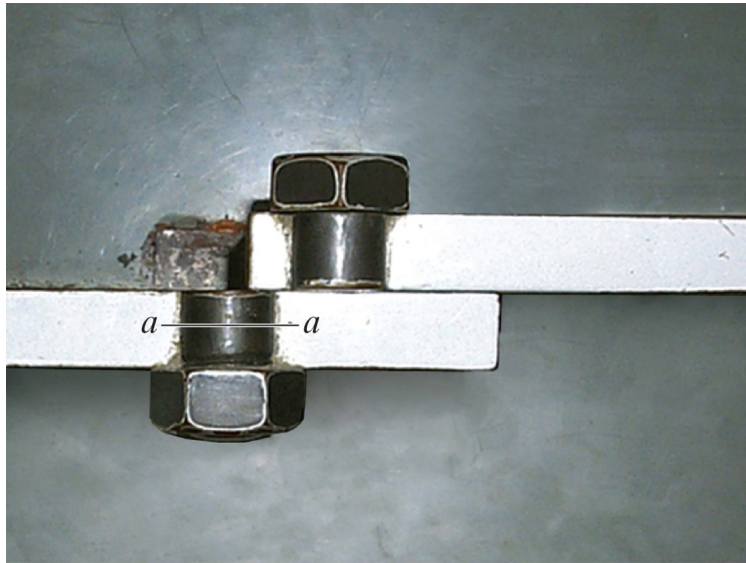
9. The bolt shown has failed due to single shear. Use free body diagrams to show why the bolt failed at this point and not somewhere else.
