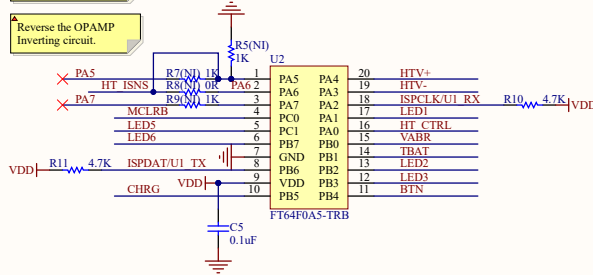
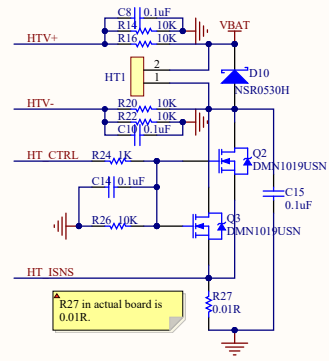
R5, R7, R8, R9 do not populate.

Reverse the OPAMP Inverting circuit.

R27 in actual board is 0.01R.

For charging status purpose - detect the presence of the 5V.
