# *VOLVO PENTA SPEED RELAY*

A Guide to Testing & Repair

# Volvo Penta Speed Relay

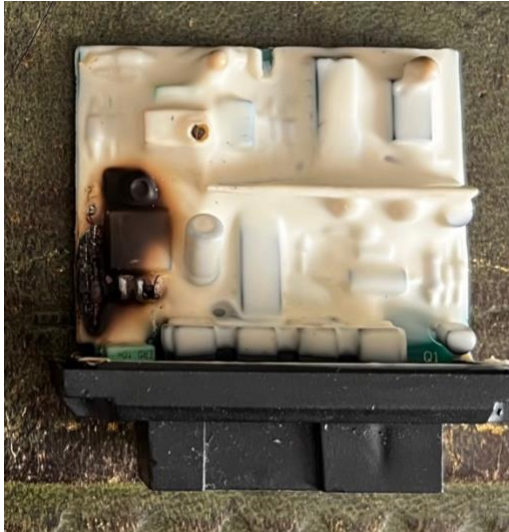
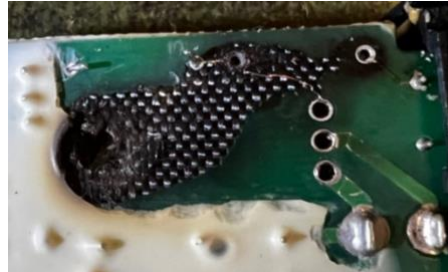
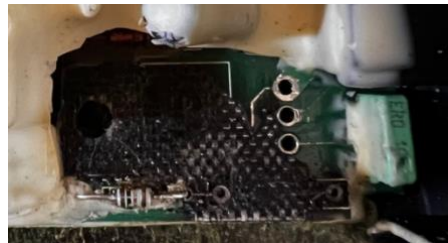
Whilst the board has suffered from heat damage which has also damaged some of the tracks and the pads it is still repairable, although the repair will be obvious.

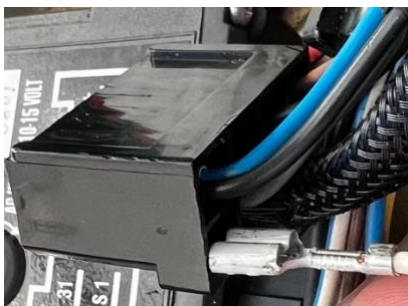
<<< Volvo connector

Locate cable S1 / Pin 5 on the Volvo connector block. Do not cut this cable. Remove the connector from the connector housing using a [connector pin removal tool](#).

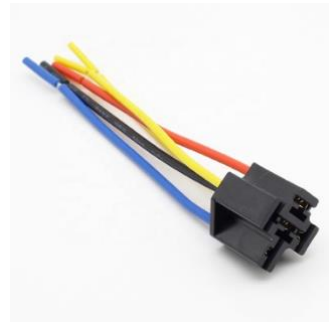
New relay socket >>>

On the new relay socket remove the existing cable for Pin 30\*\* using a pin removal tool and insert the cable removed from S1/Pin 5 into the new relay socket at Pin 30.

On the new relay socket locate pin 85.

Using another relay socket as a donor remove the same colour cable using a pin removal tool. Cut to length and join this spare cable together with the cable on pin 85. The 'new' connector obtained from the donor relay socket will then plug into the now empty position S1/Pin5 on the Volvo connector block.

On the new relay socket locate pin 87. This cable should be spliced onto cable 31/Pin 1.  
On the new relay socket locate pin 86. This cable should be spliced onto cable 15/Pin 7.

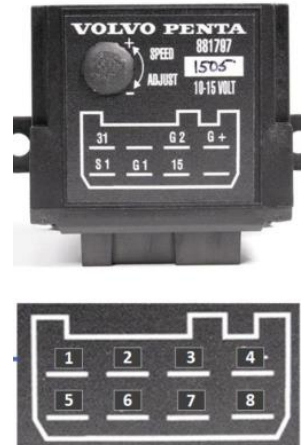
Connector	Case Identifier	Info
P1	31	GND
P2	-	n/c
P3	G2	Signal from position sensor
P4	G+	Supply to position sensor
P5	S1	Supercharger
P6	G1	Engine Speed Sensor
P7	15	Ignition Switch (+12v)
P8	-	n/c

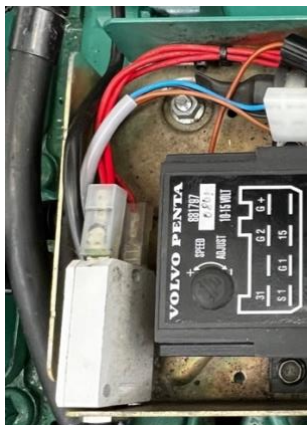
The circuit breaker / trip is the white item shown below. It will trip at 10A.

If it is tripping repeatedly then it is likely there is a fault with the supercharger coils.

Check the trip is correctly wired and has not been bypassed by a previous owner.

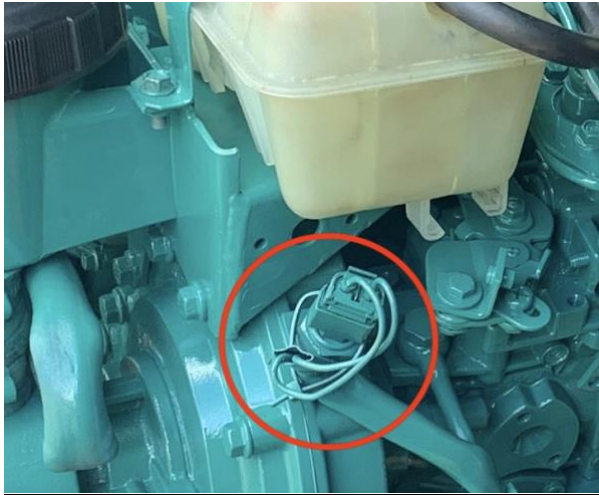
This item is located on the camshaft cover.

Inductive sensor (cog counter). Internal resistance  $1050 \Omega \pm 100 \Omega$ .

With the connector removed measure the resistance with a multimeter set to Ohms.  
Expected reading  $1050 \Omega \pm 100 \Omega$

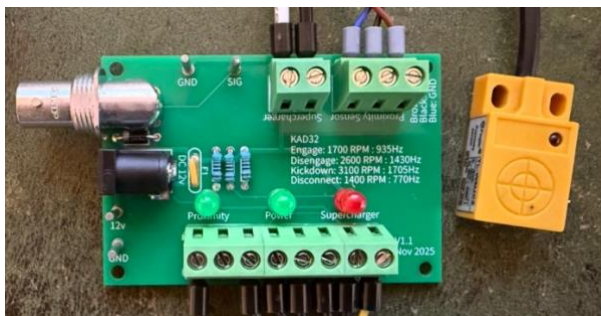
This is a test board designed to perform bench testing of the speed relay and the proximity sensor. This simplifies the connections shown in the diagram above.

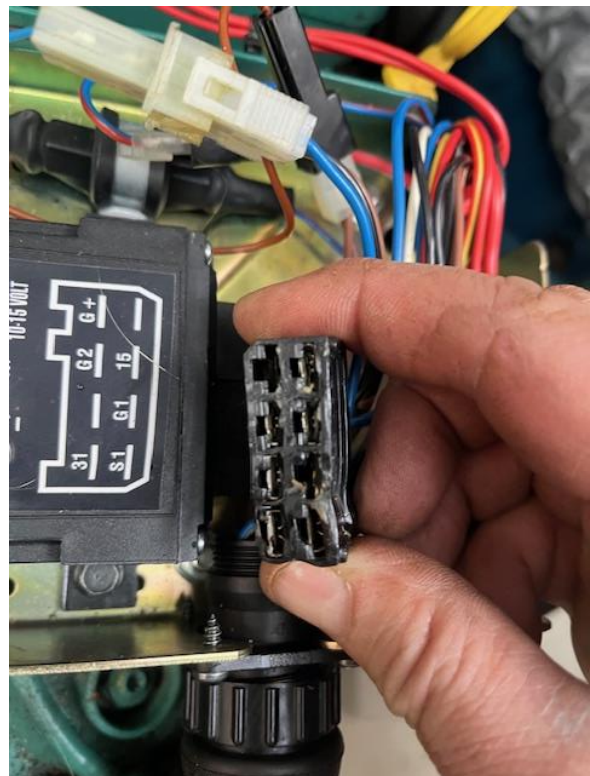
Picture below shows a wiring loom damaged by a faulty clutch coil. This caused considerable damage.

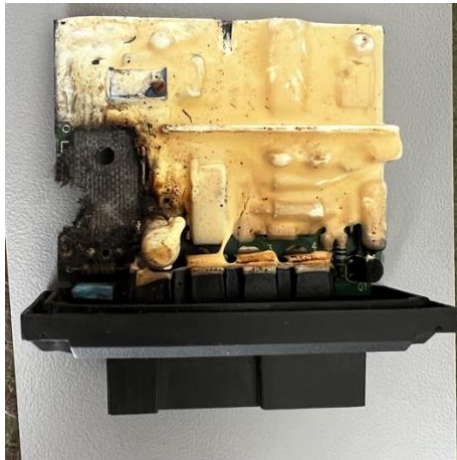
Unfortunately for this owner the speed relay was beyond repair. The heat had damaged 6 components, and the main board had started to disintegrate.

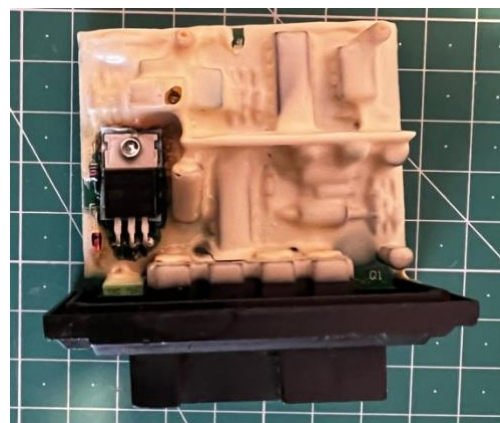
A different board and a successful repair.

This board had heat damage, but no track damage. Whilst cosmetically it does not look perfect, it is a good repair with a new transistor riveted in place.

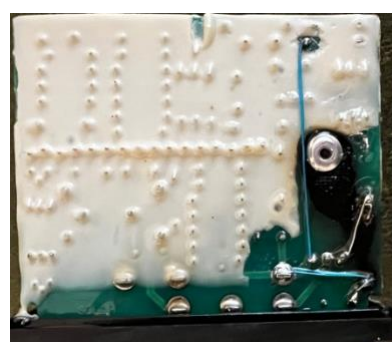
Another board with track and component damage.

Successfully repaired with the repair covered in a conformal coating to protect it from moisture and corrosion.
