Lessons Learned: The North Carolina Backyard Rain Garden Program

Abstract: Research conducted at the North Carolina State University and elsewhere has determined that bioretention practices are very effective in reducing polluted stormwater runoff from urban areas. Smaller residential bioretention areas, also known as rain gardens, have proven to be an effective means of removing metals, nutrients, sediment and fecal coliform provided that they have been designed, sited, constructed and maintained properly. The university, local and state governments have been promoting the installation of rain gardens and other stormwater practices in Phase I and II communities for many years; however, very few homeowners and commercial landscape contractors have a working knowledge of the benefits of rain gardens, their installation or their maintenance requirements. To help promote rain gardens and address these needs, the North Carolina Backyard Rain Garden Program was implemented during the summer of 2006 in a six-county pilot area. Funded as an EPA 319(h) project, the program (1) developed an education program by conducting homeowner workshops in each county, (2) installed more than 40 resid

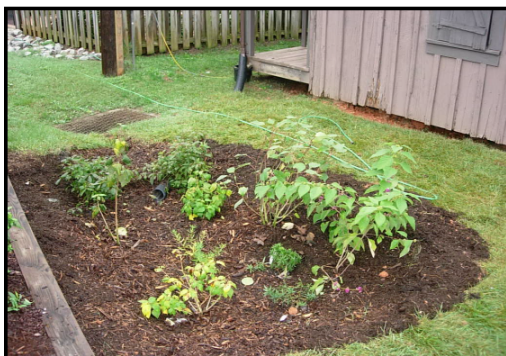
(a) Rain garden in “Good” condition.

Figure 2. Example rain gardens described as (a) “Good,” (b) “Fair” and (c) “Failure.”

Rain garden sites were re-visited approximately two years after installation and the condition of the garden was judged to be Good, Fair or a Failure. Good condition meant the practice was functioning as designed; maintenance activity was obvious, plants were cared for and thriving, and adequate storage volume had been maintained. Fair condition indicated little or no maintenance had been performed; plants showed some

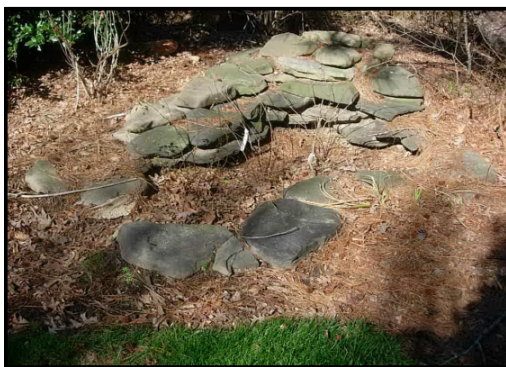
(b) Rain garden in “Fair” condition.

stress, needed pruning, or needed replacement. A “fair” rain garden, however, retained at least some treatment function. A Failure indicated the garden was either abandoned or had no maintenance performed; plants were dead or dying, mulch was absent and the rain garden was no longer capturing and treating runoff. Images of prototypical rain gardens in each category are presented in Figure 2.

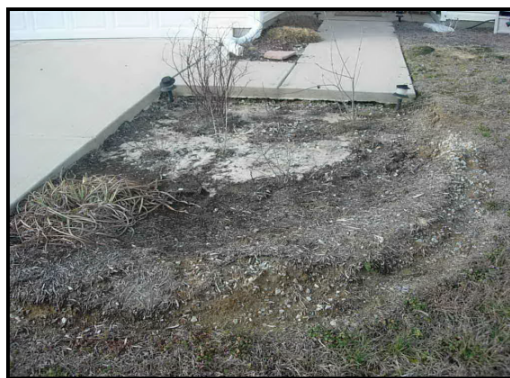
(b) Rain garden in “Poor” condition.
